**ERA19LA074**

**Diamond DA20– N346MA**

**NTSB ENGINE EXAMINATION FIELD NOTES**

**Examination Date: May 7-8, 2019**

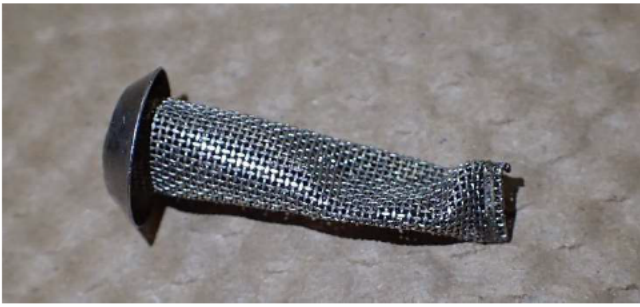
Picture 2. Fuel Pump Inlet "Finger" Screen

- A fuel pump inlet 'finger' screen was in the bottom of the crate, partially crushed but otherwise unobstructed.

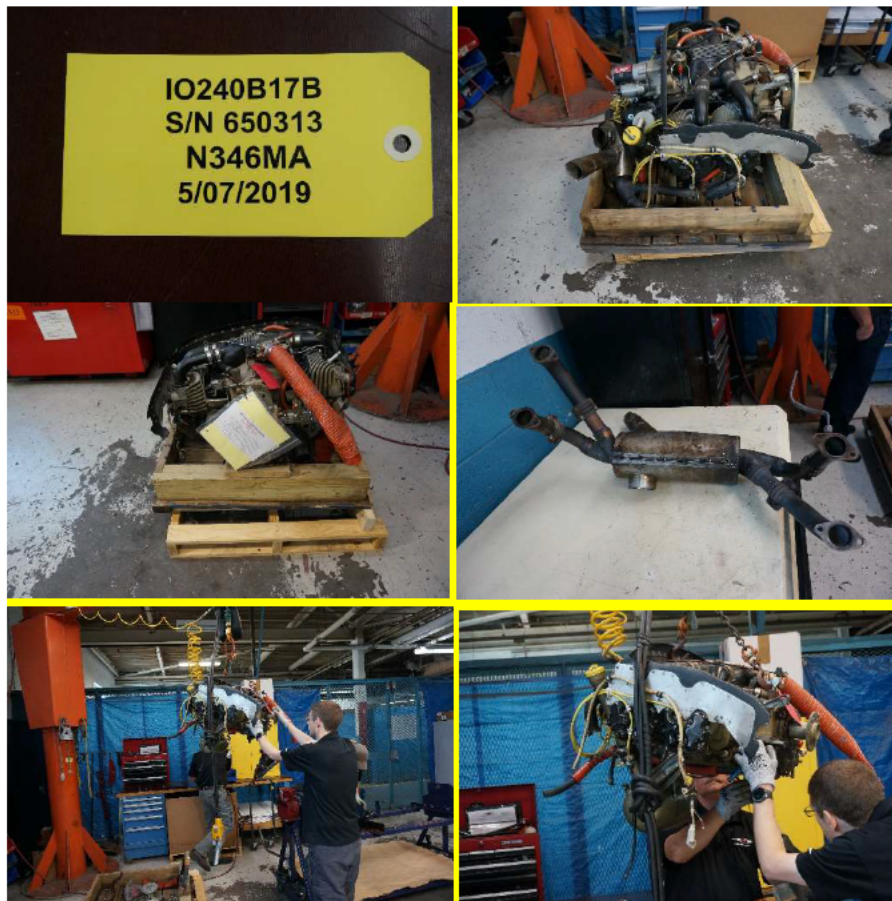
Picture 3. Engine as Received

- The Nos. 2 bottom sparkplug lead wire was damaged near its clamp location on the cylinder, the No 4 top sparkplug lead wire was damaged near its terminal end. Both were repaired prior to running engine.
- The fuel pump and manifold valve remained intact. The alternator and drive pulley were already removed and lay in the bottom of the crate.
- The lower left engine mount was damaged and could not be used.

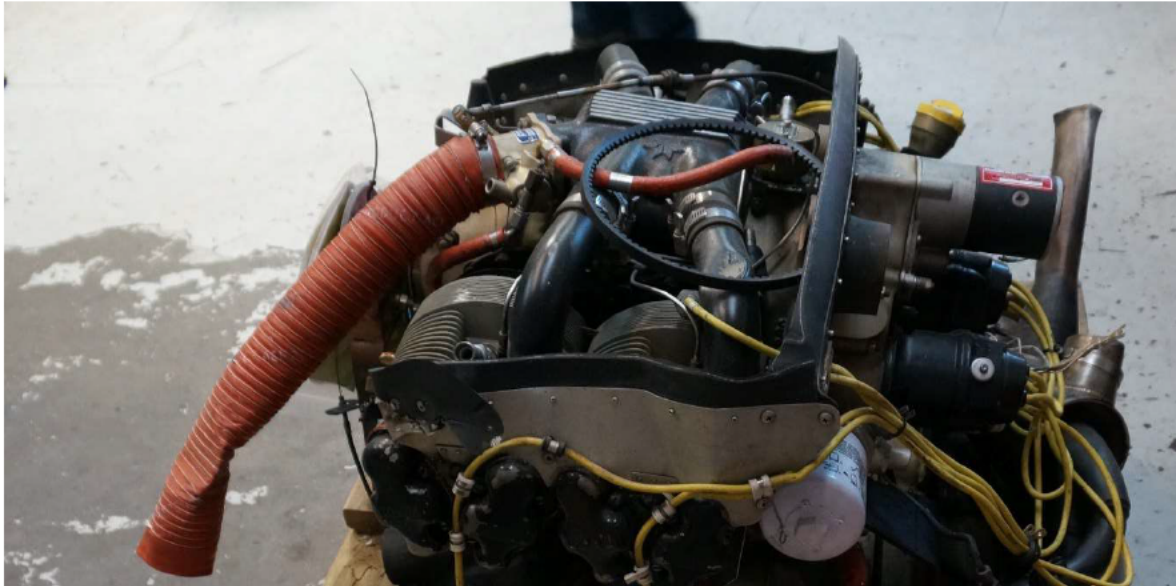
Picture 4. Engine

The exhaust manifold and muffler were not attached to the engine and were on the bottom of the crate. The air induction tube remained attached to the engine. The throttle and metering unit and intake manifold assembly remained intact.

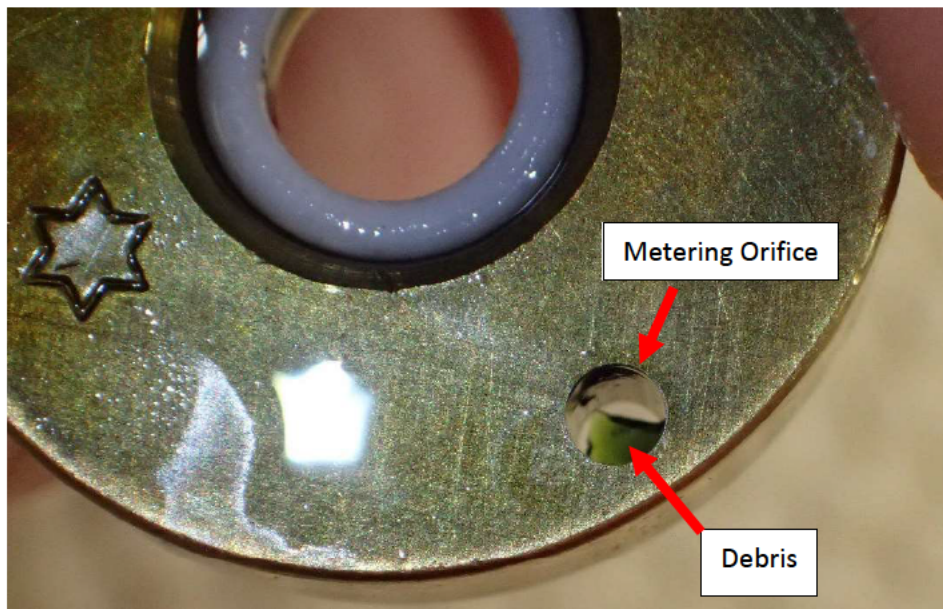
Picture 6. Debris Lodged in Metering Plug Orifice

The original throttle and metering unit (installed during accident flight) was removed and tested on a production test bench. The test parameter for fuel flow was below allowable limits at all throttle positions (see attached test sheet).

The original throttle and metering unit was disassembled. A piece of debris about 1/16" square and dark green in color, was found lodged in the metering plug orifice.

A sample of known torque putty was submitted for comparison to the unknown sample. The known torque putty sample was a green, glassy solid. The spectrum of the known torque putty sample was very similar to the unknown spectrum but was not an exact match. However, based on peak matches in both spectra at  $\sim 3400\text{ cm}^{-1}$ ,  $\sim 2920\text{ cm}^{-1}$  and  $\sim 2870\text{ cm}^{-1}$ ,  $\sim 1720\text{ cm}^{-1}$ ,  $\sim 1170\text{ cm}^{-1}$ , and  $\sim 860\text{ cm}^{-1}$ , the unknown material was most likely a piece of torque putty of similar composition to the known sample or a degraded sample of the known torque putty.

The debris was removed, and the throttle and metering unit was reassembled and installed on the engine. The original fuel pump was installed on the engine. The engine test ran satisfactorily/normally on subsequent test runs.

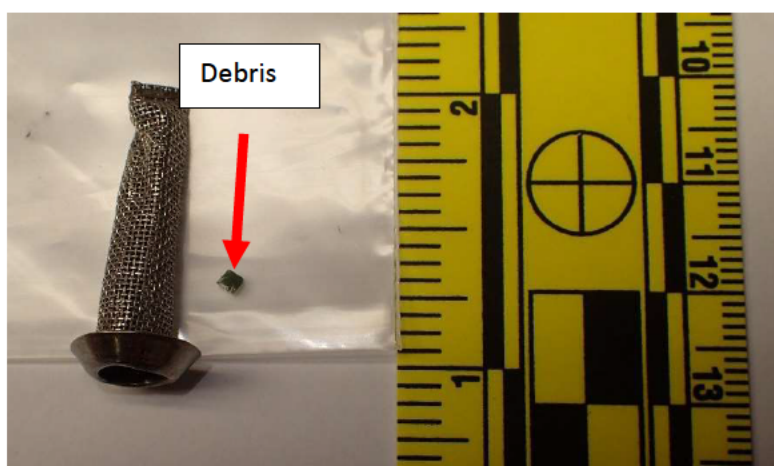
Picture 7. Debris and "Finger" Screen

Some debris was found inside the previously installed fuel manifold. It was downstream of the manifold's filter screen, and similar in color/texture to the debris that was found in the accident throttle and metering unit orifice, though much smaller in size. No debris were found in the previously installed fuel pump or throttle and metering unit.
