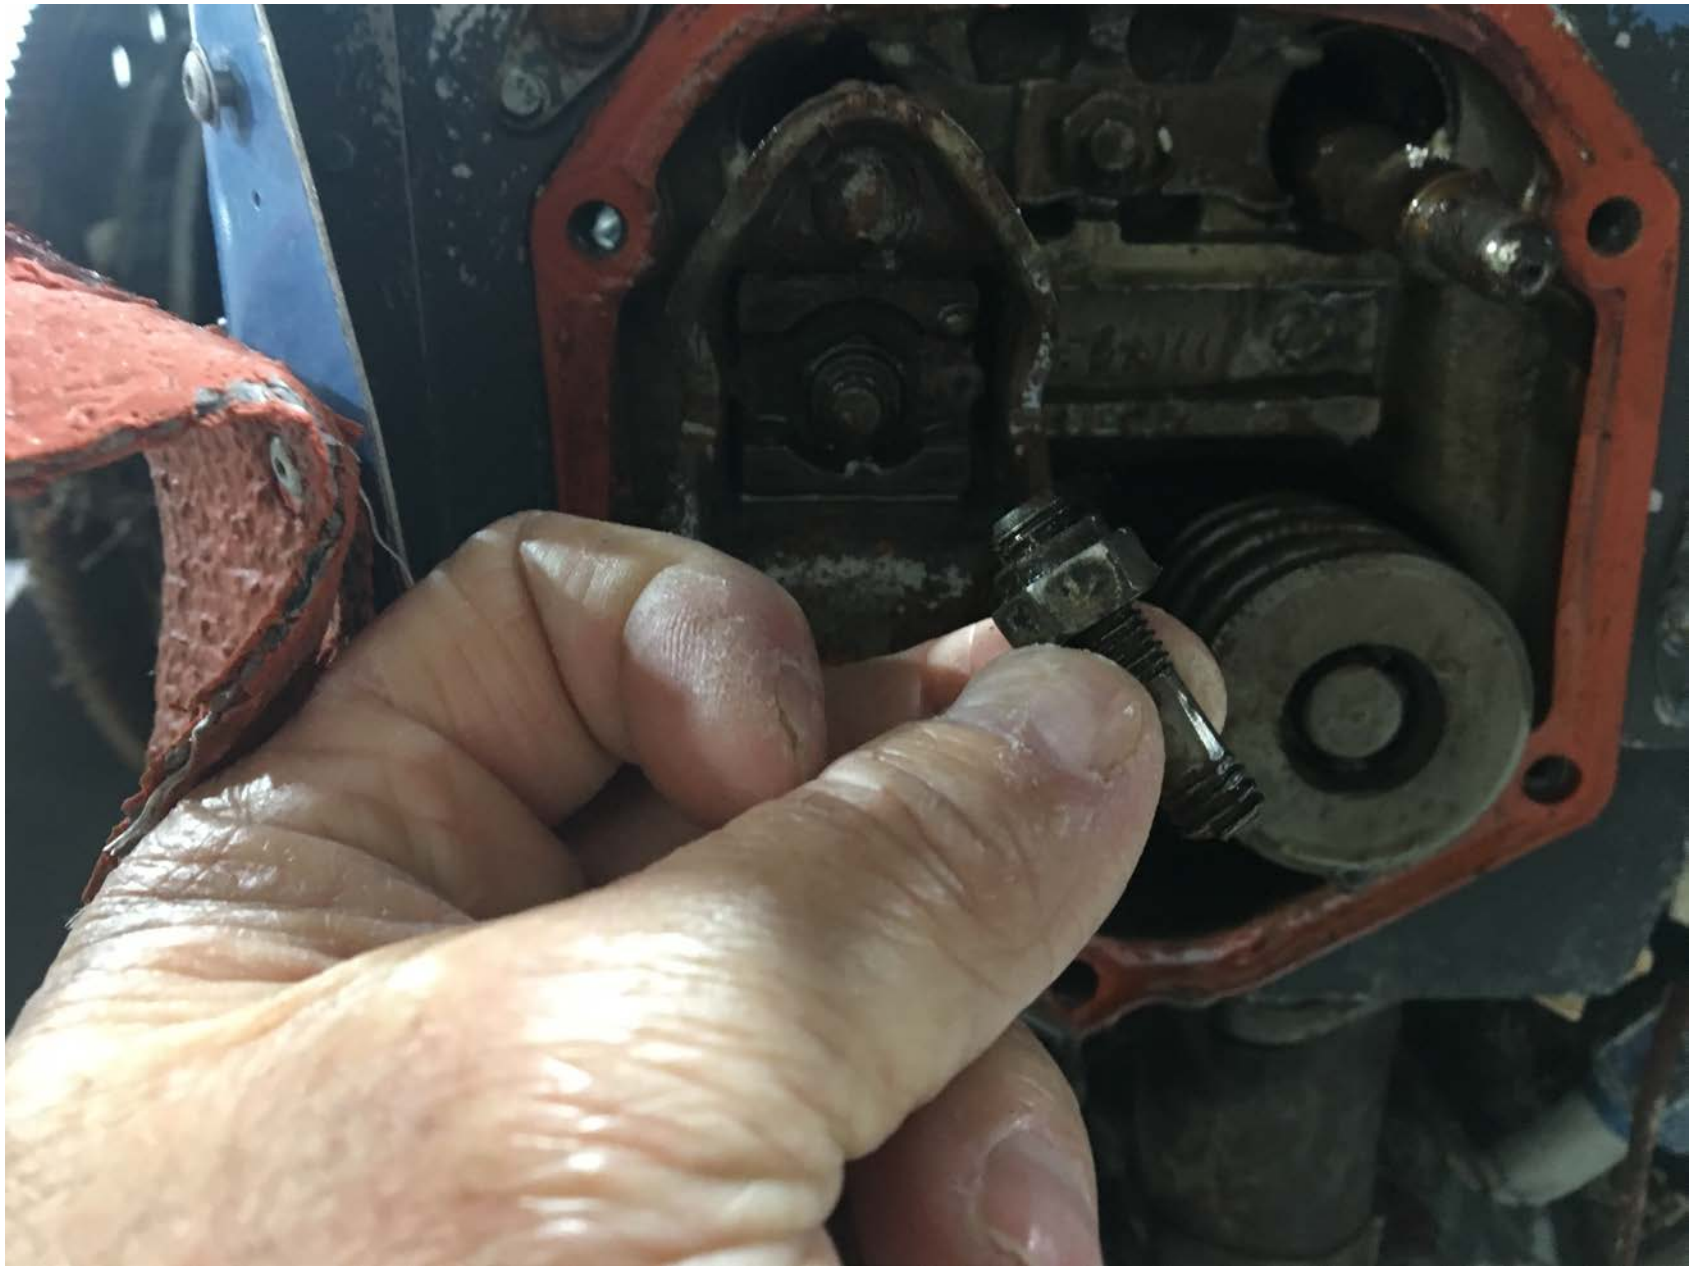
**Photo 2 – Fractured Stud, exhaust rocker arm.**

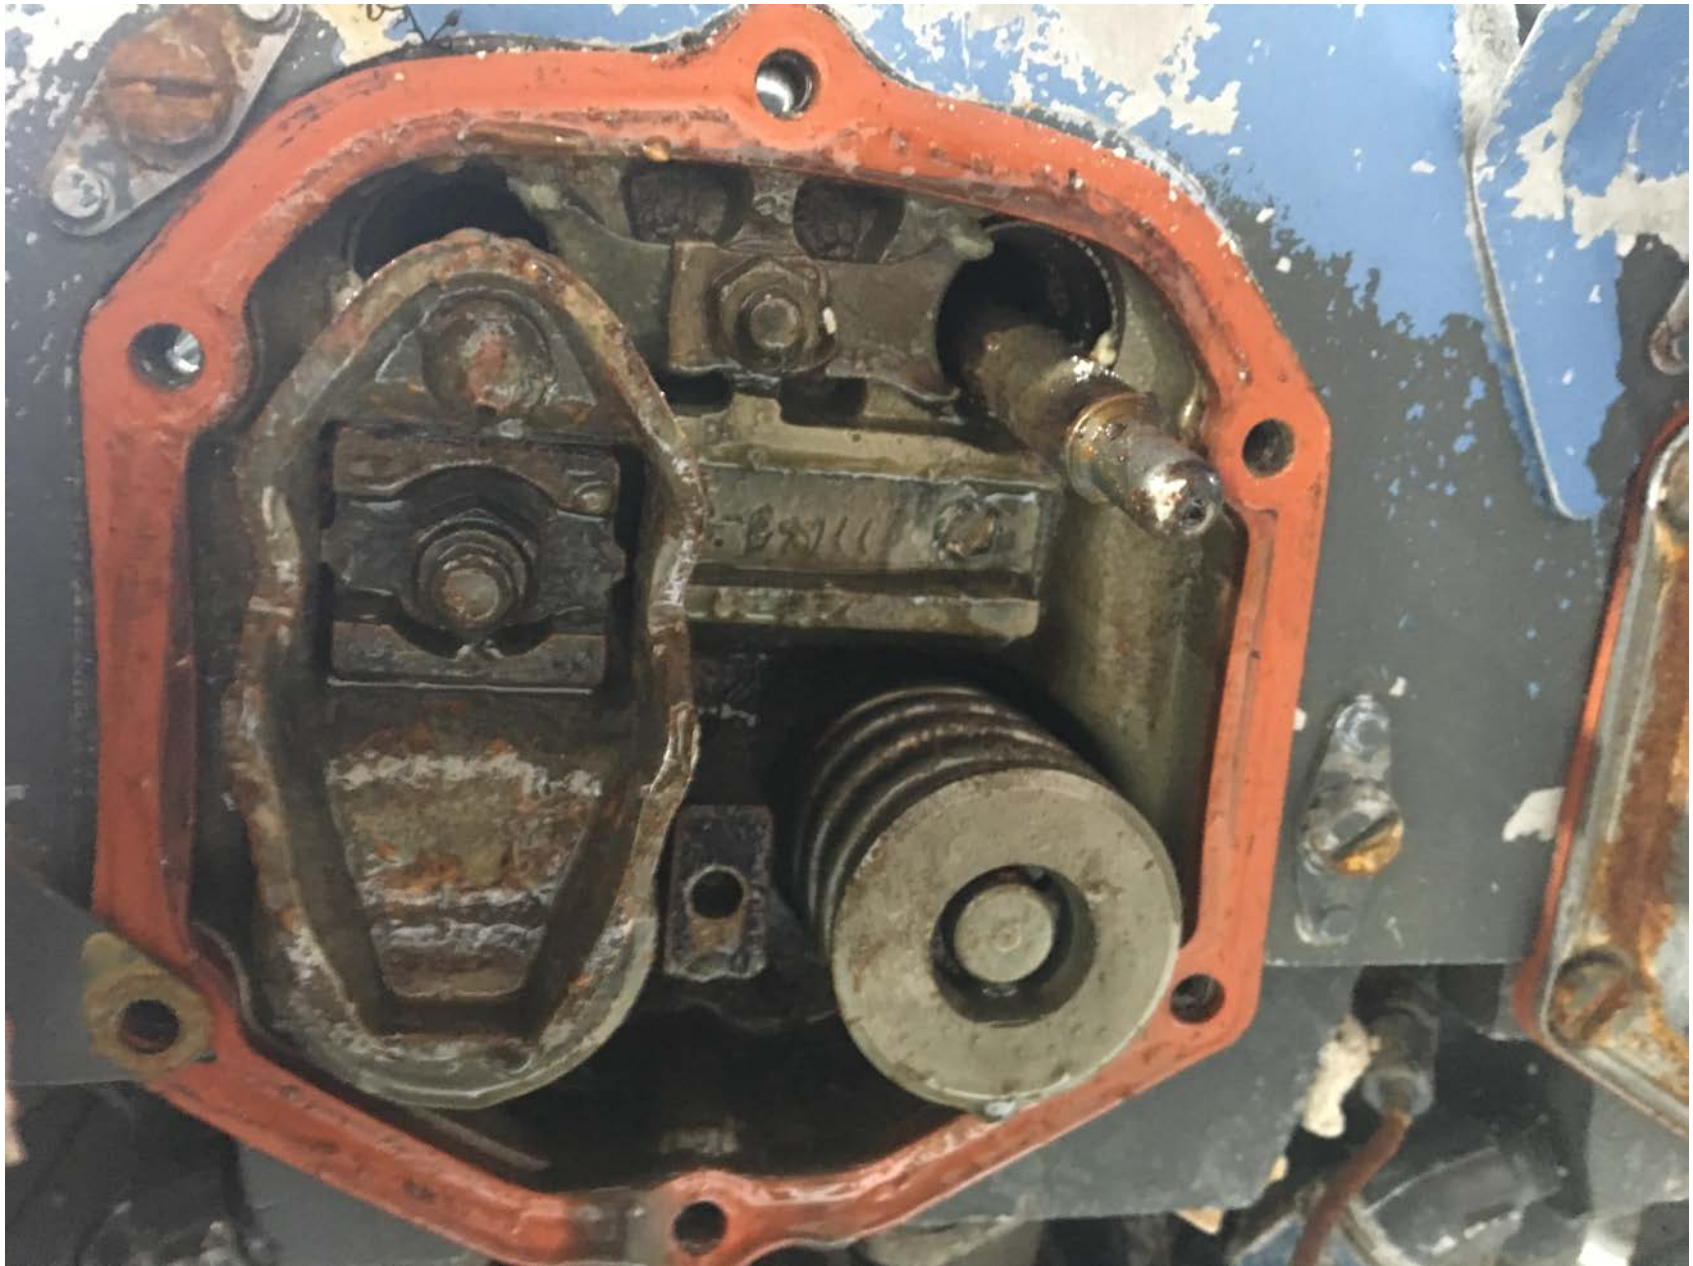
**Photo 3 – No. 2 cylinder, fractured rocker arm stud.**
