**NATIONAL TRANSPORTATION SAFETY BOARD**  
Vehicle Recorder Division  
Washington, DC 20594

## **Onboard Image Recorder**

**Specialist's Factual Report**  
**By Gerald Kawamoto**

| NTSB Number: | ERA19LA080 |

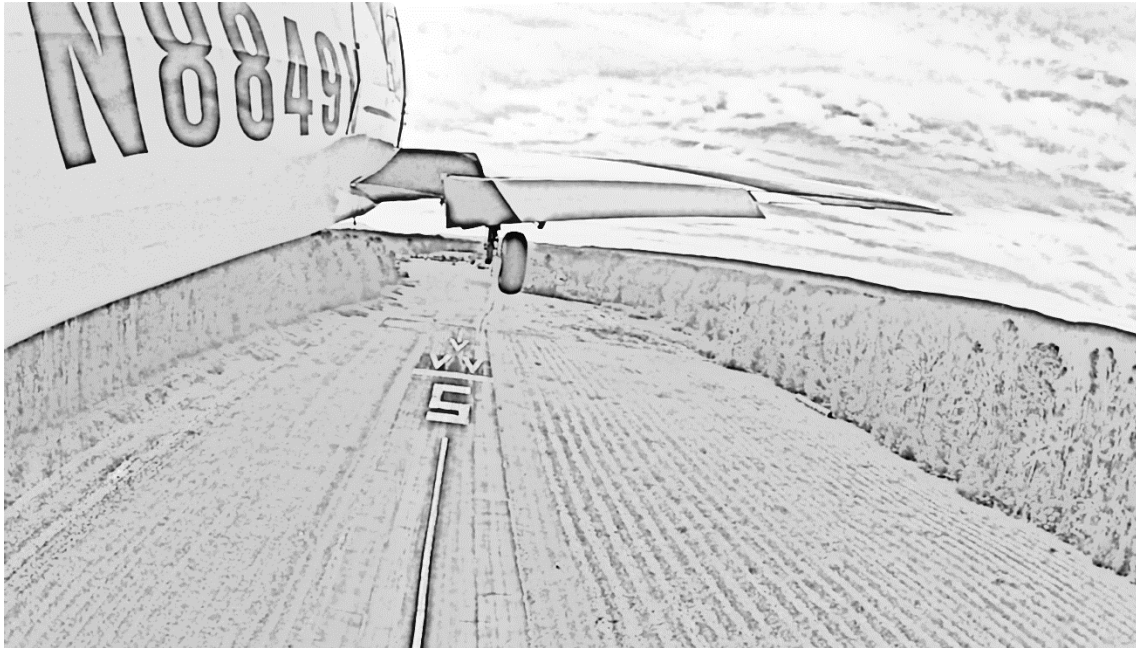
Figure 1 is a digital illustration of the camera's field of view. The GoPro was mounted on the right horizontal stabilizer looking forward. It captured the right flap and right aileron positions as well as an indication of whether the engine was running. No audio track was included with the video file.

Figure 1. A digital illustration of the field of view of the camera on the right horizontal stabilizer.

At 19:44 the aircraft had rolled approximately 90 degrees left and the aircraft's nose had begun to fall through the horizon (becoming negative in pitch). During this time the right aileron is observed in an upward position (right roll command). At this time the aircraft appeared to depart controlled flight. The aircraft continued to roll left sharply and appeared to enter a left spin. The aircraft completed approximately one full rotation of a left spin and impacted the water at 19:50. During the time in which the aircraft was descending in a left spin, the right aileron was observed in mostly an upward position. During the pitch up and subsequent departure from controlled flight, the flaps were observed in the up position and the propeller continued to rotate and did not appear to lose RPM.

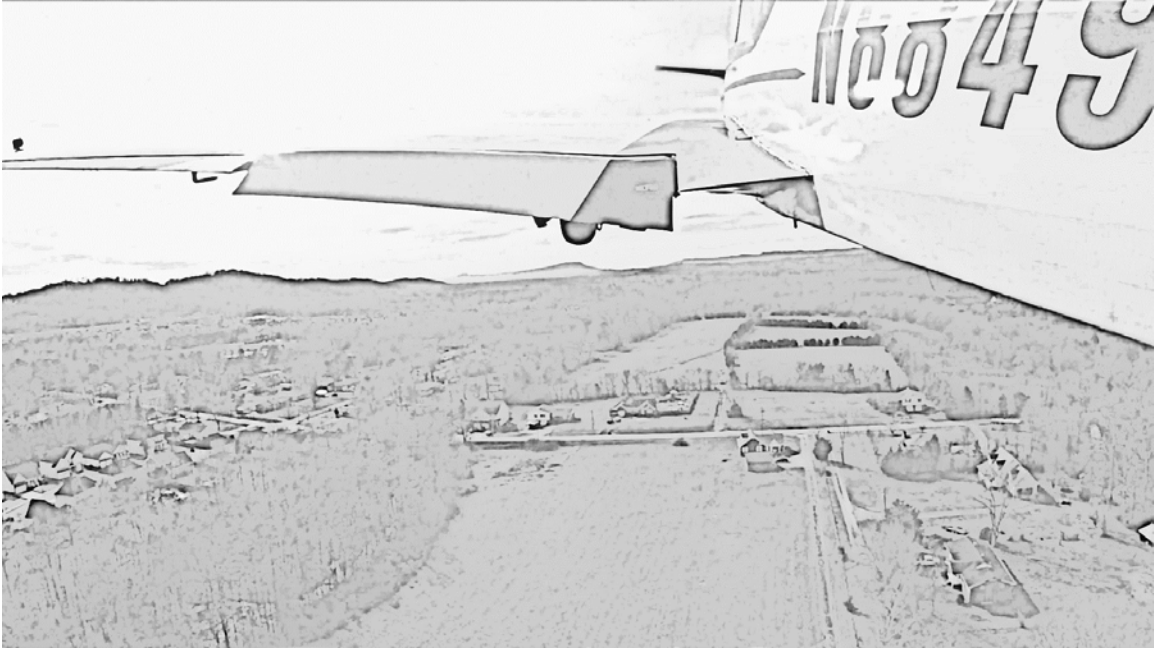
Figure 2 is a digital illustration of the camera's field of view. The GoPro was mounted on the left horizontal stabilizer looking forward. It captured the left flap and left aileron positions as well as an indication of whether the engine was running. An audio track was included with the video files.

**Figure 2. A digital illustration of the field of view of the camera on the left horizontal stabilizer.**

The video and audio files were mostly unremarkable. The video content contained the same type of information observed in the right horizontal stabilizer files but on the other side of the aircraft.
