## Air Safety Investigations Aircraft Incident/Accident Technical Report

| <b>Aircraft Incident/<br/>Accident Information</b> | Year: 2008 | Make: Cessna | Model: LC41-550FG |
| Air Safety Investigator: Andrew L. Hall | | Report #: ASI-19-AA-T | Report date: 11-08-19 |

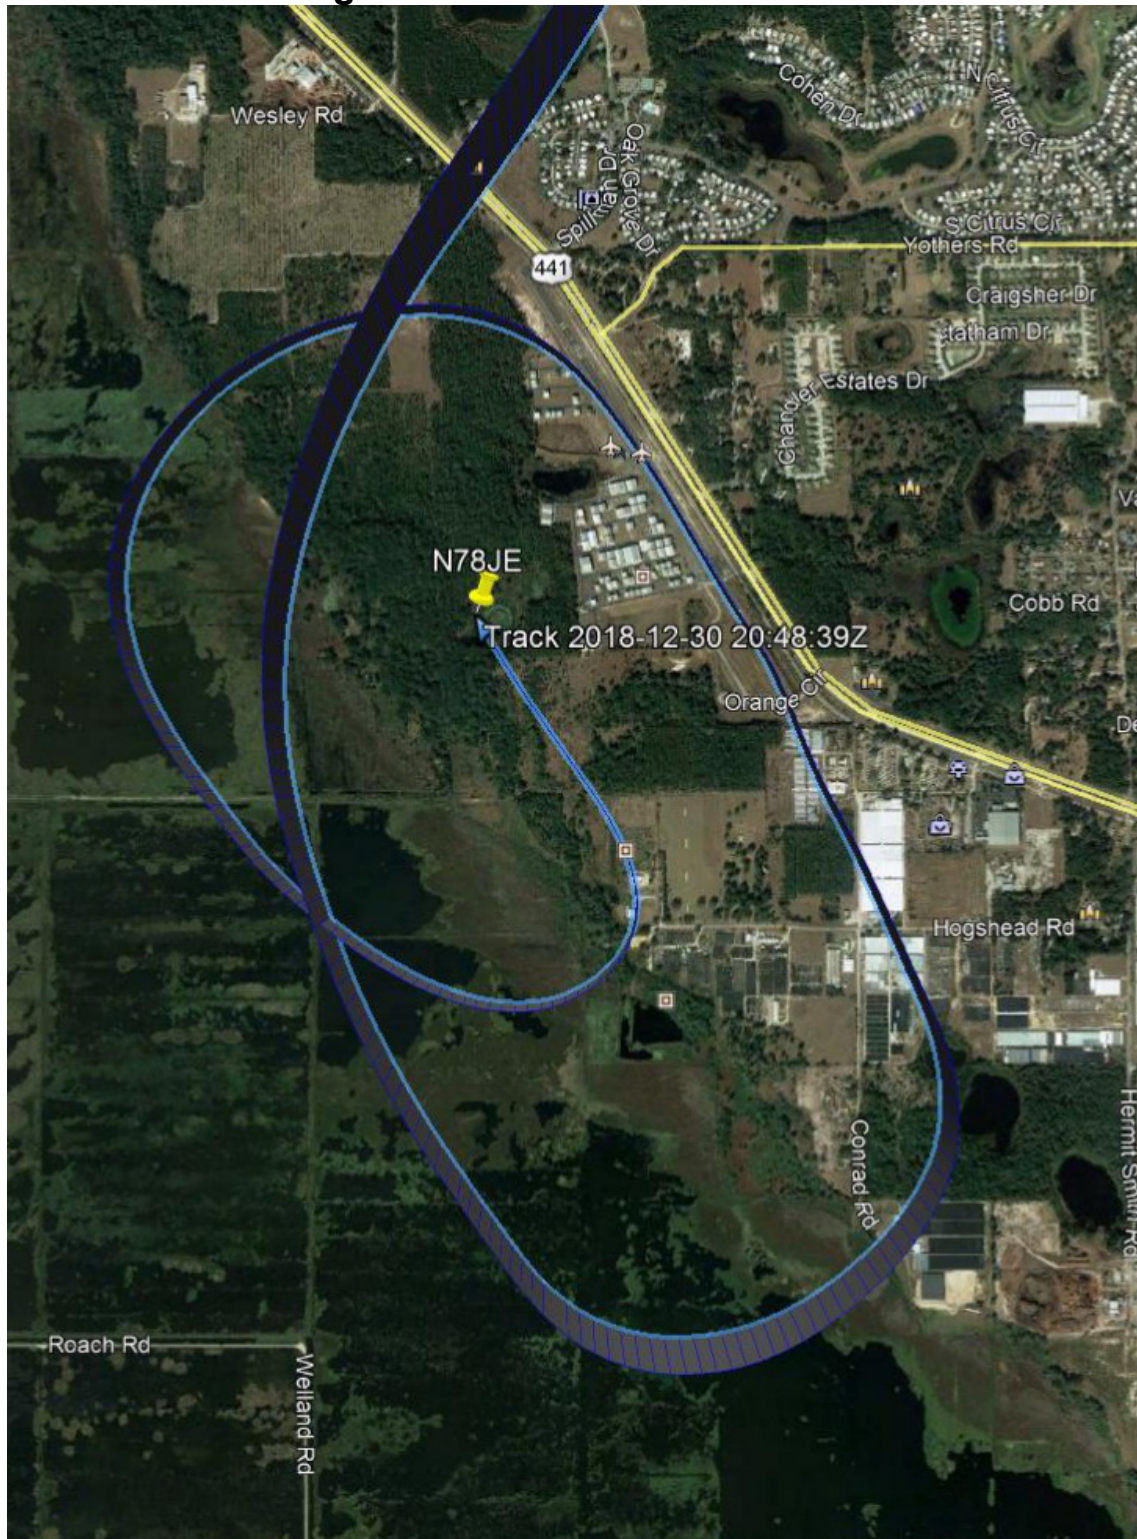
End of flight track derived from the G1000 data on the log card.
