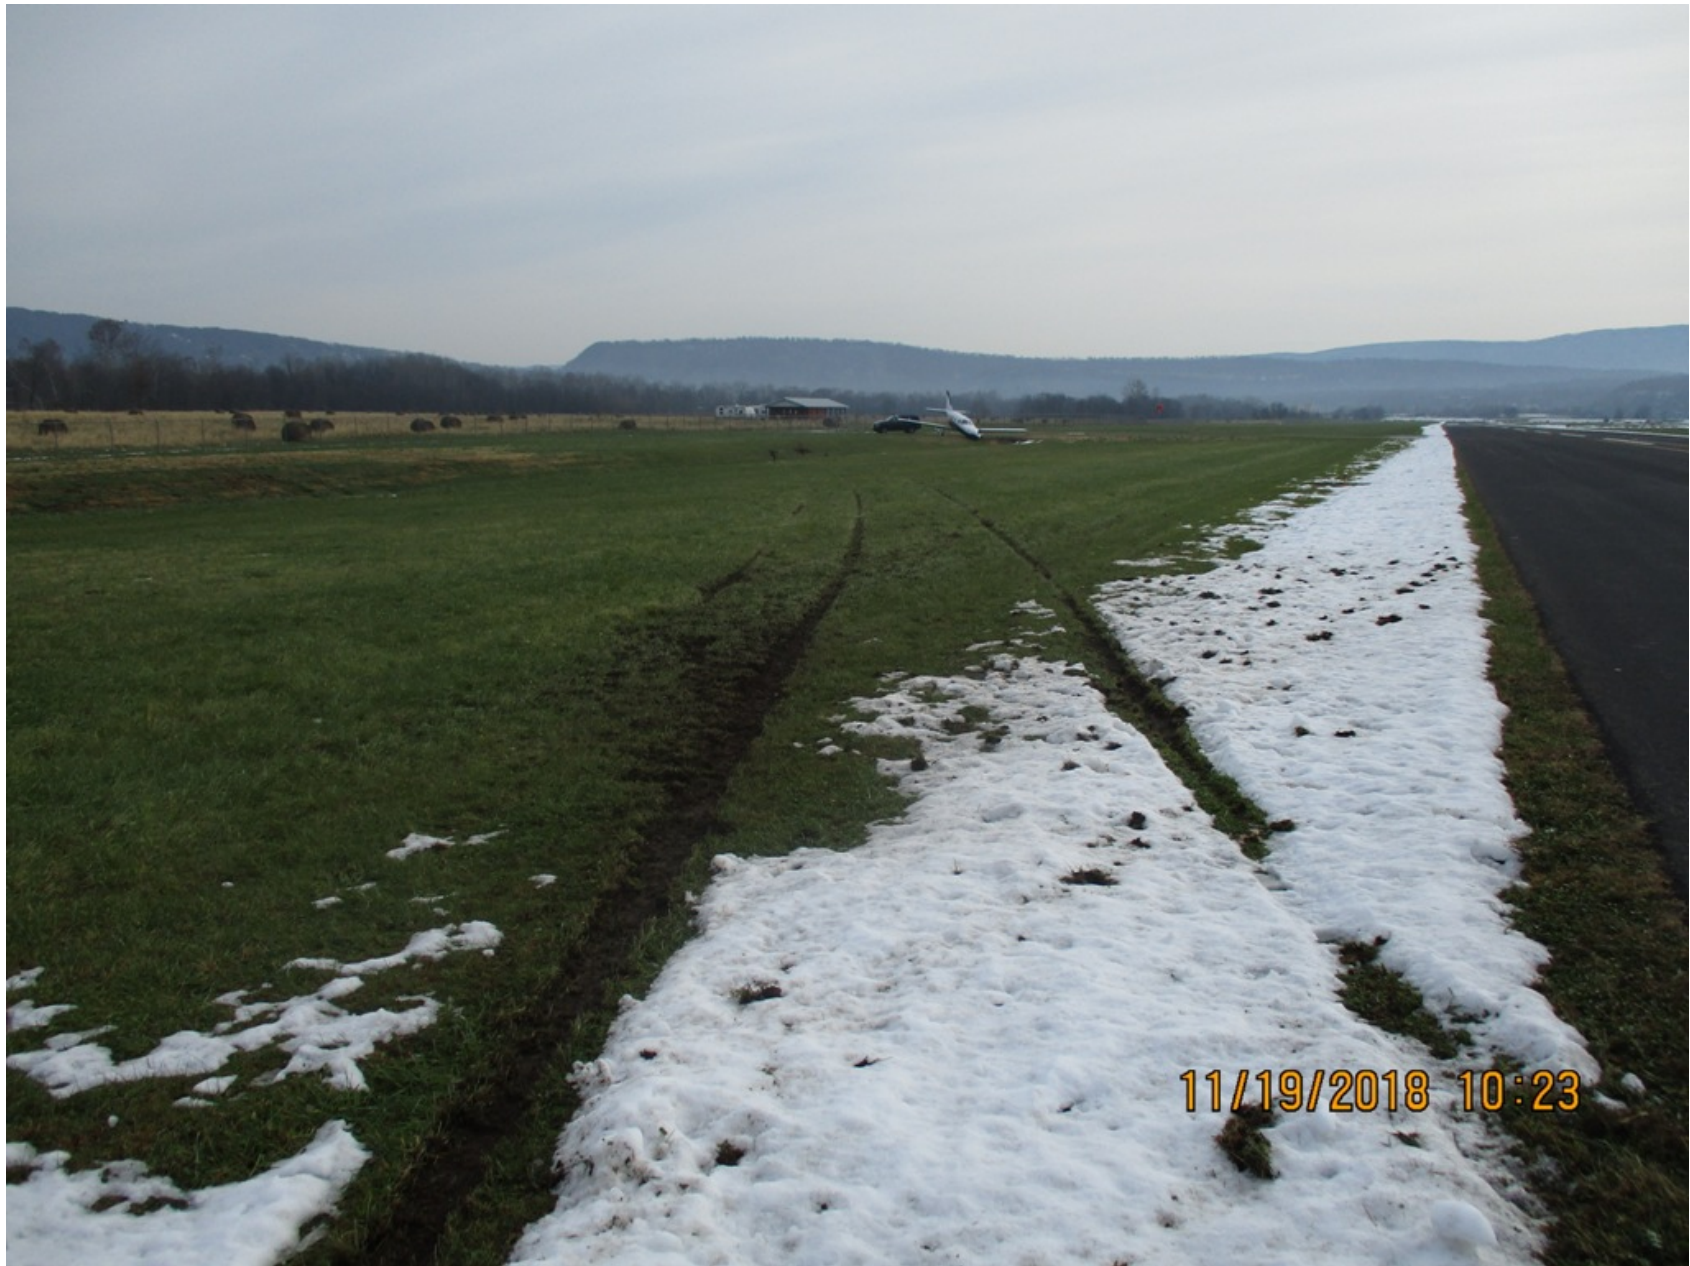
**Photo 1 – FAA Digital Photograph. View Depicting the Skid Marks in Grass and Airplane in the Background.**

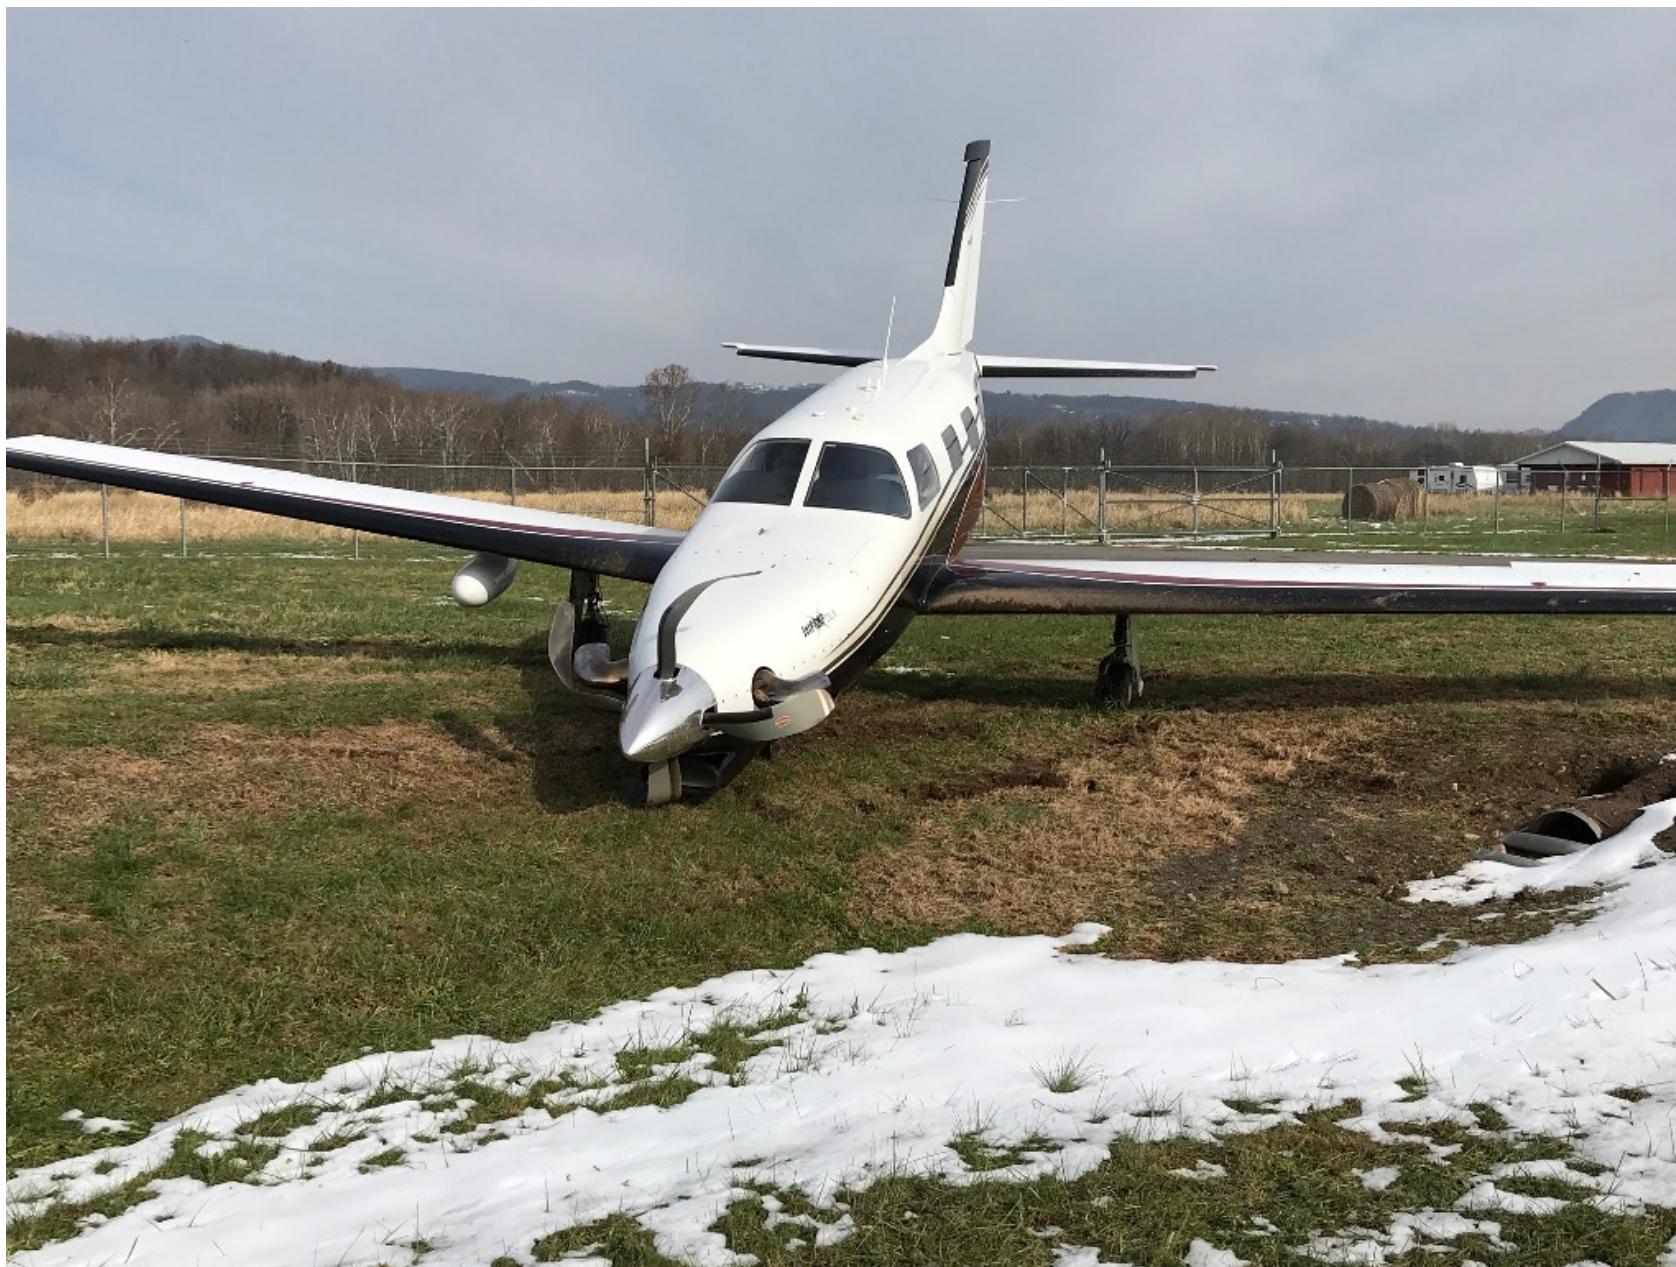
**Photo 2 - FAA Digital Photograph. Frontal View of the Airplane Where it Came to Rest. Note the collapse Nose Landing Gear.**

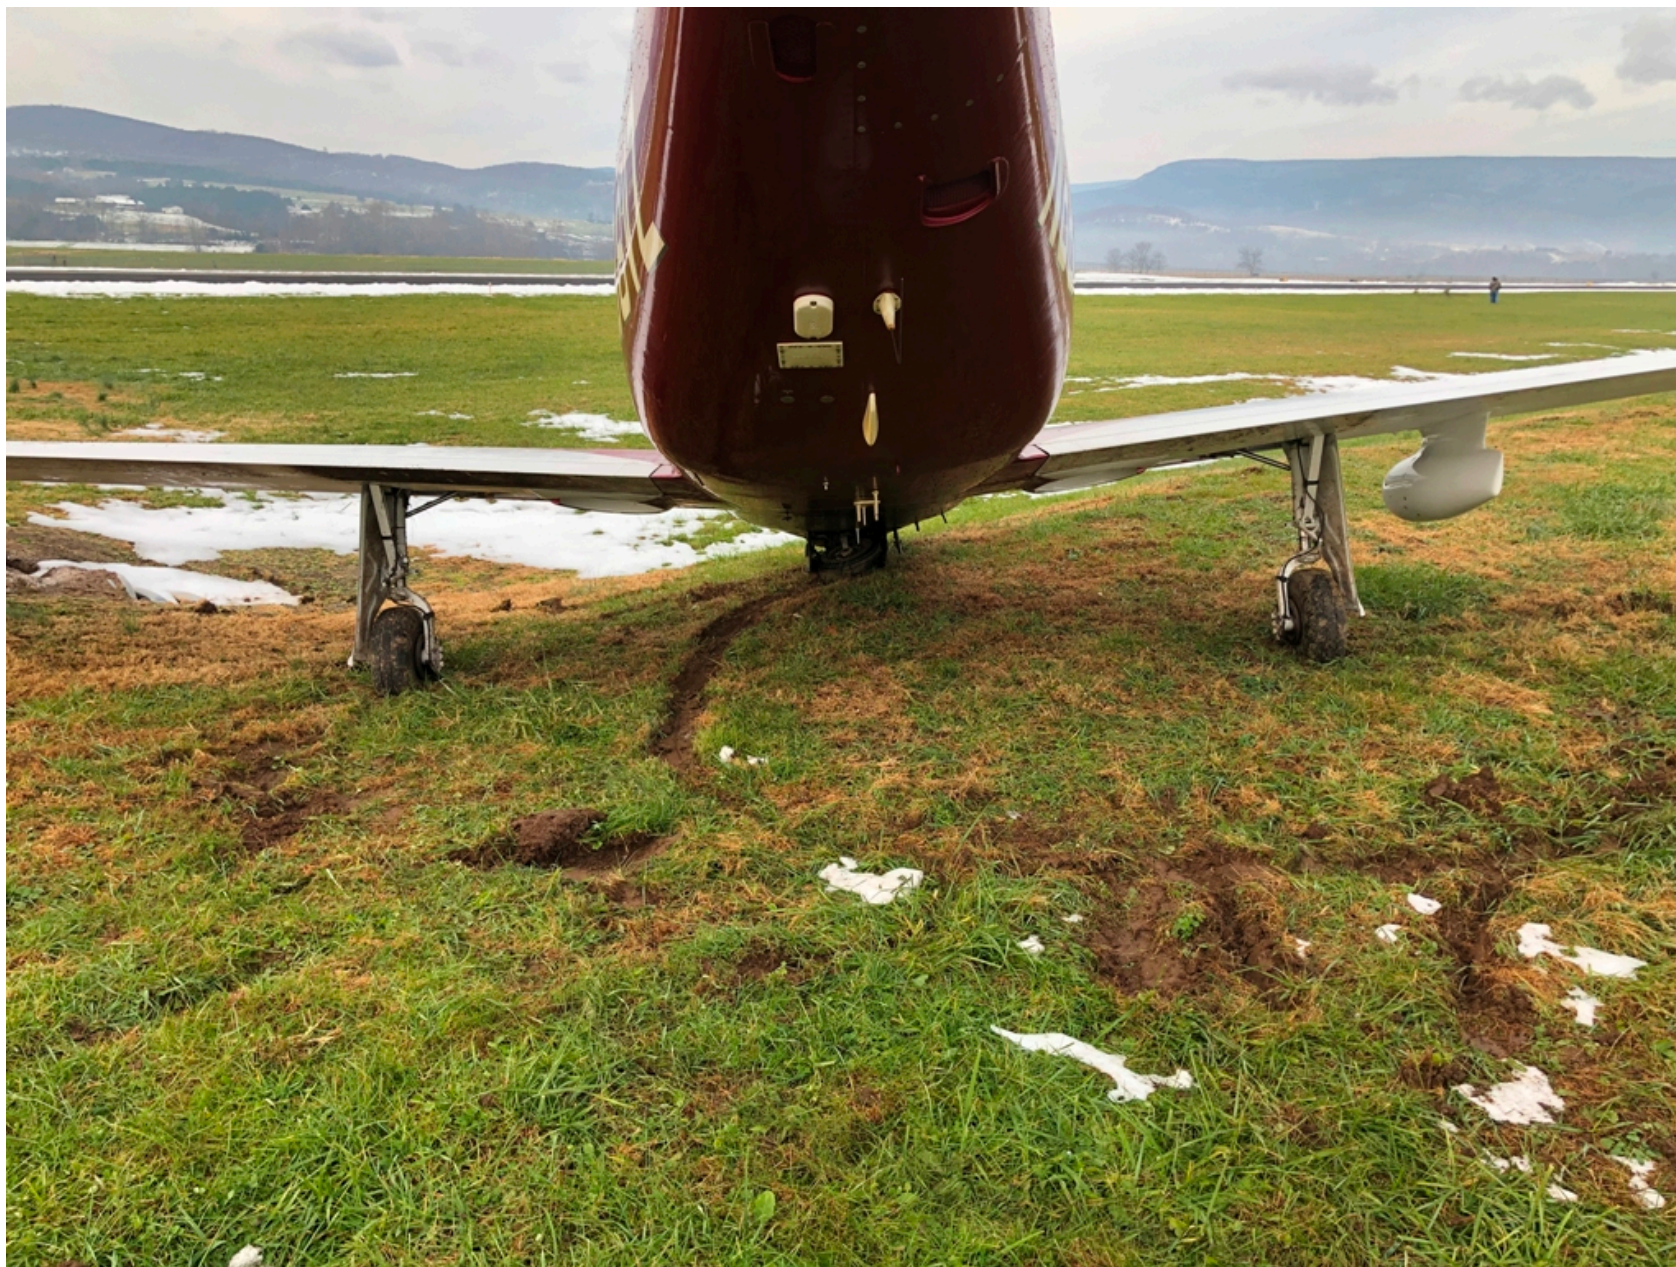
**Photo 3 – Photograph From Pilot. View From Empennage Looking Forward. Note the Collapsed Nose Landing Gear.**

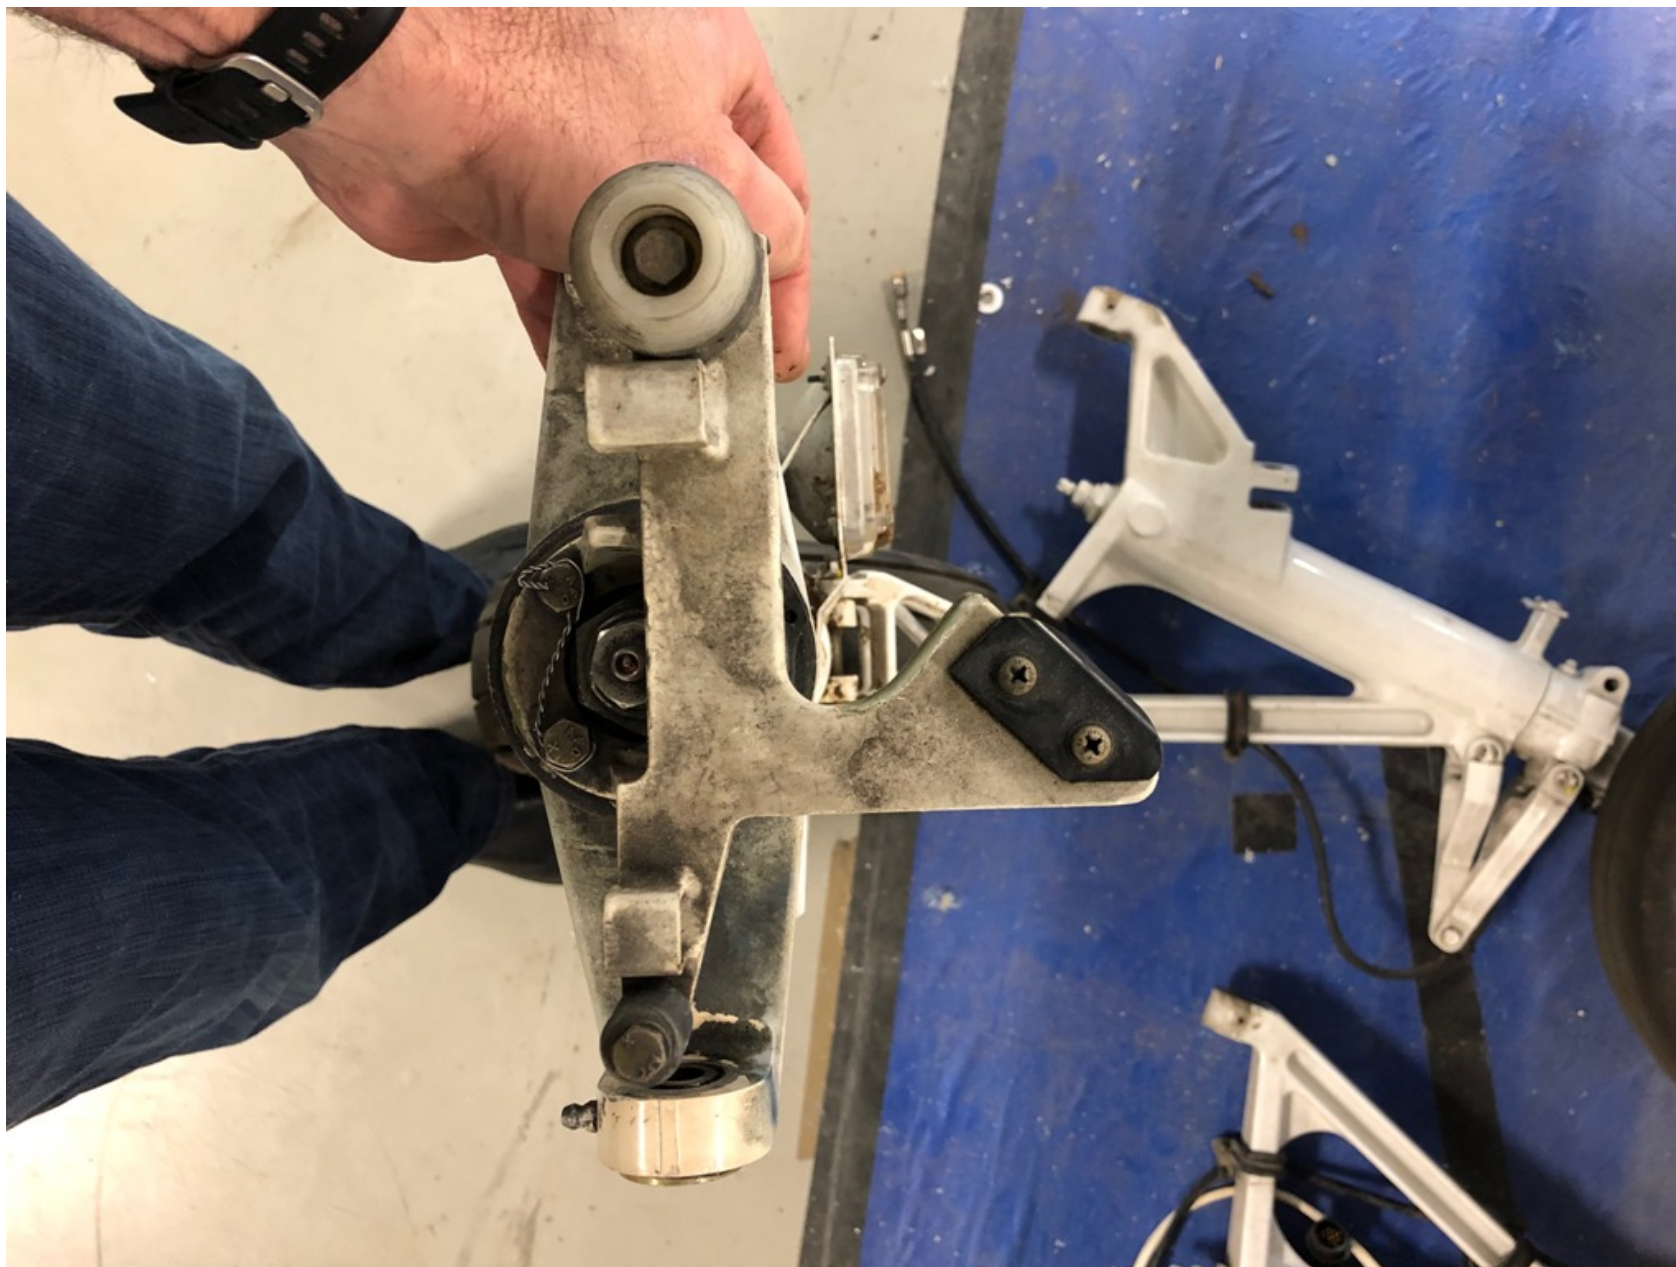
**Photo 4 - Photograph From Pilot. View of the Upper Portion of the Nose Landing Gear Trunnion Assembly and Steering Horn.**

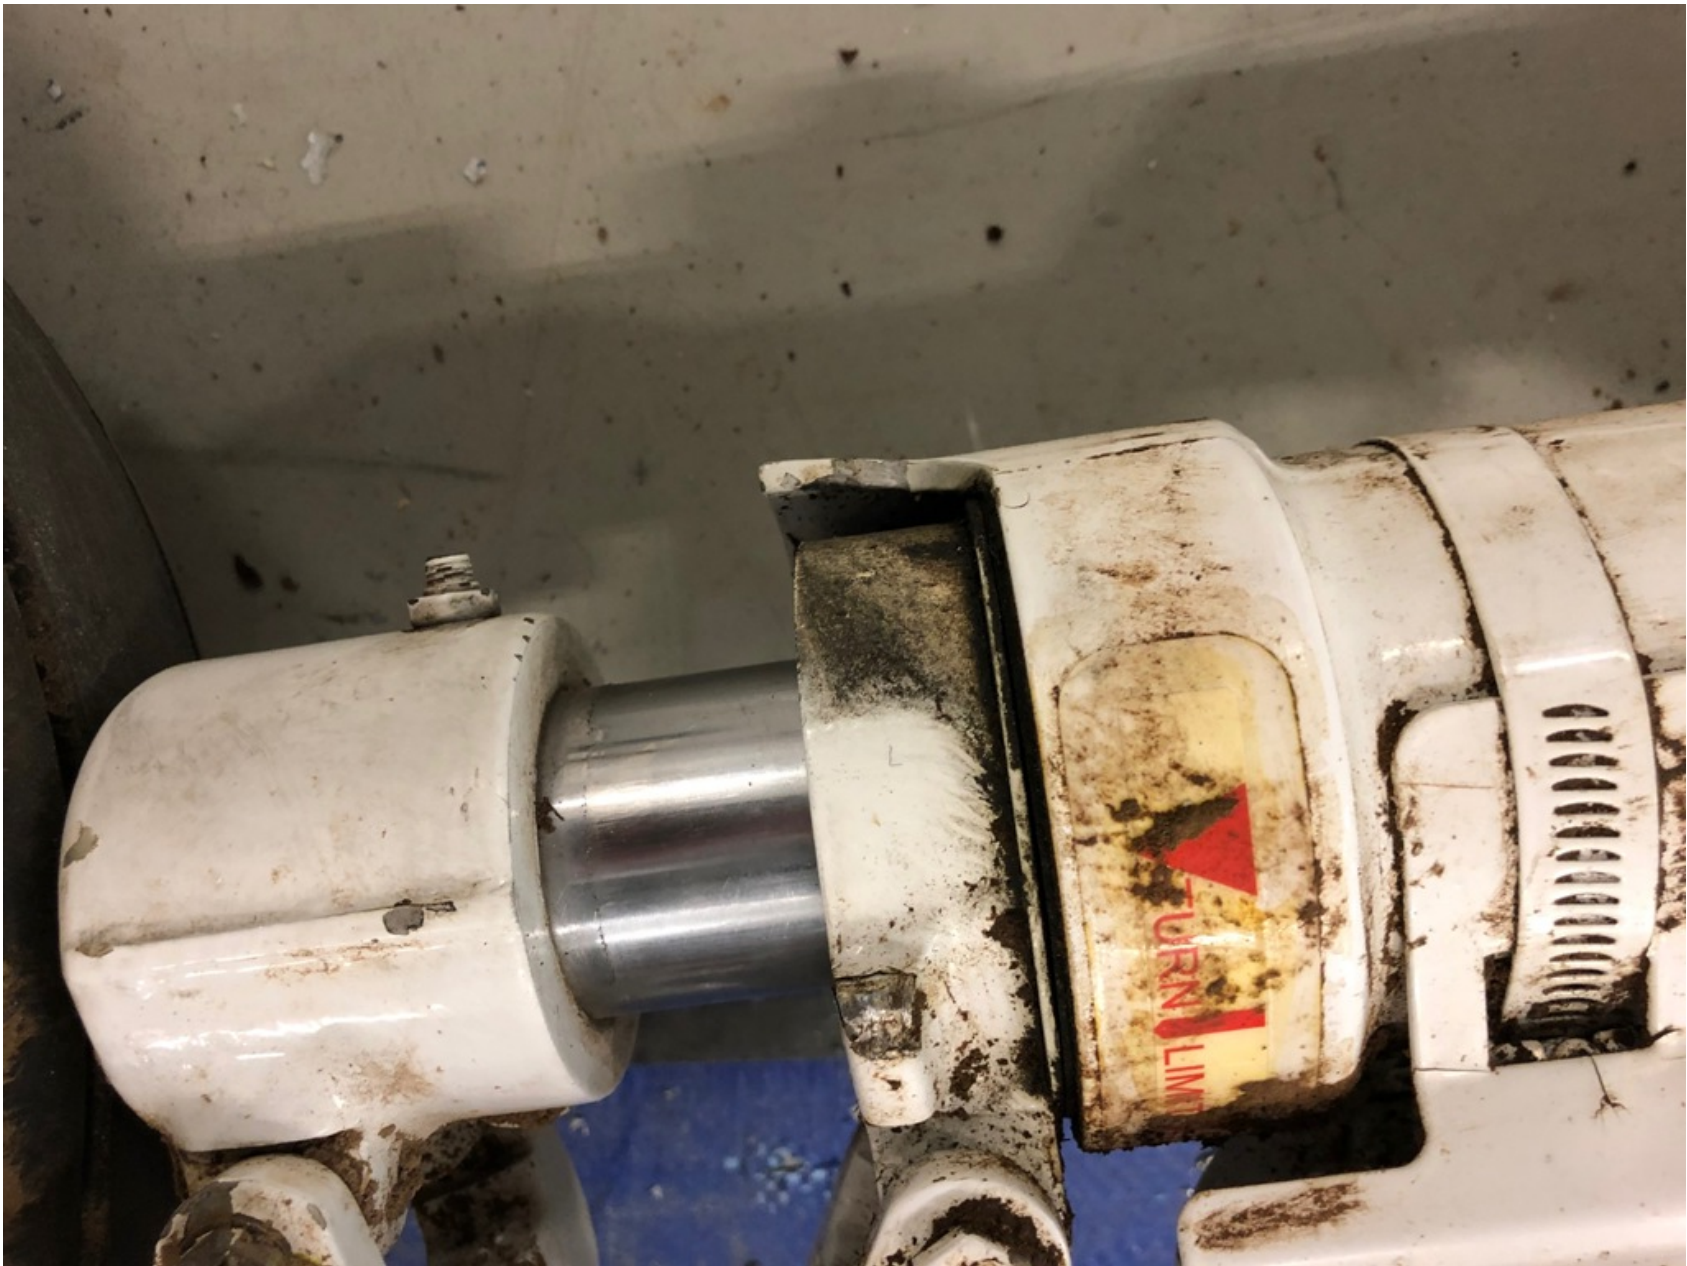
**Photo 5 - Photograph From Pilot. View of the Damage to the Lower Portion of the Nose Landing Gear Trunnion Assembly.**

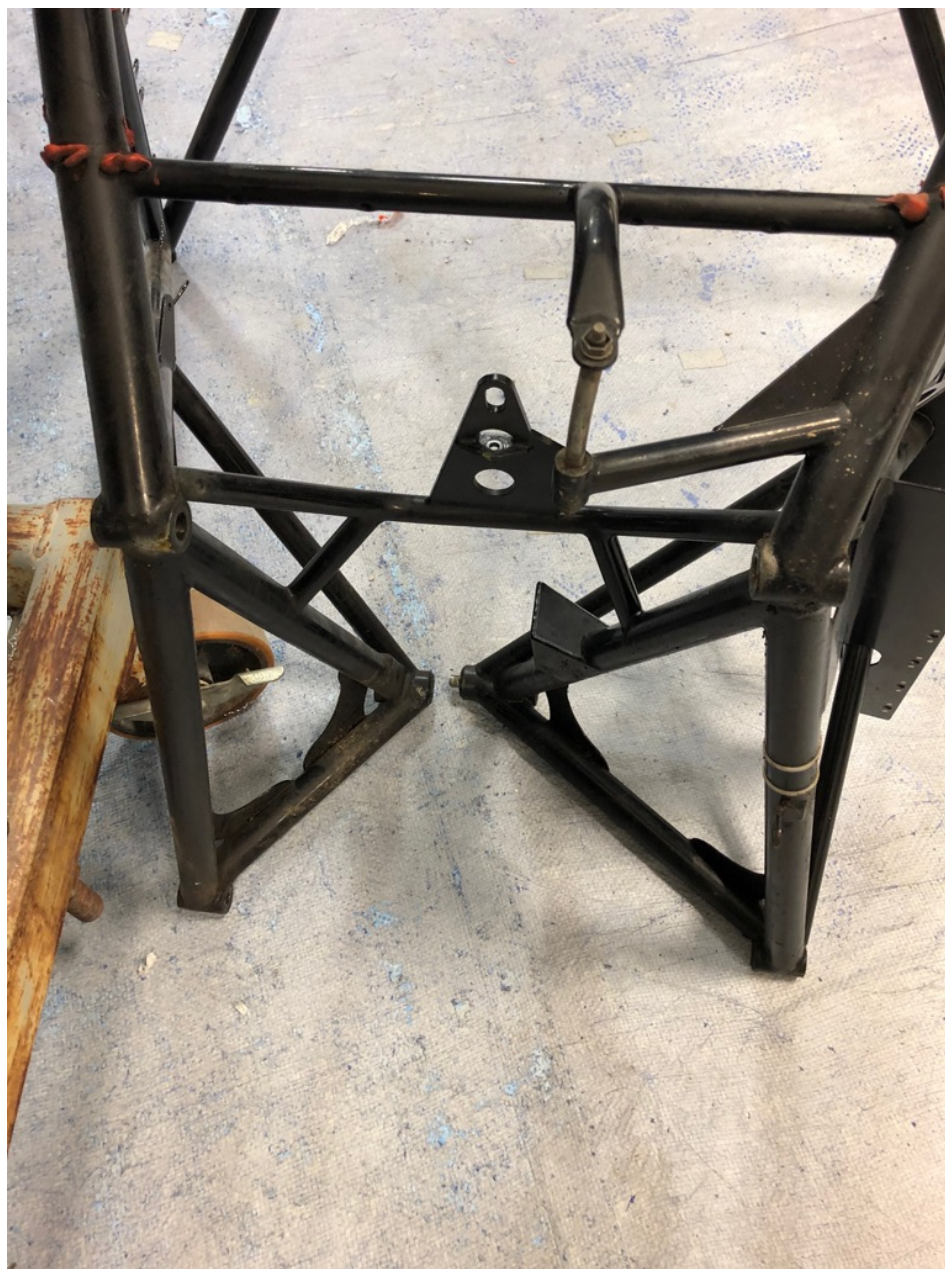
**Photo 6 - Photograph From Pilot. View of the Engine Mount. Note the sheared bolt that Attached the Nose Landing Gear Actuator.**
