## **NATIONAL TRANSPORTATION SAFETY BOARD**

### **Specialist's Report**

# **METEOROLOGY**

ERA19LA097

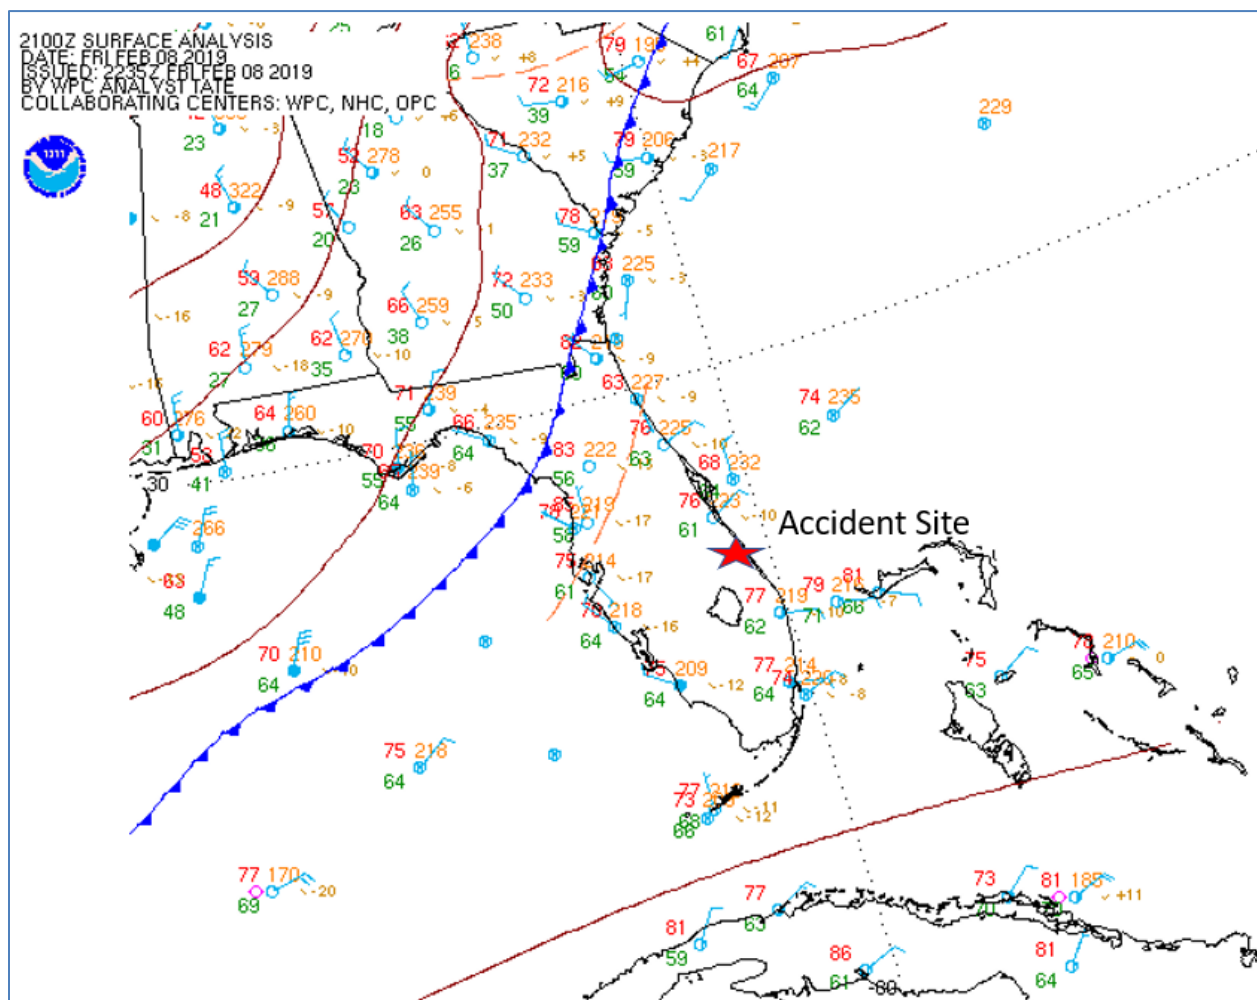
Figure 1 - NWS southeast Surface Analysis Chart for 1600 EST

The NWS southeast Surface Analysis Chart for 1600 EST on February 8, 2019 is included as figure 1 with the approximate accident site noted by a red star. The chart depicted a low-pressure center of 1017-hectopascals (hPa)<sup>1</sup> over North Carolina (just off the chart) with an associated cold front extending southwestward through South Carolina, into southeastern Georgia, and into northern Florida. Ahead of the cold front was a trough of low-pressure that extended from near Jacksonville southwestward to the Tampa area. A ridge of high pressure extended over central and southern Florida, with a weak pressure gradient over the region. The accident site was located ahead of the cold front and the trough on the warm air side of the front and in a region of a weak pressure gradient.

The station models in the vicinity of the accident site indicated light easterly winds at approximately 10 knots, with scattered to broken cloud cover, and temperatures in the upper 70's degrees Fahrenheit (°F), with dew point in the low 60's °F. No significant weather was reported phenomena were reported in the vicinity of the accident site.

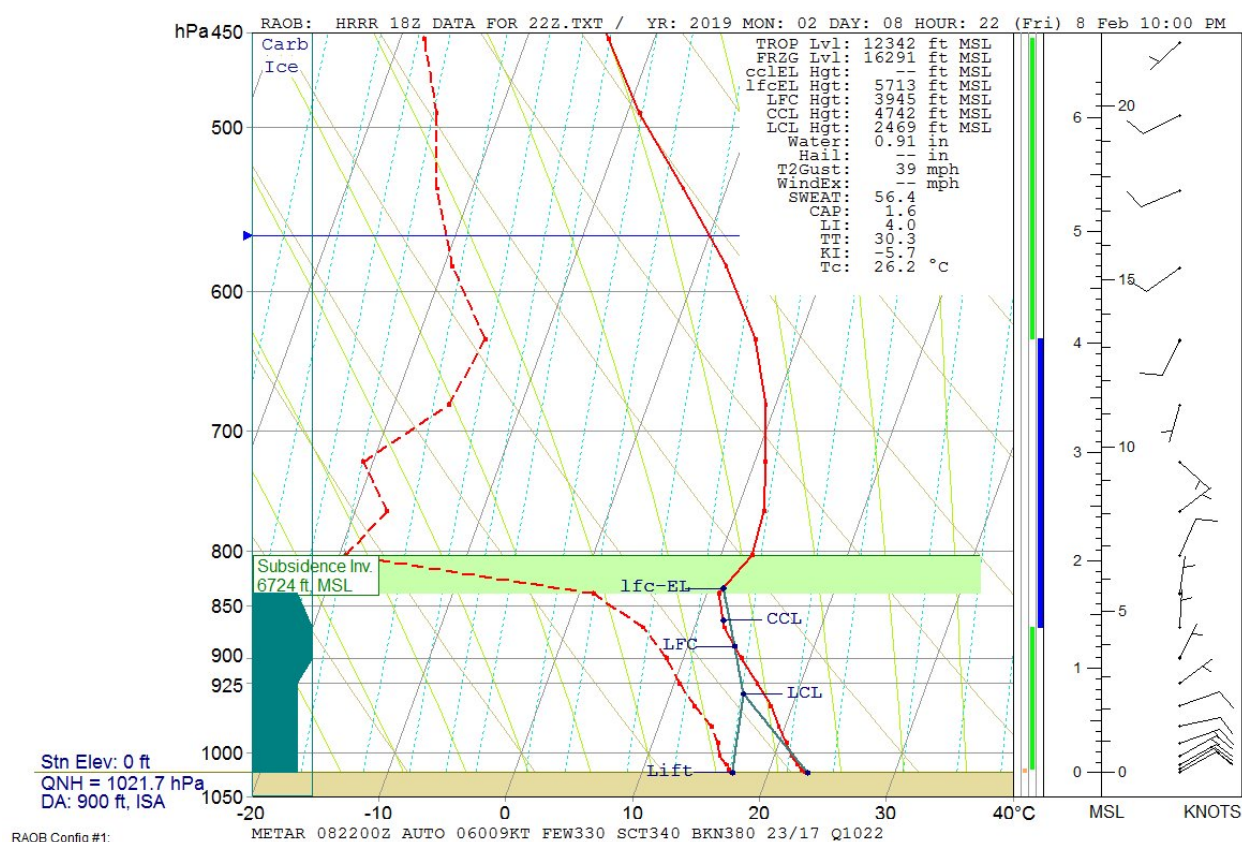
diagram<sup>3</sup> using the complete Rawinsonde Observation RAOB program software<sup>4</sup>. Figure 2 is the HRRR sounding plot from the surface through 450-hPa or approximately 21,000 ft over the accident site coordinates.

The initial model run for the HRRR was based on 1500 EST data and run for 1700 EST. The model sounding expected a surface temperature of 23° C (73° F), a dew point temperature of 17° C (63° F), with a relative humidity of approximately 70%, and a density altitude of approximately 900 ft, which was consistent with the METAR observation. The HRRR sounding depicted a temperature inversion due to subsidence was noted at 6,724 ft with drying conditions immediately above the inversion. The RAOB algorithm indicated a high probability of carburetor icing from the surface to the inversion or through 5,000 ft and is indicated by the dark green bar on the left side of the diagram.

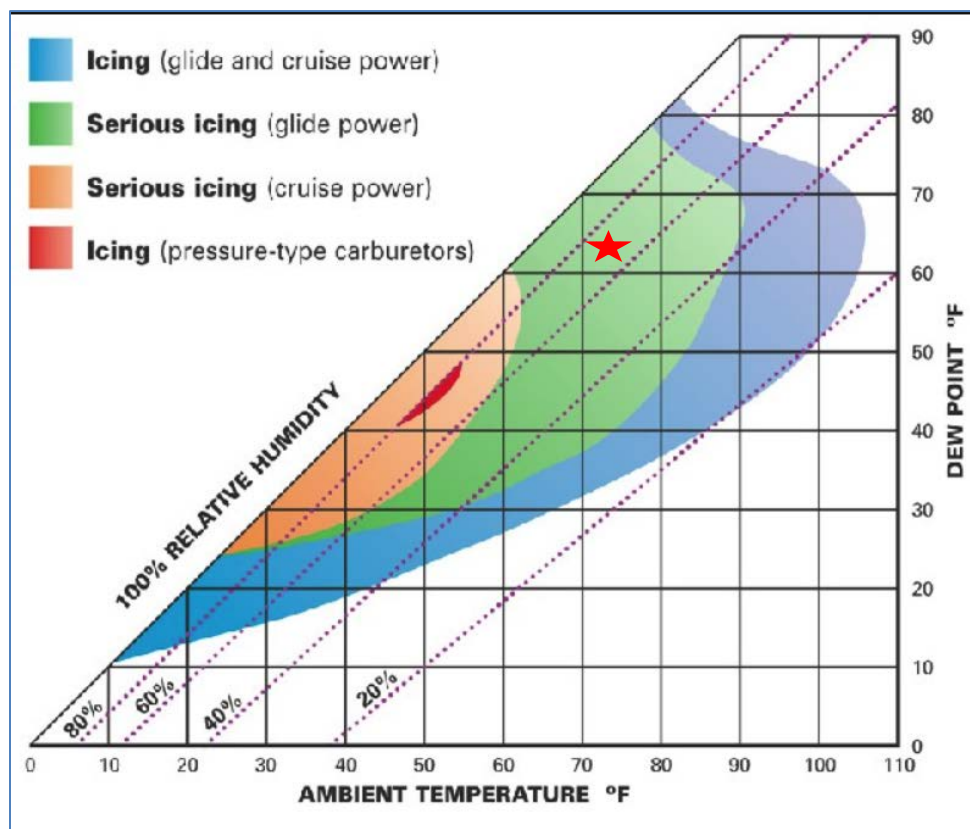
Figure 2 – Probability of Carburetor Icing

The FAA Special Airworthiness Information Bulletin (SAIB) CE-09-35 issued in June 2009 warns pilots of the potential hazards associated with carburetor icing. The following graph depicts the probability of carburetor icing for various temperatures and relative humidity conditions from that bulletin:

A red star has been added to the chart to depict the conditions at KVRB at the time of the accident, which was in the "Serious Icing" category at glide power.

To prevent carburetor icing, the pilot should:

- Assure the proper functionality of the carburetor heat during the ground (Before Takeoff) check.

- Use carburetor heat on approach and descent when operating at low power settings, or in conditions where carburetor icing is probable.

The pilot should respond to carburetor icing by applying full carburetor heat immediately. The engine may run rough initially for short time while ice melts.
