**NATIONAL TRANSPORTATION SAFETY BOARD**

Office of Aviation Safety  
Eastern Region

**Wreckage Photo Array**

**ERA19LA097**

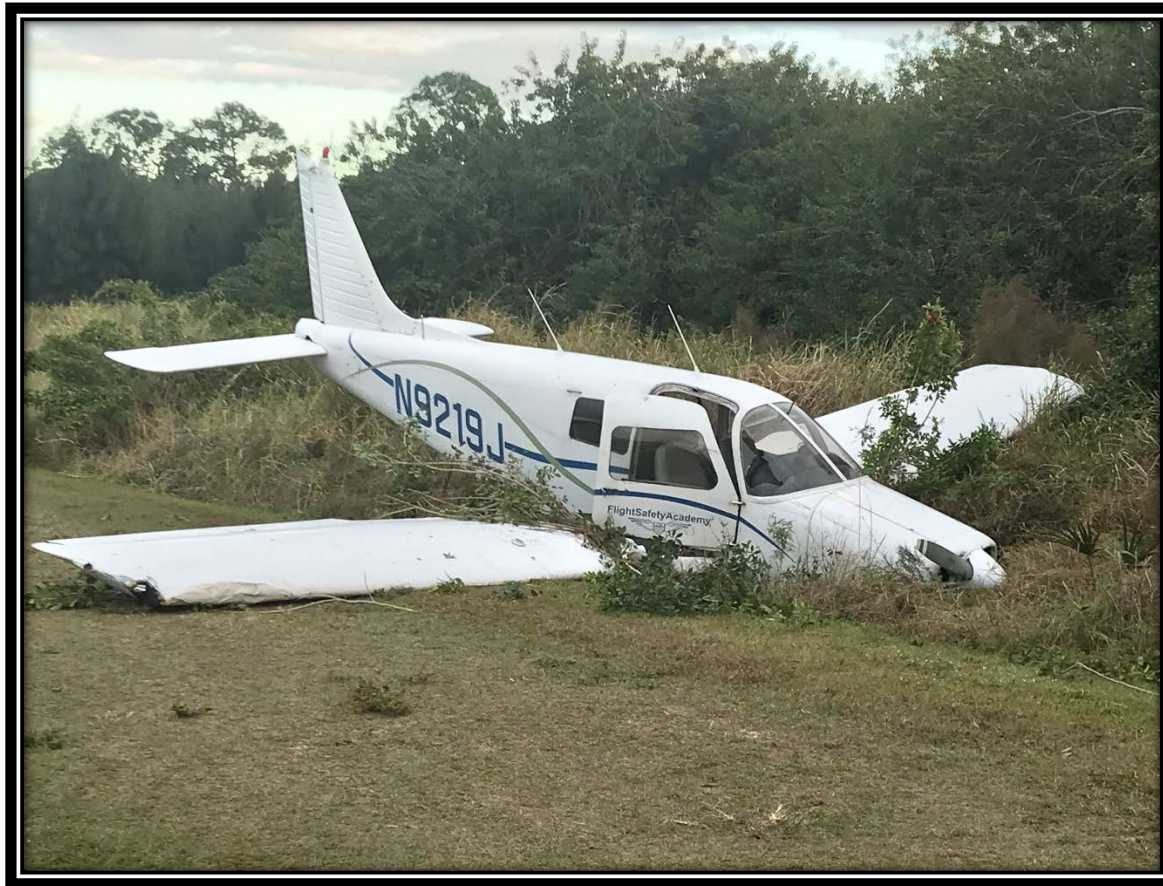
**Photo 1 – Airplane at Accident Scene (Photo Courtesy of FlightSafety)**

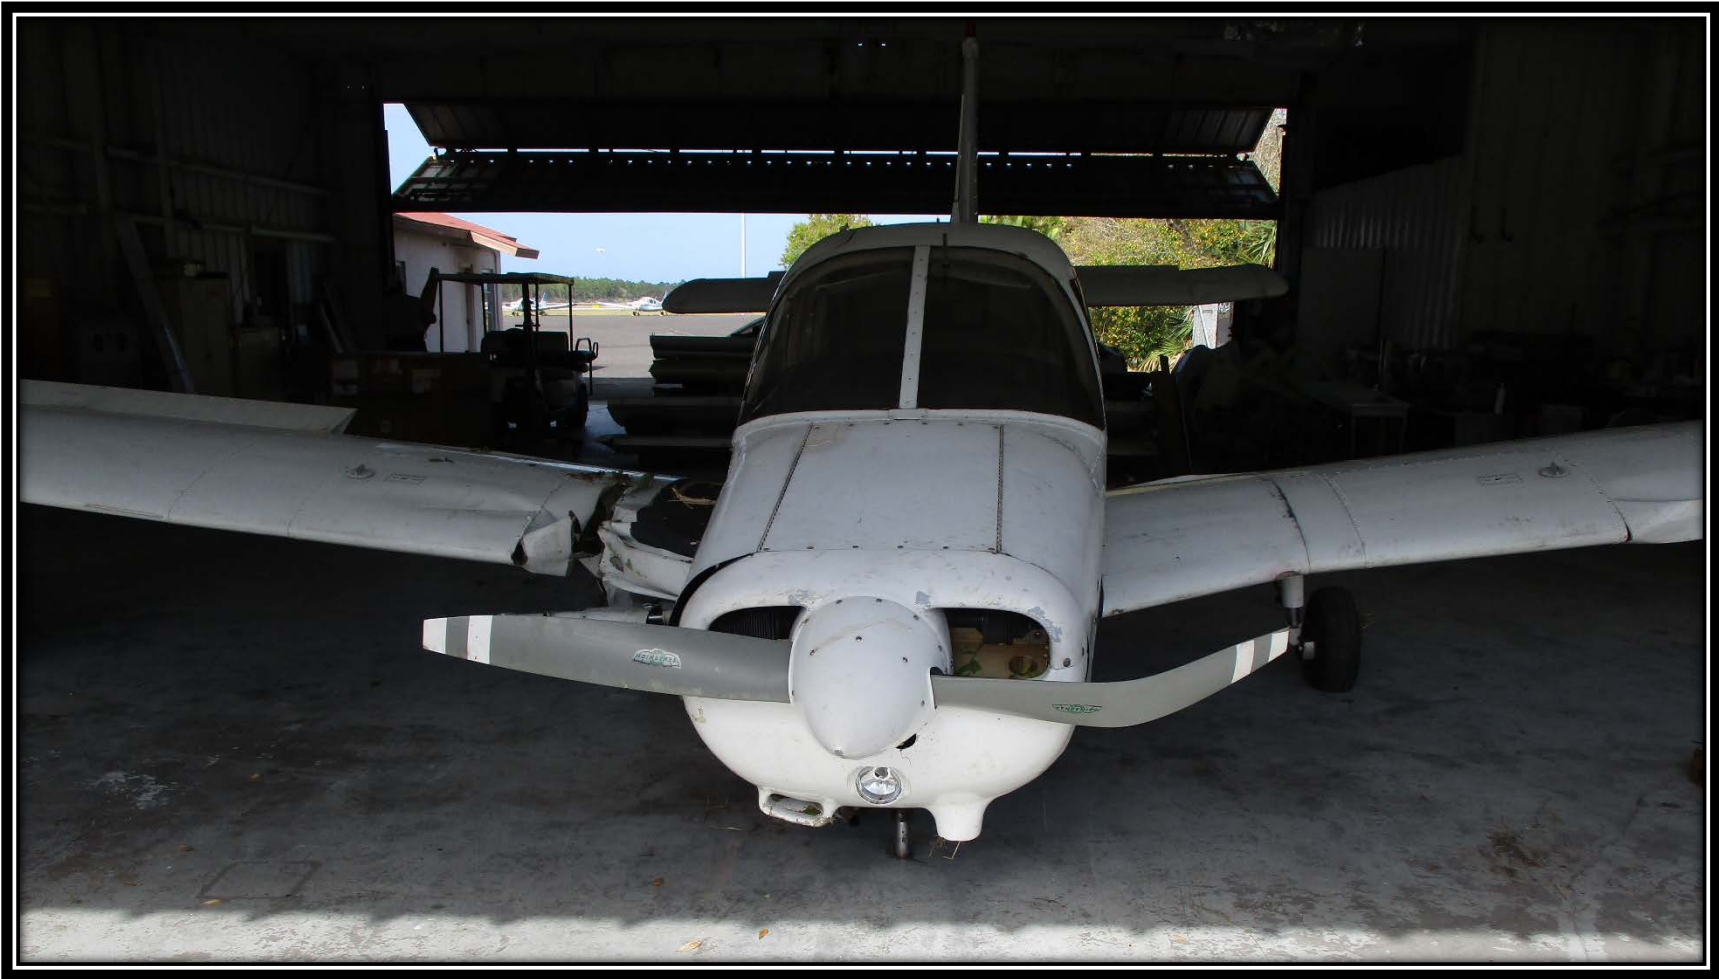
**Photo 2 – Airplane – View from Front (Photo Courtesy of FAA)**

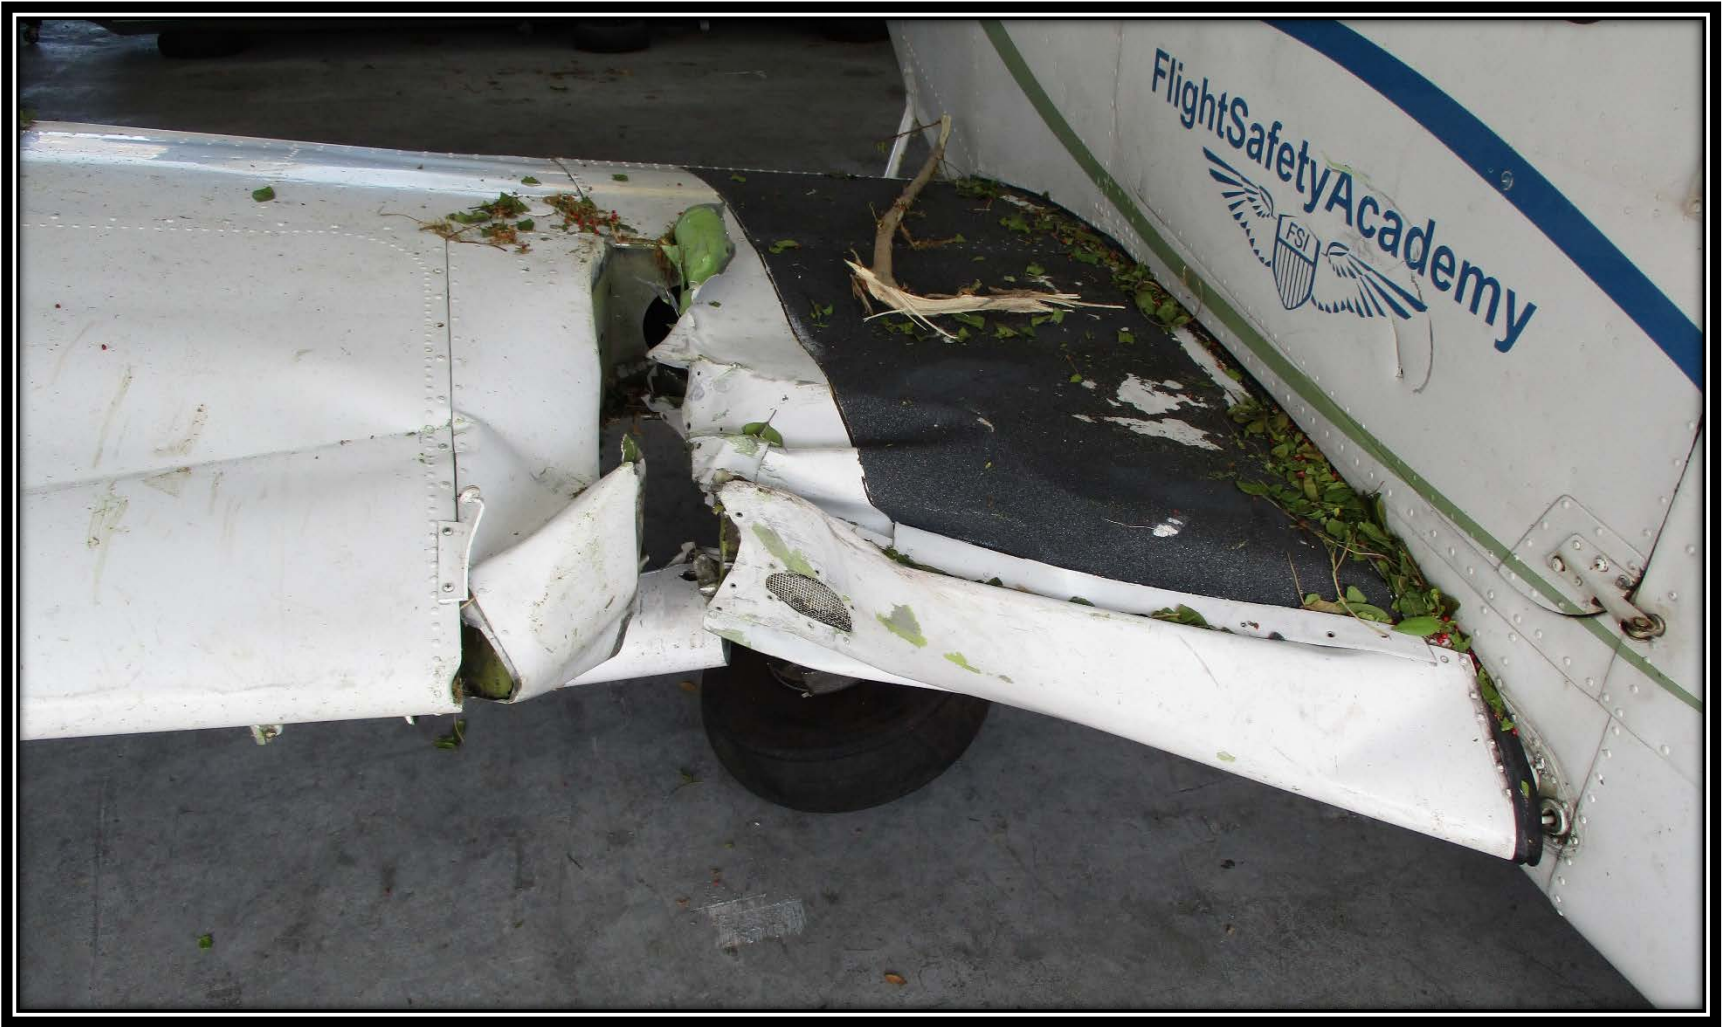
**Photo 3 – Right Wing Fracture (Photo Courtesy of FAA)**

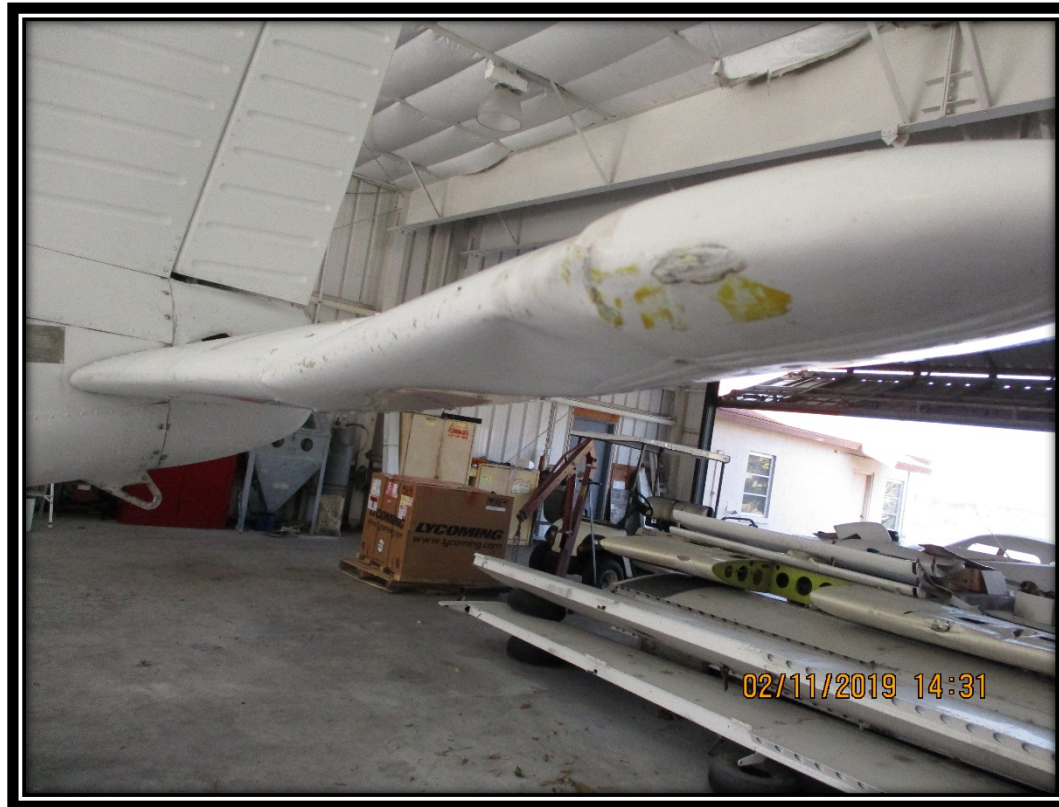
**Photo 4 – Stabilator (Photo Courtesy of FAA)**

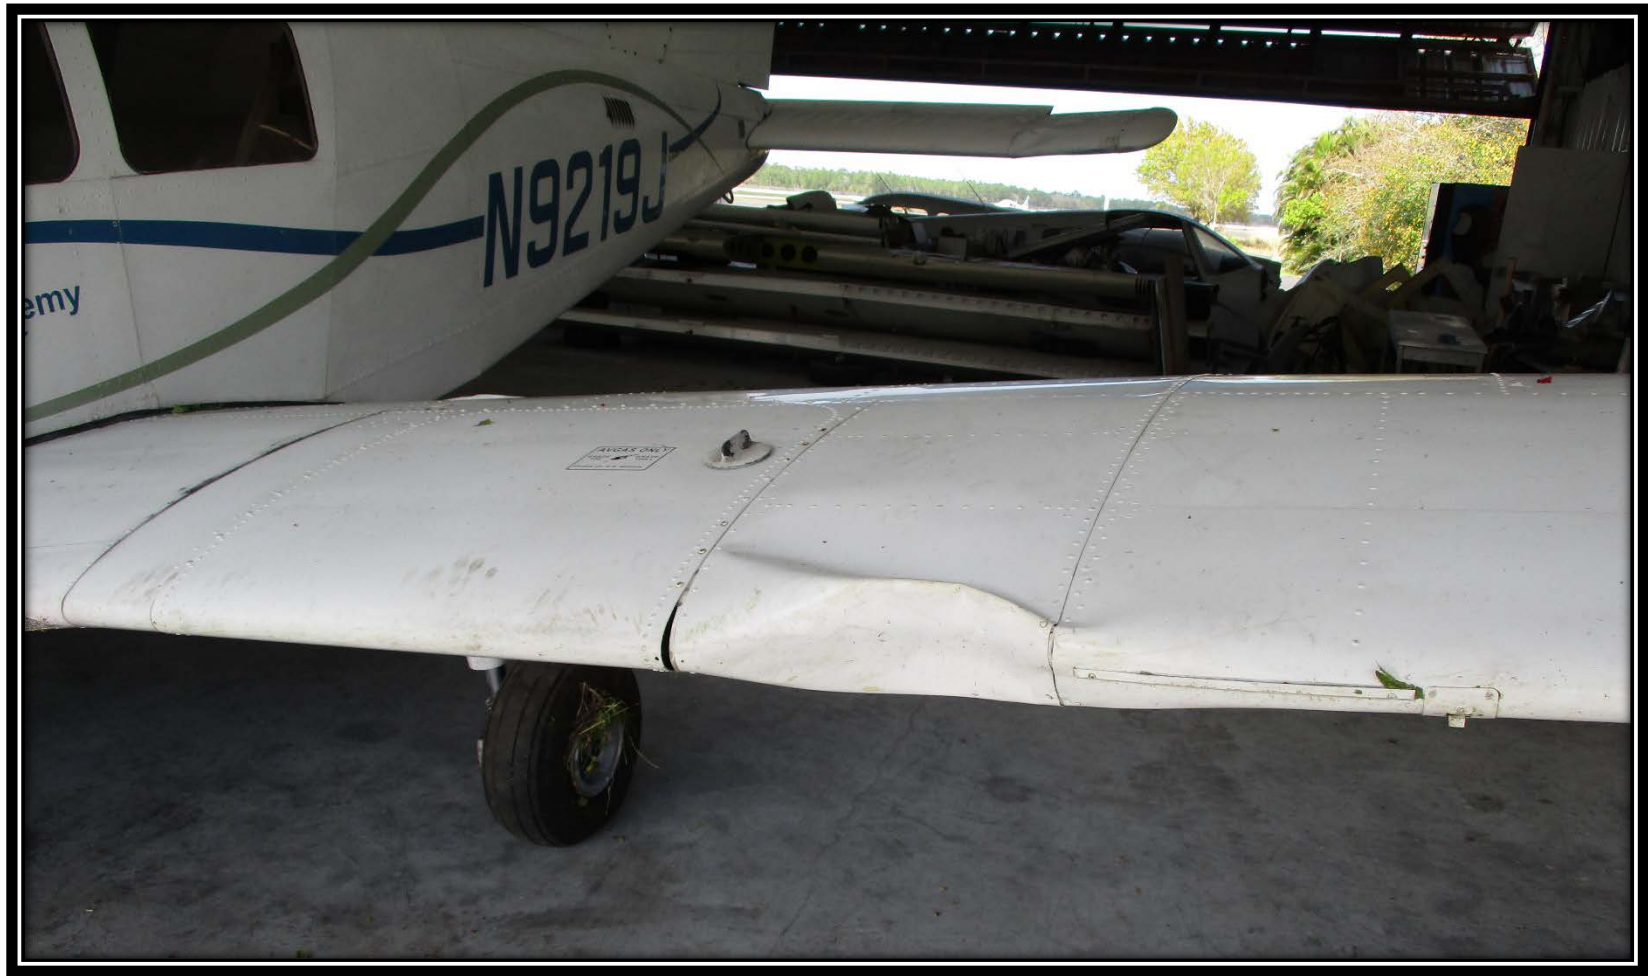
**Photo 5 – Left Wing (Photo Courtesy of FAA)**

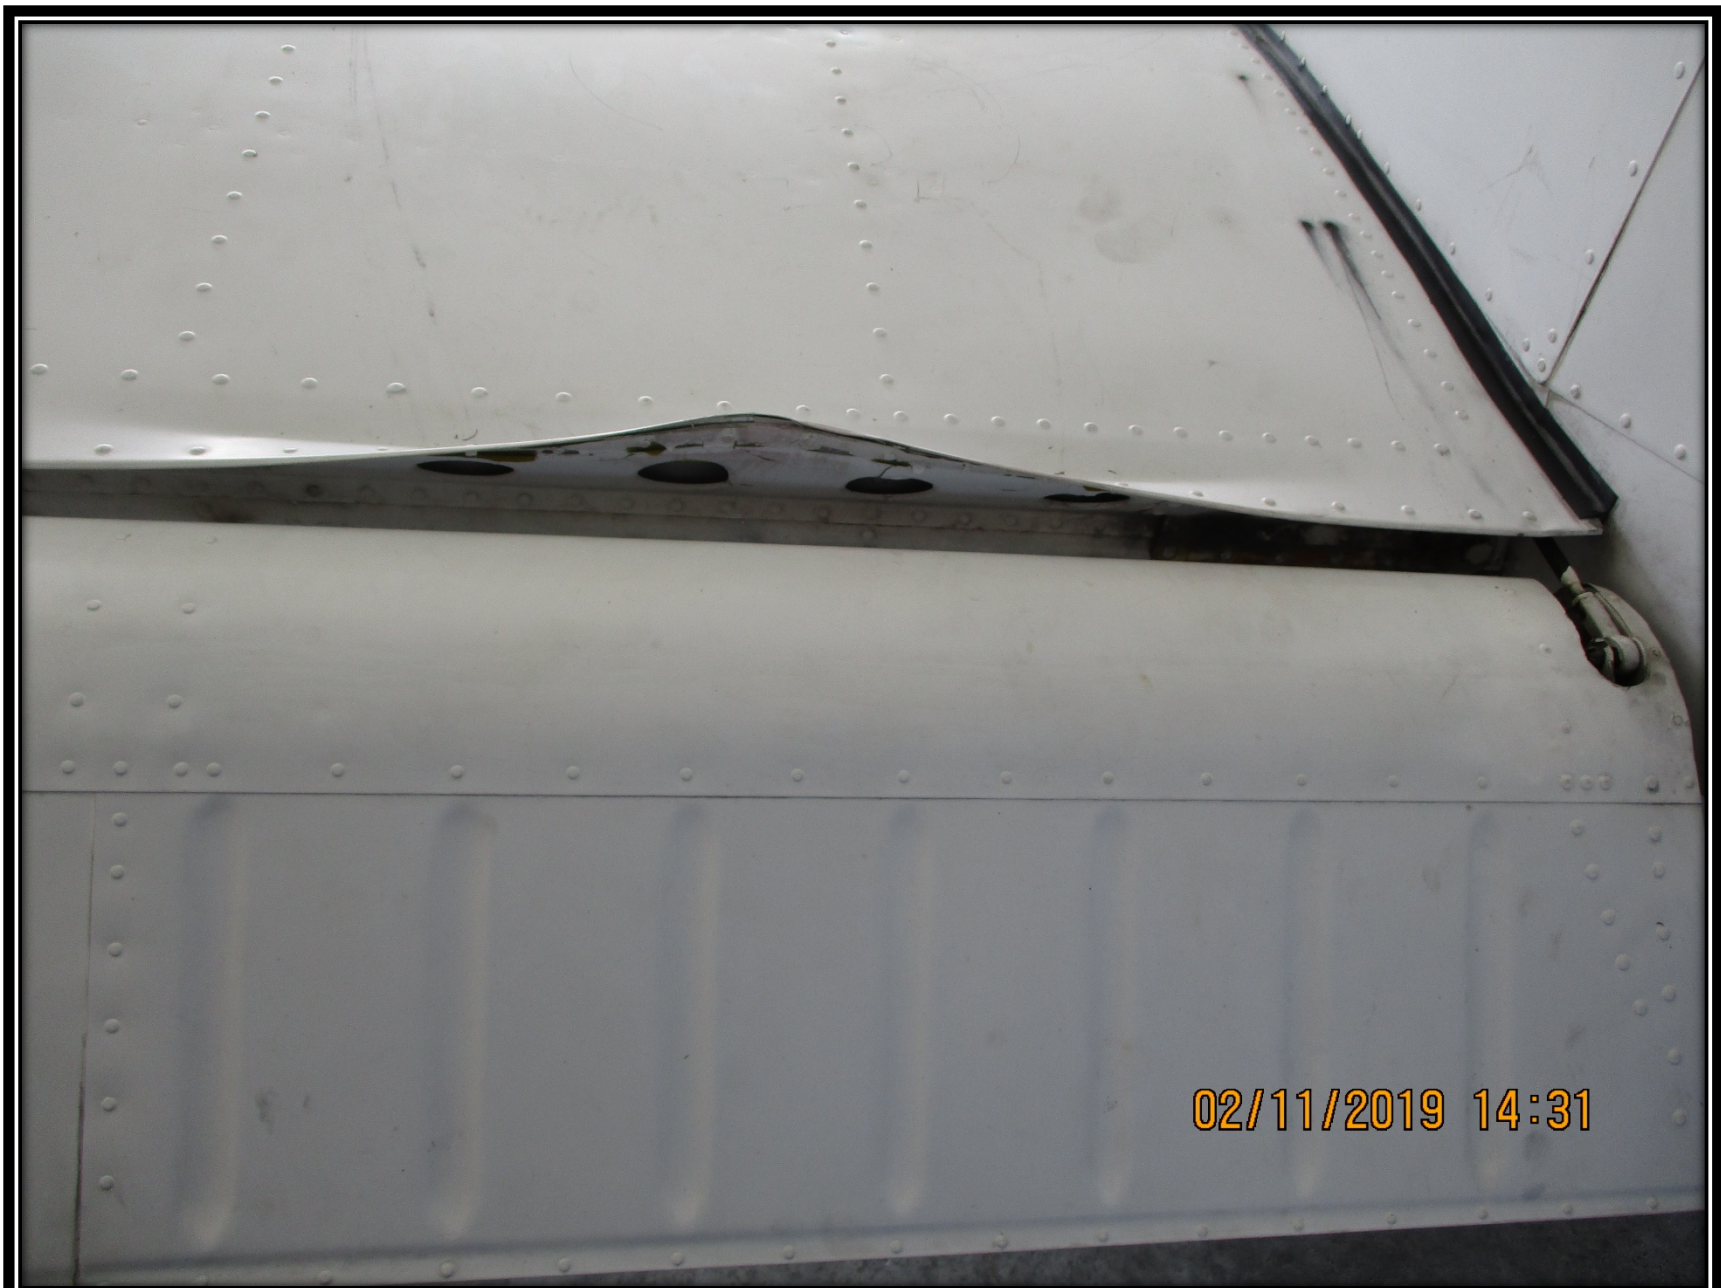
**Photo 6 – Left Wing Trailing Edge (Photo Courtesy of FAA)**

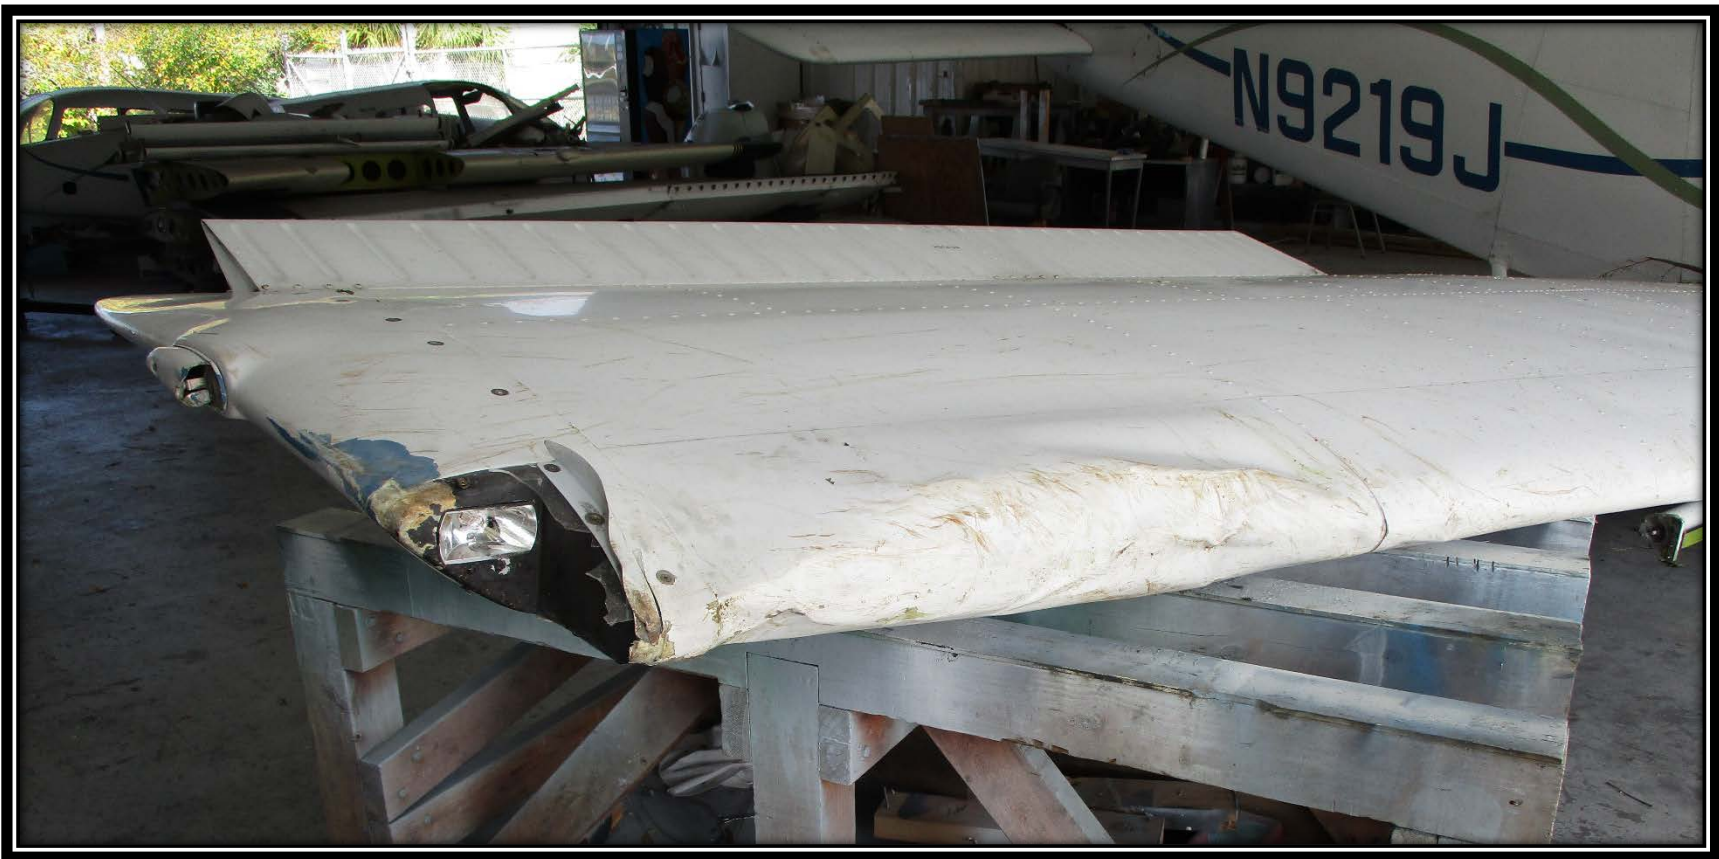
**Photo 7 – Right Wing Outer Leading Edge (Photo Courtesy of FAA)**
