**NATIONAL TRANSPORTATION SAFETY BOARD**

**AIRFRAME AND ENGINE EXAMINATION**

**ERA19LA097**

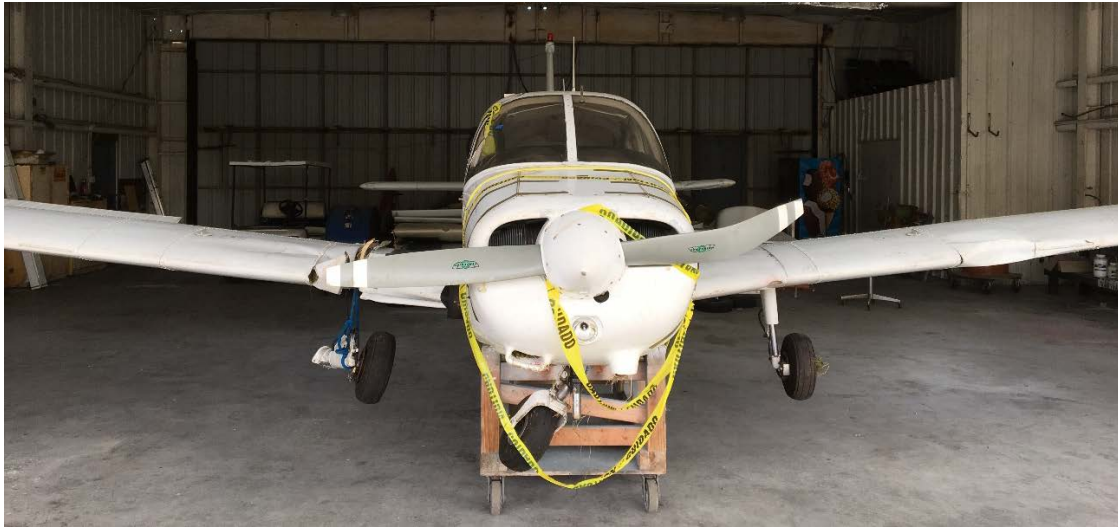
Figure 1: Airplane front view

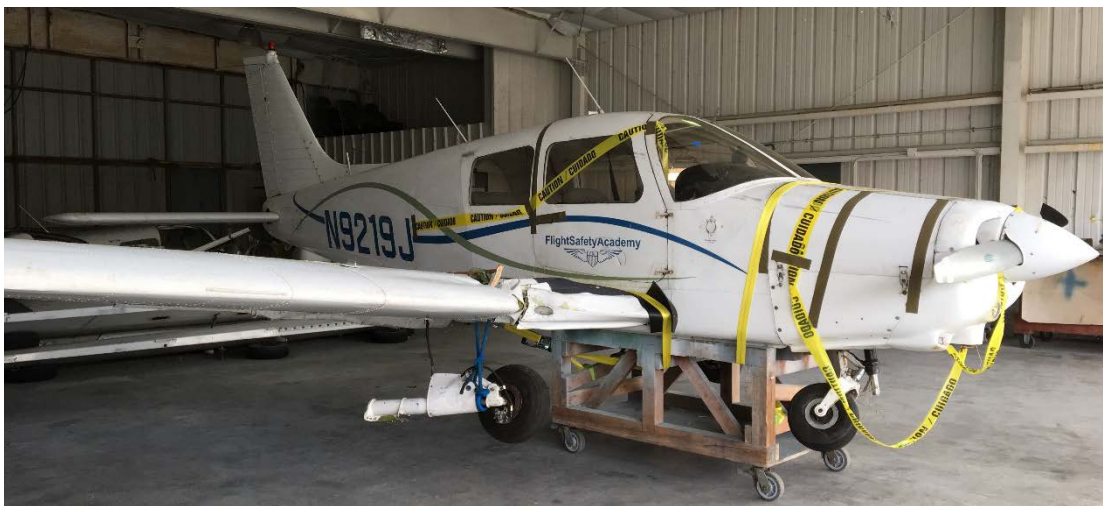
Figure 2: Airplane front right view

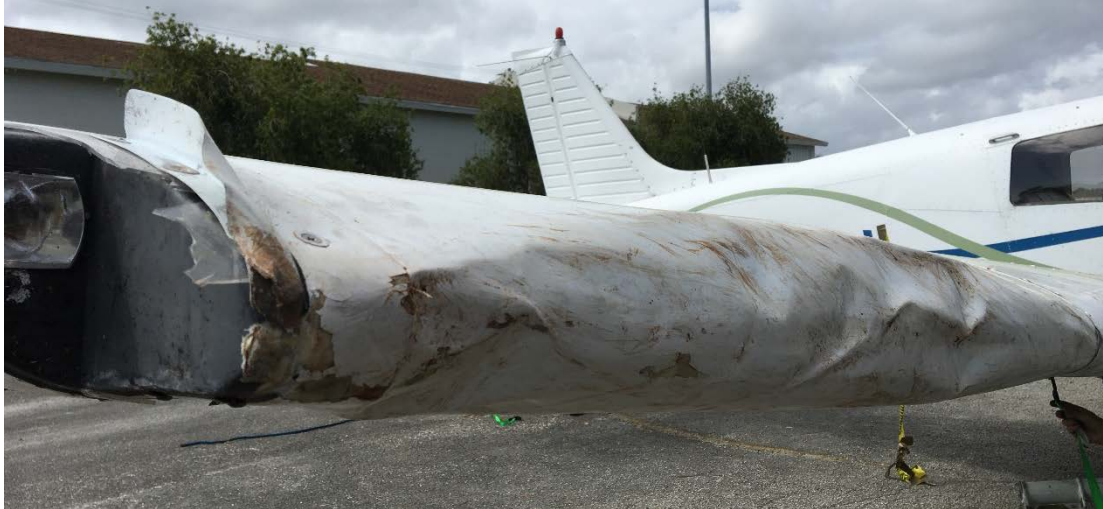
The airplane remained intact following the accident. The left wing leading edge showed aft crushing. The left flap was impact damaged in a positive direction. The outer left 18 inches of the stabilator was bent upward about 15 degrees. The right wingtip was crushed and the right wing leading edge inboard of the right fuel tank was torn back to the main spar by a utility pole. The landing gear was fractured off and one propeller blade was bent aft. The propeller showed no rotational scoring.

Figure 3: Right wing outboard leading edge

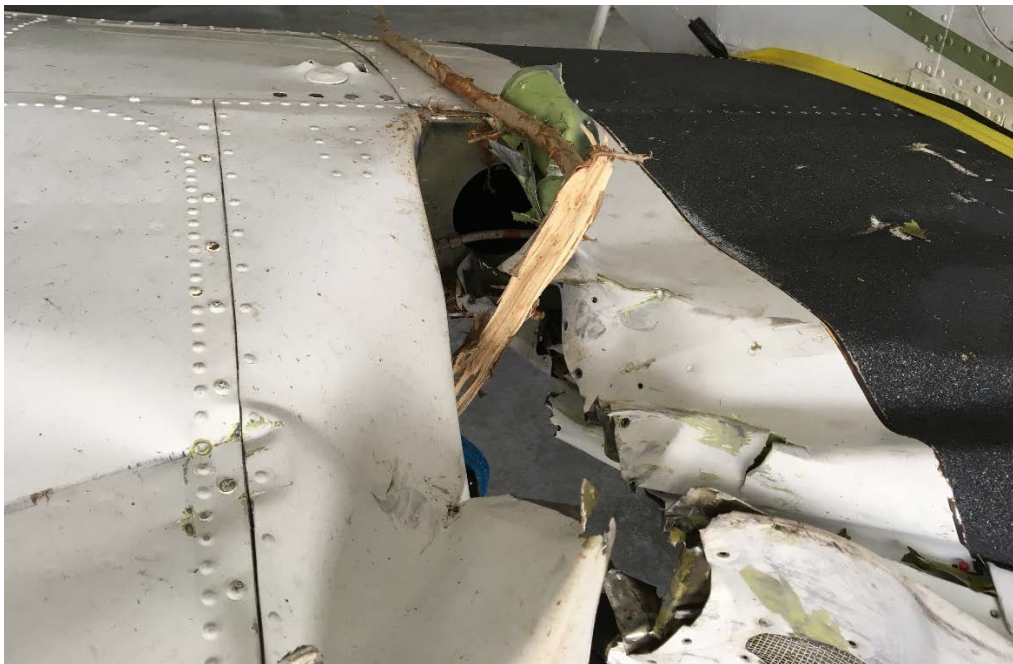
Figure 4: Right wing fracture close-up

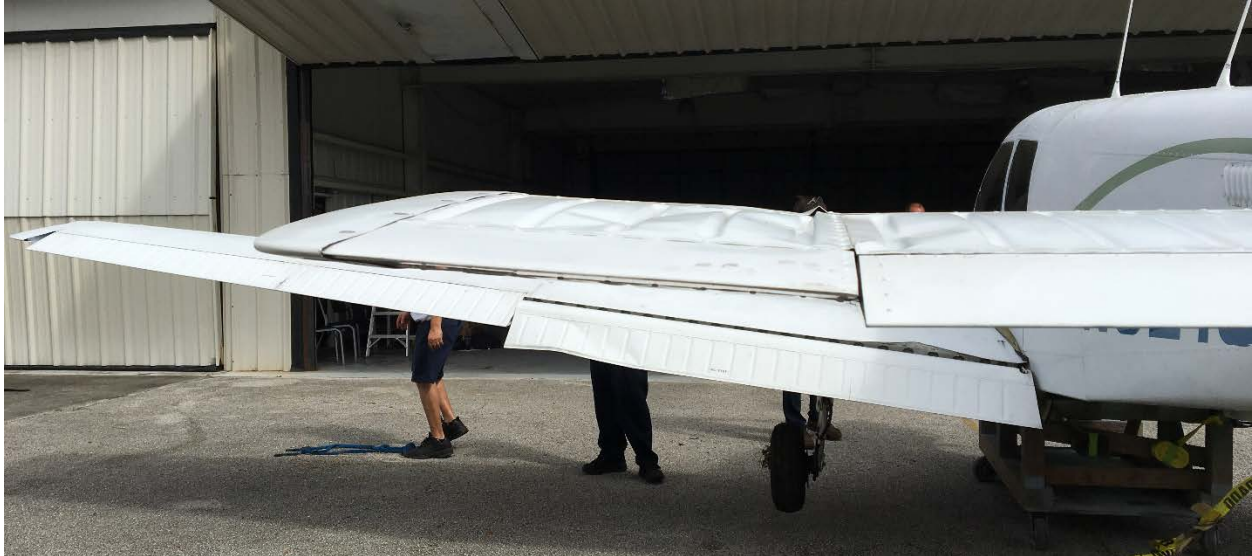
Figure 5: Left rear view wing trailing edge and stabilator

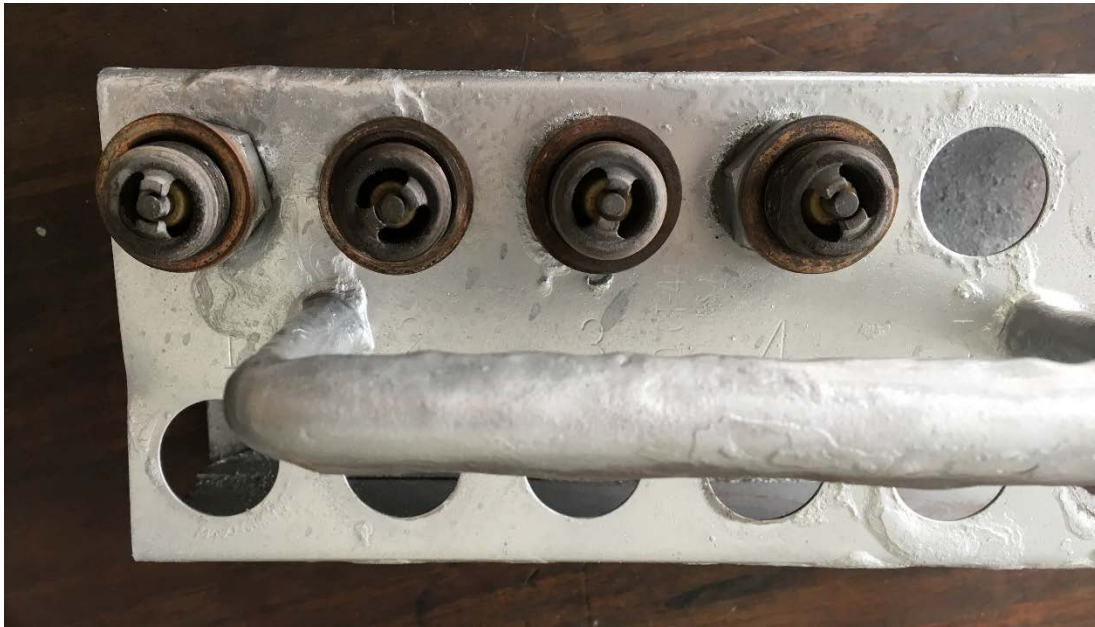
The external engine exam revealed no impact damage. The engine cowl was removed, and the engine appeared clean and well-maintained. All the spark plugs were removed and visually examined. The spark plugs appeared new and revealed no anomalies. Engine oil level indicated 7 quarts. The engine was rotated by hand and compression was confirmed on all four cylinders using thumb compression. Normal valvetrain movement was observed when the crankshaft was rotated, and the impulse couplings could be heard from the magnetos. Fuel was drained from the gascolator and carburetor. The fuel was light blue in color with a smell and look consistent with 100 low lead and was free from water and debris. Examination of the engine's cylinders with a lighted borescope revealed no damage to the cylinders or pistons. The valves and pistons displayed normal wear.

Figure 6: Spark plugs

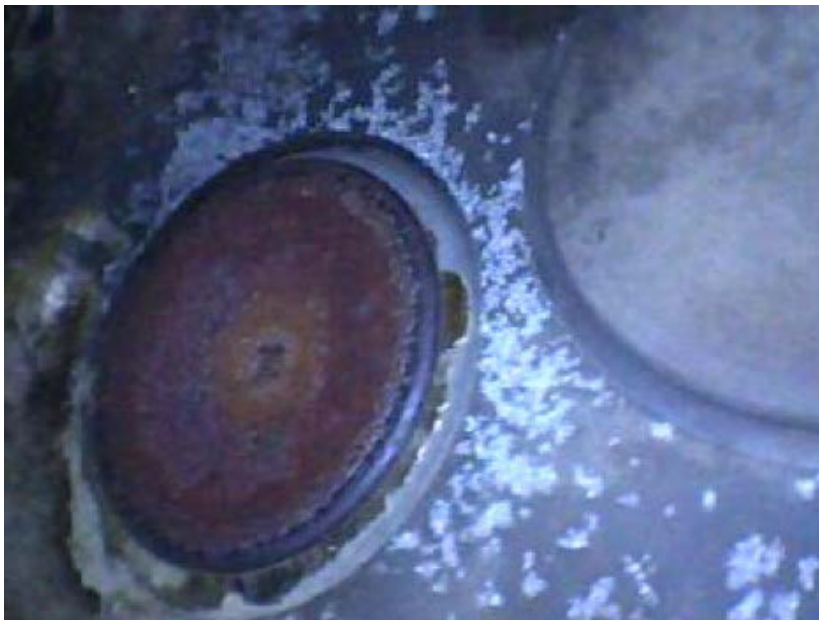
Figure 7: No. 1 cylinder valves

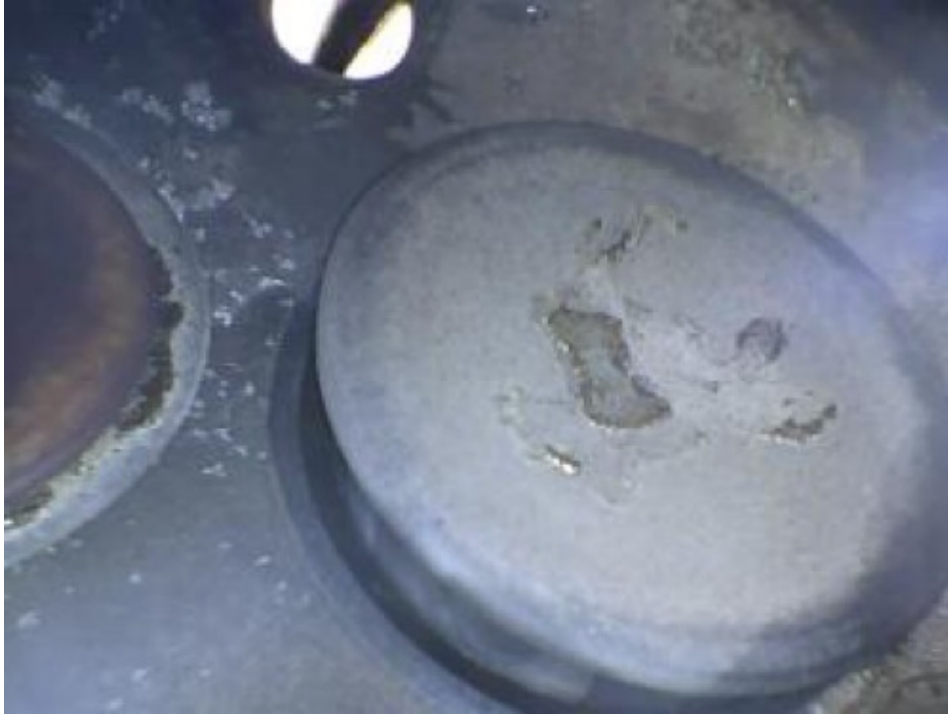
Figure 8: No. 2 cylinder valves

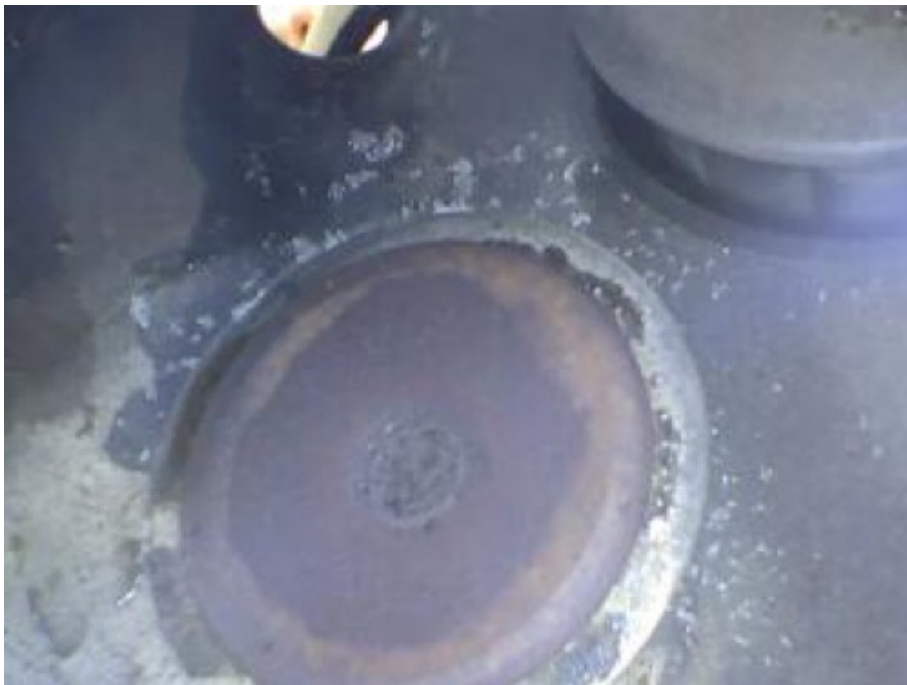
Figure 9: No. 3 cylinder valves

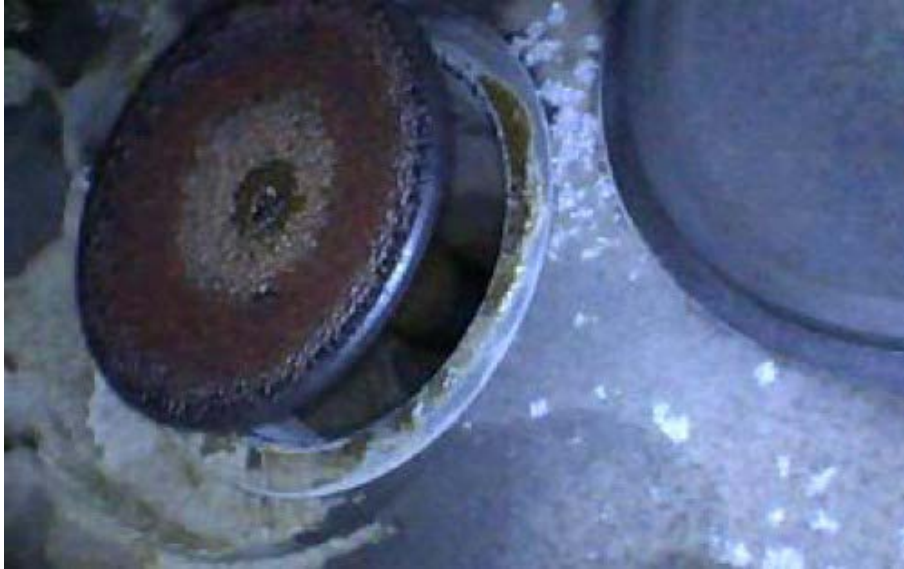
Figure 10: No. 4 cylinder valves
