## ENGINE EXAMINATION REPORT

| ENGINE MODEL | IO-470-L |
| AIRCRAFT REGISTRATION | N323MT |
| FILE NUMBER | 18-373 |

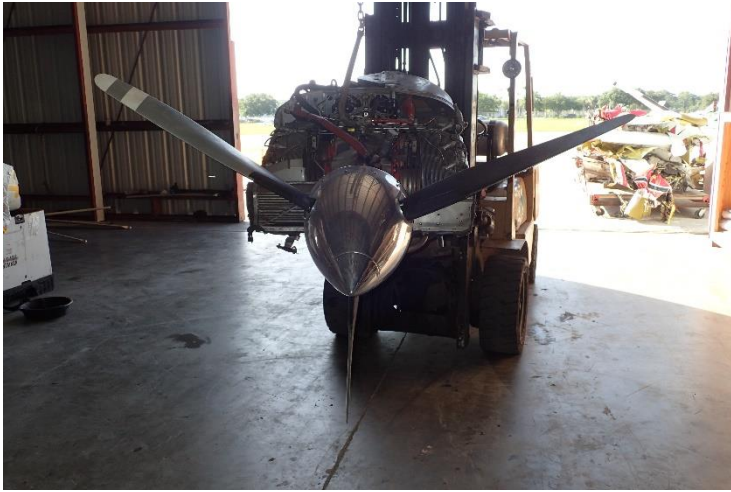
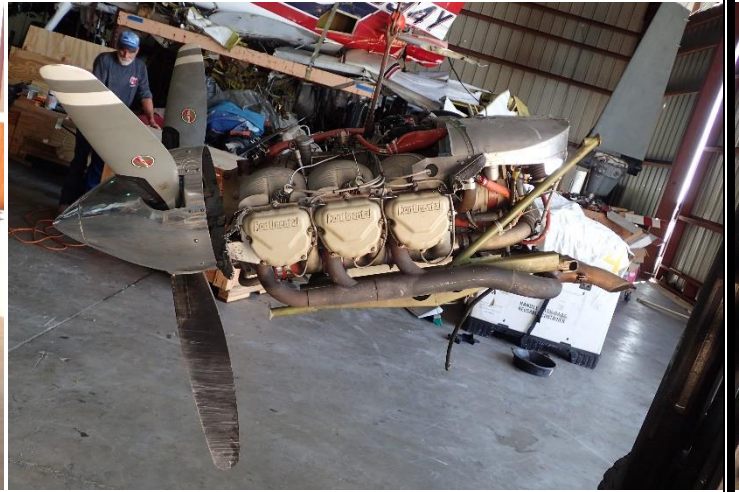
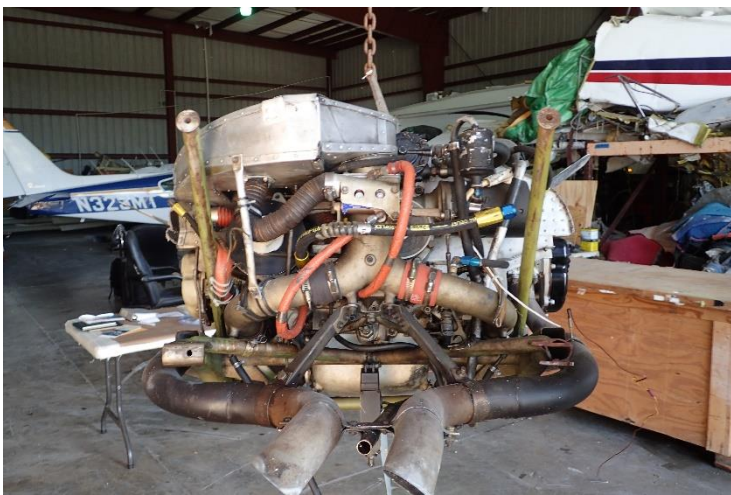
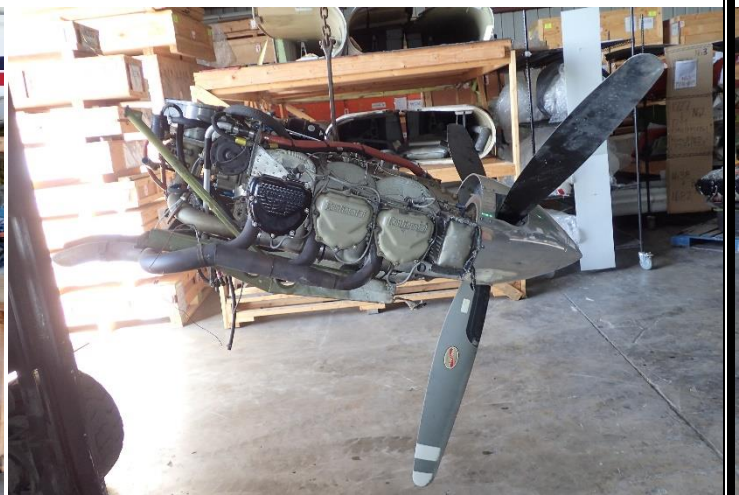
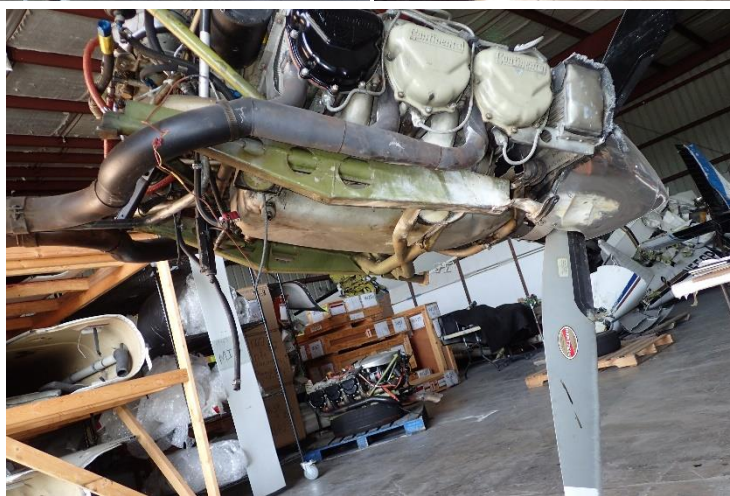
The engine had been removed from the airframe prior to the examination. The engine remained attached to the airframe engine mounts and the engine displayed impact damage to the bottom, front portion of the engine; the induction tubes were crushed and one of the risers was broken and the oil sump was dented. The crankcase remained intact and there were no signs of a catastrophic internal engine failure. The three blade, constant speed propeller remained attached to the crankshaft and all three propeller blades appeared to be in the feathered position and the blades displayed minimal damage. All six cylinders remained attached to their cylinder bays and were undamaged.

The exhaust system remained attached to the engine and was undamaged; there were no signs of exhaust leaks noted. The induction system displayed impact damage towards the front of the engine; the balance tube was crushed and one of the induction risers was broken. There were no signs of induction leaks noted.

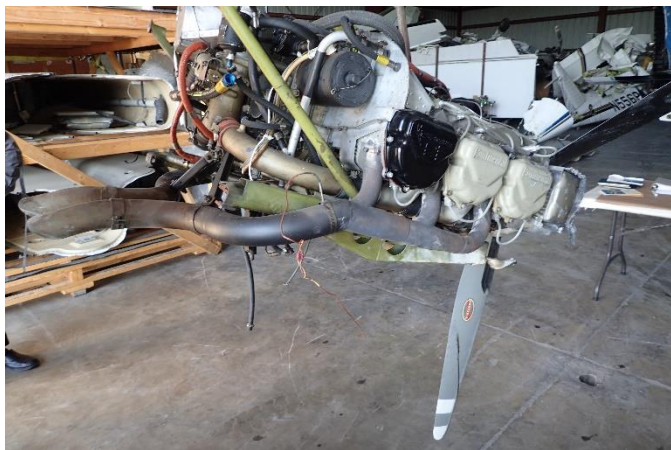
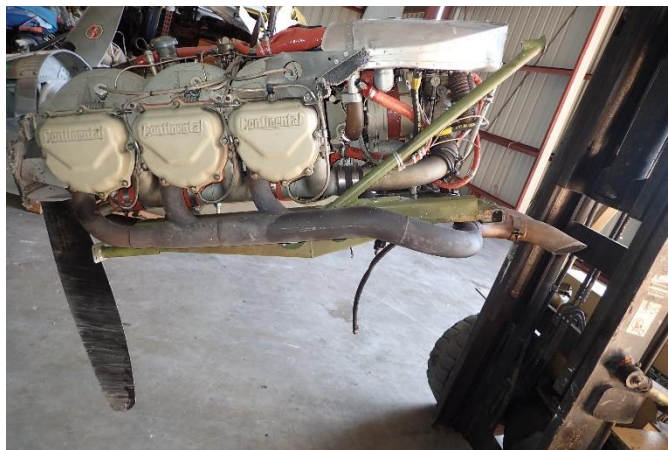
#### EXHAUST SYSTEM

**Condition:** The exhaust system remained attached to the engine and was undamaged. There were no signs of exhaust leaks or other anomalies observed.

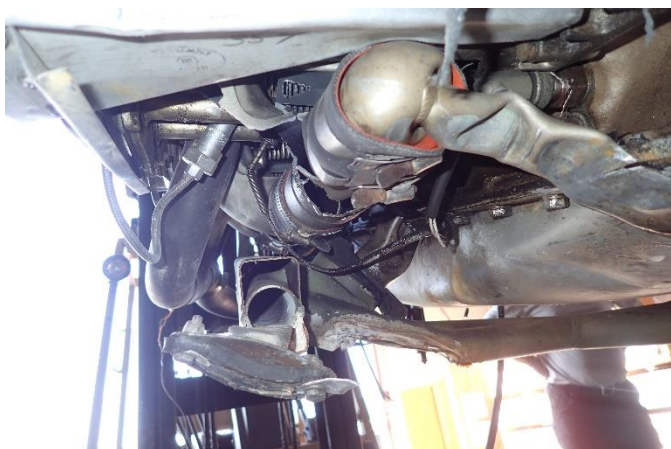
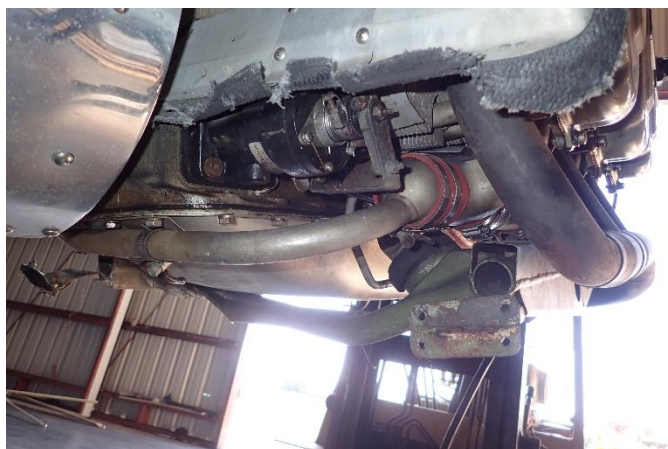
#### INDUCTION SYSTEM

**Condition:** The induction system remained attached to the engine and displayed impact damage concentrated to the forward portions of the induction system; the balance tube was crushed and one of the induction risers was broken. There were no signs of induction leaks noted. After the throttle and metering assembly was removed the inside of the induction risers were inspected; there were no signs of blockages noted. There were no anomalies observed.

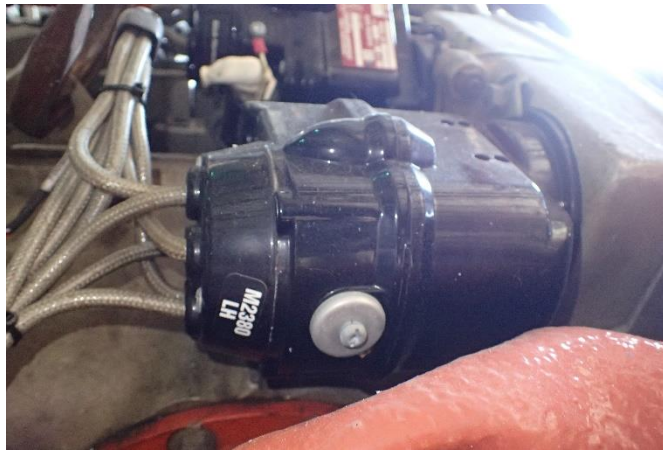
### LEFT MAGNETO

The magneto remained attached to its installation point and was undamaged. During crankshaft rotation it was noted that the impulse coupling operated normally. During impulse coupling operation the magneto was capable of producing a spark to each ignition lead end in the correct order; it was noted that the magneto would fire in sync with the right magneto. There were no anomalies noted.

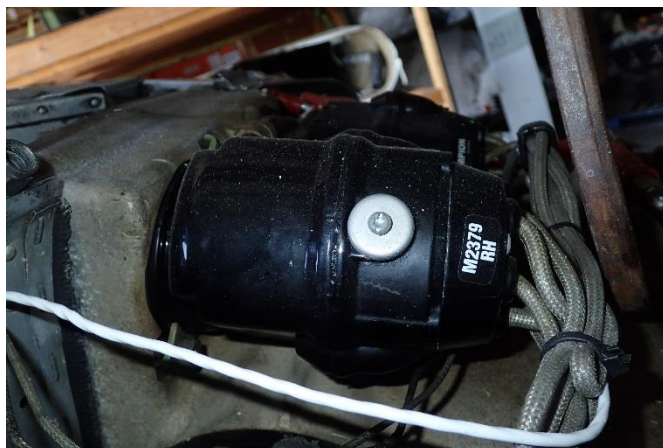
### RIGHT MAGNETO

The magneto remained attached to its installation point and was undamaged. During crankshaft rotation it was noted that the impulse coupling operated normally. During impulse coupling operation the magneto was capable of producing a spark to each ignition lead end in the correct order; it was noted that the magneto would fire in sync with the left magneto. There were no anomalies noted.

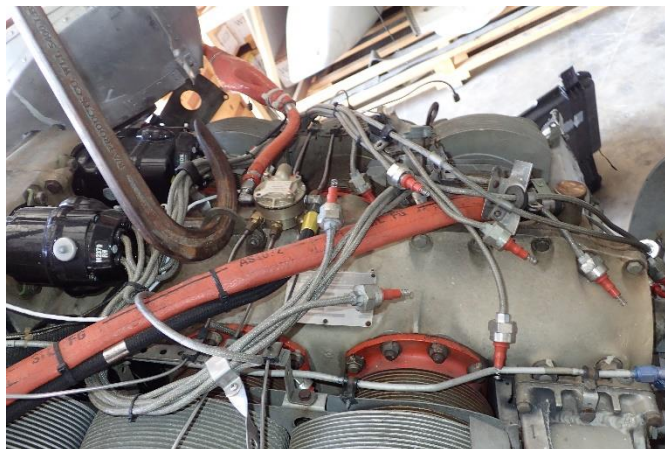
## IGNITION HARNESS

The ignition harness remained attached to both magnetos and to each spark plug. During magneto impulse coupling operation, it was observed that each ignition lead was capable of conducting a spark to the lead end. There were no anomalies observed.

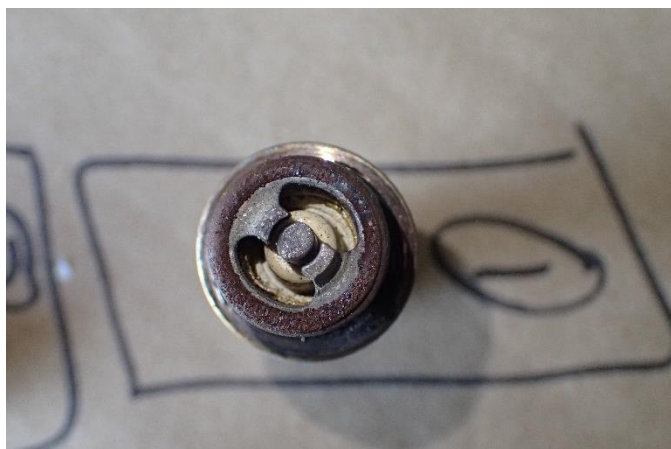
#1 Top Spark Plug

All of the spark plugs remained installed in their cylinders and were undamaged. The top spark plugs were removed, and the electrodes were visually inspected; the bottom spark plug electrodes were inspected using a lighted borescope. All of the electrodes displayed normal operating and most of the spark plugs were in a normally worn out condition. There were no anomalies that would have prevented normal operation noted.

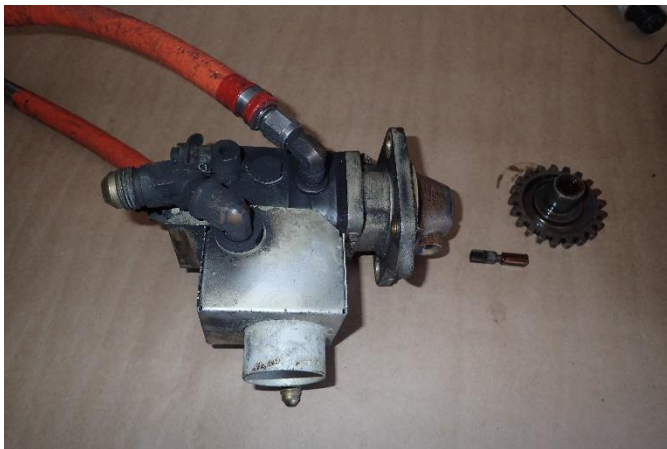
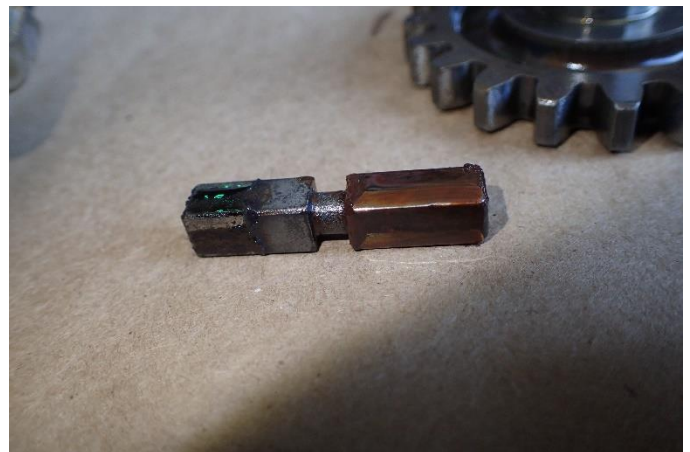
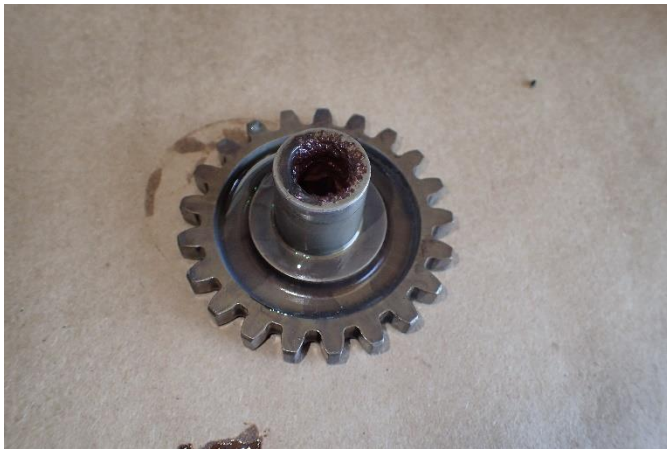
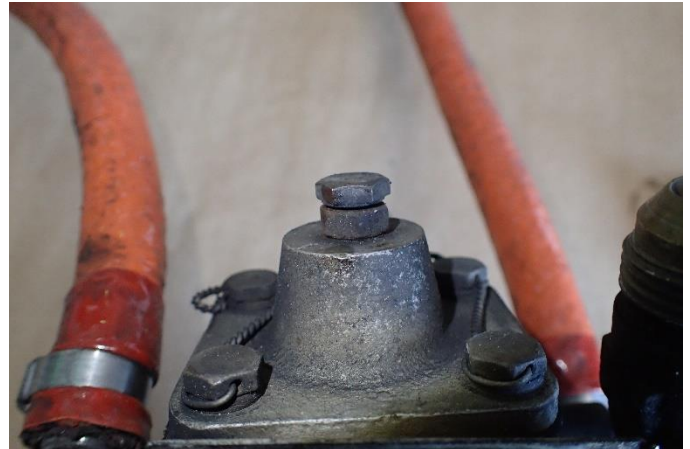
## FUEL PUMP

The fuel pump remained attached to its installation point and was undamaged; all of the fuel line AN fittings on the fuel pump remained secured (the fuel inlet line and fuel vapor return line had been disconnected at the firewall prior to the examination). The fuel pump was removed, and it was noted that the fuel pump drive coupling remained intact and the drive shaft was capable of rotation. During fuel pump drive rotation the fuel pump was capable of pumping out residual fluid that was consistent with 100LL Avgas. It was noted that the fuel pump low end adjustment bolt was screwed in all the way to the jam nut.

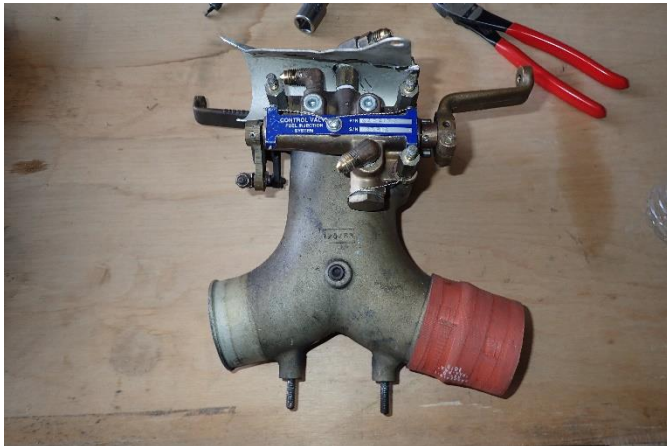
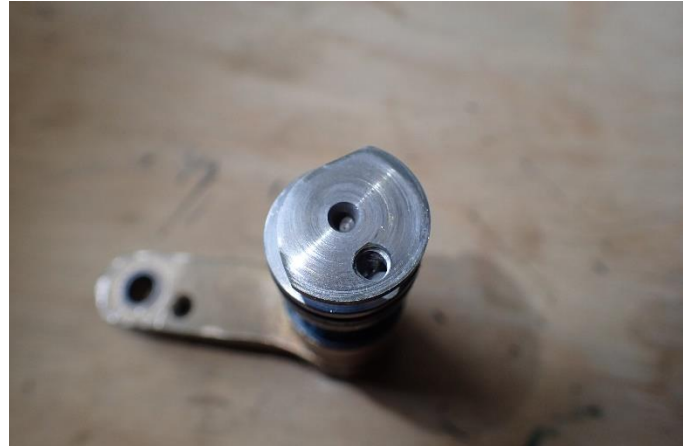
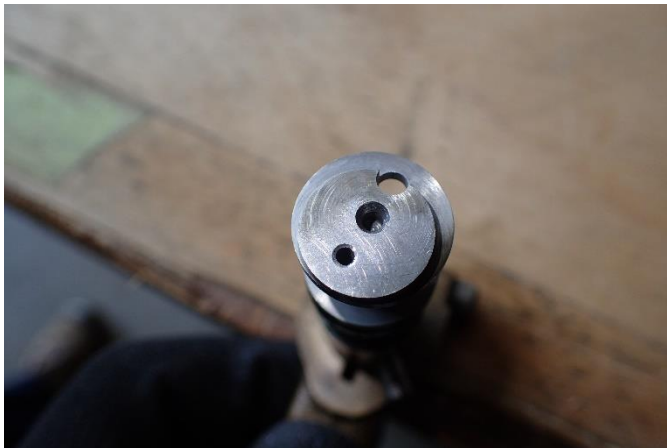
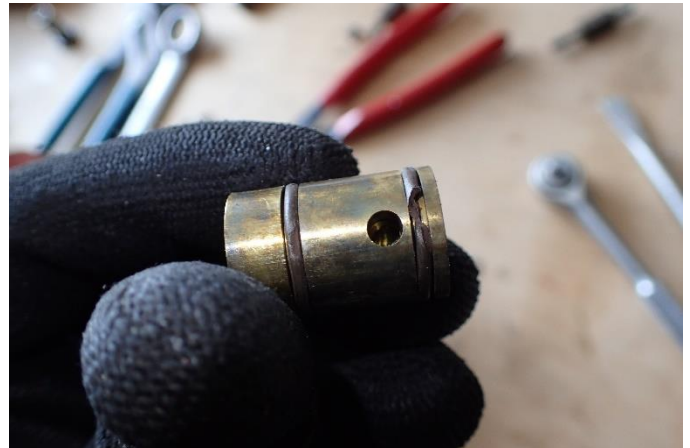
## THROTTLE BODY METERING UNIT

The throttle and metering assembly remained attached to its installation point and was undamaged. The assembly was removed and it was noted both the throttle and mixture control arms remained secured to their shafts and were capable of movement; however, it was observed that the throttle control full throttle stop pin was worn down and would allow the throttle valve to move past full open. The metering assembly was disassembled, and the internal components were visually examined; the mixture and throttle metering cams and the metering plug displayed normal operating signatures (it was noted that one of the metering plug O-rings was torn which was consistent with damage from removal). The fuel inlet screen was removed and visually inspected; it was noted that there was some fibrous material within the screen; however, the screen was not blocked. It was noted that the assembly had a non-standard dataplate.

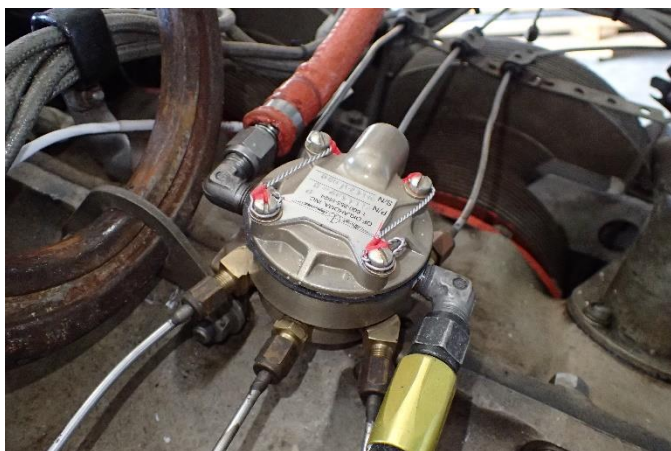
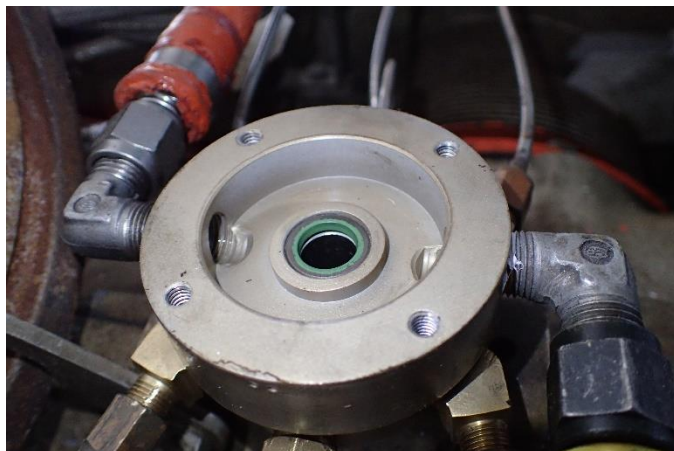
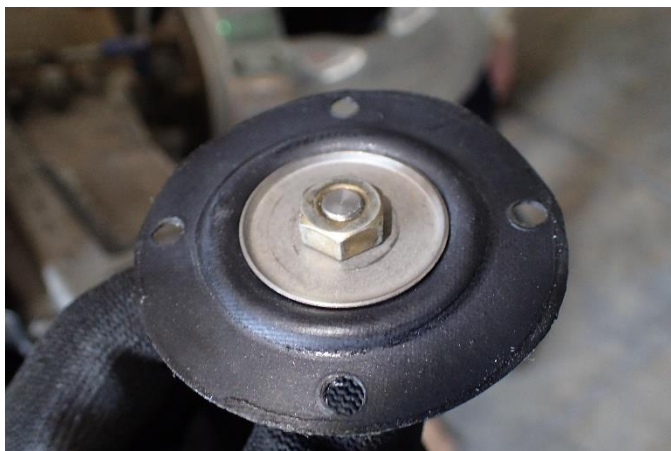
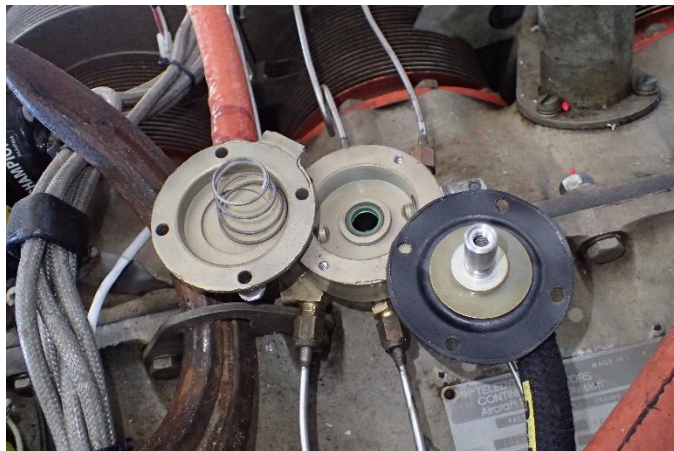
**FUEL MANIFOLD VALVE**

The fuel manifold valve remained attached to its installation point and was undamaged; all of the fuel lines were noted to be secure and there were no signs of fuel leaks around the assembly. The manifold valve was disassembled, and the internal components were visually inspected. It was noted that the fuel manifold valve did not have a screen installed. The diaphragm, plunger, and spring all showed normal operating signatures.

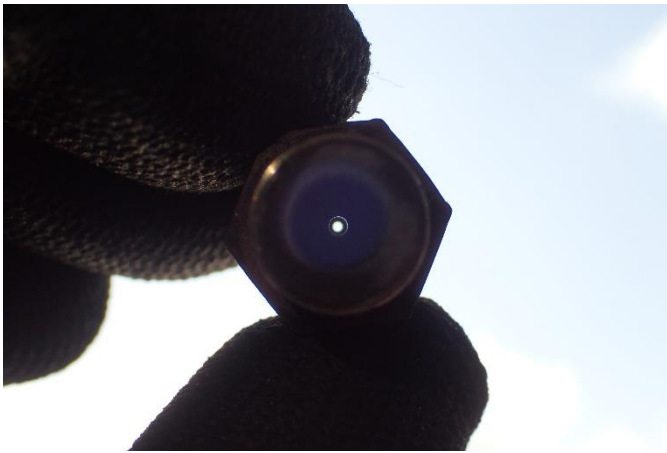
#1 Nozzle

All of the fuel nozzles remained installed in their cylinders and were undamaged and the fuel lines were secure. The nozzles were removed and visually inspected; all of the fuel nozzles were unobstructed and displayed normal operating signatures. There were no anomalies observed.

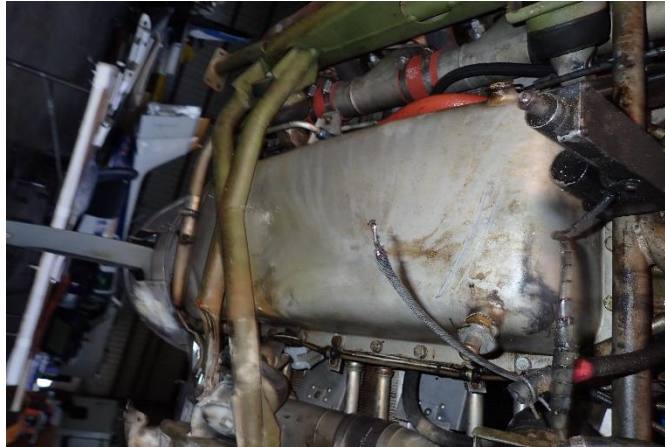
**PAGE 16 of 30****LUBRICATION SYSTEM****OIL SUMP****Condition:**

The oil sump remained attached to the engine and displayed minor impact damage in the form of dents. There were no anomalies noted.

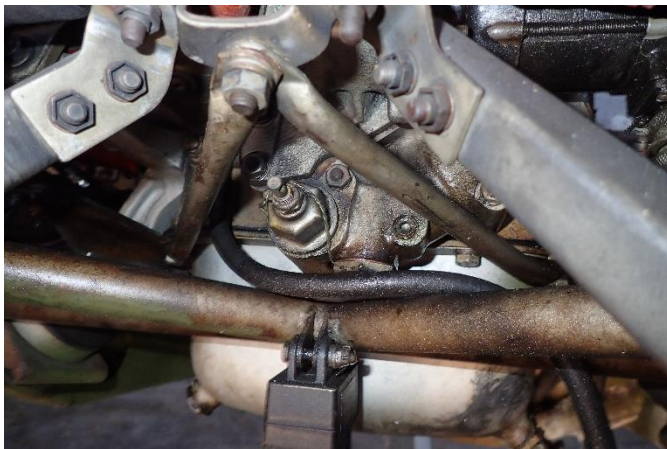
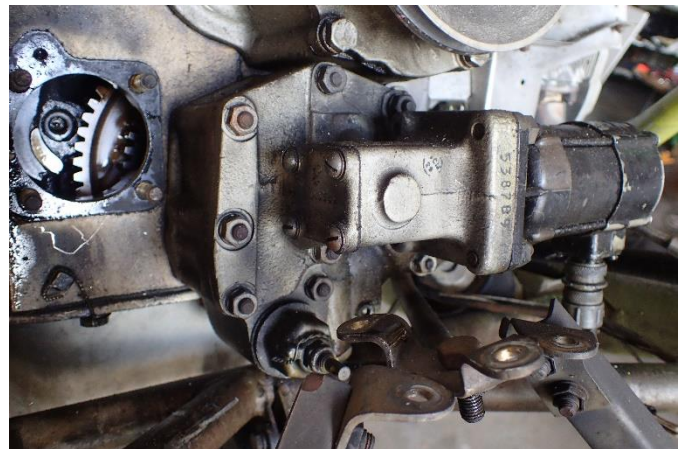
**OIL PUMP****Condition:**

The oil pump remained attached to its installation point and was undamaged. During crankshaft rotation it was noted that oil would pump out of the oil pressure indication line. There were no anomalies observed.

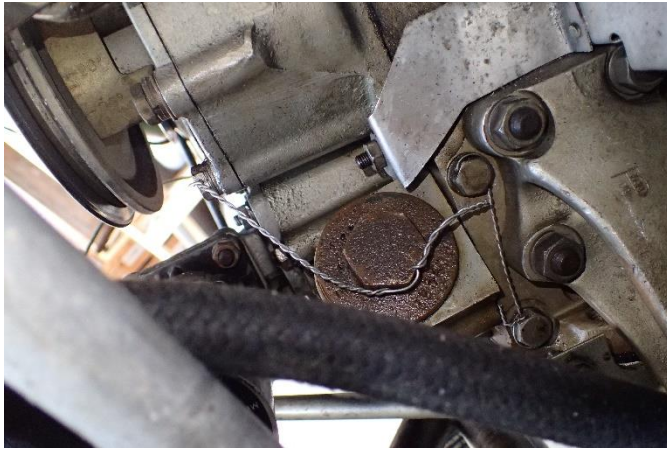
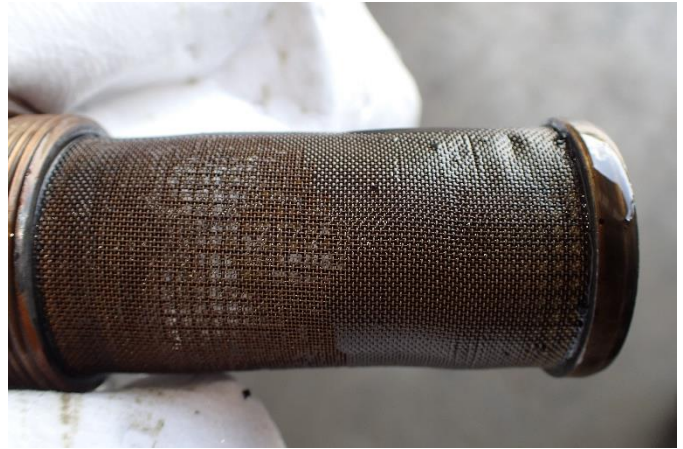
## OIL SCREEN

The oil screen remained secured in its installation point and was undamaged. The oil screen was removed, and the screen was visually inspected; it was noted that there was a small amount of carbon deposits and there was no metallic material noted within the screen. There were no anomalies observed.

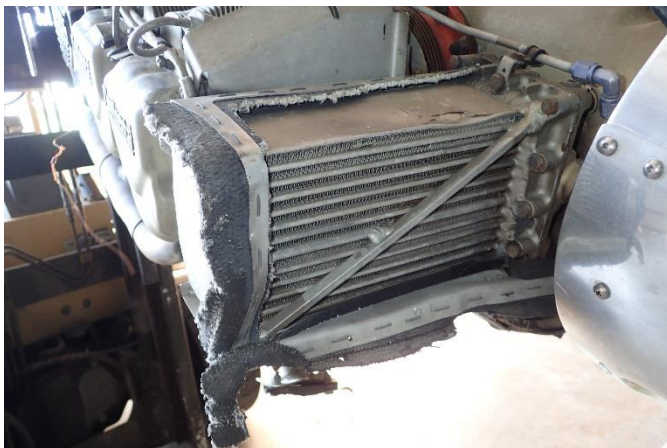
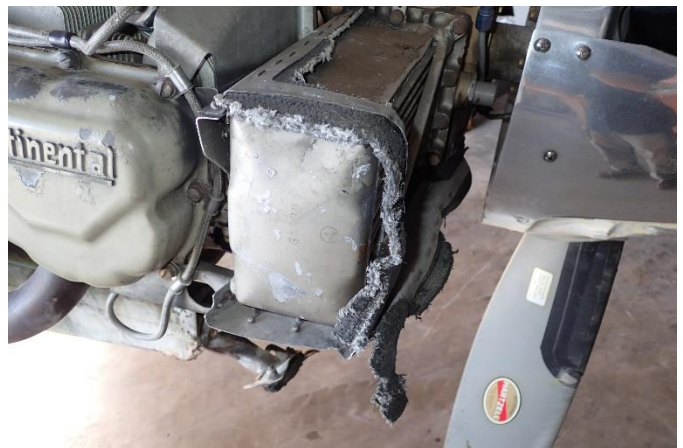
## OIL COOLER

The oil cooler remained attached to its installation point and displayed minor impact damage signatures. There were no anomalies noted.

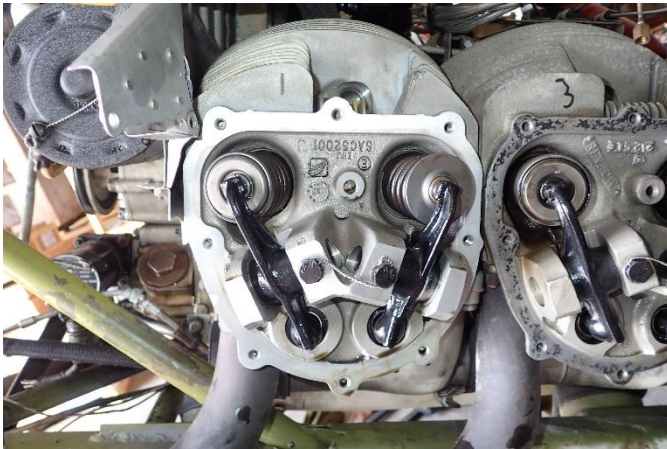
#1 Cylinder Overhead Components

All of the cylinders remained attached to their cylinder bays and were undamaged. The cylinders were inspected using a lighted borescope; the cylinder bores, piston faces, and valve heads displayed normal operating and combustion signatures. The overhead components (valves, springs, and rocker arms) displayed normal operating and lubrication signatures. During crankshaft rotation all six cylinders displayed good thumb compression and suction and all of the rocker arms and valves operated normally.

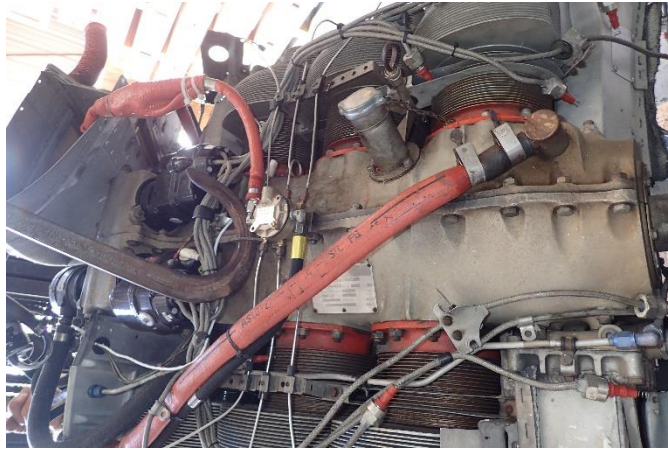
### CRANKCASE ASSEMBLY

| Condition: | The crankcase remained intact and was undamaged. There were no signs of a catastrophic internal engine failure observed. There were no anomalies observed. | | | |

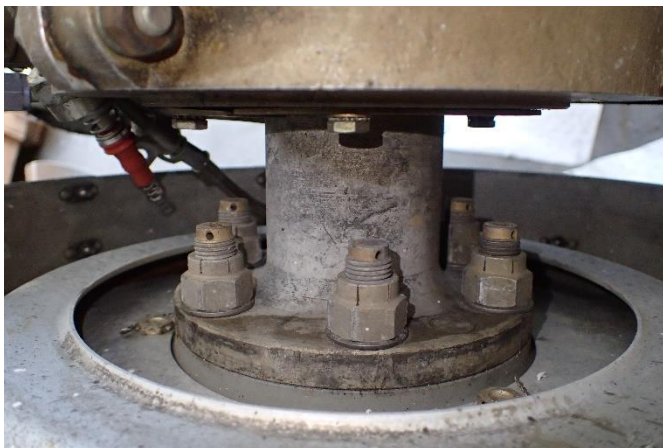
The crankshaft remained intact and was undamaged. The crankshaft was rotated manually by moving the propeller and continuity was established between the crankshaft, camshaft, connecting rods, and associated components. There were no anomalies noted with the crankshaft.

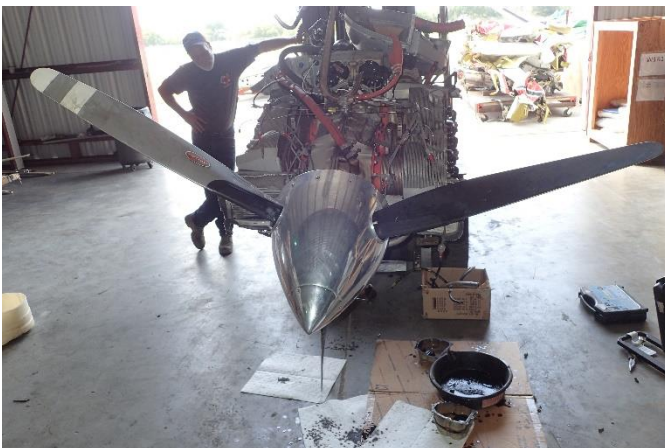
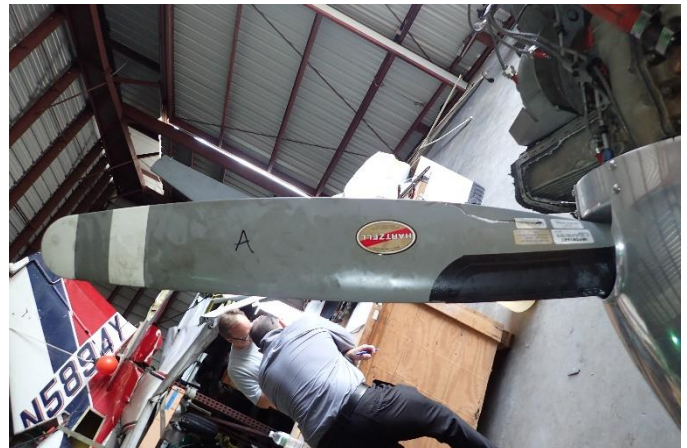
### PROPELLER

The three blade, constant speed propeller remained attached to the crankshaft and appeared to be in the feathered position. All three propeller blades remained within the hub and displayed minimal damage; the propeller blade marked "C" displayed minor chordwise scratches and leading-edge polishing, the other two blades were undamaged.
