## ENGINE EXAMINATION REPORT

| ENGINE MODEL | IO-470-L |
| AIRCRAFT REGISTRATION | N323MT |
| FILE NUMBER | 18-373 |

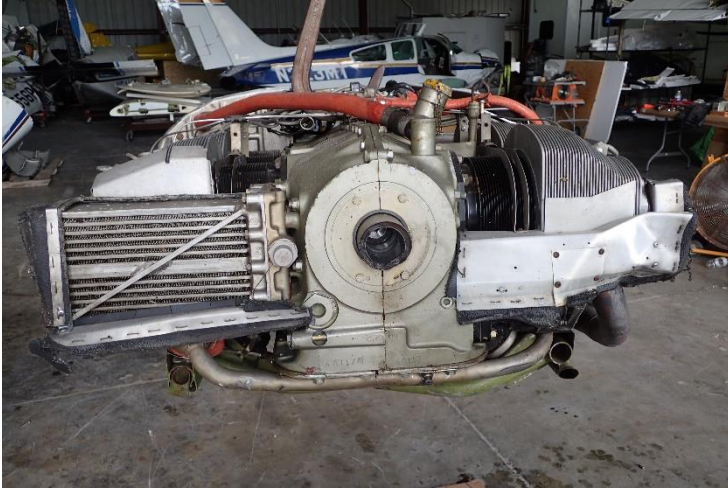
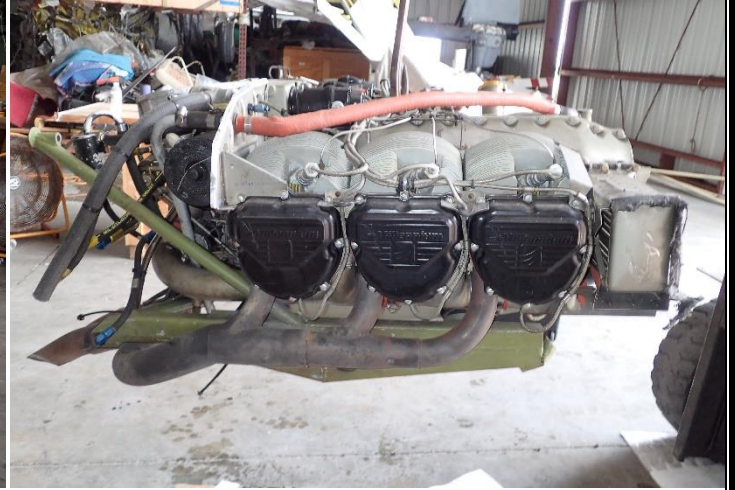
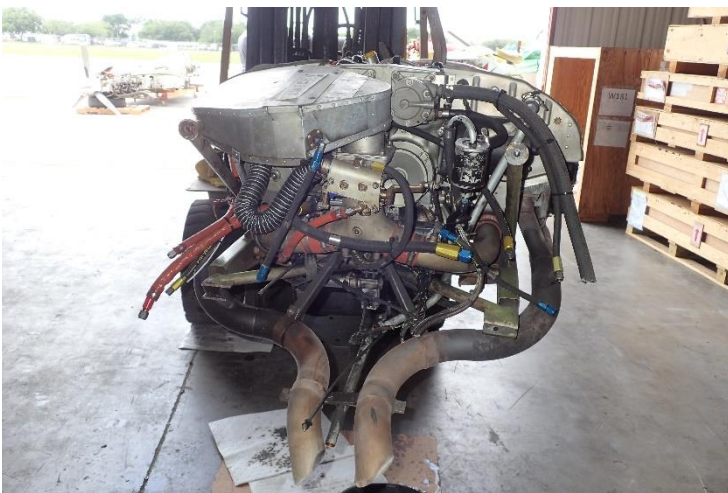
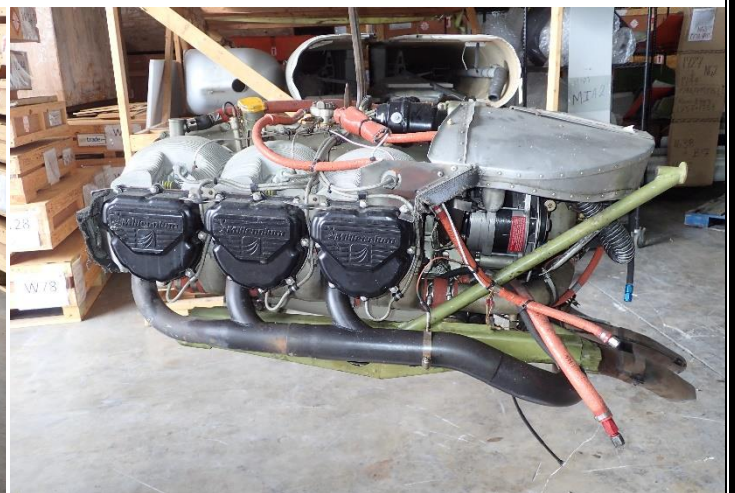
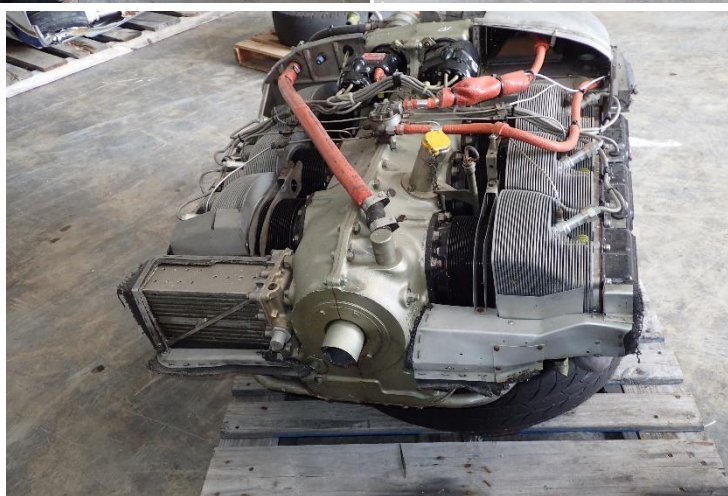
The engine had been removed from the airframe prior to the engine examination. The engine displayed impact damage signatures with most of the damage occurring to the forward portions of the engine. The three blade, constant speed propeller remained attached to the propeller flange; however, the propeller flange had broken free from the rest of the crankshaft. According to the FAA the propeller was found at the accident site. The crankcase displayed minor impact damage and there were no signs of a catastrophic internal engine failure. All six cylinders remained attached to their cylinder bays and were undamaged.

The exhaust system remained attached to the engine and was undamaged; there were no signs of exhaust leaks noted. The induction system remained attached to the engine and displayed minor impact damage to the balance tube. There were no signs of induction leaks noted.

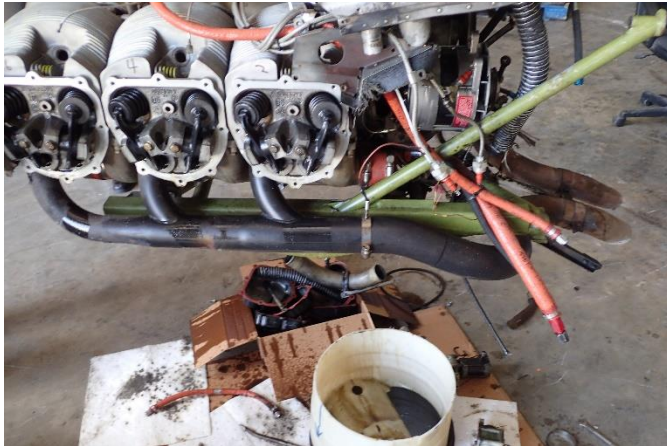
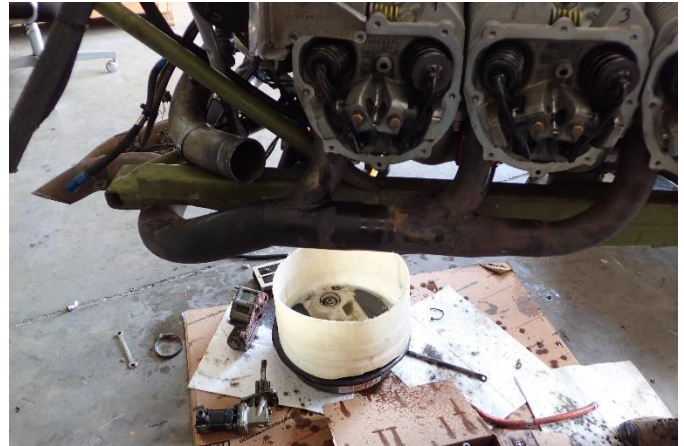
The exhaust system remained attached to the engine and was undamaged. There were no signs of exhaust leaks noted with any of the exhaust components.

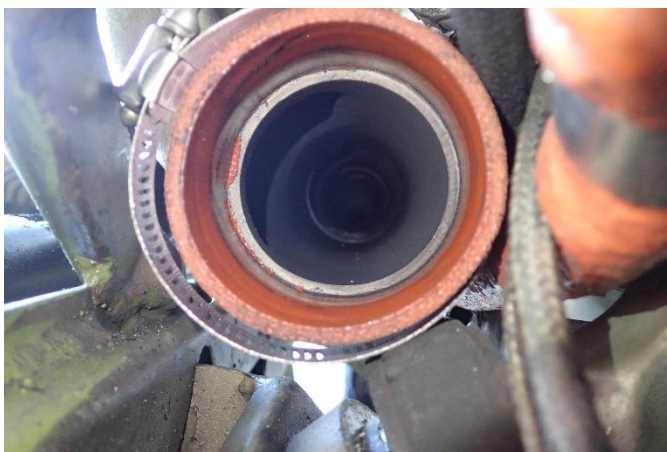
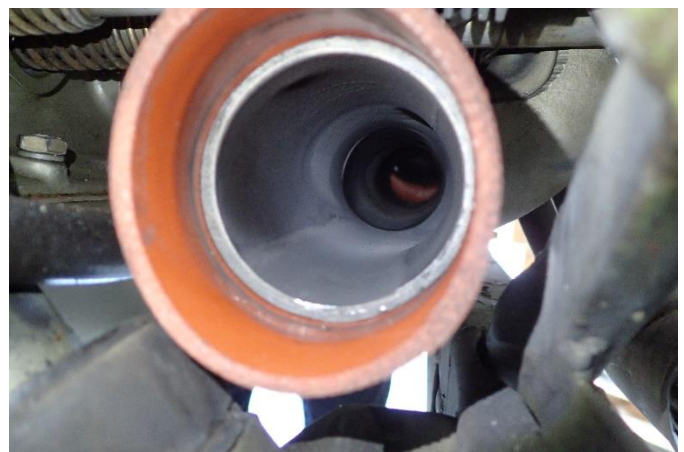
The induction system remained intact and displayed minor impact damage to the balance tube. There were no signs of induction leaks around any of the intake components. After the throttle and metering assembly was removed along with two induction pipes the internal portions of the induction system was inspected; there were no blockages or other anomalies noted.

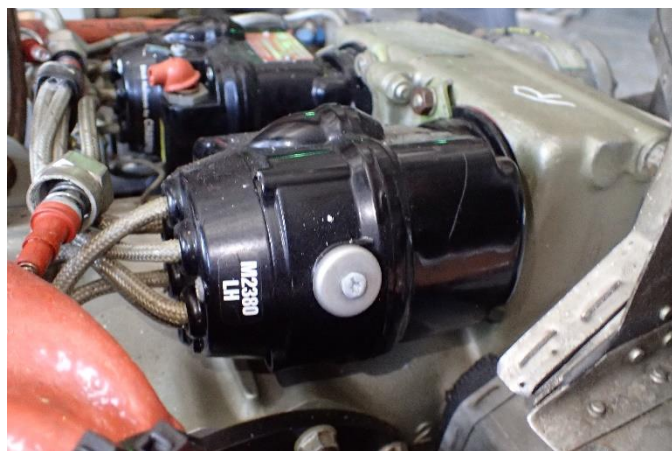
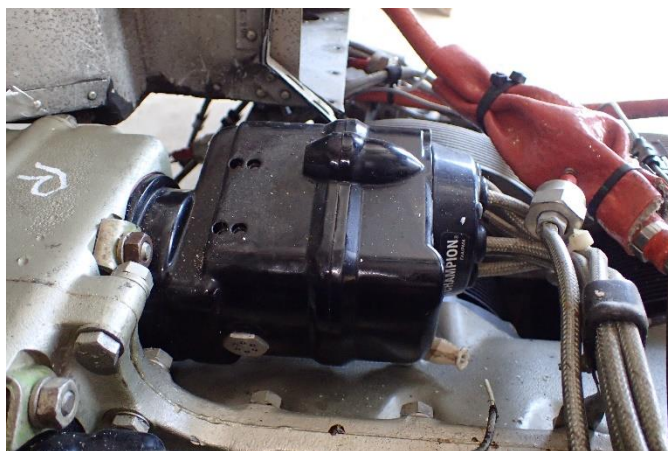
The magneto remained attached to its installation point and was undamaged. During crankshaft rotation it was noted that the impulse coupling would operate. During impulse coupling operation it was observed that the magneto was capable of producing a spark to each ignition lead end in the correct order and was in sync with the right magneto. There were no anomalies noted with the magneto.

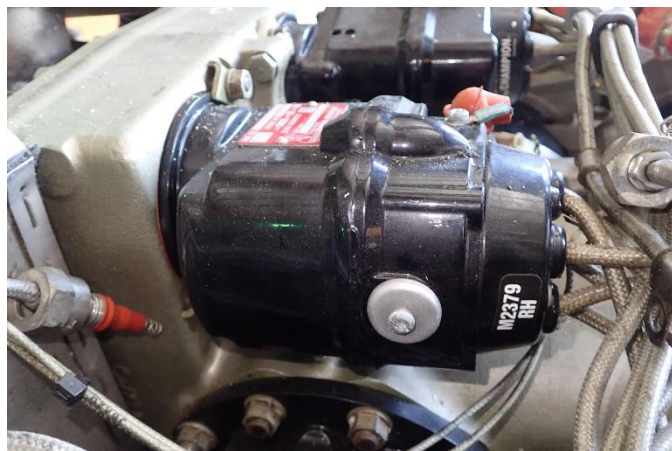
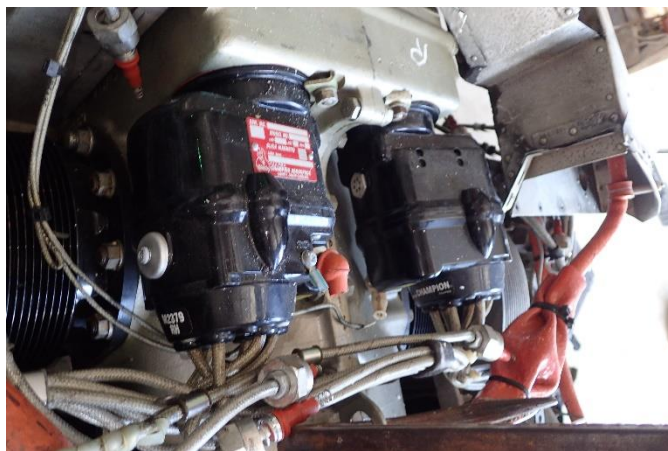
The magneto remained attached to its installation point and was undamaged. During crankshaft rotation it was noted that the impulse coupling would operate. During impulse coupling operation it was observed that the magneto was capable of producing a spark to each ignition lead end in the correct order and was in sync with the left magneto. There were no anomalies noted with the magneto.

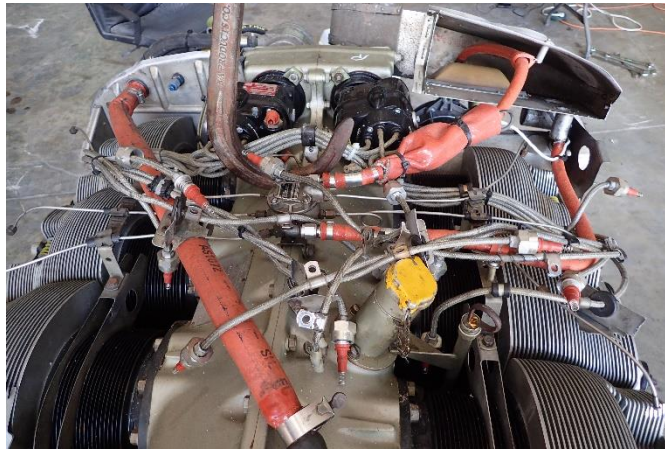
The ignition harness remained attached to both magnetos and to each spark plug. There were no signs of damage to the ignition leads. During magneto impulse coupling operation, it was noted that each ignition lead was capable of conducting a spark from the magneto to the ignition lead end. There were no anomalies observed.

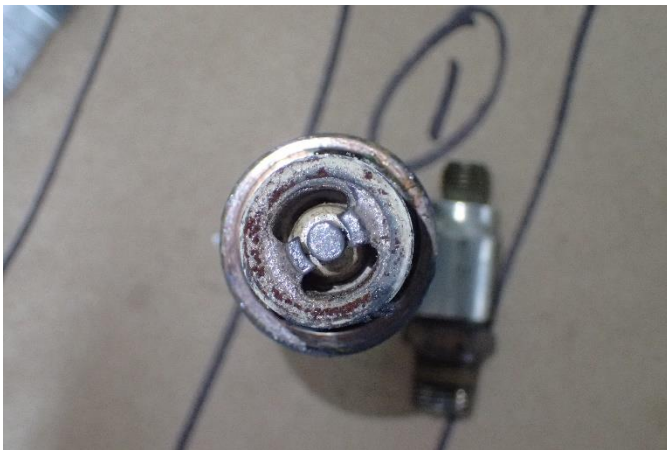
#1 Top Spark Plug

All of the spark plugs remained installed in their cylinders and were undamaged. The top spark plugs were removed, and the electrodes were visually examined; the bottom spark plug electrodes were examined using a lighted borescope. All of the electrodes displayed normal operating signatures and most of the spark plugs were in a normal worn out condition. There were no anomalies noted that would have prevented normal operation.

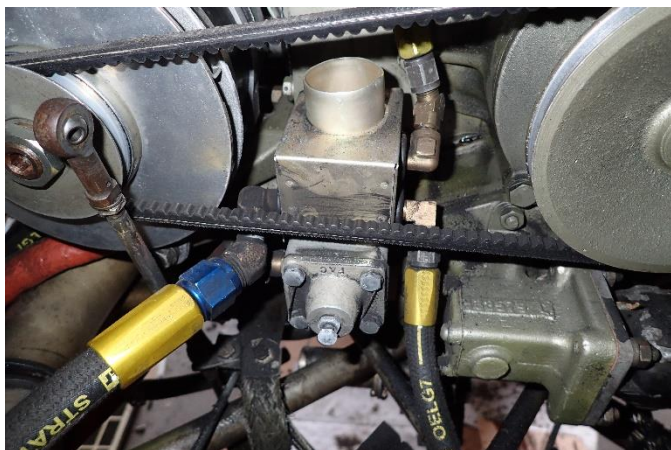
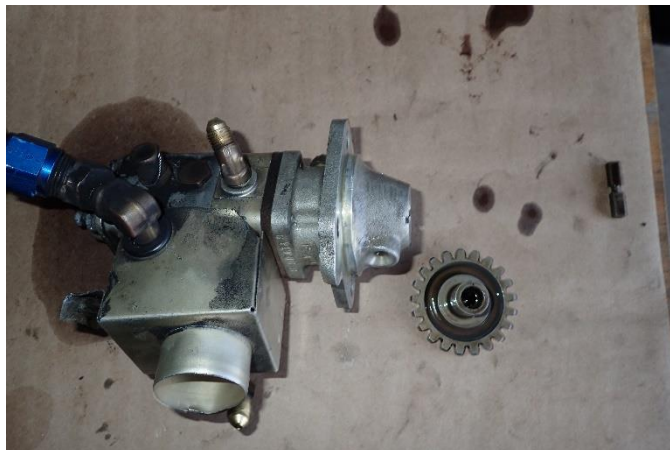
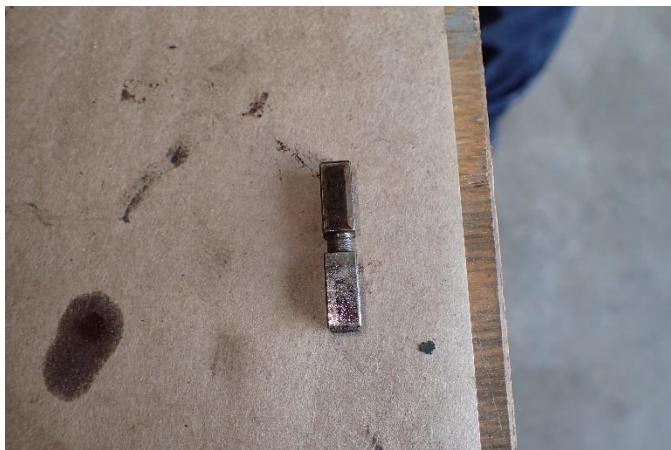
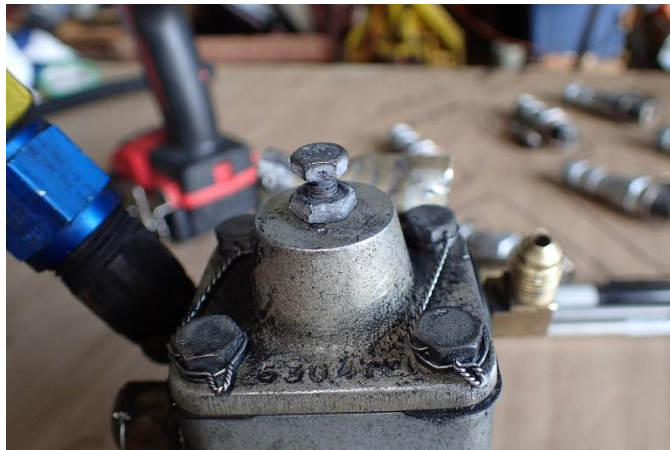
The fuel pump remained attached to its installation point and was undamaged. The fuel pump was removed, and it was noted that the fuel pump drive coupling remained intact. The fuel pump was primed using fuel and the fuel pump inlet fuel line was submersed in the fuel. The fuel pump drive shaft was then rotated using an electric drill and it was noted that the fuel pump was capable of pumping the fuel. There were no anomalies noted.

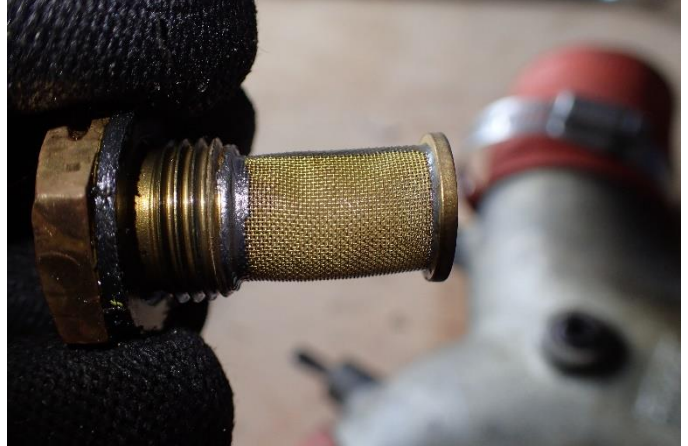
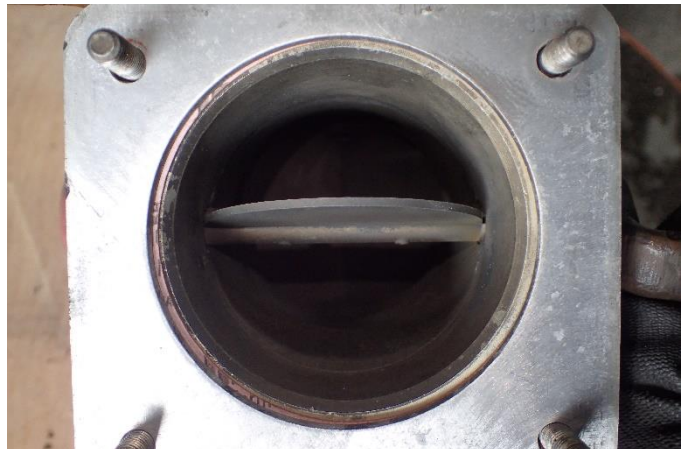
The throttle and metering assembly remained attached to its installation point and was undamaged. The mixture control arm and the throttle control arms remained secured to their shafts and were capable of movement; it was noted that the full throttle stop pin was not installed and the brass housing was worn which allowed the throttle valve to move past the full throttle position. The fuel inlet screen was removed and was noted to be clear of contaminants.

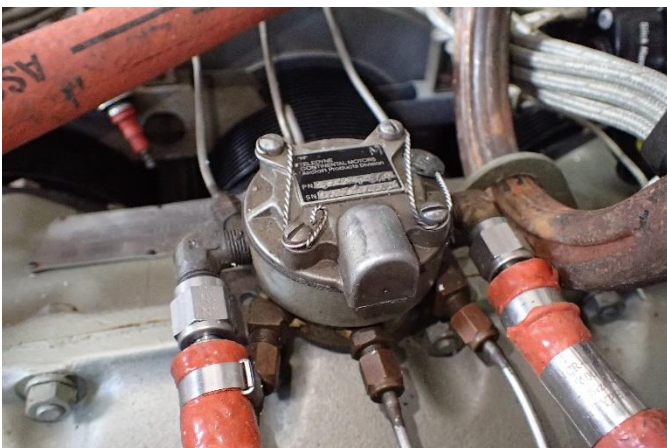
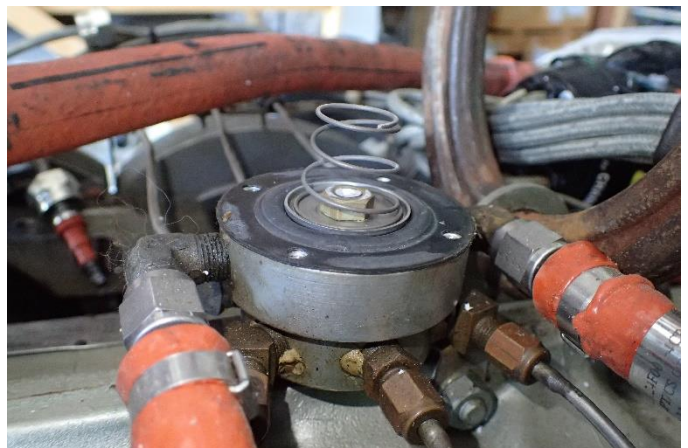
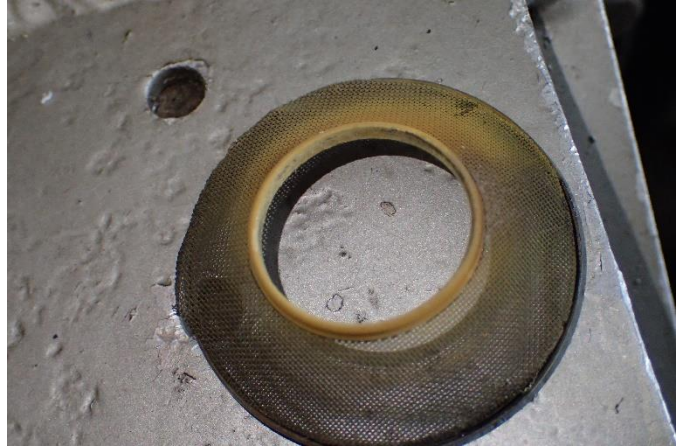
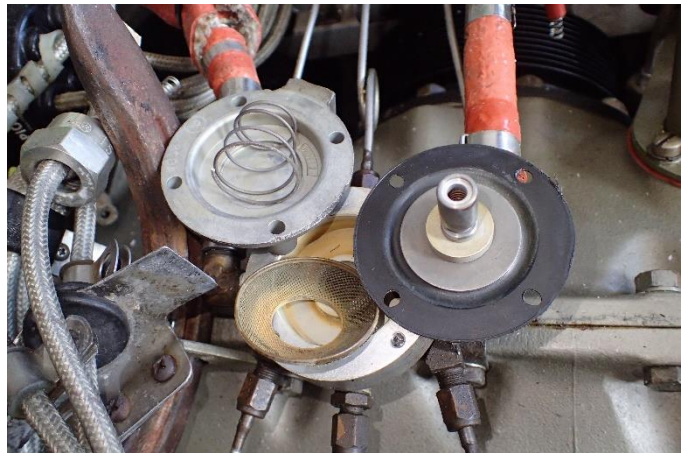
The fuel manifold valve remained attached to its installation point and was undamaged. The manifold valve was disassembled, and the internal components were visually examined. The spring, plunger, and diaphragm displayed normal operating signatures and the screen was clear of contaminants. It was noted that the housing displayed a significant amount of discoloration that was orange in color.

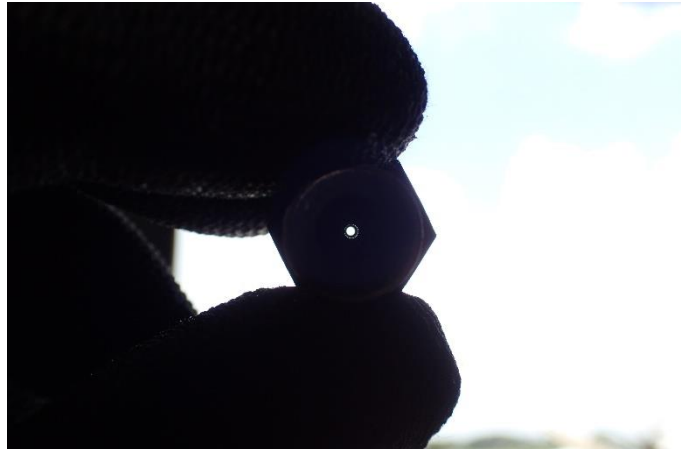
#2 Nozzle

| Position | #1 | #3 | #5 | #2 | #4 | #6 |
|---|---|---|---|---|---|---|
| Condition: | All of the fuel nozzles remained installed in their cylinders and were undamaged. The nozzles were removed, and it was noted that all of the nozzles were unobstructed. There were no anomalies noted. | | | | | |

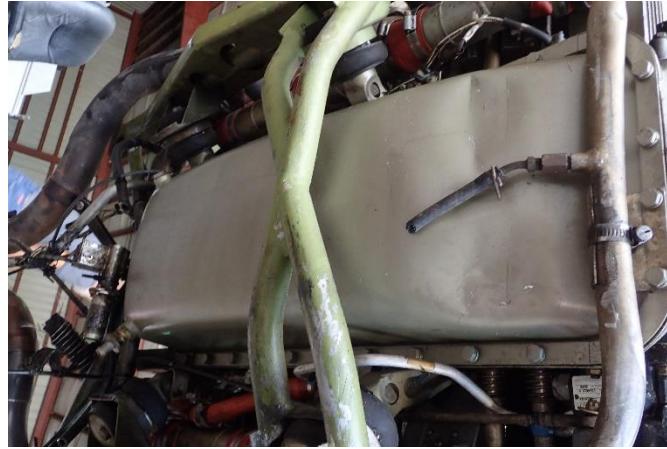
The oil sump remained intact and displayed minor impact damage in the form of denting. There were no anomalies noted.

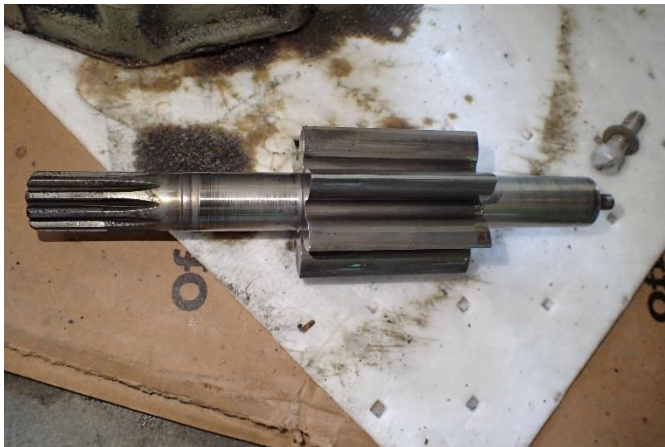
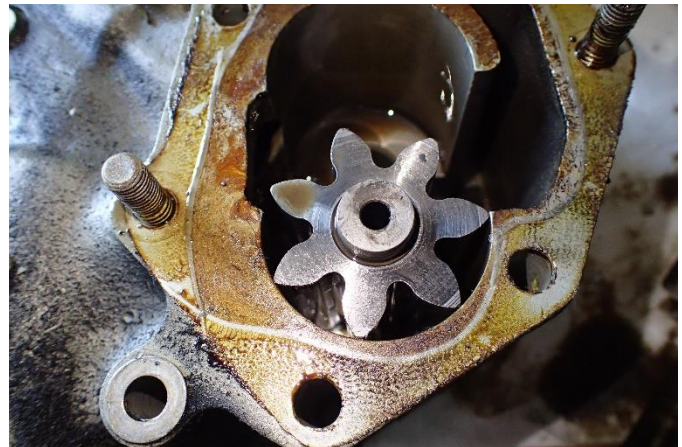
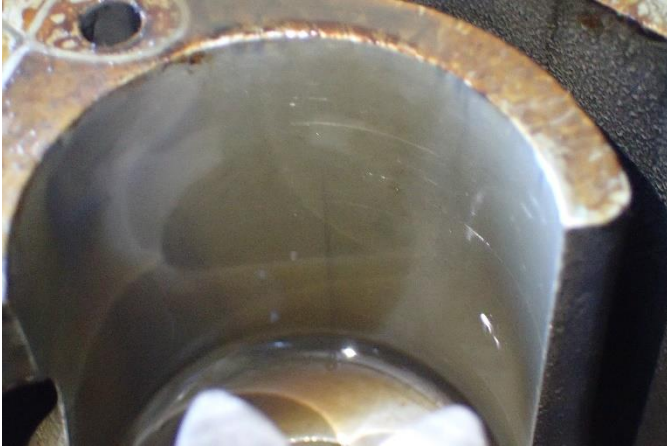
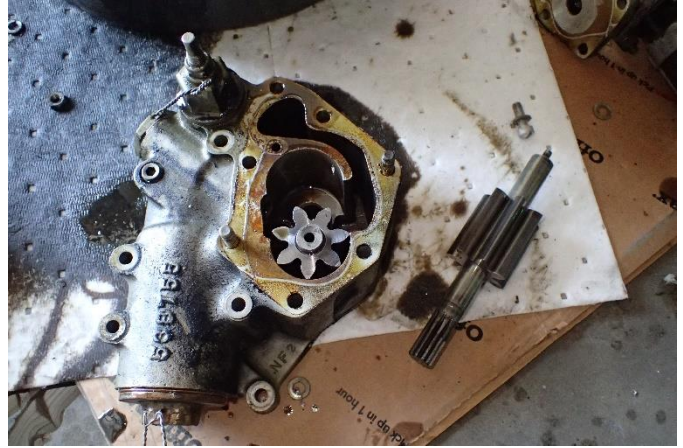
The oil pump remained attached to its installation point and was undamaged. The oil pump was removed, and the oil pump drive gears and housing were visually examined; the components displayed normal operating signatures. There were no anomalies observed.

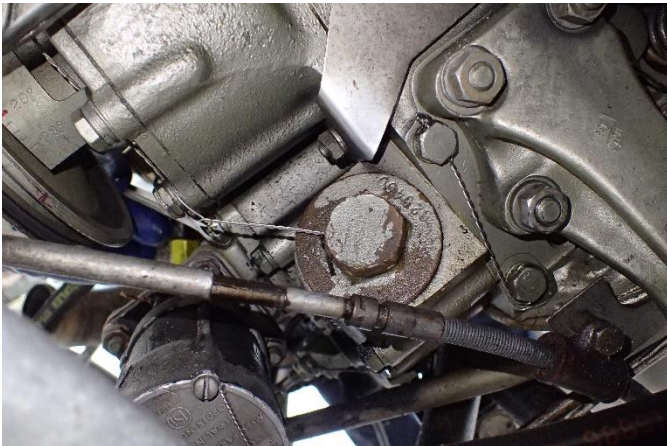
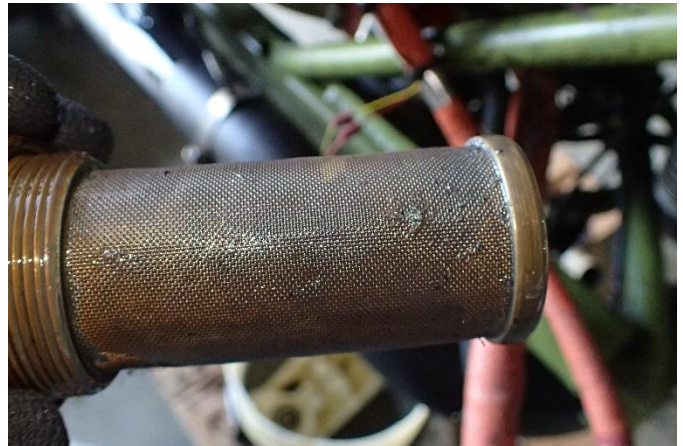
The oil screen remained secured in its installation point and there were no signs of impact damage. The oil screen was removed and visually inspected; the screen contained material consistent with carbon and there were no signs of metallic material within the screen. There were no anomalies noted.

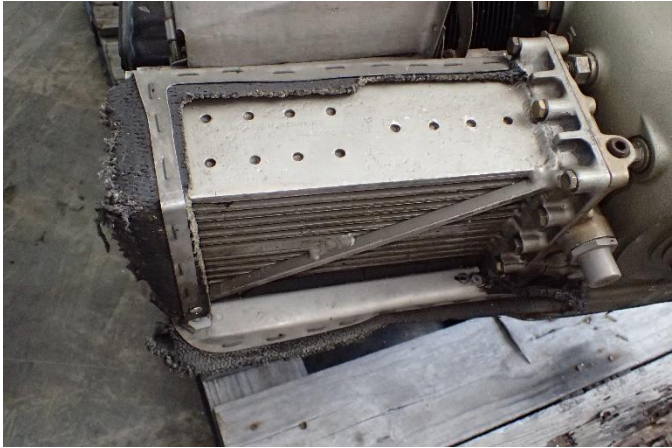
| Condition: | The oil cooler remained attached to its installation point and was undamaged. There were no anomalies observed. | | |

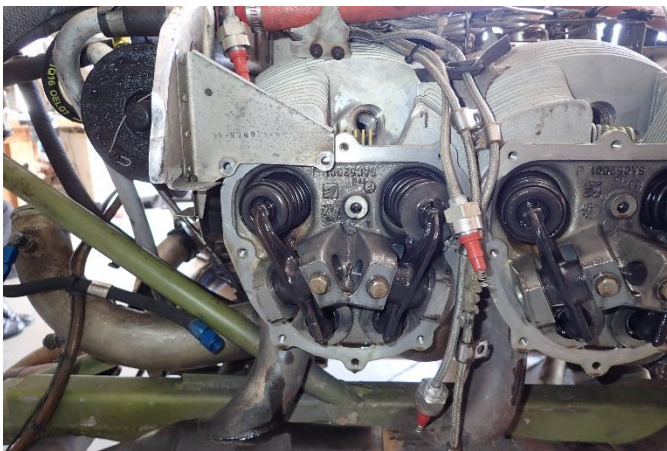
#1 Cylinder Overhead

All of the cylinders remained attached to their cylinder bays and were undamaged. The cylinders were inspected using a lighted borescope; the cylinder bores, piston faces, and valve heads displayed normal operating and combustion signatures. The overhead components (valves, springs, and rocker arms) displayed normal operating and lubrication signatures. During crankshaft rotation all six cylinders displayed good thumb compression and suction and all of the rocker arms and valves operated normally during crankshaft rotation.

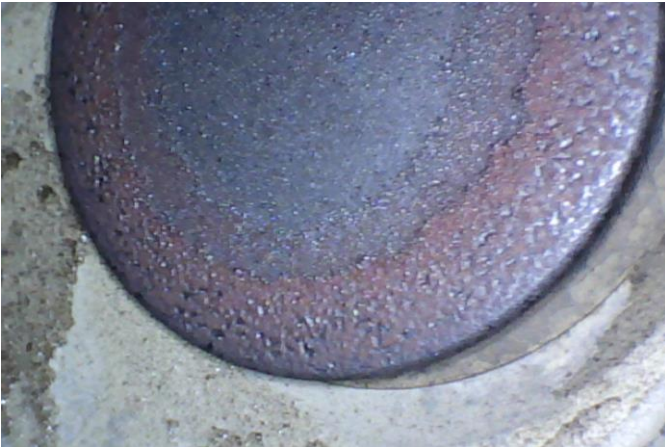
#1 Exhaust Valve

The valve heads were inspected using a lighted borescope; the valve heads displayed normal operating and combustion signatures. The valve springs and stems displayed normal operating and lubrication signatures. During crankshaft rotation all of the valves operated normally. There were no anomalies observed.

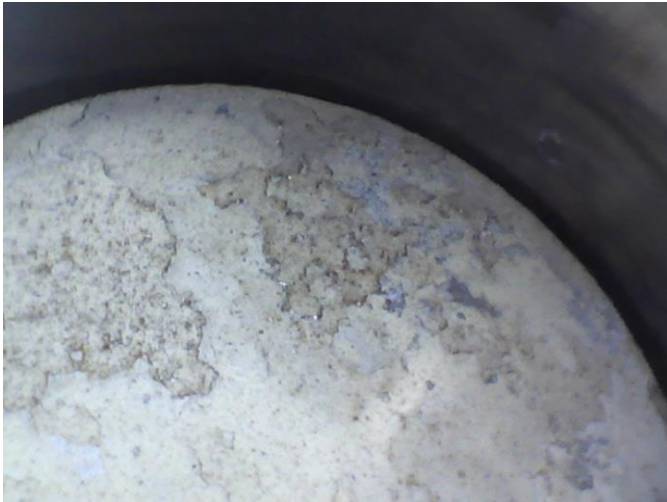
#1 Piston

All of the piston faces were inspected using a lighted borescope; the piston faces displayed normal operating and combustion signatures. During crankshaft rotation all of the pistons operated normally. There were no anomalies observed.

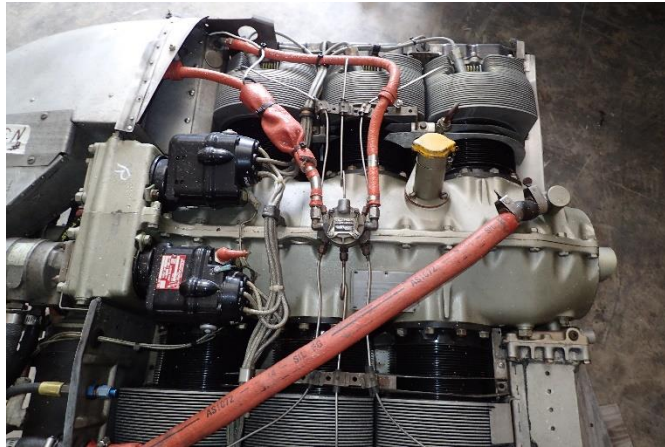
| Condition: | The crankcase remained intact and was undamaged. There were no signs of a catastrophic internal engine failure noted. There were no anomalies observed. | | | |

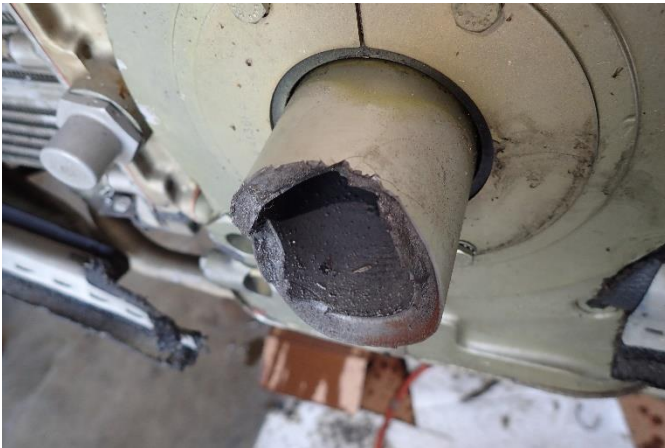
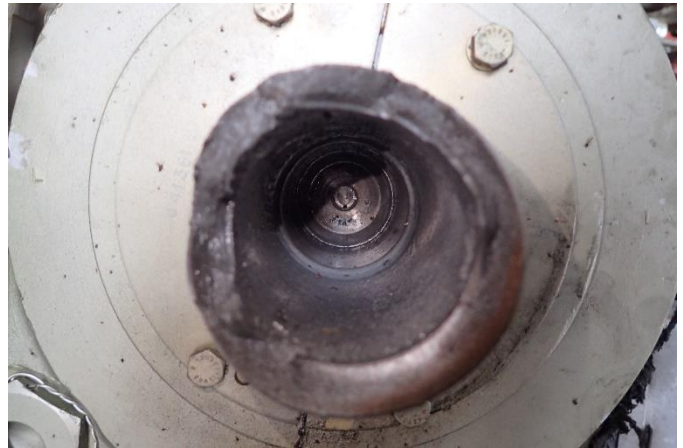
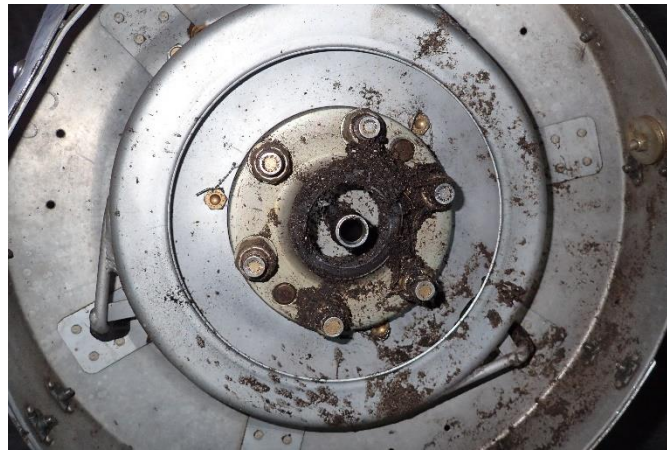
The propeller flange had broken free from the crankshaft and remained attached to the propeller; the damage was consistent with impact damage. The crankshaft was rotated using a tool inserted into one of the accessory drive gears; the crankshaft rotated normally, and continuity was established between the crankshaft, camshaft, connecting rods, and associated components. There were no anomalies noted.

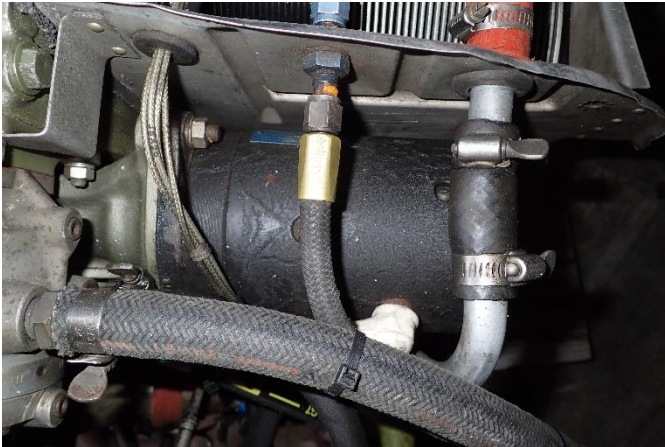
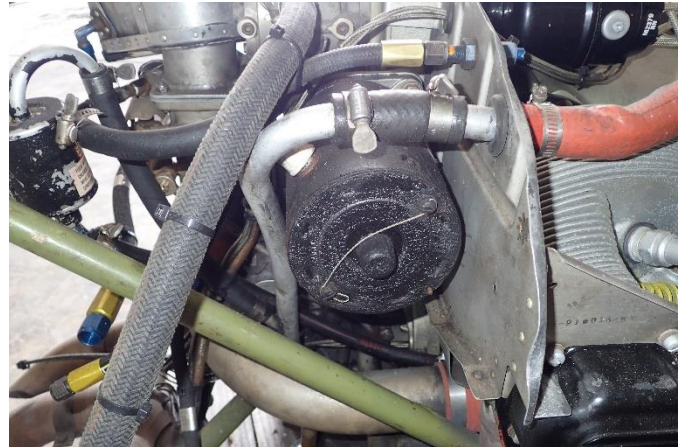
The starter remained attached to the starter adapter and was undamaged. There were no anomalies observed.

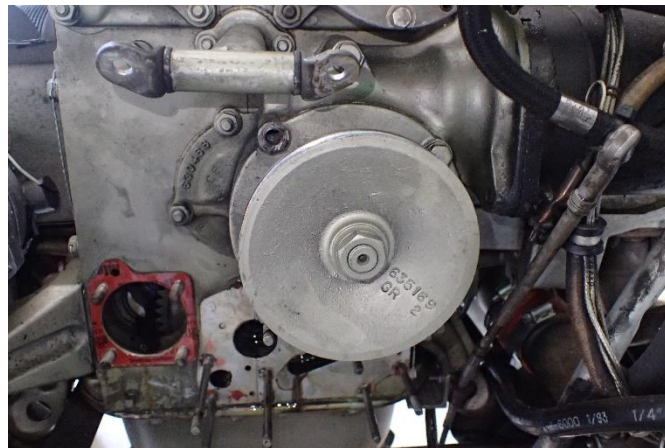
The starter adapter remained attached to its installation point and was undamaged. There were no anomalies noted with the starter adapter.

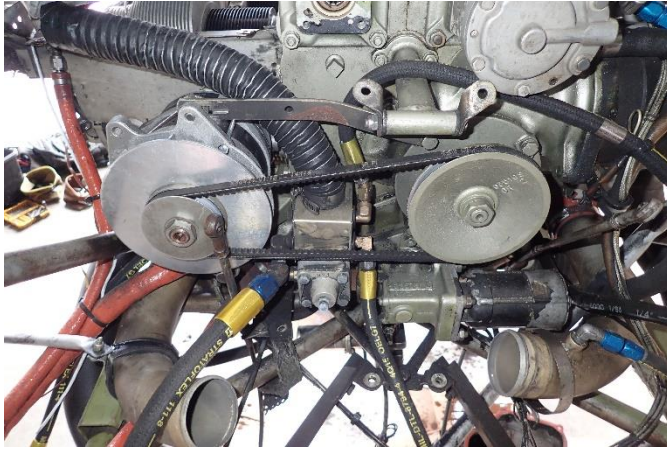
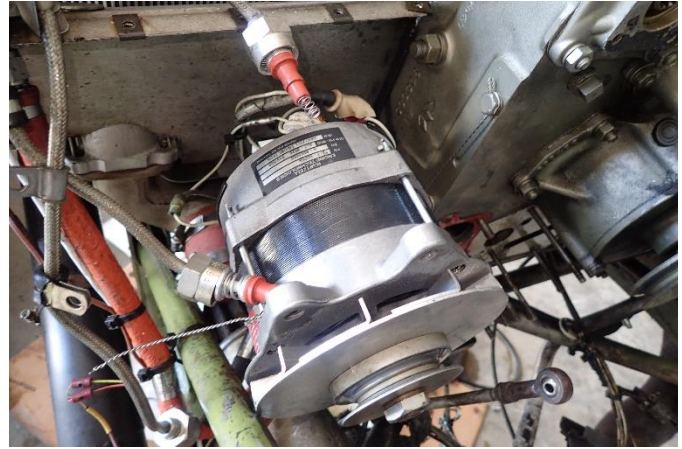
The alternator remained attached to its installation point and was undamaged. The alternator belt remained secured and the alternator drive rotated normally. There were no anomalies observed.

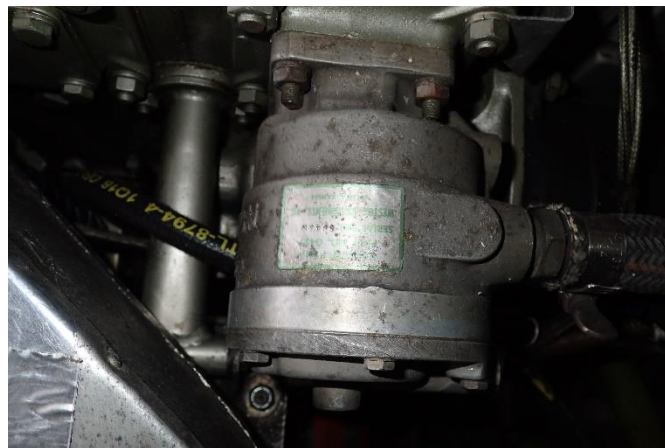
The vacuum pump remained attached to its installation point and was undamaged. There were no anomalies observed.

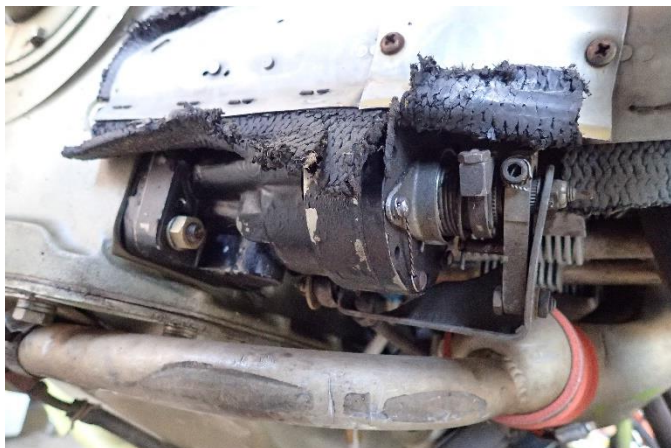
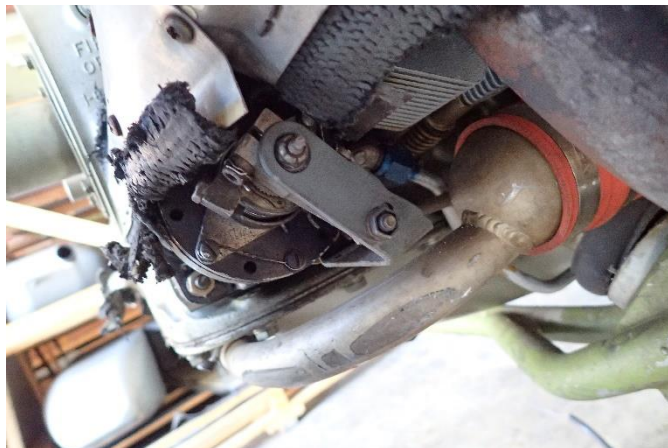
| PROPELLER GOVERNOR | Manufacturer: Woodward | P/N: B210438 | S/N: 1584612 M |
|---|---|---|---|
| Condition: | The governor remained attached to its installation point and was undamaged. The propeller control arm was capable of normal movement and there were no signs of oil leaks around the governor. There were no anomalies observed. | | |

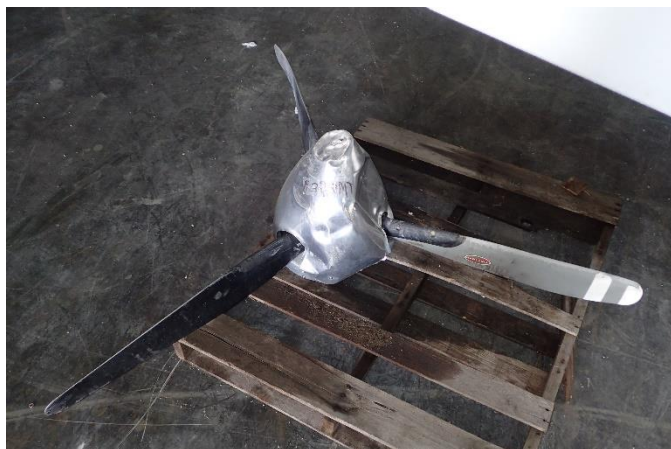
Propeller

| PROPELLER | Manufacturer: Hartzell | P/N: Not observed | S/N: Not observed |
|---|---|---|---|
| Condition: | The three blade, constant speed propeller remained attached to the propeller flange; however, the propeller flange had broken free from the rest of the crankshaft which was consistent with impact damage. All three propeller blades remained within the propeller hub and the blades appeared to be in the feathered position. The propeller blade marked "A" displayed minor twisting and leading-edge polishing. The propeller blade marked "B" displayed minor aft bending deformation and the propeller blade marked "C" was undamaged. | | |
