## **Report of Findings**

**Date of accident:** March 30 2019  
**Location of the accident:** Palatka, FL  
**Aircraft registration:** N81KK  
**Aircraft type:** Flight Design CTLS  
**Engine type and S/N:** Rotax 912ULS S/N 5649648  
**NTSB or TSB file number:** ERA19LA141  
**Date of Report:** April 4<sup>th</sup> 2019  
**File number:** 2019-012

### **Preliminary engine inspection**

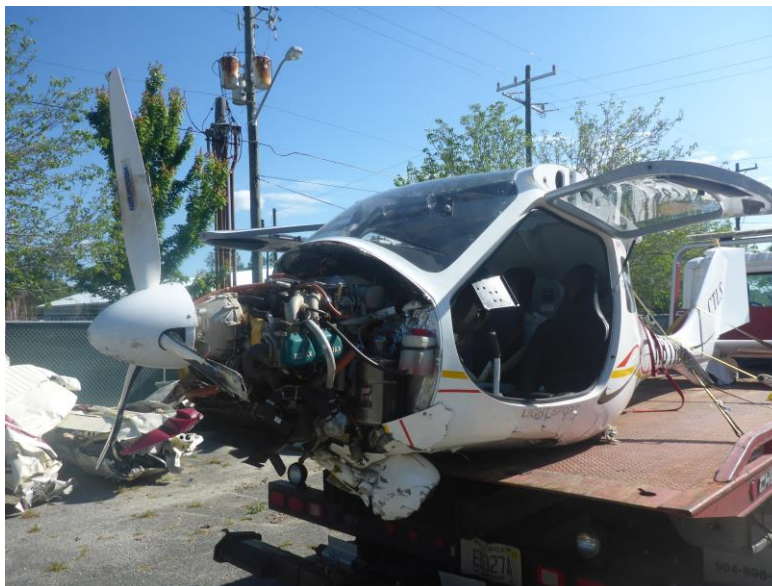
The aircraft sustained severe impact damage to its landing gear, propeller and engine cowling. The aircraft's wings were previously removed and the fuselage was placed on the back of a flat deck for examination.

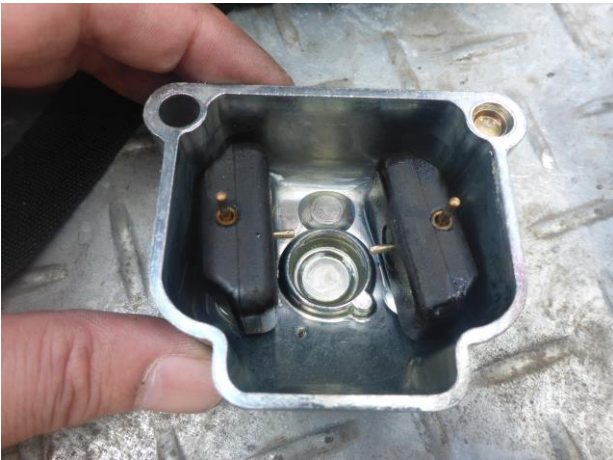
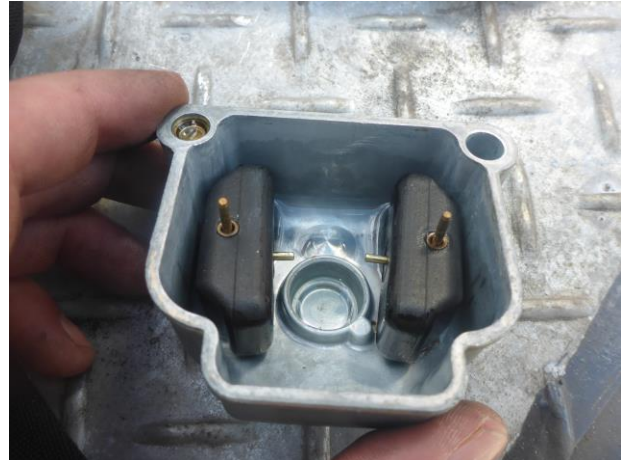
- The carburetor float bowls were removed and examined for fuel quantity, fuel quality, and contamination. Both float bowls were found absent of any fuel or contamination.
- The carburetor main jets were clear of any obstruction
- The carburetor float appeared to be in good overall condition.

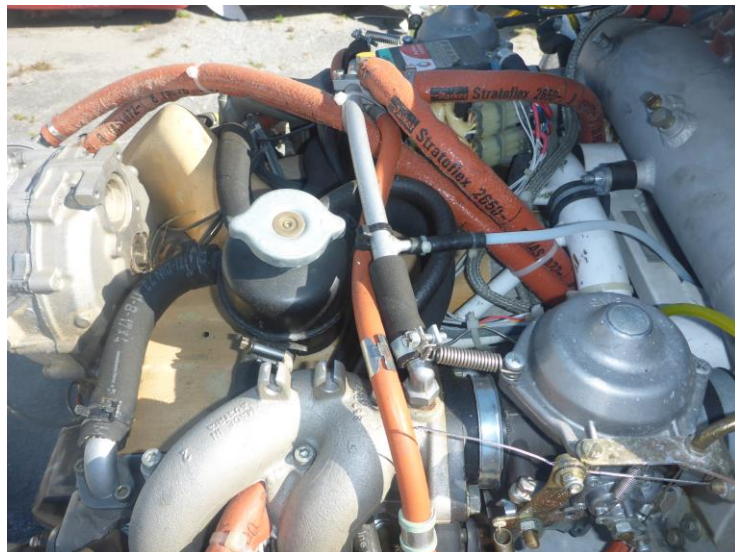
- The fuel lines were in good overall condition and protected by a fire sleeve. No anomalies were found with the fuel lines or fuel system.

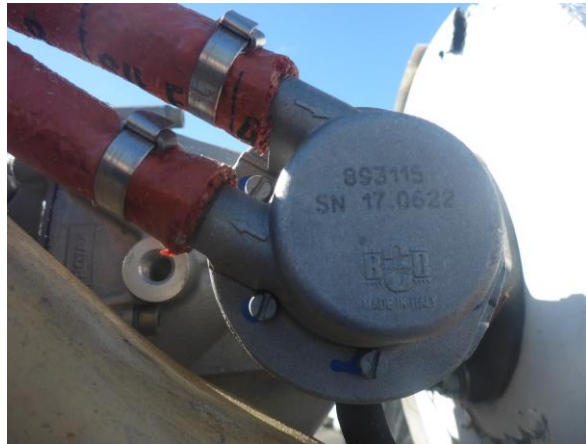
- Fuel Pump P/N 893 115, S/N 17.0622 was the correct type and in good overall condition. No anomalies were found with the fuel pump.

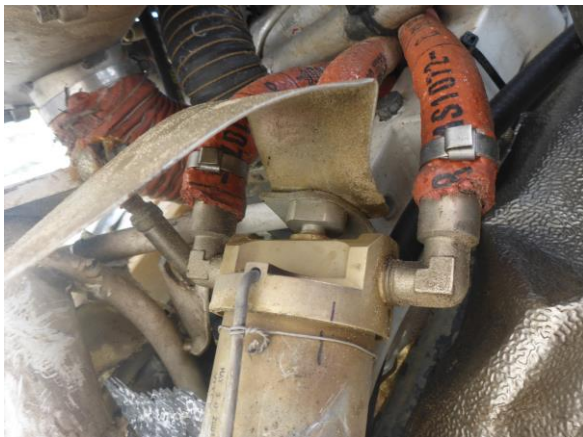
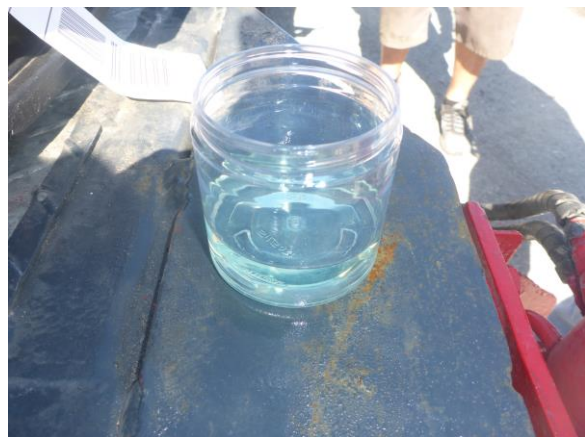
- The gascolator bowl was drained into a clear container. A minimal amount of fuel was contained inside the gascolator. The fuel appeared to be Av-Gas 100LL based on the color and odor. The fuel appeared to be free of any contamination.

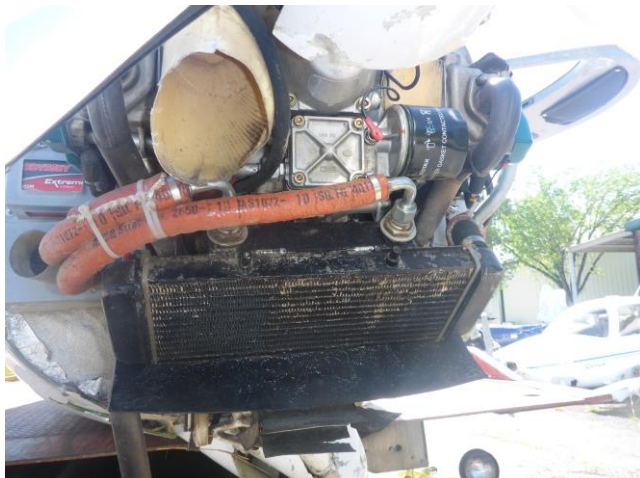
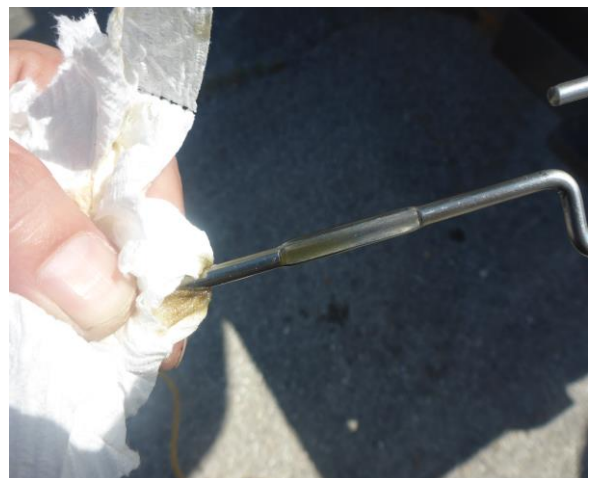
- The lubrication system appeared to be in good overall condition and intact. The oil level was checked and found to be within operational limits. No anomalies seen with the oil lubrication system.

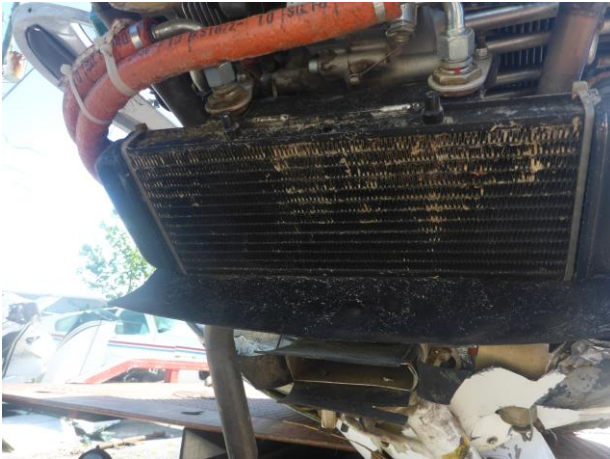
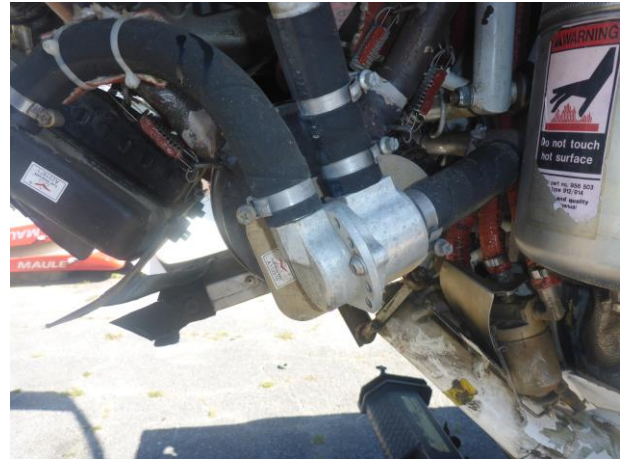
- The cooling system was examined for condition and anomalies. No anomalies were found with the cooling system and it appeared to be in good overall condition with no breaches. Coolant was found contained within the coolant expansion tank. An aftermarket coolant thermostat was found installed within the coolant system.

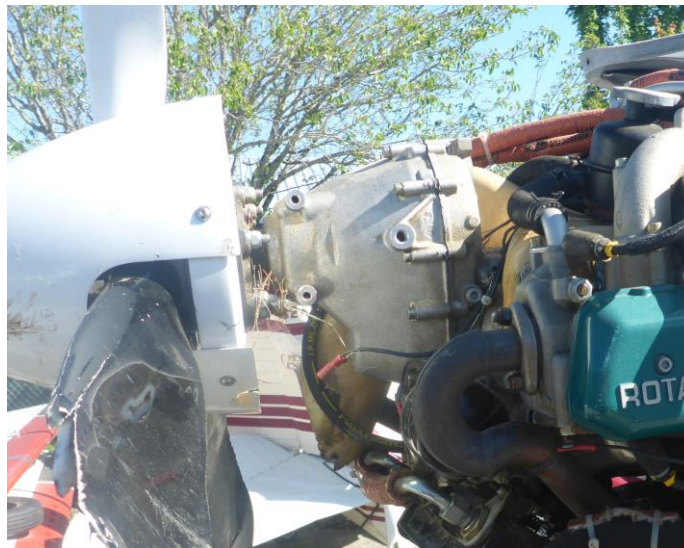
The propeller shaft was rotated to see if any binding or unusual noises could be felt or heard coming from the reduction gearbox. No anomalies with the reduction gearbox were noted.

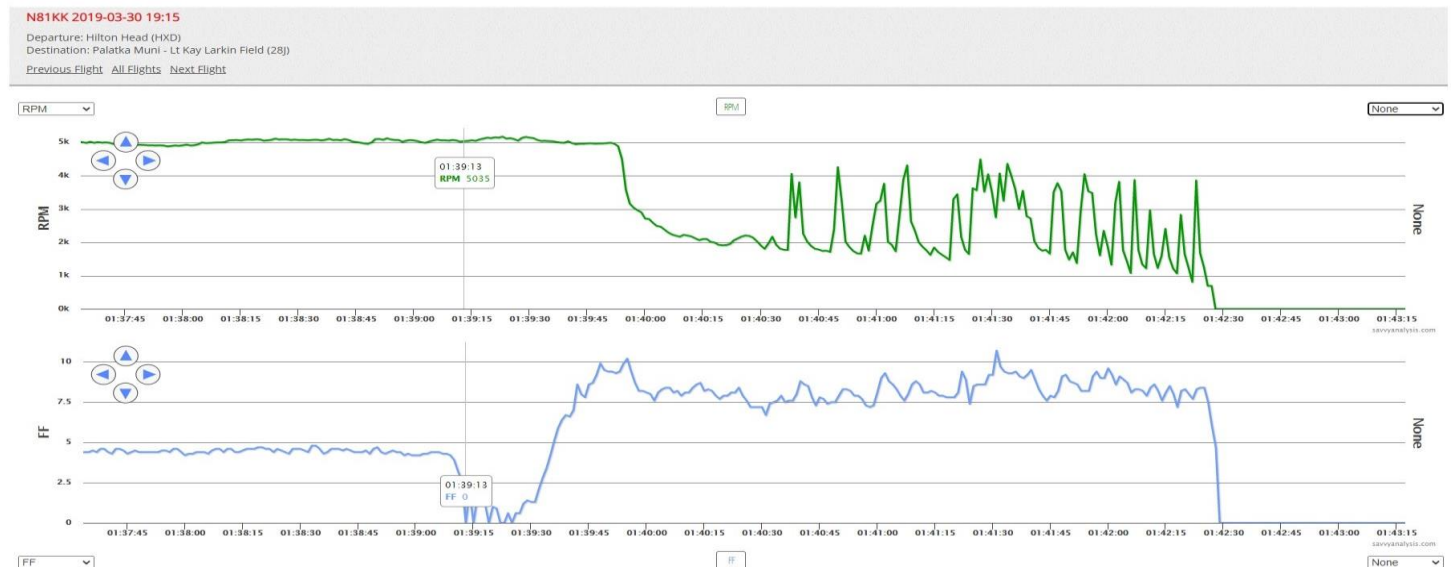
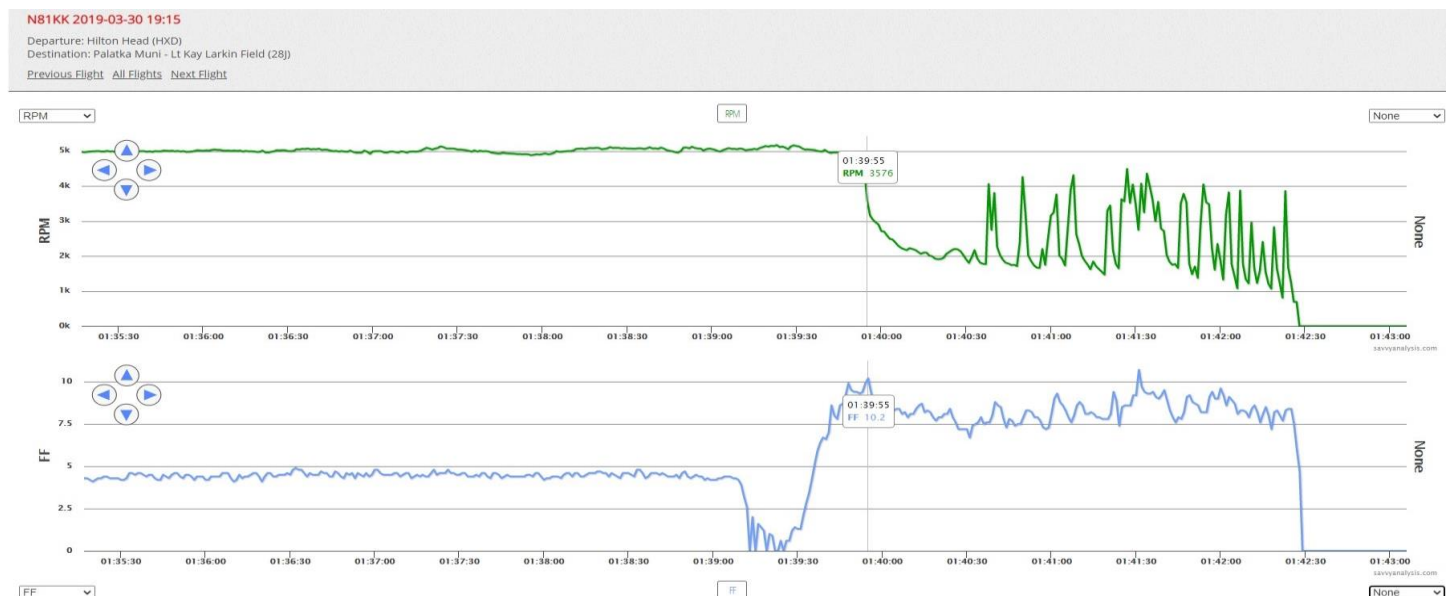
The engine parameter data contained within the Dynon flight instrument was extracted and analyzed. The Dynon engine data showed fuel flow dropped to 0 GPH at the **1:39:13** time stamp. At time stamp **1:39:56**, fuel flow spiked to 10.2 GPH indicating that air was being introduced into the fuel system resulting in a substantial increase in fuel flow. Normal fuel flow on the Rotax 912ULS engine is approximately 4.8 GPH at 5000 RPM. As air is introduced into the fuel system, it speeds up the impeller on the fuel flow transducer, resulting in a spike/increase of fuel flow indication.

Based off the engine examination, engine test run and analysis of the Dynon data, it appears the aircraft ran out of fuel resulting in the engine to lose power.

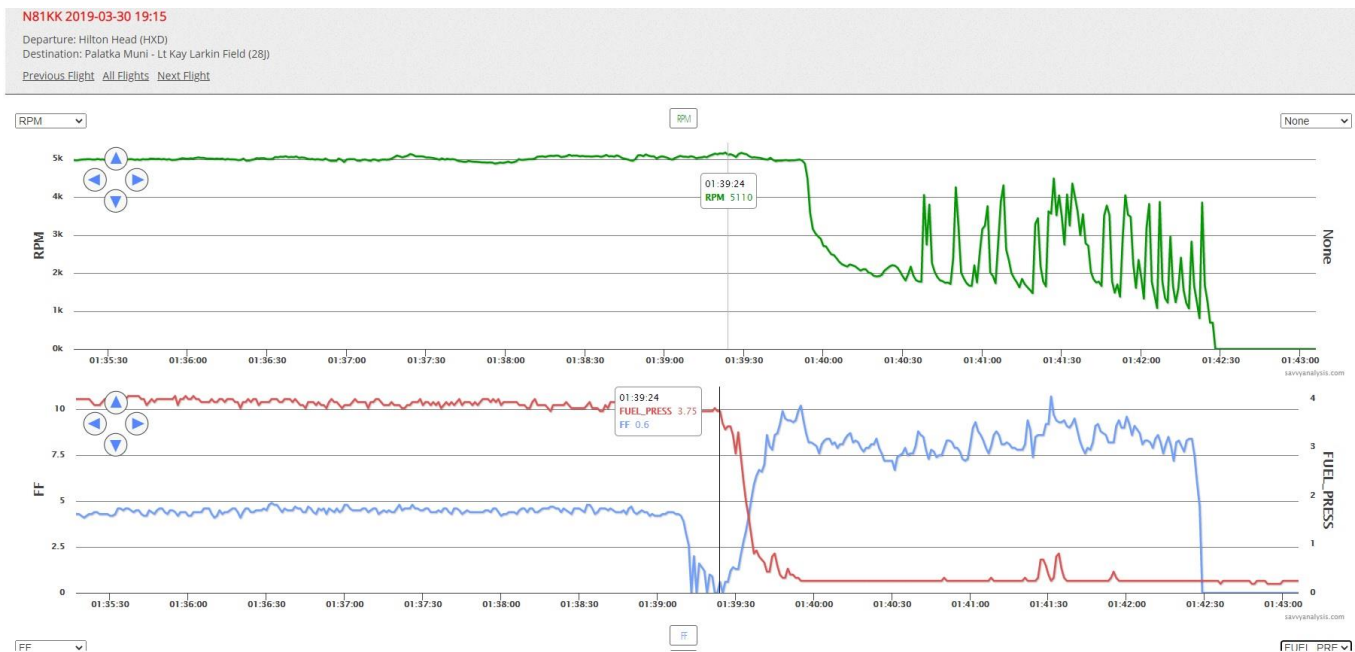
At time stamp **1:39:24** Fuel pressure began to drop to zero. Since the fuel pressure dropped after the fuel flow, this was an indication the aircrafts fuel pump was operating normally and that the fuel system was absent of fuel.

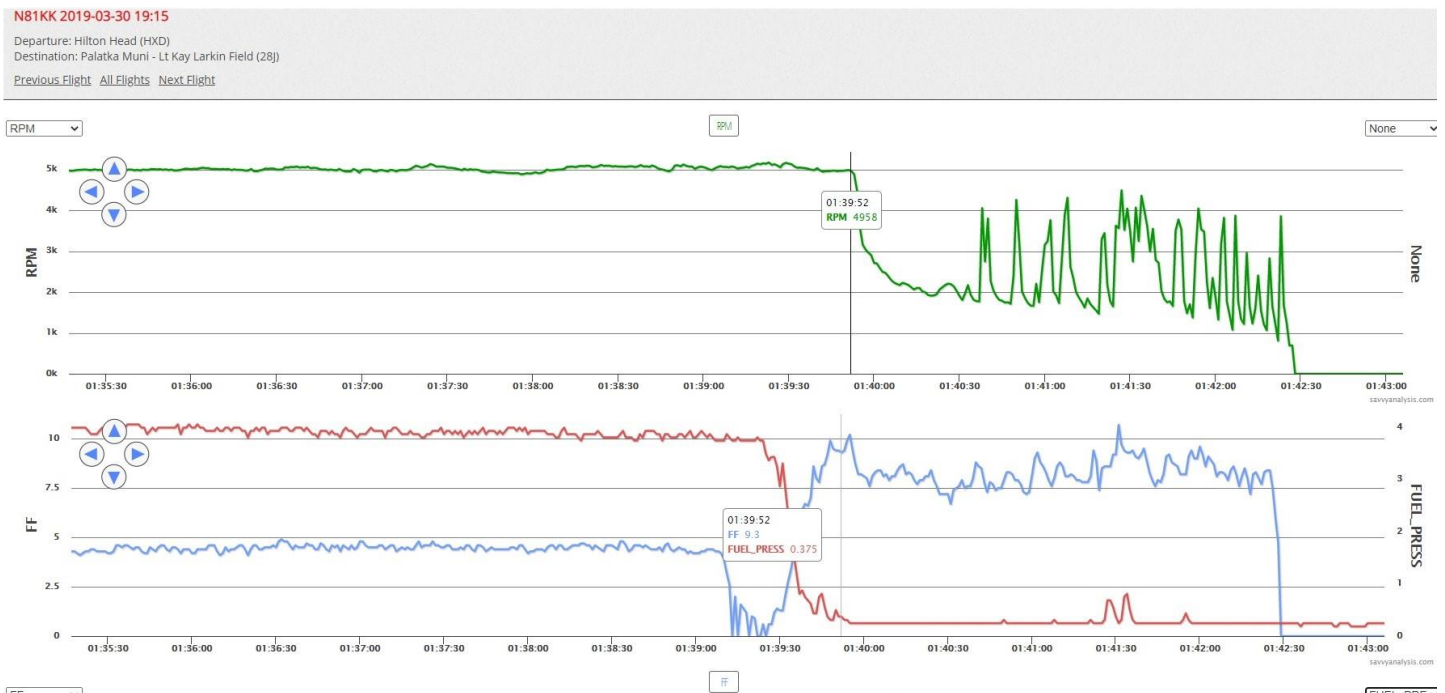
At time stamp **1:39:52** engine RPM began to drop and fluctuate rapidly (39 seconds after fuel flow dropped to 0 GPH and 28 seconds after fuel pressure dropped to 0 PSI)
