### **III. INFORMATION ON BRS SYSTEM IN ACCIDENT AIRCRAFT**

#### **A – Description of BRS-1350HS**

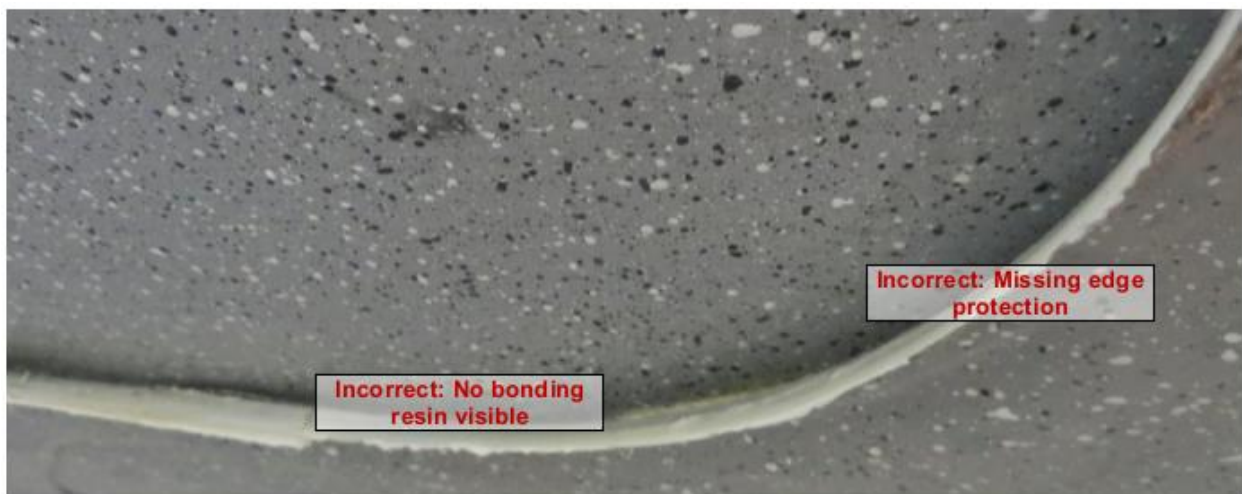
- An example of incorrect paint, finish and installation is provided as shown:

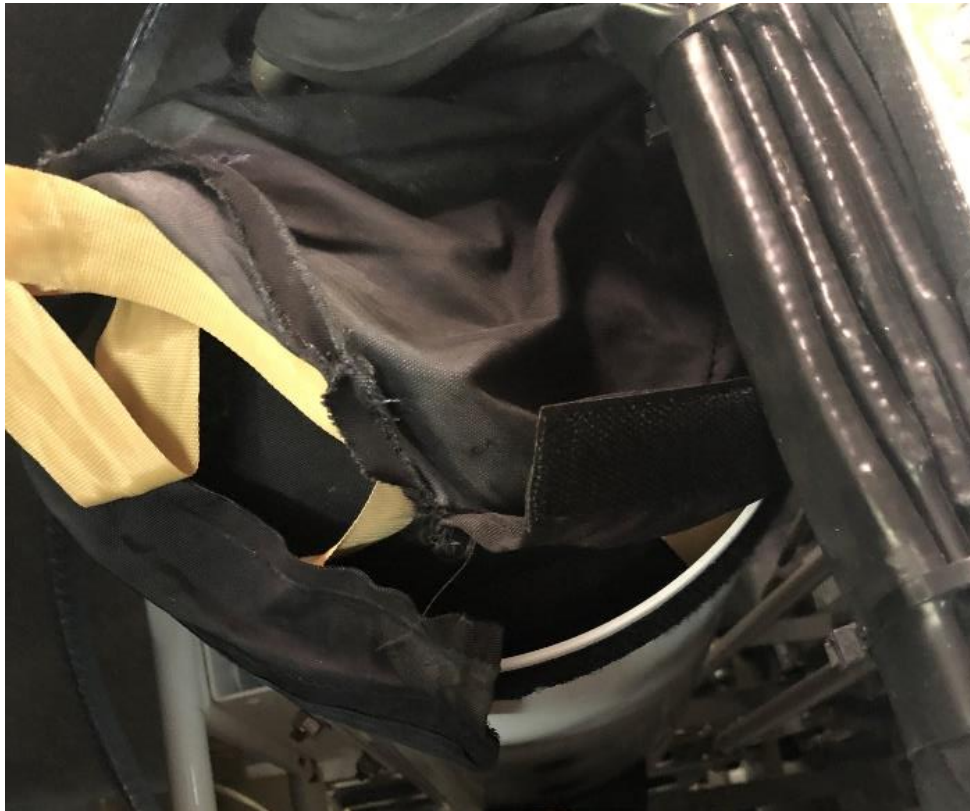
**A. Condition of System at time of April 24, 2019 Inspection**

At the time of inspection, the packed parachute was located inside the canister. The fabric cover was affixed to the top of the canister with Velcro. The Velcro was partially removed on the side facing the rocket motor. The fabric cover was also torn on the right side. The Kevlar extraction bands exhibited tension marks on the left 2 straps and folding marks on the right 2 straps. The tension marks on the left 2 straps was consisted with indications of pull stress.

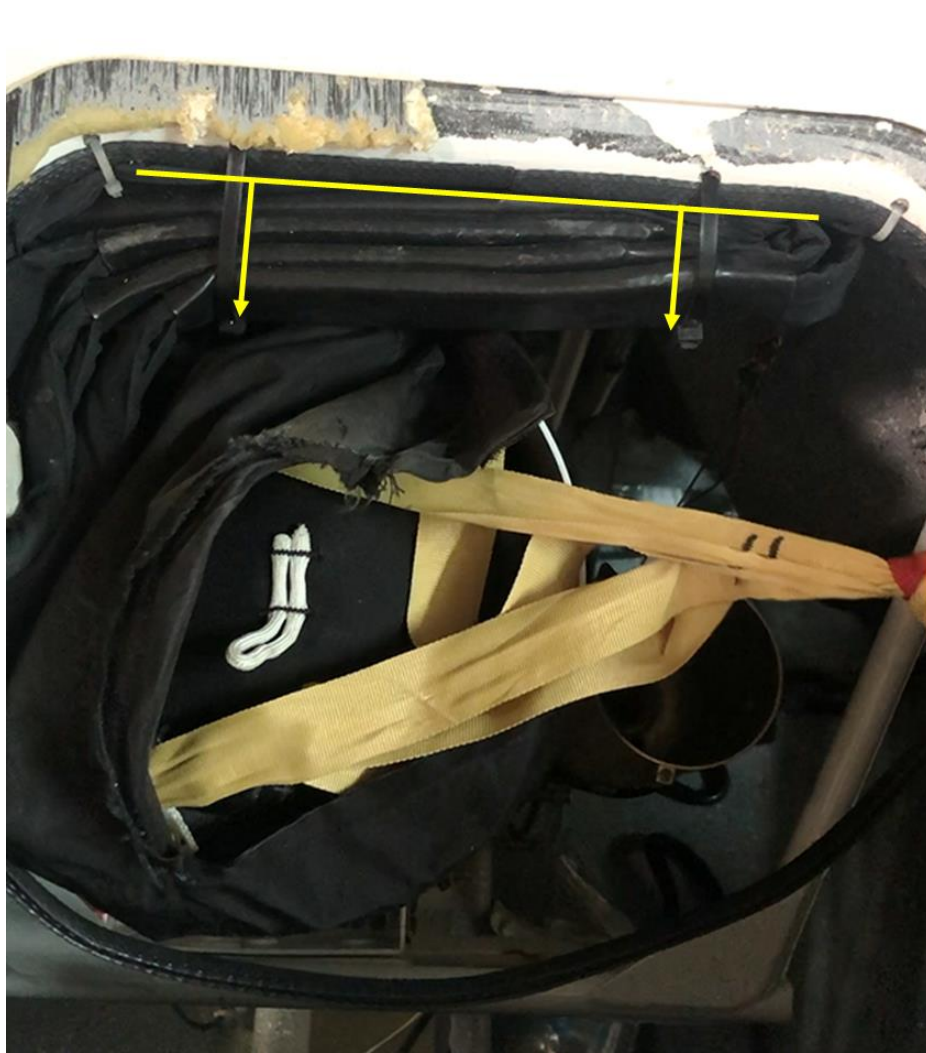
## **B. Improperly Secured S-folded Harnesses**

The S-folded Harnesses were improperly secured to the inside of the egress panel. The S-folded Harnesses improperly protruded into and blocked the egress opening. The S-folded Harnesses also improperly protruded into and blocked the opening of the parachute canister.

This condition fails to comply with BRS Parachute Installation Manual sections 2.6, 4.4, or 4.5. Similarly, this condition fails to comply with the BRS Pre-Flight Checklist advising that pilots should check that the parachute harnesses do not interfere with the firing of the rocket or extraction of the parachute.

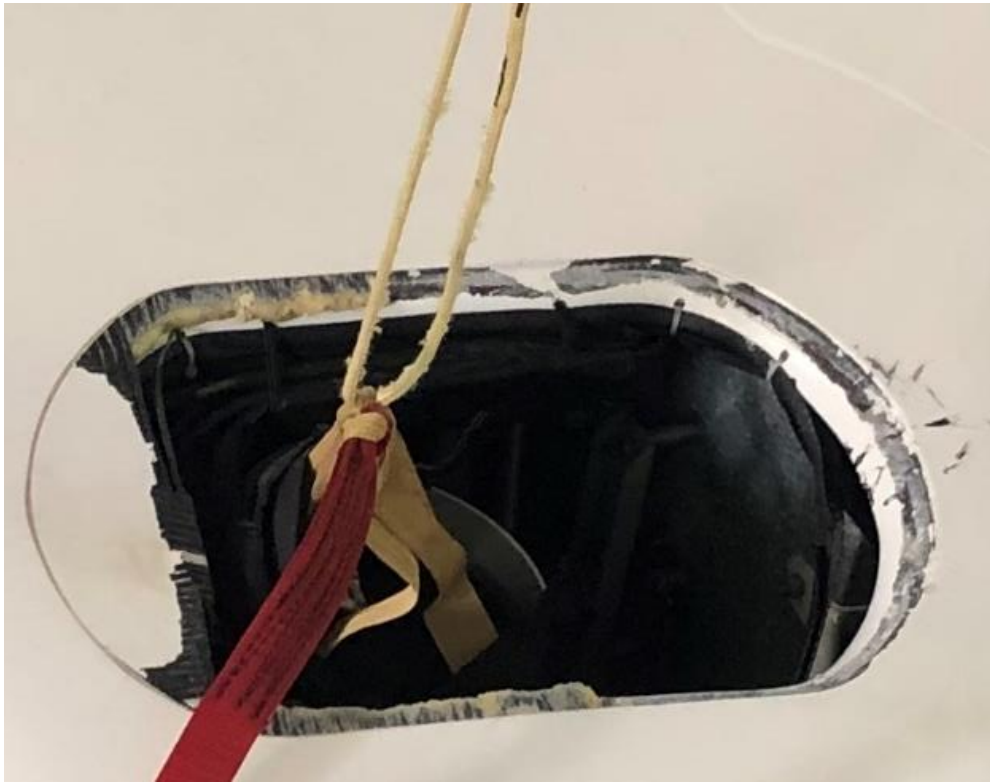
**C. Egress Panel Failed to Detach**

A significant portion of the egress panel remained attached to the airframe. The resin underneath the attached portion of egress panel remained intact. The remaining portion of egress panel did not release when the rocket motor struck the panel. The remaining portion of egress panel protruded into and blocked the opening of the parachute canister.

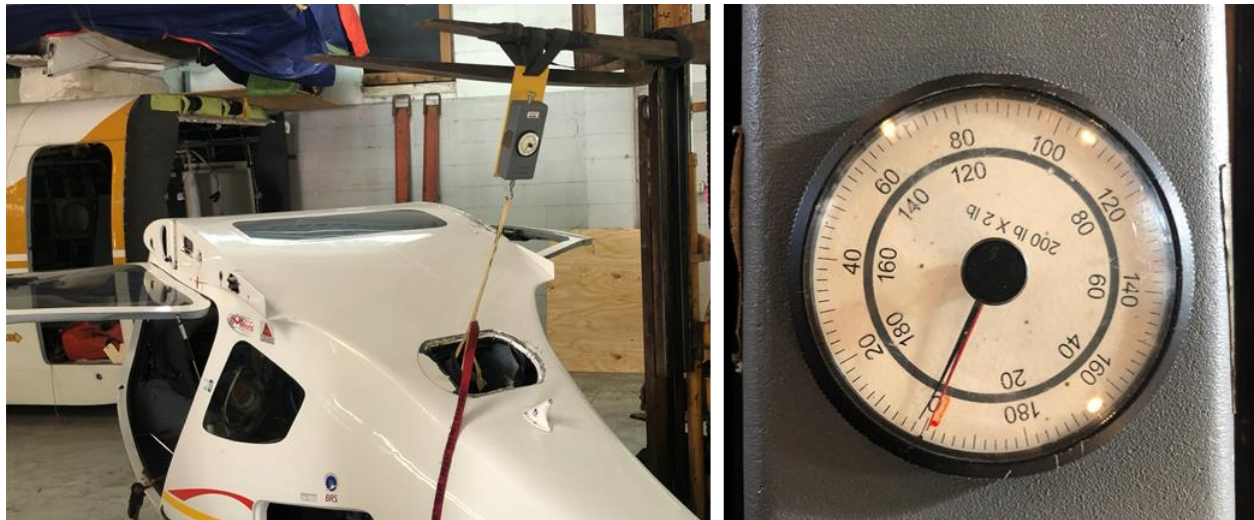
#### D. Extraction Test

An extraction test was administered to measure the pull-force necessary to extract the parachute from the canister. A calibrated pull tester was suspended above the egress opening from a forklift. The Kevlar extraction bands were attached to the pull tester and the forks were raised.

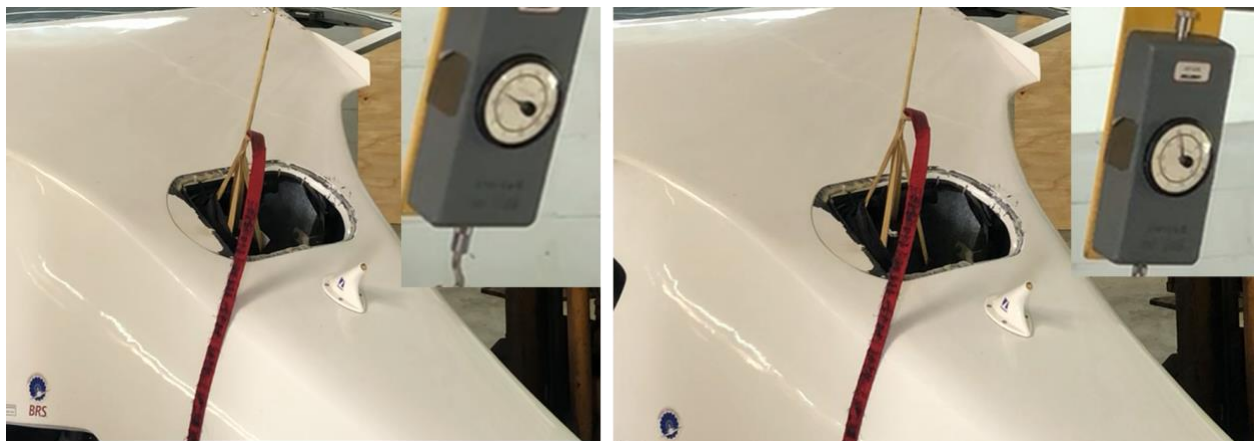
Initial movement of the parachute bag started at 55 pounds of pull-force. The bag continued moving up through 80 pounds of pull force. This value matched bench-testing of the system which showed pull force values at between 50-80 pounds.

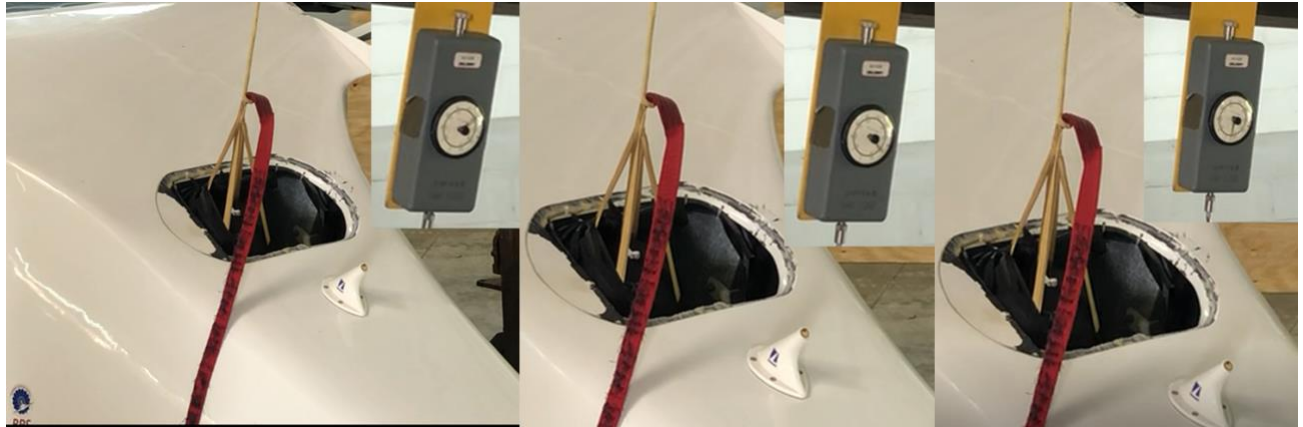
The parachute bag then contacted the improperly secured S-folded Harnesses stowed on the inside of the egress panel. The Harnesses blocked the opening of the parachute canister and exerted pressure on the parachute bag. The pull-force continued to increase to over 200 pounds and exceeded the tolerance of the pull-gauge used for this test.

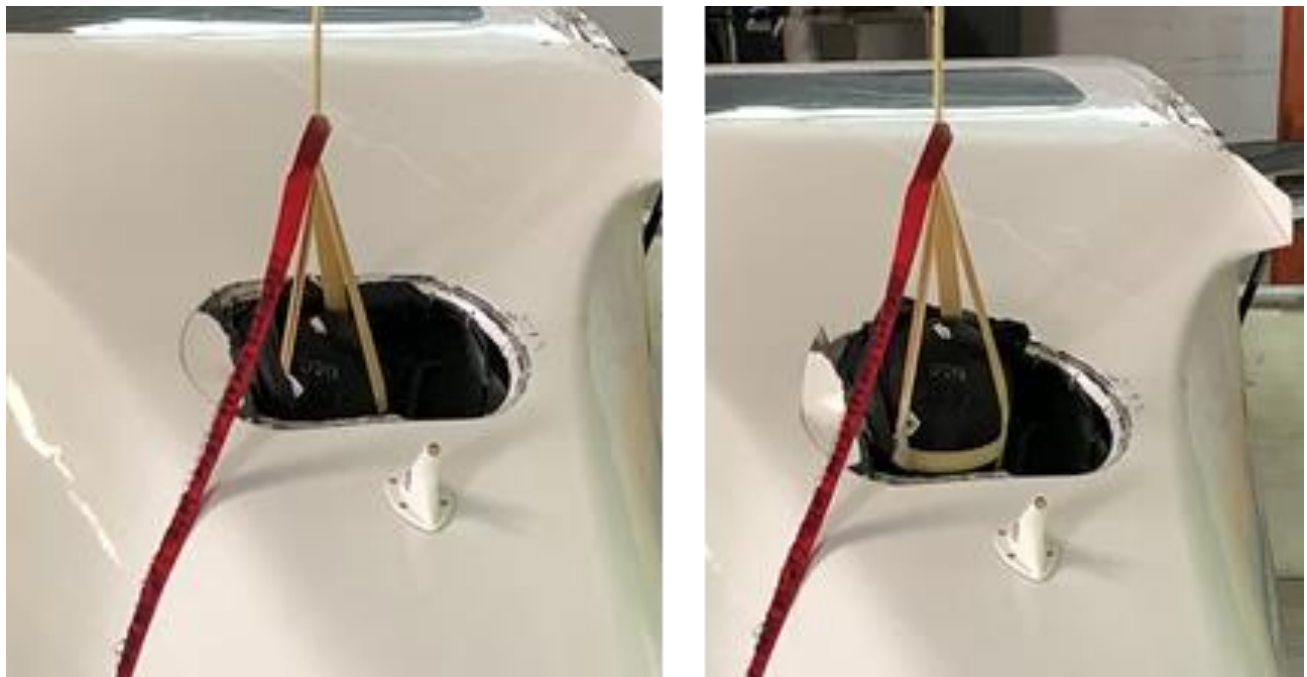
The parachute bag also made contact with the remaining section of egress panel.

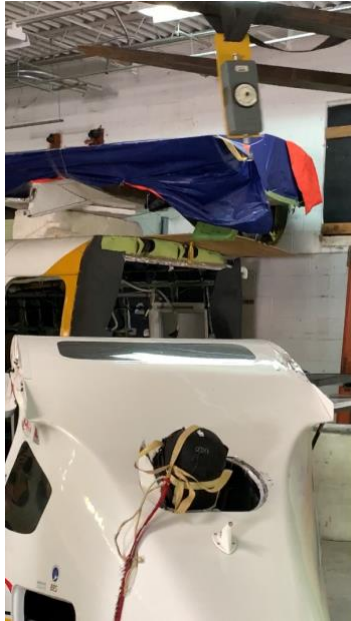
The remaining section of egress panel blocked the opening of the parachute canister and also exerted pressure on the parachute bag. The pull-force continued to increase until the hook on the pull-tester actually failed.

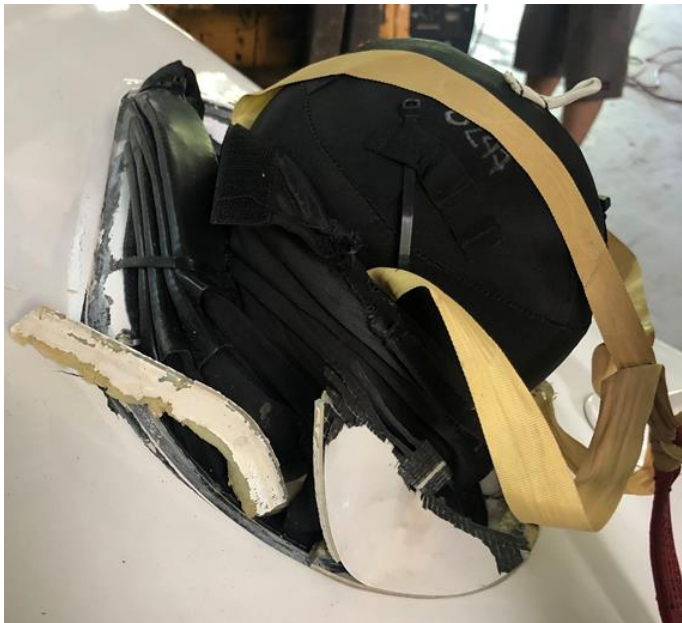
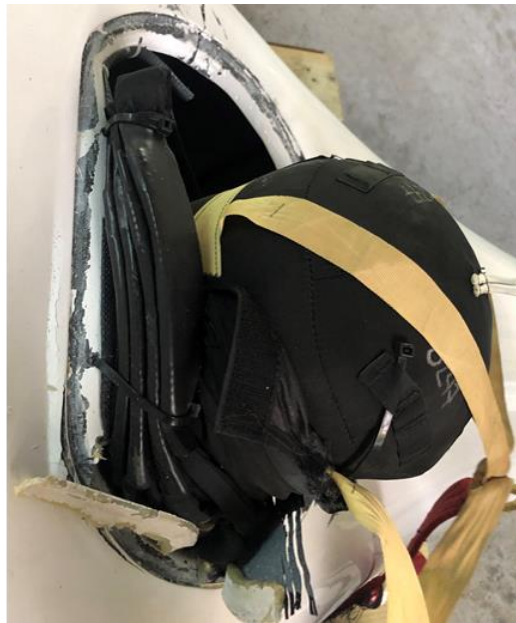
At the time the hook on the pull-tester failed, the parachute bag was wedged between the improperly stowed S-folded Harnesses and the remaining portion of egress panel.

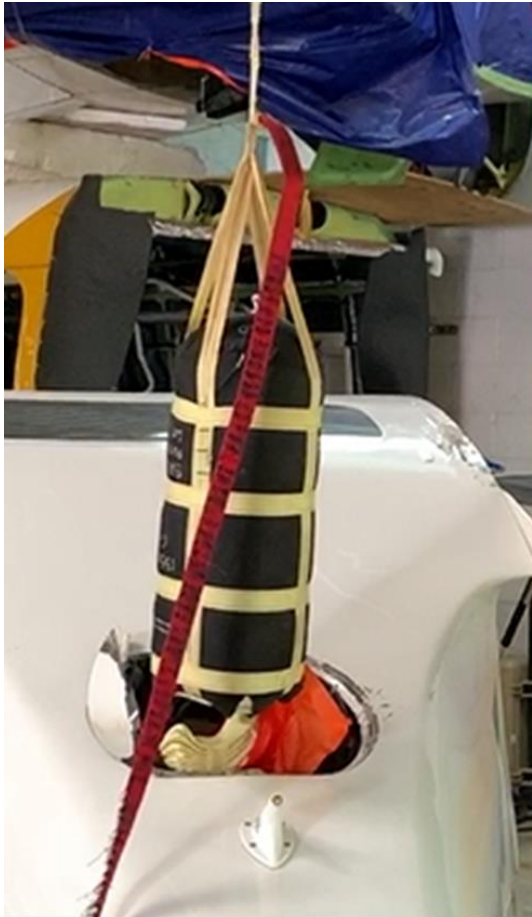
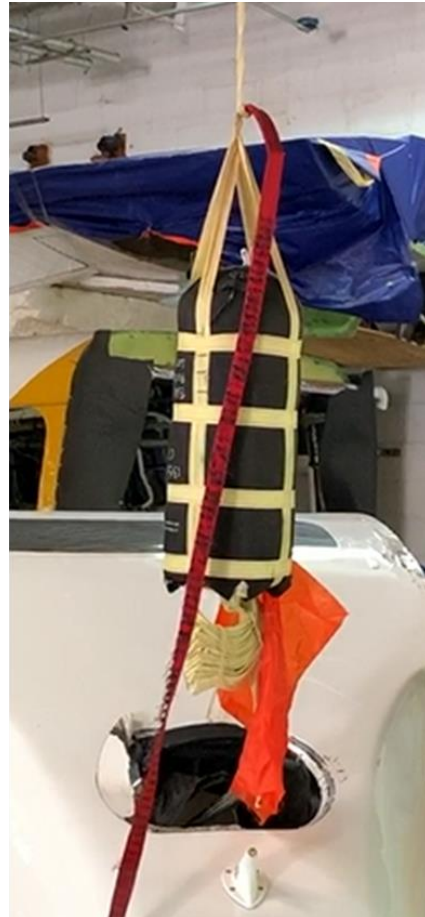
The hook on the pull-tester was replaced and the straps on the parachute bag were then re-attached to the pull-tester. The parachute bag was then fully extracted from the canister without the use of a gauge.

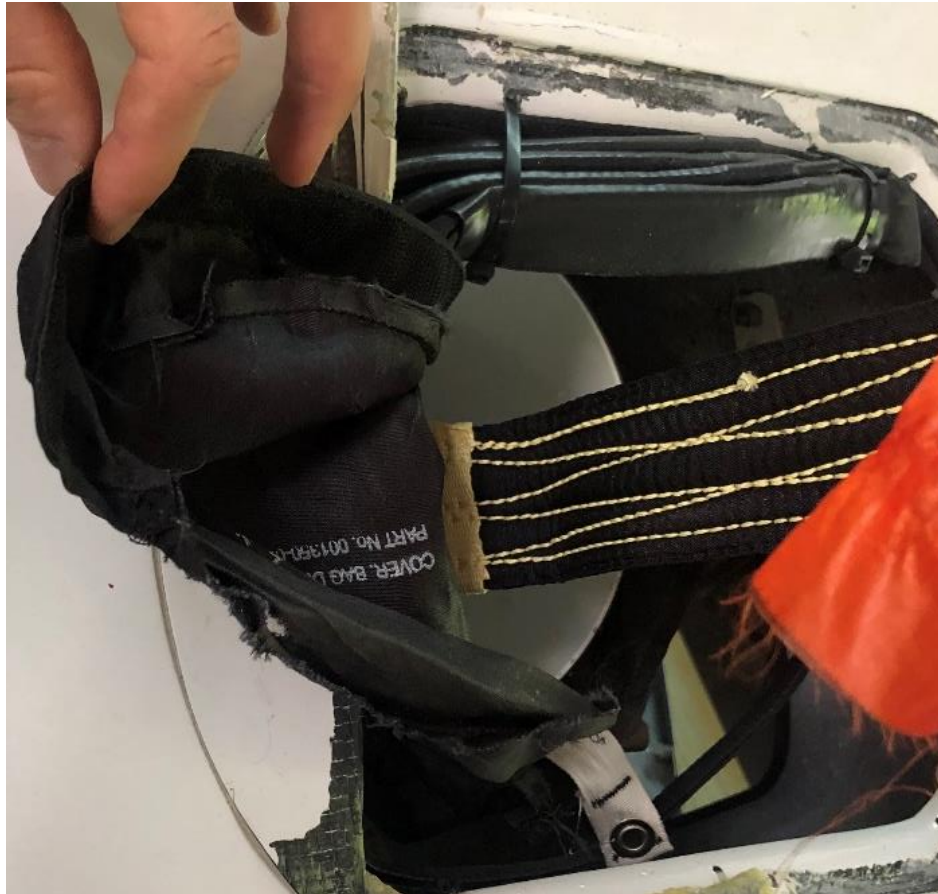
With the parachute bag fully extracted, the S-folded Harnesses returned to their pre-extraction position and continued to protrude into and block both the egress opening and the parachute canister opening.

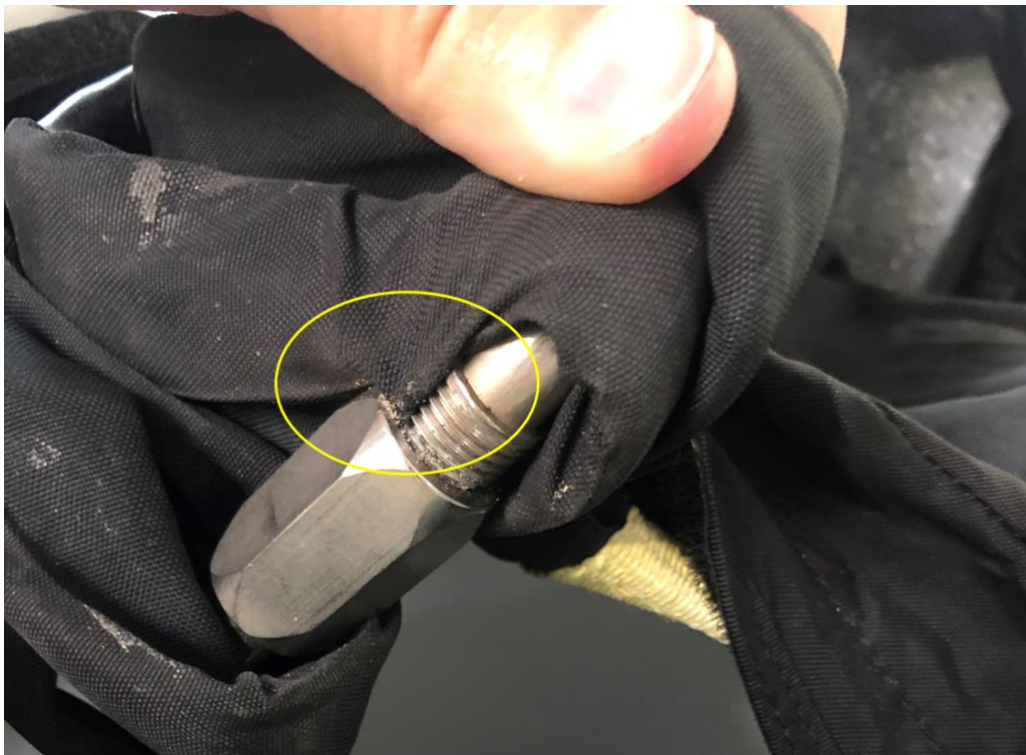
The ½ inch Quick-link that connected all four Harnesses to the parachute riser was improperly fastened. The nylon sheathing from the aircraft harness was caught in the threads and the barrel was improperly threaded. The barrel was only secured by about two rotations of threading. There was no Loctite 242 applied to the threads.

This condition fails to comply with BRS Parachute Installation Manual section 4.5. Similarly, this condition fails to comply with the BRS Pre-Flight Checklist advising that pilots should check that the Quick-link is properly secured.

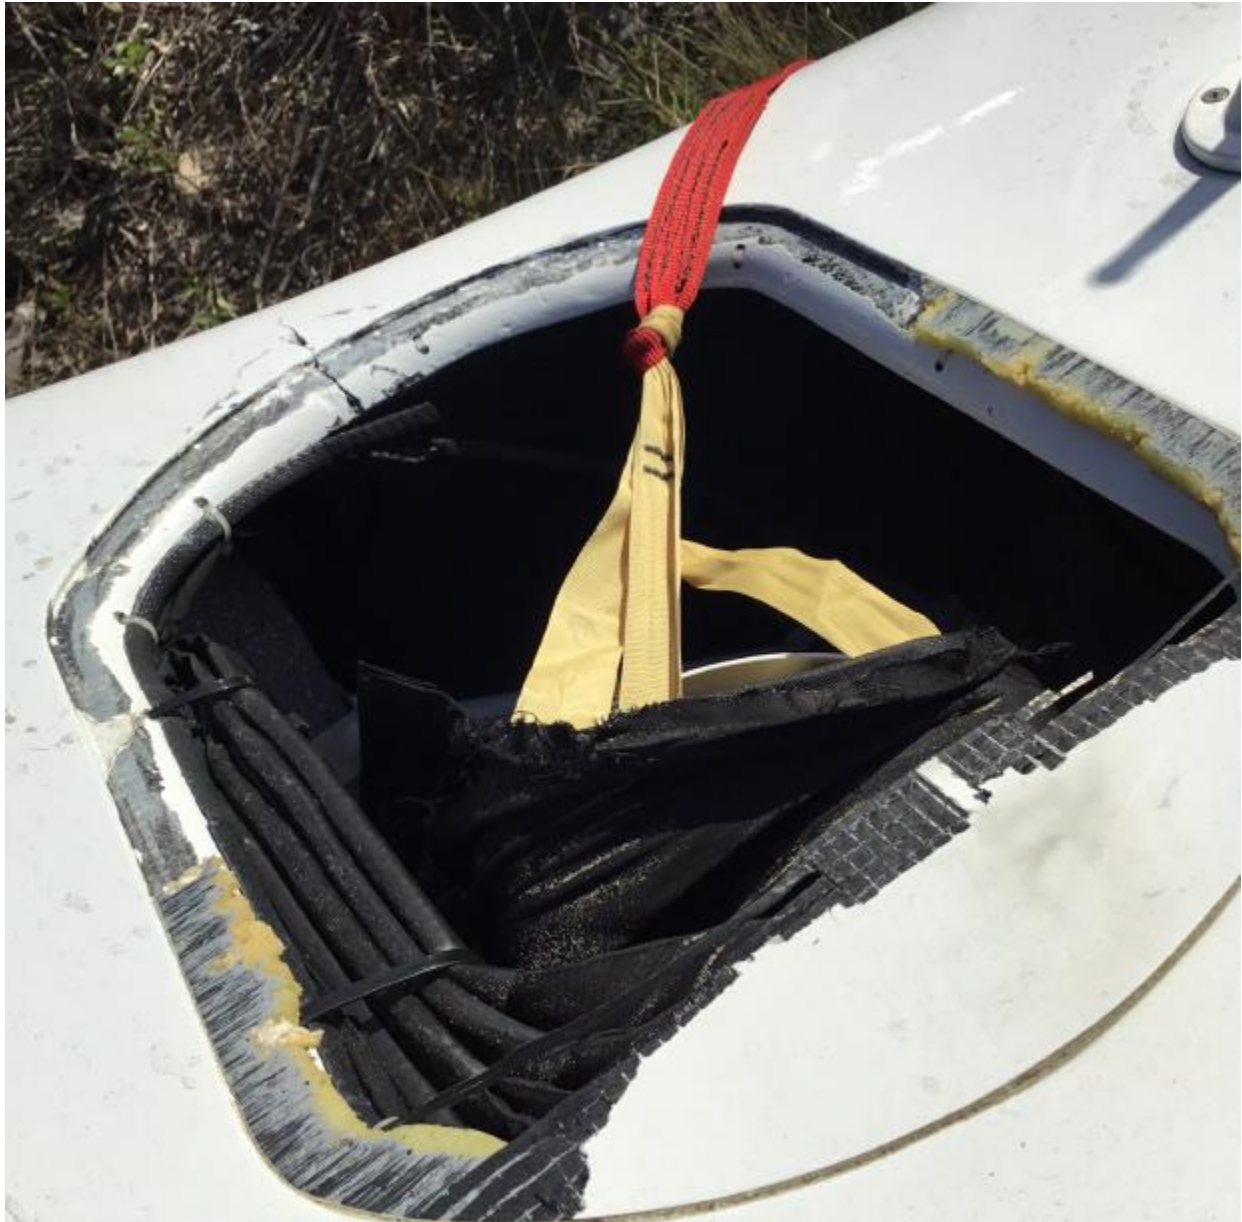
**G. The Adhesive for the Egress Panel was Yellow in Color and Brittle**

The adhesive attached the egress panel to the airframe was yellow in color and brittle to the touch.

The adhesive did not conform with the manufacture specifications contained within Section 3.3.2 of SB-ASTM-CTL5-11.

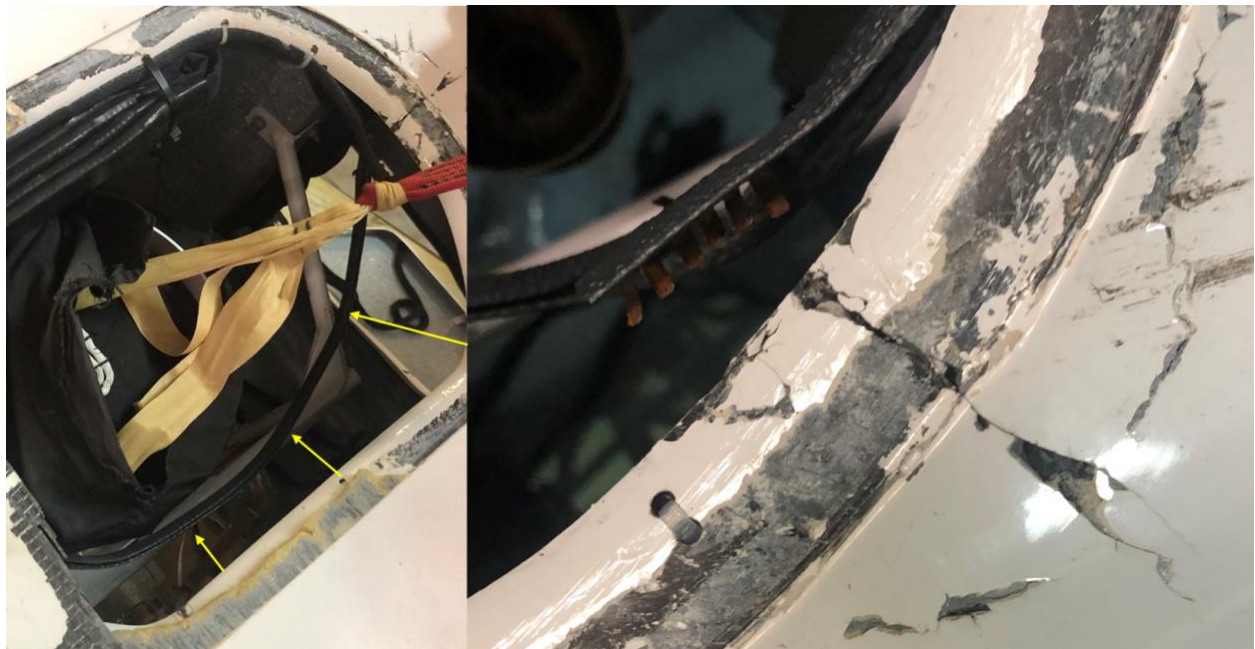
**H. Black Plastic Edge Protection was missing and easily displaced**

The edge of the extraction opening was no longer covered with the black plastic edge protector. The black plastic edge protection was easily removed from the edge of the flange.

These conditions did not conform with the manufacture specifications contained within Section 3.3.2 of SB-ASTM-CTLS-11.

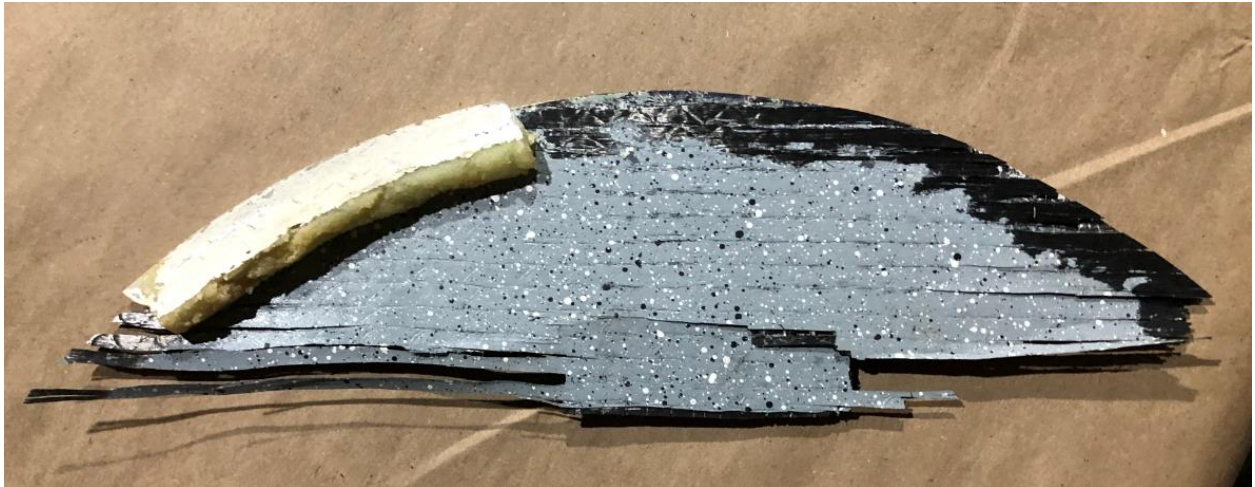
**I. The inside surface of egress panel matches the incorrect example from the Service Bulletin**

The inside surface of the egress panel matches the incorrect example from the Service Bulletin.

This condition did not conform with the manufacture specifications contained within Section 3.3.2 of SB-ASTM-CTLS-11.
