**From:** Deforge Carolyn  
**Sent:** Thursday, September 12, 2019 4:14 PM  
**To:** Hicks Ralph  
**Subject:** FW: Material Lab Request (ERA19LA141)  
**Attachments:** Evidence Control BRS.pdf; Request-for-Materials-Laboratory-Examination-Form.pdf; Form Returned: Request%20for%20Materials%20Laboratory%20Examination%20Form.pdf

**From:** Budinski Michael <[REDACTED]>  
**Sent:** Thursday, September 12, 2019 3:33 PM  
**To:** Deforge Carolyn <[REDACTED]>; Hicks Ralph <[REDACTED]>  
**Subject:** Material Lab Request (ERA19LA141)

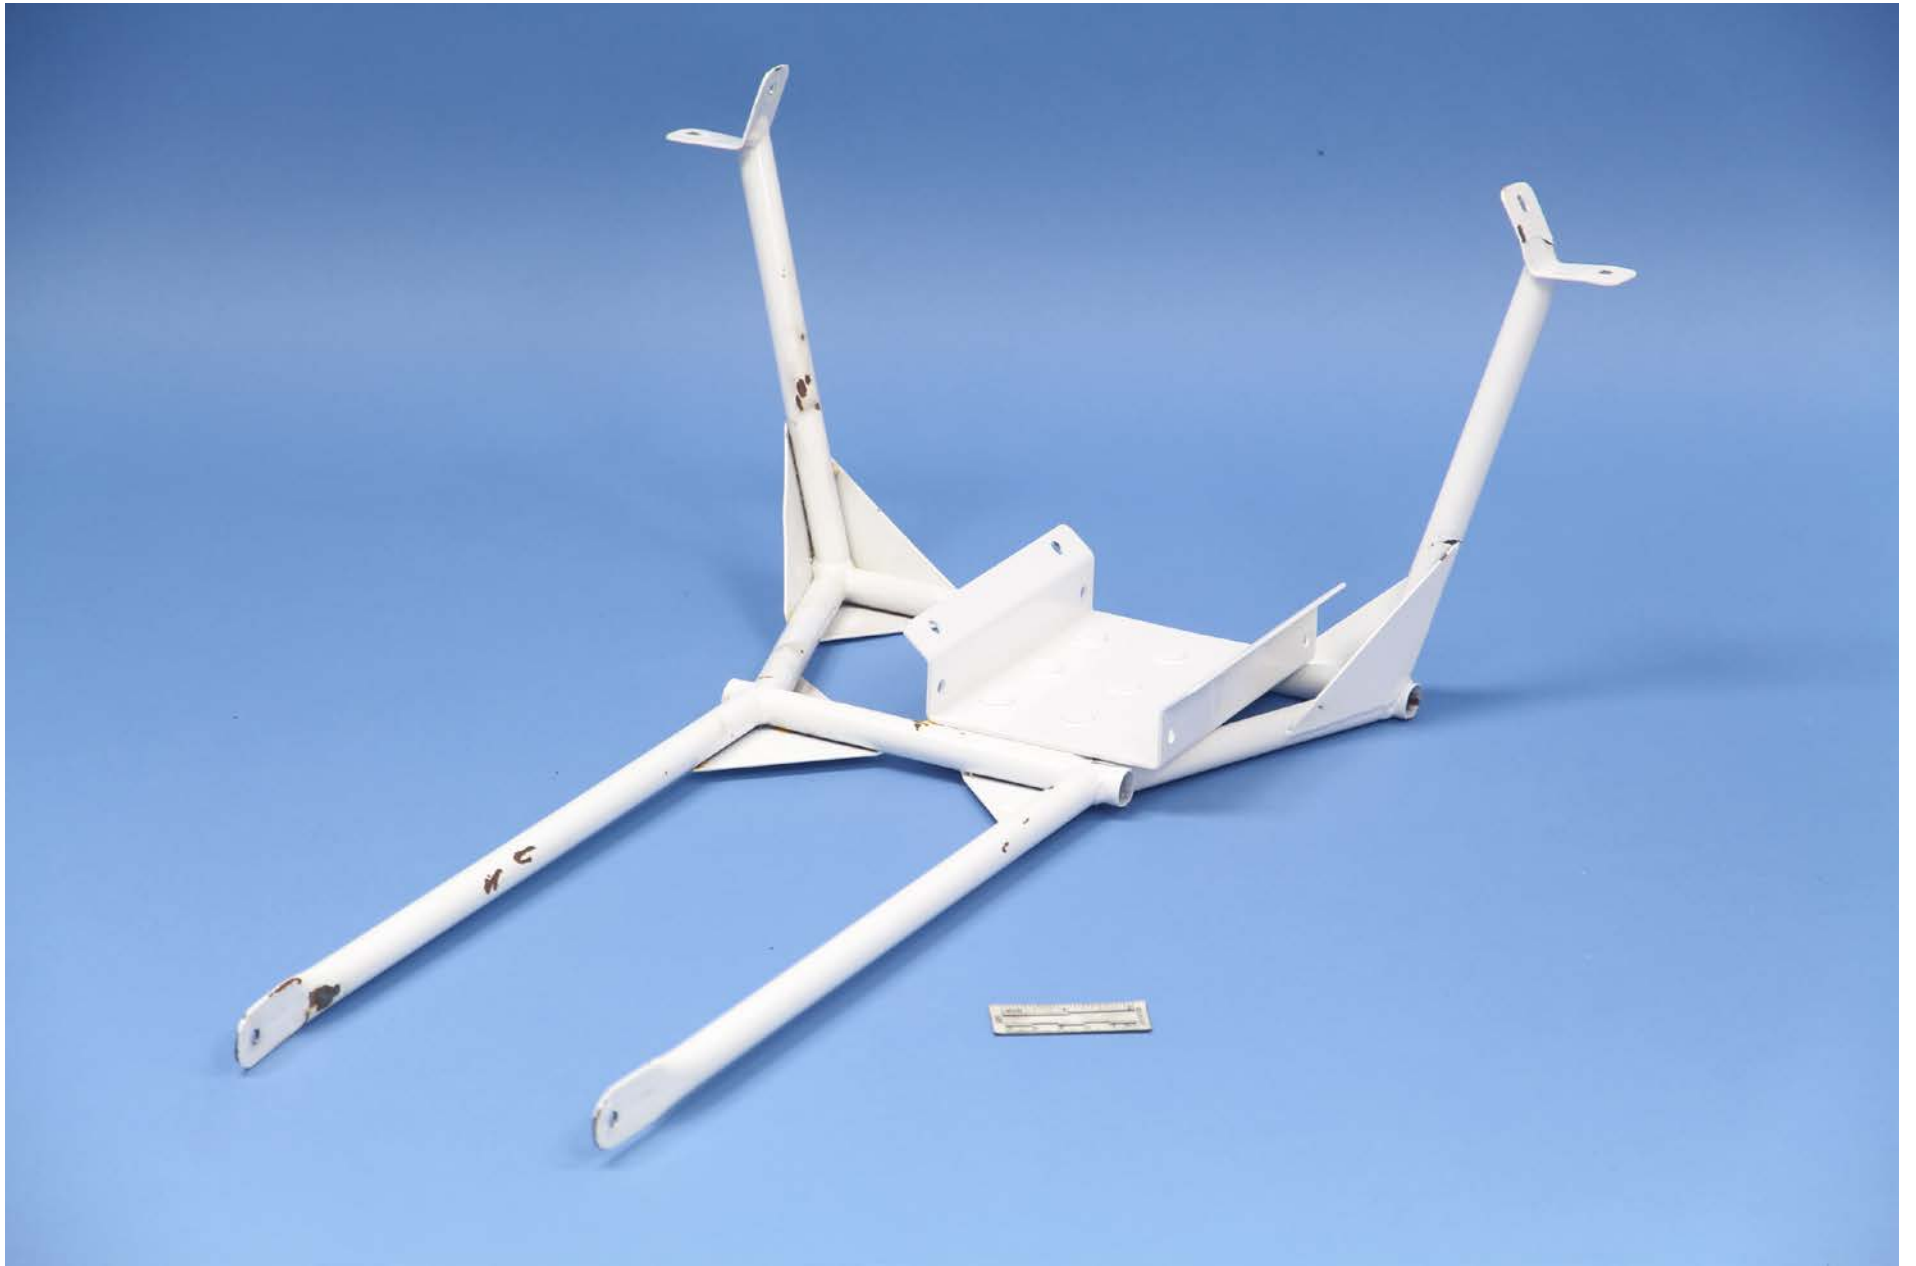
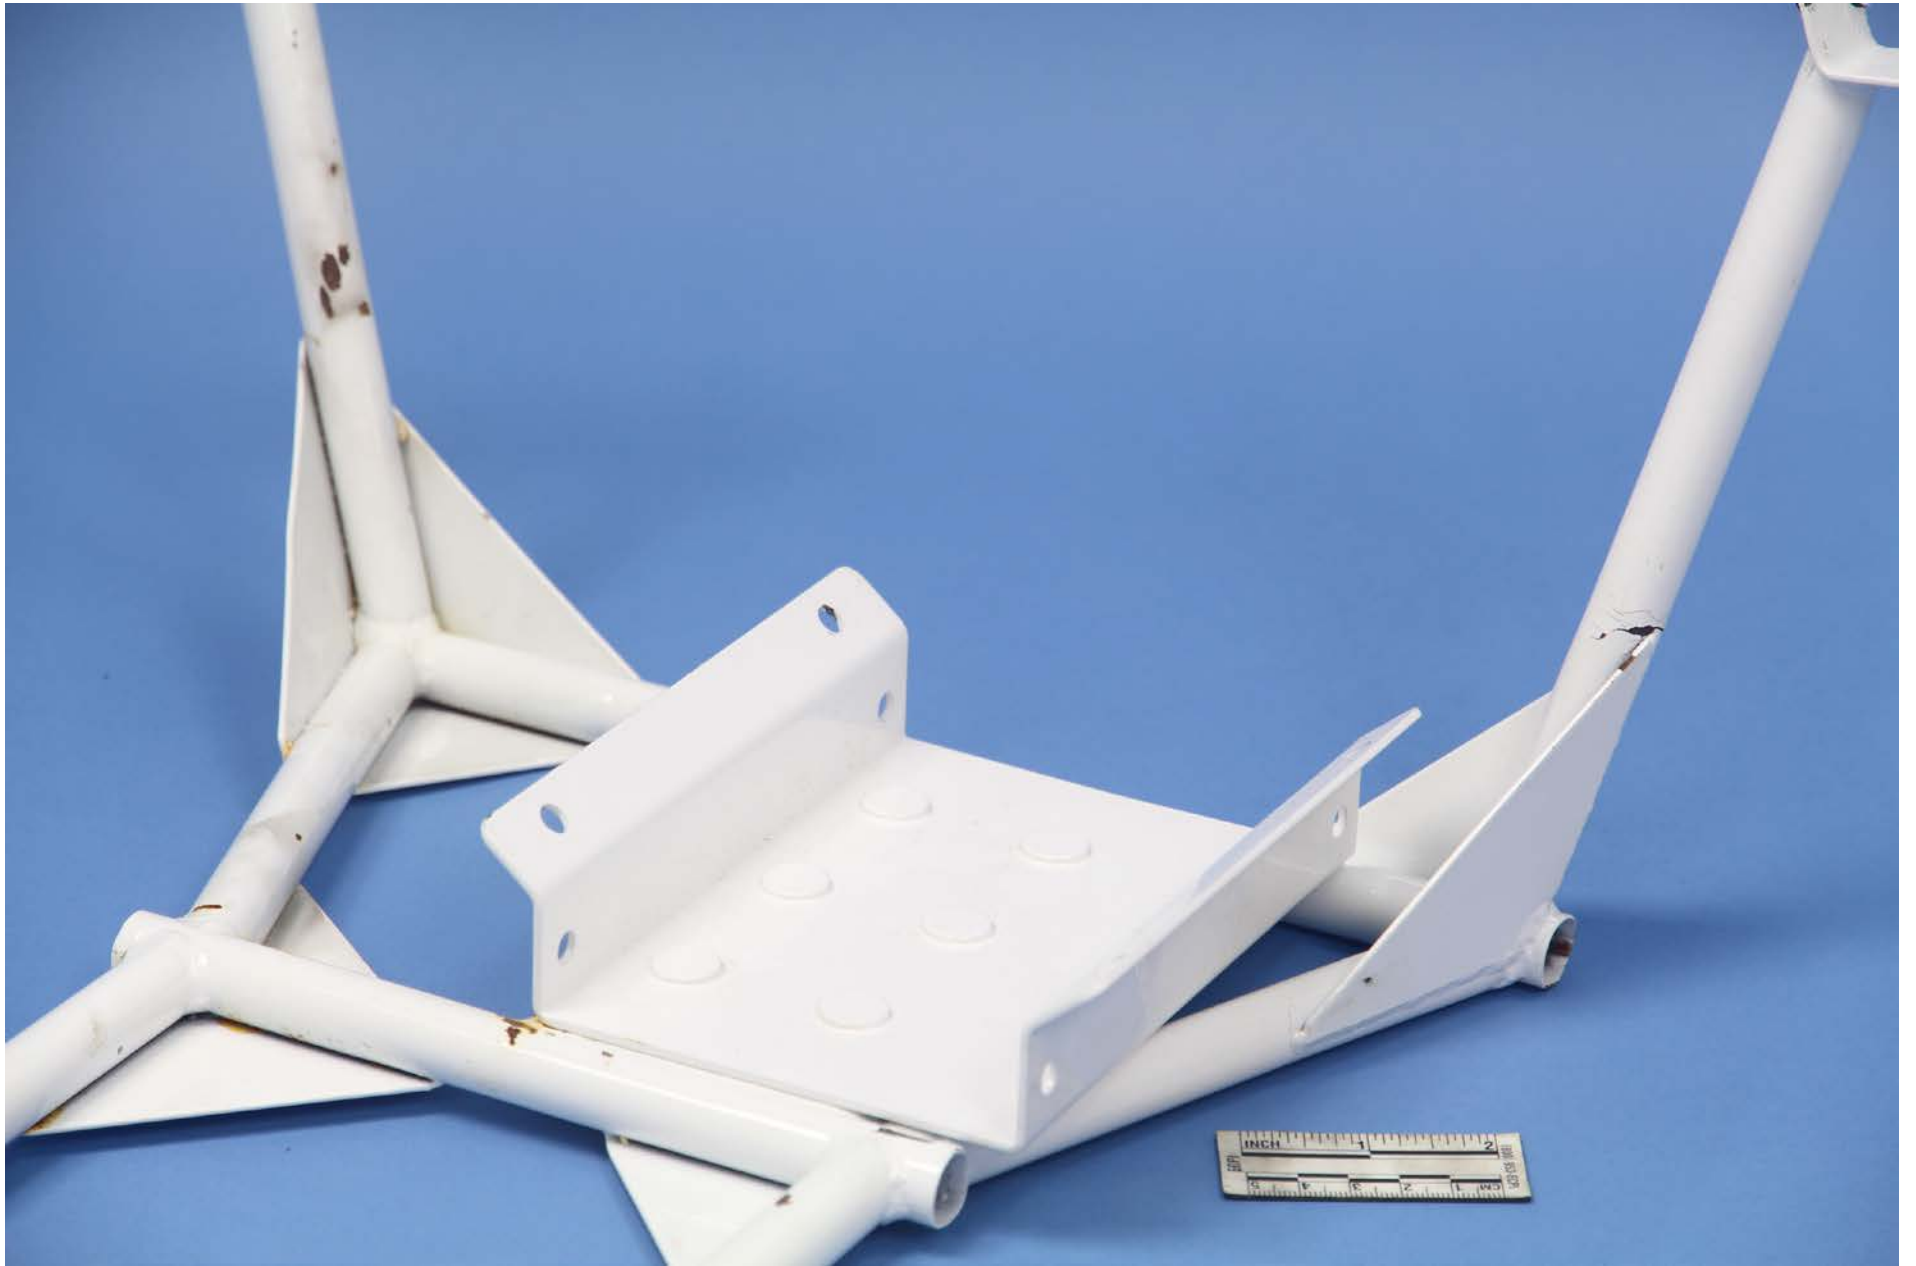
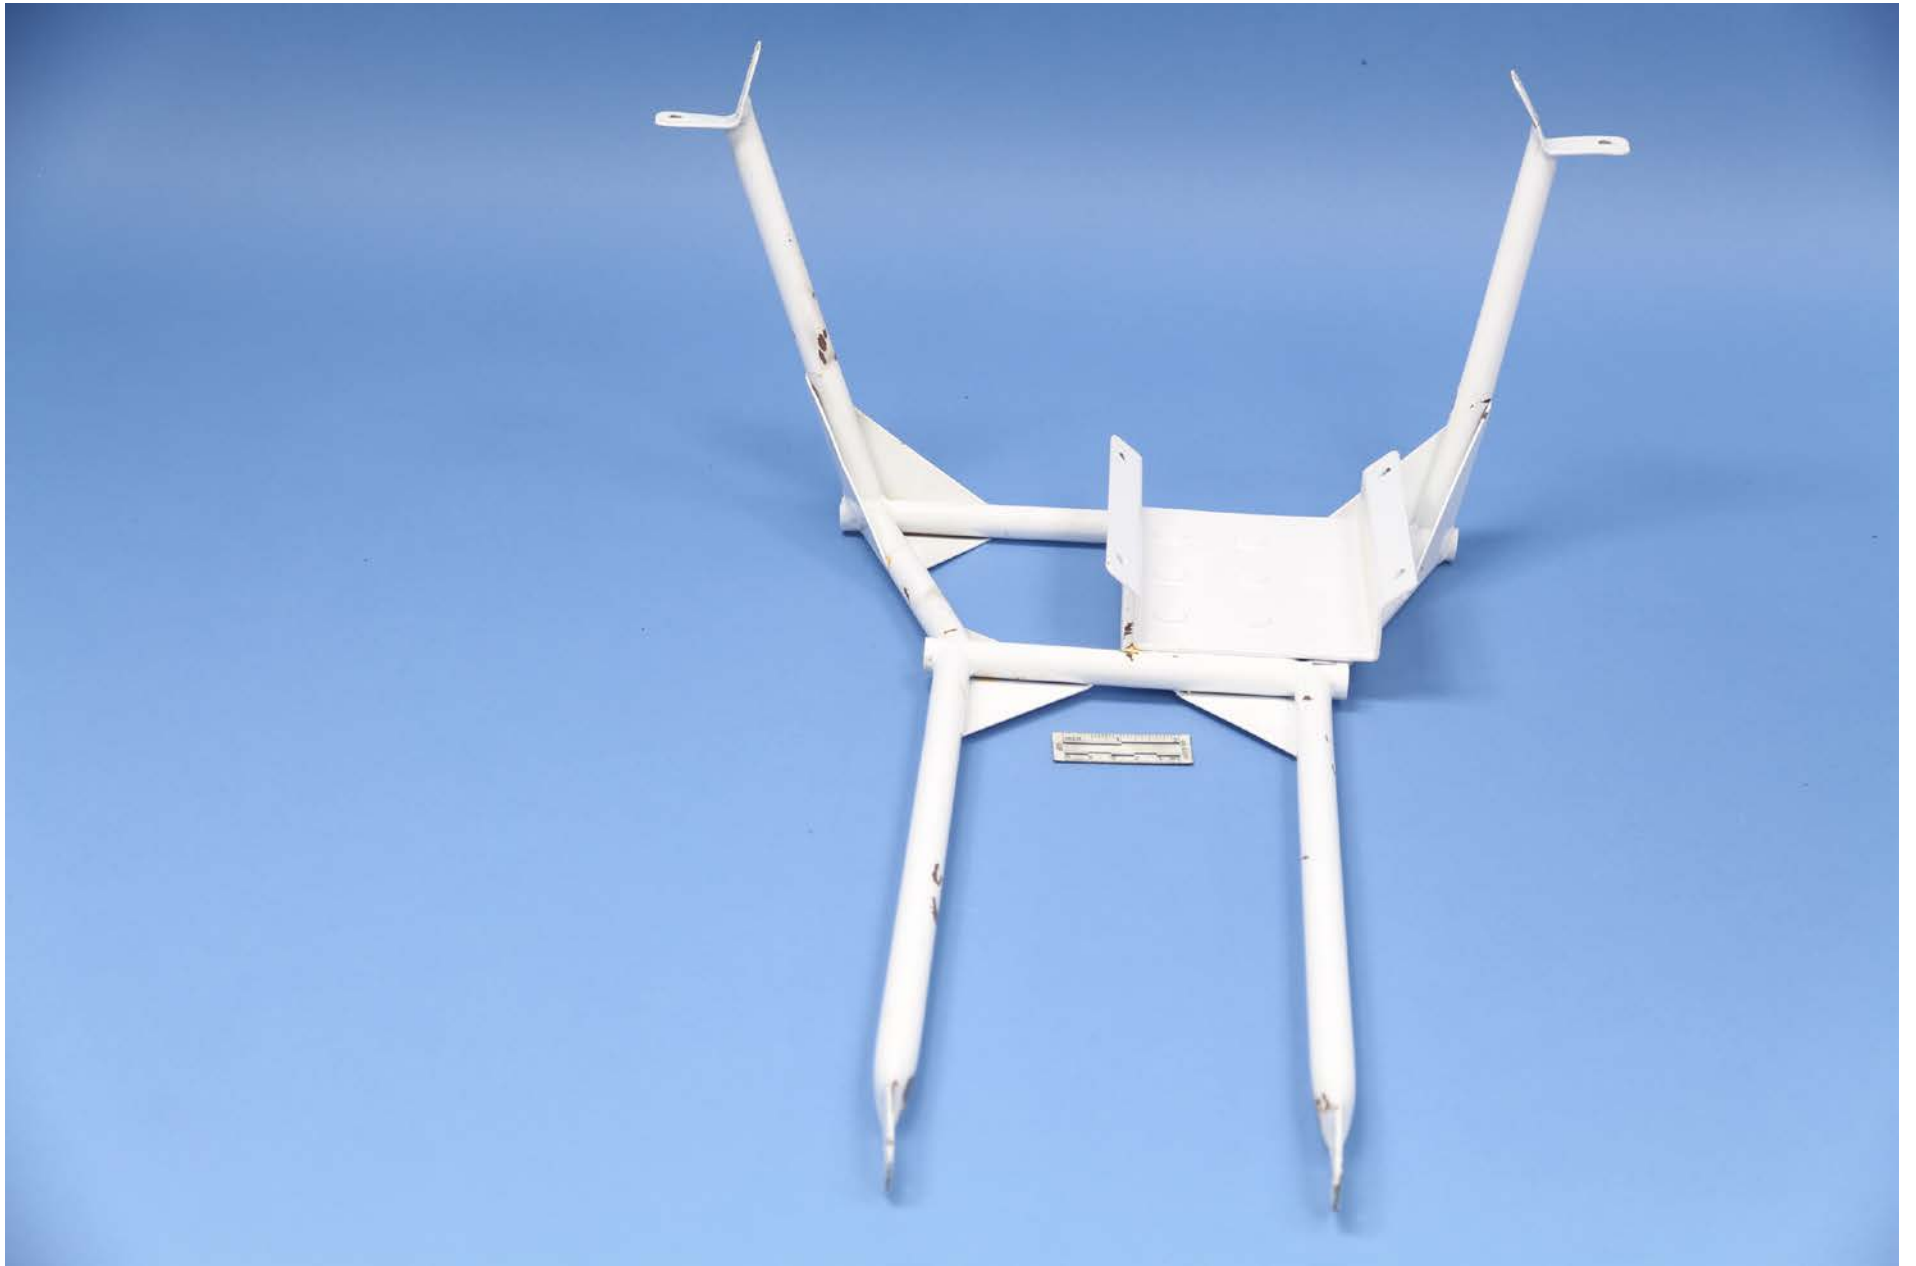
Ralph - I also looked at the parts. Although there are several marks, it was impossible to determine if one of them had been there prior to impact. They were all corroded with no discernable difference in the corrosion levels.

We've examined the bracket adjacent to Ballistic Recovery System (BRS) and were not able to discern any marks or damage consistent with deployment issues.
