## RECORD OF CONVERSATION

**Date: April 8, 2019**  
**Person Contacted: Danny Cox**  
**NTSB Accident Number: ERA19LA143**

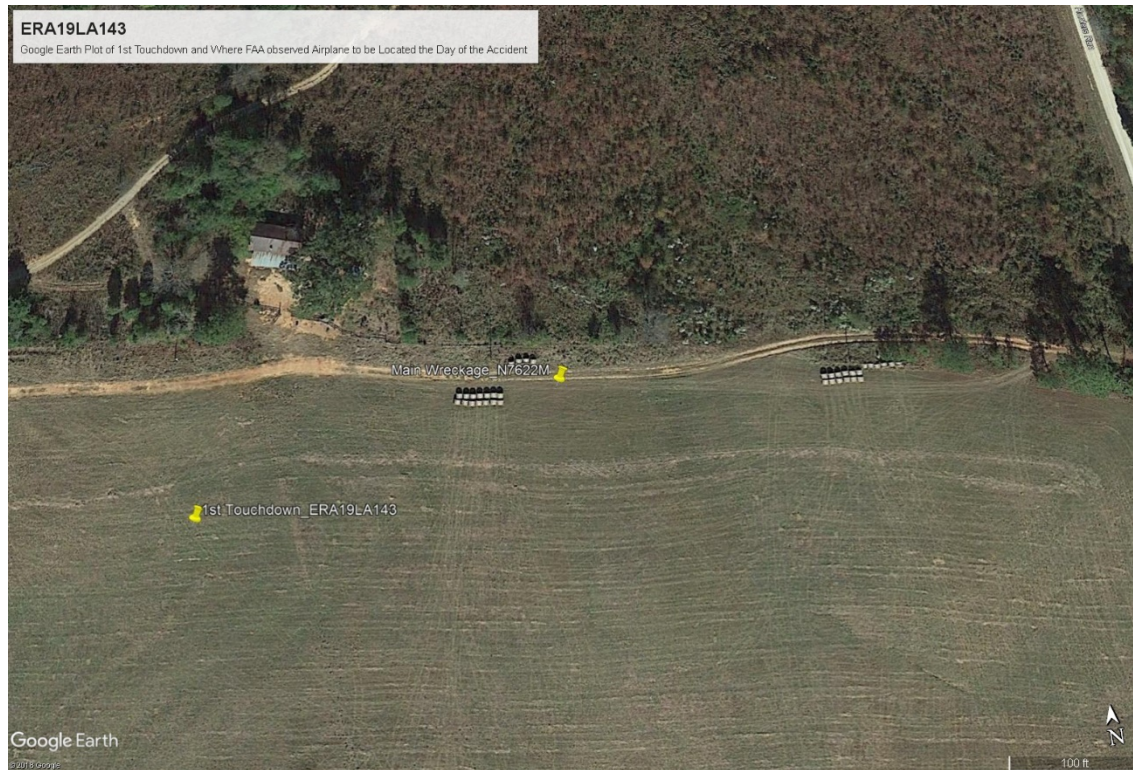
He reported that the airplane had been moved before he arrived. The 1<sup>st</sup> touchdown point was 33.7689° N and -081.9866° W. The airplane had been moved when he arrived. It was located at 33.7691° N and -081.9856° W. He estimated it was about 1,000 feet from the 1<sup>st</sup> touchdown to the location of the airplane.<sup>1</sup>

<sup>1</sup> Using Google Earth, the distance and direction between/from the 1<sup>st</sup> touchdown and the observed position of the airplane was about 310 feet and 076°.

Figure 1: Google Earth Plot Depicting 1<sup>st</sup> Touchdown Location and Where FAA observed the airplane to be located.
