## MEMORANDUM FOR RECORD

**May 24, 2019**

**Subject:** ERA19LA149 – Examination of Airplane

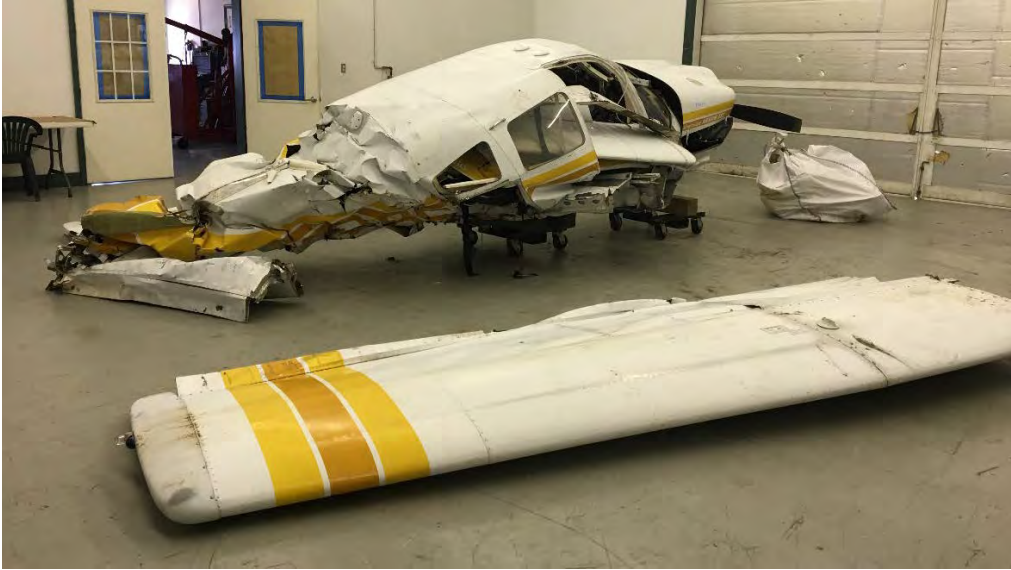
- The right wing trailing edge was impact the entirety of its length.
- The right wing exhibited a puncture fracture near the wing root and the right wing fuel tank was devoid of fuel.

*Figure 1: View of Wreckage from Right*

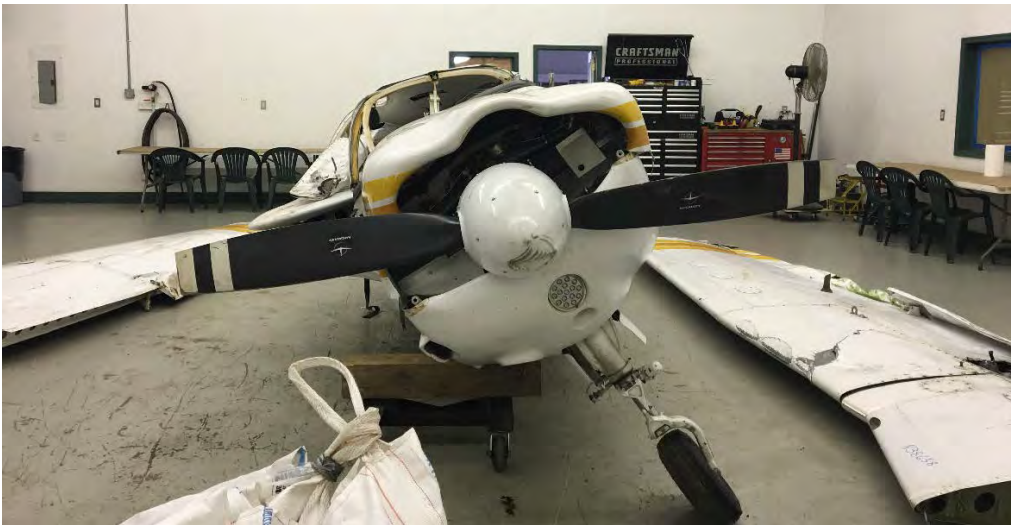
- Spinner exhibited impact marks with power lines.
- The engine section was attached and canted upward, and the left fuselage was bent and fractured forward of the cockpit.

- The propeller blade remained attached to engine
- The leading edge of one propeller blade exhibited wire strike marks midspan.
- The fuselage aft of the wings and the empennage were impact damaged and crushed forward

*Figure 2: View of Wreckage from Front*

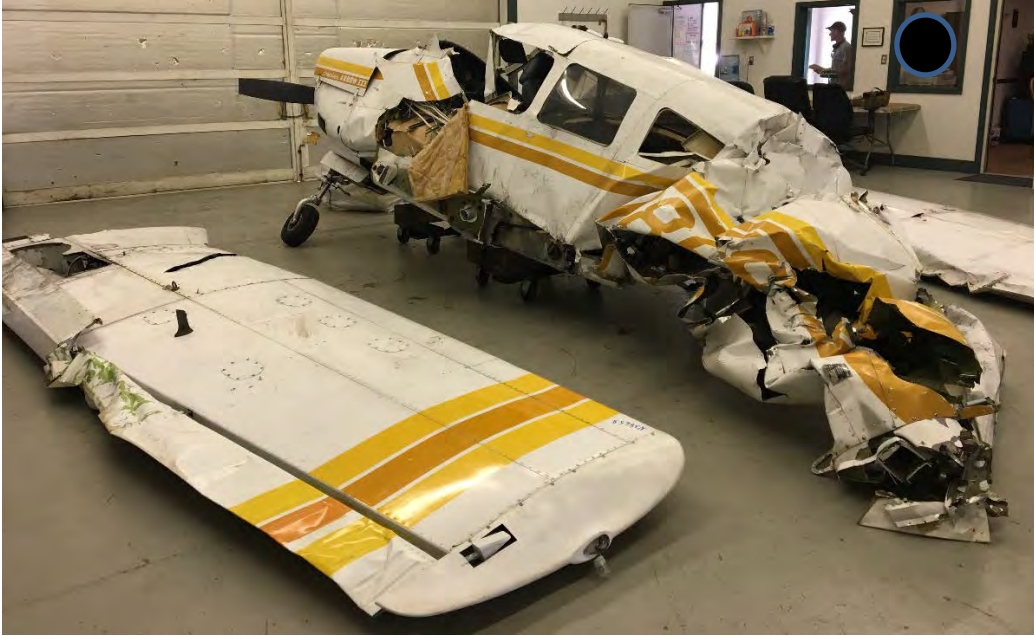
- The trailing edge of the left wing was impact damaged along most of its length.
- The left wing evidenced a wire-tear from the leading edge to mid-wing.

*Figure 3: View of Wreckage from Left*

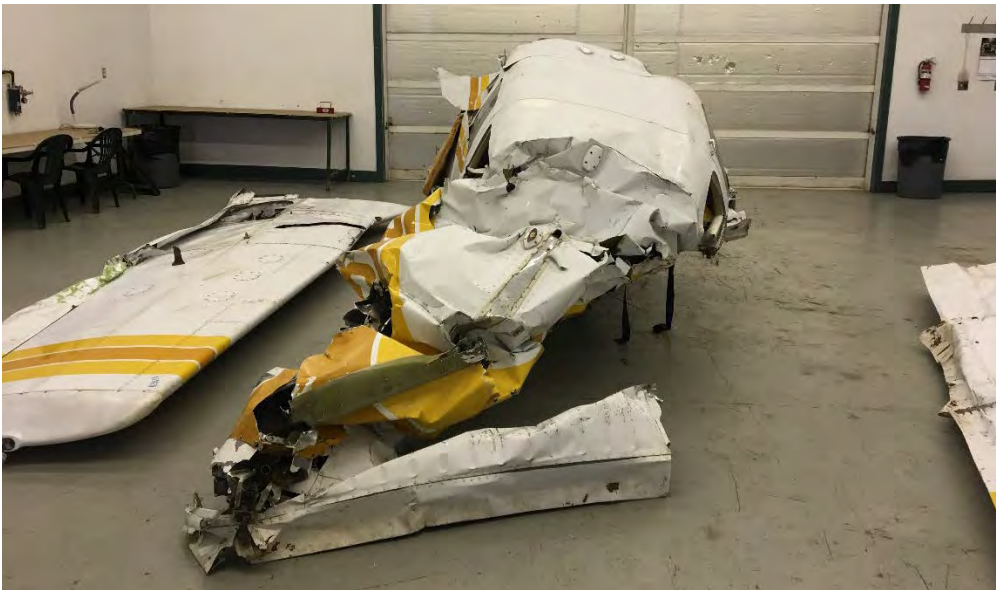
- Several cups of fuel were recovered from the left wing fuel tank, which was fractured.
- The vertical stabilizer and rudder were fractured and crushed toward the right horizontal stabilizer.

- The left horizontal stabilizer was attached to tail and the elevator was impact crushed.
- The right horizontal stabilizer and elevator were intact, and impact crushed.

*Figure 4: View of Wreckage from Rear*

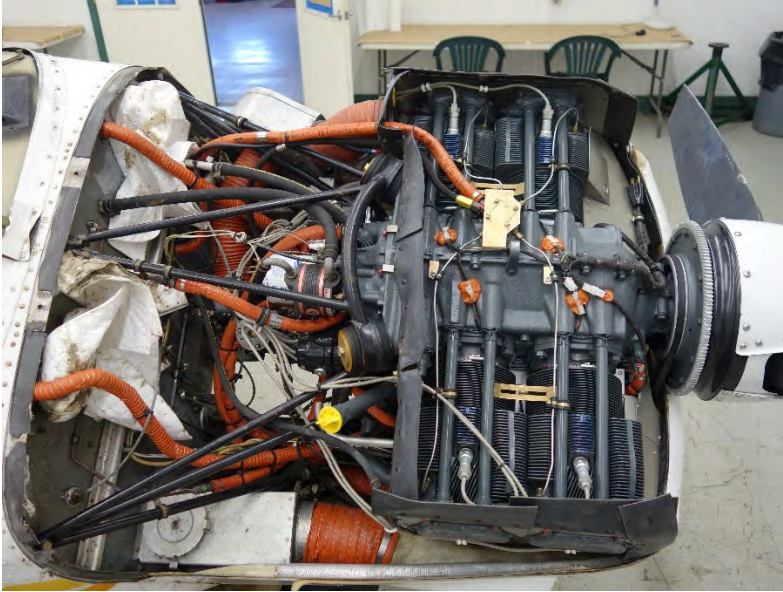
- No anomalies noted in exterior engine inspection
- Propeller would not rotate
- Removed air filter cover: free of obstruction from induction to fuel servo

*Figure 5: View of Uncowled Engine (Photo Courtesy of Piper Aircraft)*

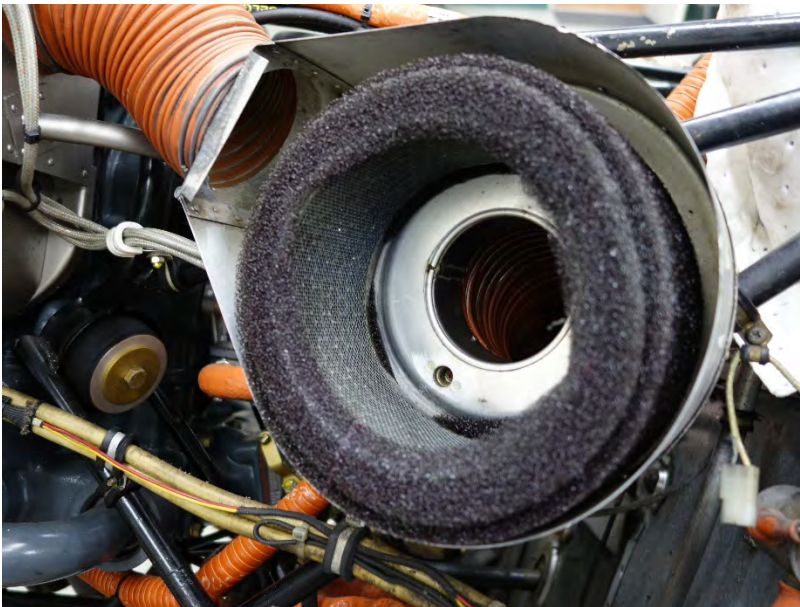
*Figure 6: Air Intake and Filter Free from Obstruction (Photo Courtesy of Piper Aircraft)*

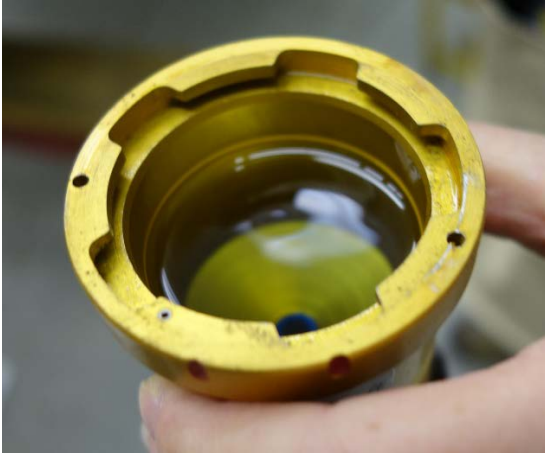
*Figure 7: Fuel Strainer (Photo Courtesy of Piper Aircraft)*

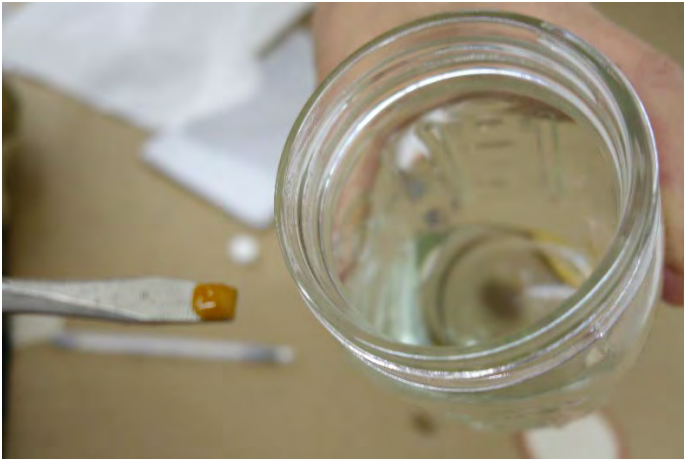
- Removed fuel strainer:  $\frac{3}{4}$  full of blue liquid consistent with 100LL; tested with water paste; no water detected
- Tested fuel selector: no anomalies noted

*Figure 8: Fuel in Strainer Tested Free from Water (Photo Courtesy of Piper Aircraft)*

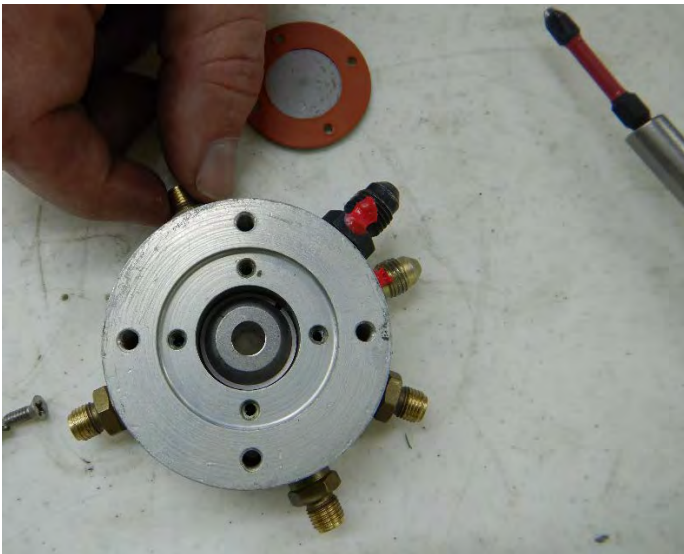
- Removed and examined fuel flow divider: diaphragm intact and free from corrosion and contaminants
- Removed top spark plugs: all plugs normal when compared to Champion Check-A-Plug card; plug No.3 oil fouled

*Figure 9: Fuel Flow Divider and Diaphragm*

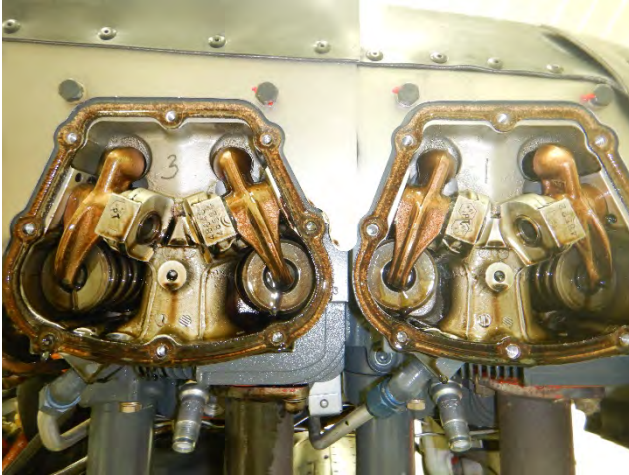
- Removal of rocker covers revealed large amounts of oil in Cylinders No. 1 and 3
- Borescope of cylinders revealed excess oil cylinders No 1 and 3 but no other anomalies noted

*Figure 10: Rocker Covers Removed from Cylinders Nos 3 and 1*

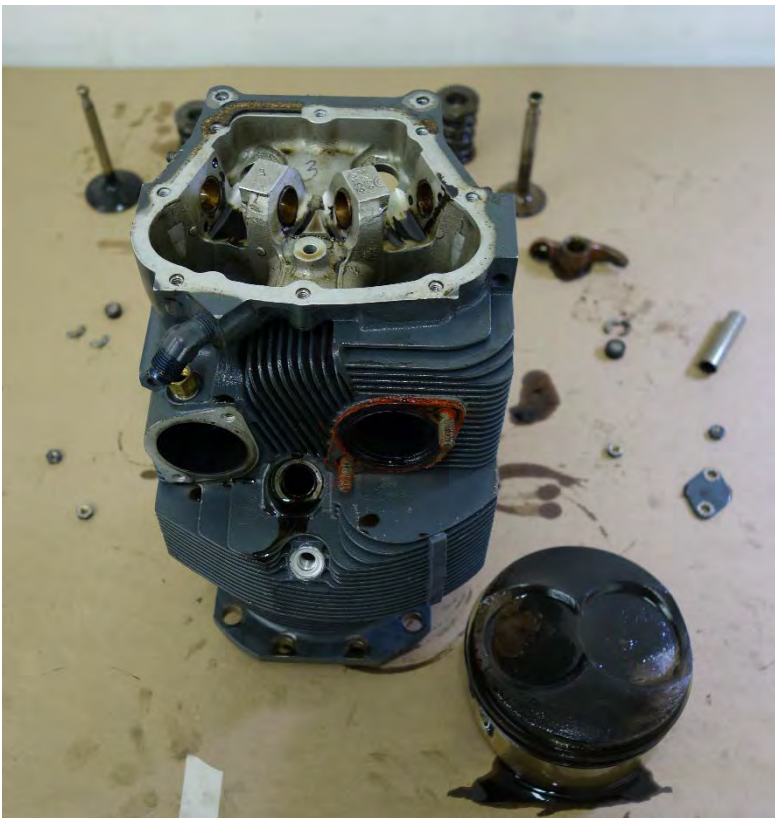
- Removed and examined No. 3 cylinder: no anomalies noted
- Examined fuel injectors: clean and clear
- Engine driven fuel pump was full of fuel when fuel lines were removed

*Figure 11: No. 3 Cylinder Head and Piston (Photo Courtesy of Piper Aircraft)*

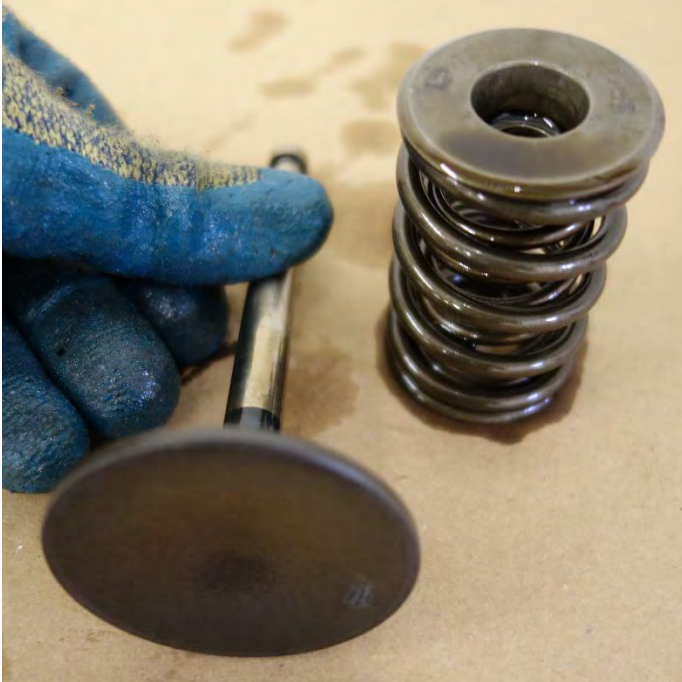
*Figure 12: No. 3 Intake Valve and Spring (Photo Courtesy of Piper Aircraft)*

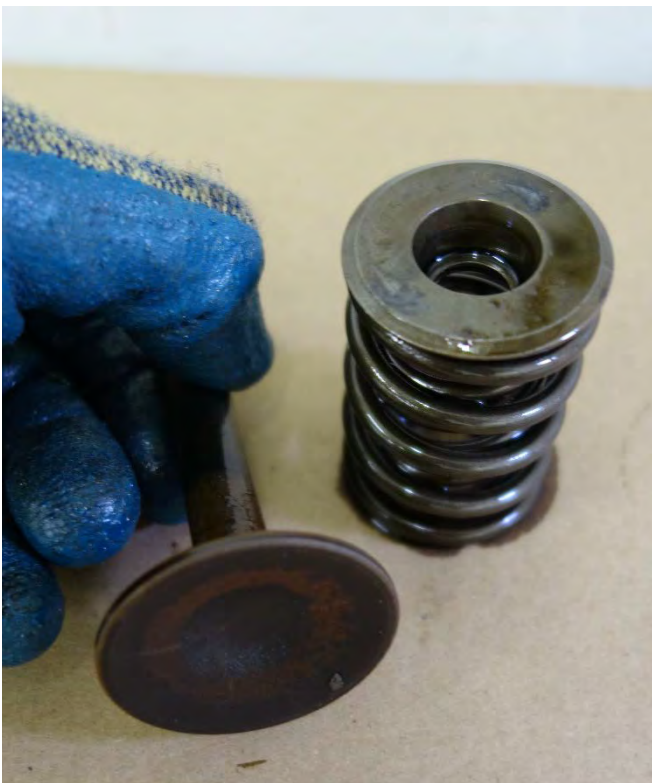
- Pulled fuel injectors, no obstructions noted
- No. 3 air induction tube was found to contain  $\sim \frac{1}{2}$  c oil
- No. 3 exhaust pipe contained  $\sim \frac{1}{2}$  c oil

*Figure 13: No. 3 Exhaust Valve and Spring (Photo Courtesy of Piper Aircraft)*

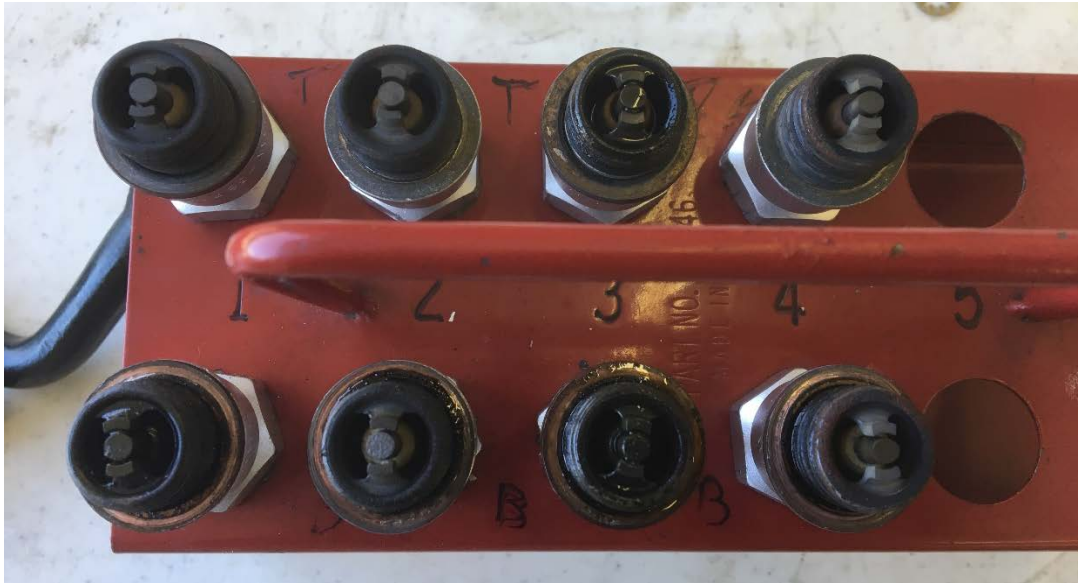
Figure 14: Spark Plugs

- Removed lower spark plugs: all plugs normal when compared to Champion Check-A-Plug card; plugs No.1 and 3 oil fouled
- Removed oil filter: no anomalies noted
