**NATIONAL TRANSPORTATION SAFETY BOARD**  
Office of Aviation Safety  
Washington, D.C. 20594

## **Engine Examination**

Aircraft: Cessna 172

NTSB Number: ERA19LA150

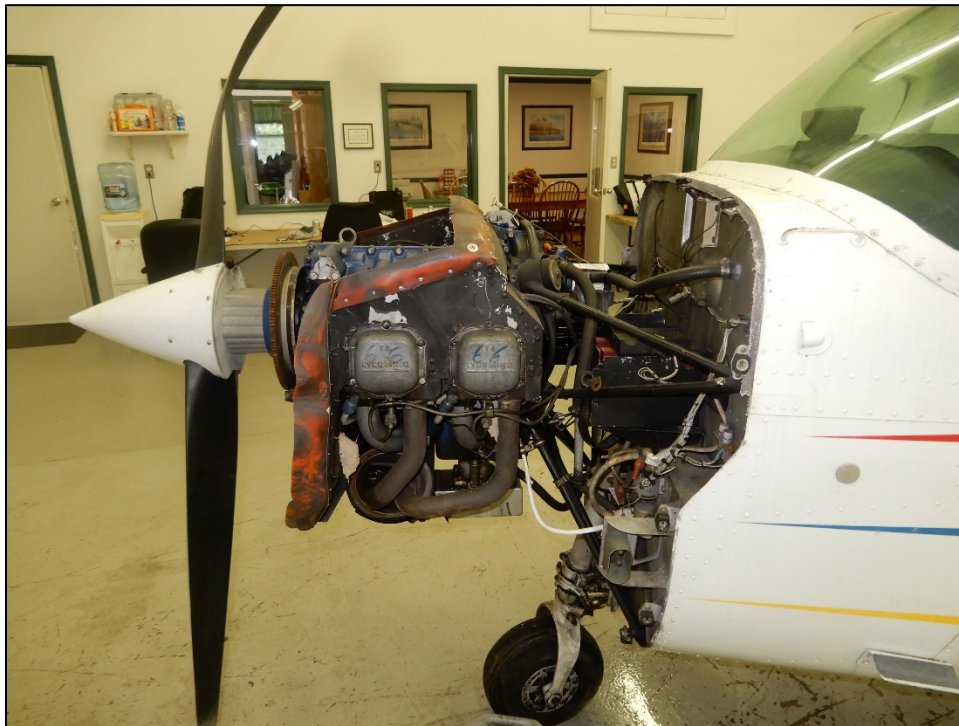
The engine remained attached the firewall. The propeller could be moved by hand freely. When the propeller was rotated by hand, thumb compression and suction was confirmed on each cylinder and each piston moved freely. The oil dipstick read 5.5 quarts. The oil appeared brown in color.

**Figure 1: Overview of Engine Attached to the Firewall**

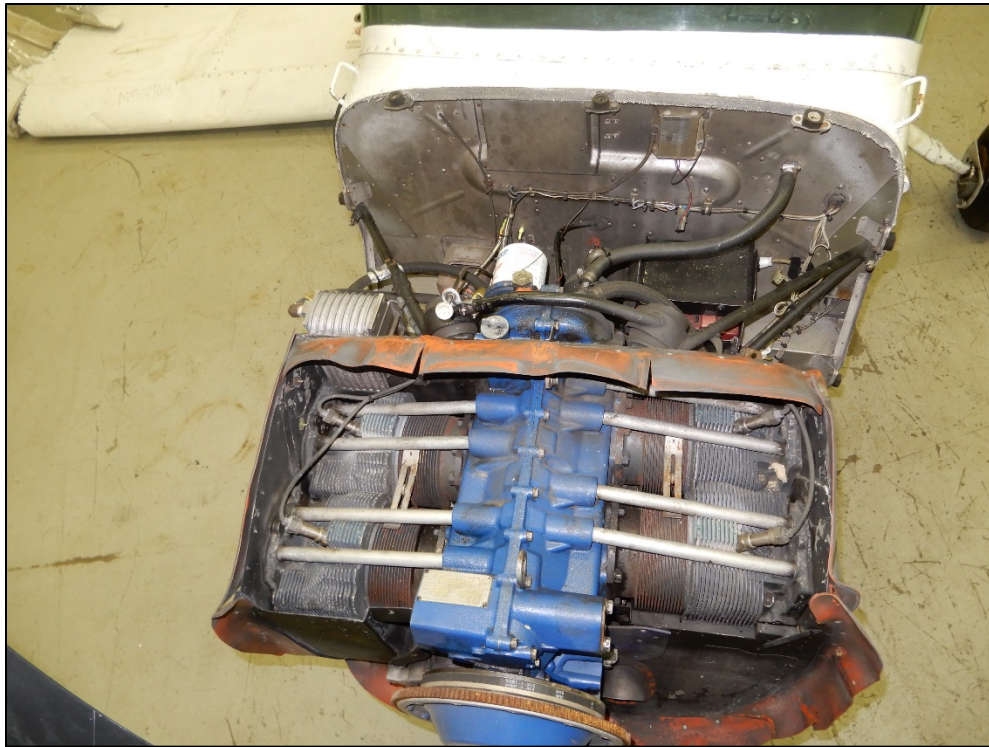
**Figure 2: Overview of the Top of the Engine**

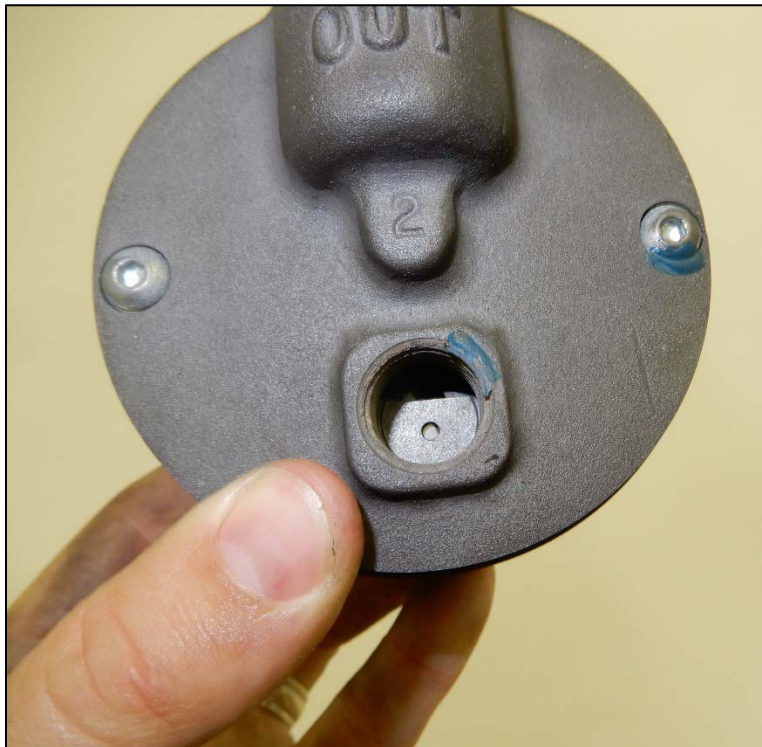
The throttle lever moved the butterfly valve located on the carburetor. The vacuum pump hose was removed, and no obstructions were noted. The vacuum pump was removed from the accessory section of the engine. When comparing the wear indicator port to the manufacture wear chart, it was found to be within tolerances. The pump gear moved freely.

**Figure 3: View of the Vacuum Pump and its Wear Indicator**
