## ENGINE EXAMINATION REPORT

| ENGINE MODEL | O-200-A |
| AIRCRAFT MAKE & MODEL | Cessna 150G |

| EXAMINATION | | ACCIDENT DATA | |
|---|---|---|---|
| DATE | 07/02/2019 | NTSB ACCIDENT # | ERA19LA151 |

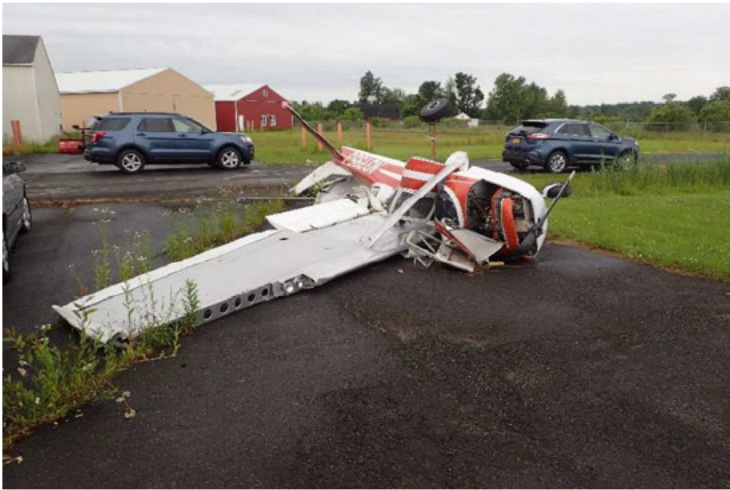
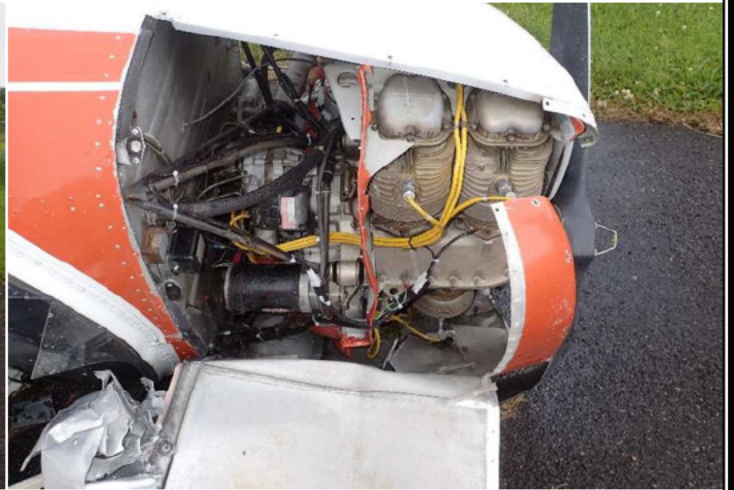
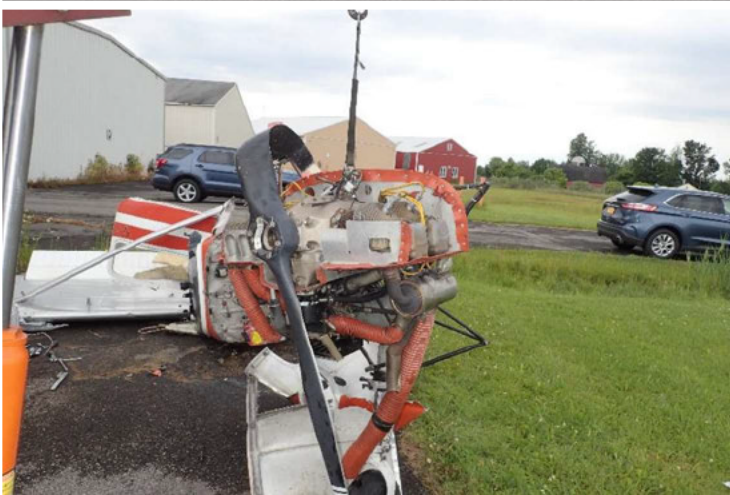
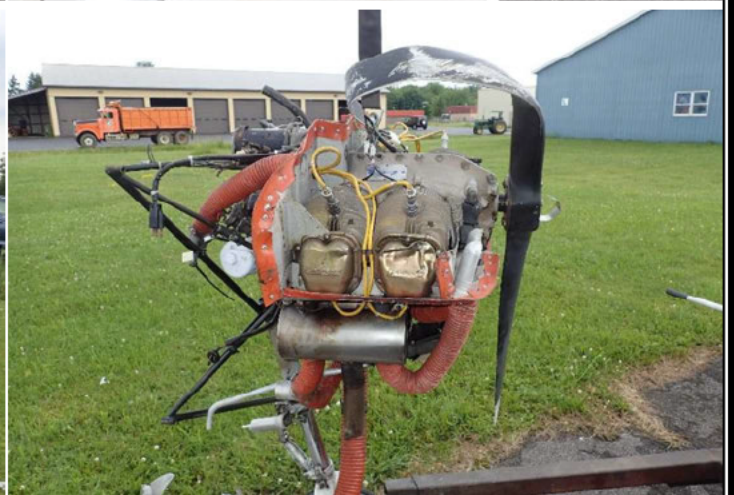
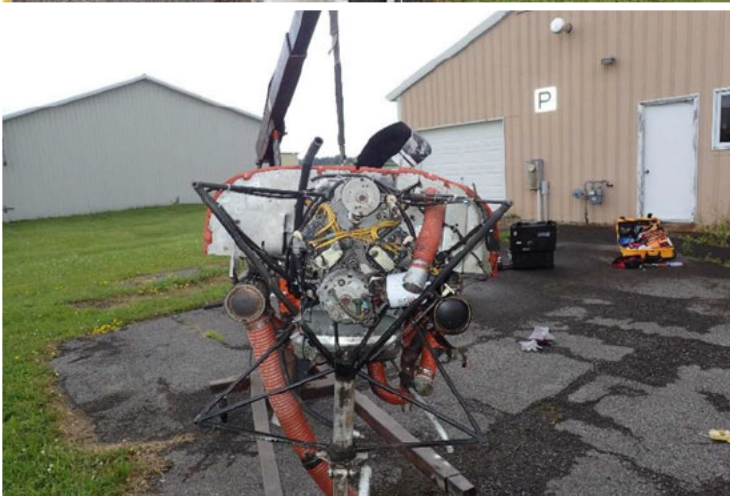
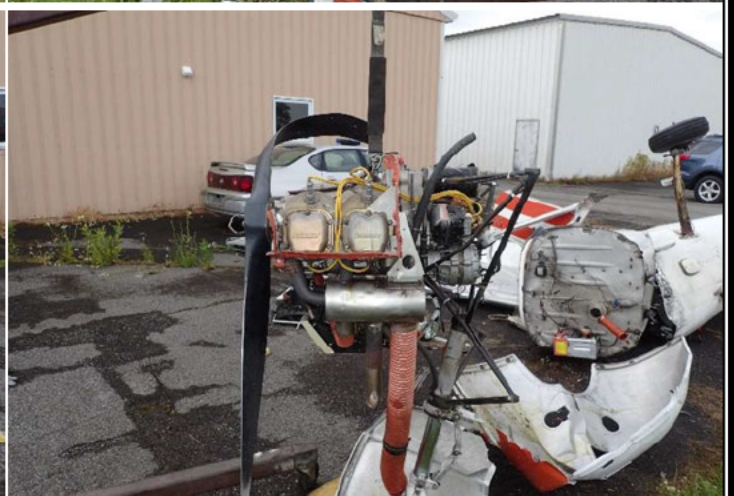
The engine remained attached to the airframe through the engine mounts, wires, cables, and hoses. The engine displayed some impact damage signatures with most of the damage occurring to the right-side cylinders. The engine was removed from the firewall to facilitate further inspection. The crankcase remained intact and there were no signs of a catastrophic internal engine failure. The two blade, fixed pitched propeller remained attached to the crankshaft and displayed impact damage signatures. All four cylinders remained attached to their cylinder bays and displayed varying amounts of impact damage; the right-side cylinders displayed the most damage.

Both magnetos remained attached to their installation points and were undamaged. The ignition harness remained attached to both magnetos and to each spark plug; the ignition lead ends displayed minor impact damage to the #1 and the #3 top ignition lead ends. All of the spark plugs remained installed in their cylinders and the #1 top spark plug was noted to be loose and displayed impact damage.

The carburetor remained attached to its installation point and was undamaged; there were no signs of fuel leaks and the fuel line was secured to the carburetor inlet as well as the fuel strainer outlet fitting.

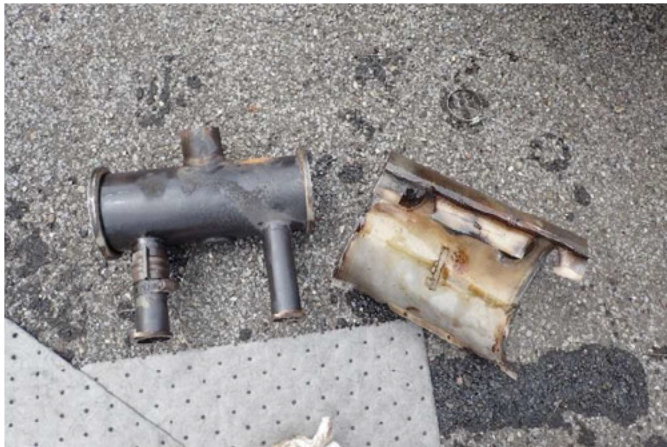
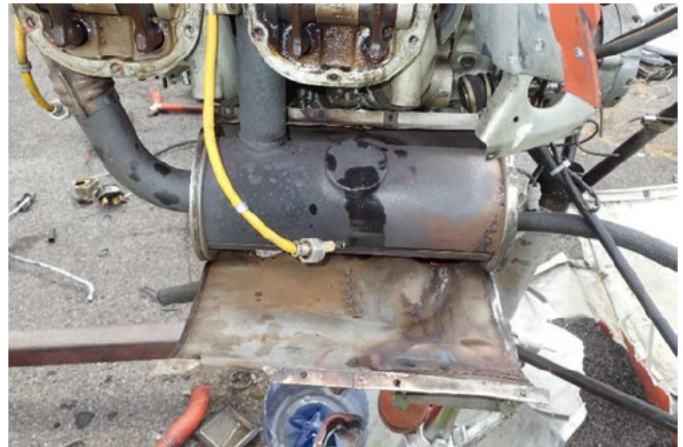
### EXHAUST SYSTEM

The exhaust system remained attached to the engine and displayed minor impact damage to the tail pipes. The exhaust shrouds were removed from both exhaust mufflers and there were no signs of cracks or exhaust leaks. There were no signs of exhaust leaks or blockages with the exhaust system. The heat exchanger scat tubing for the carburetor heat was examined and there were no blockages noted.

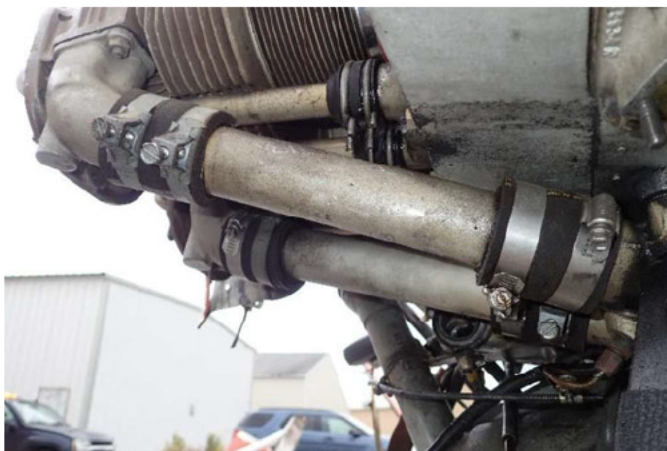
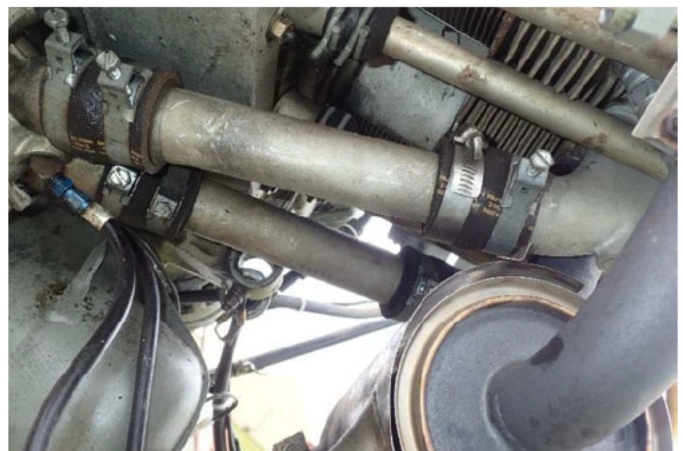
### INDUCTION SYSTEM

The engine induction system was undamaged; it was noted that the induction air filter had been removed prior to the examination. There were no signs of induction leaks or blockages noted. Due to impact damage the operation of the carb heat cable could not be tested; however, the control arm on the induction air box worked normally.

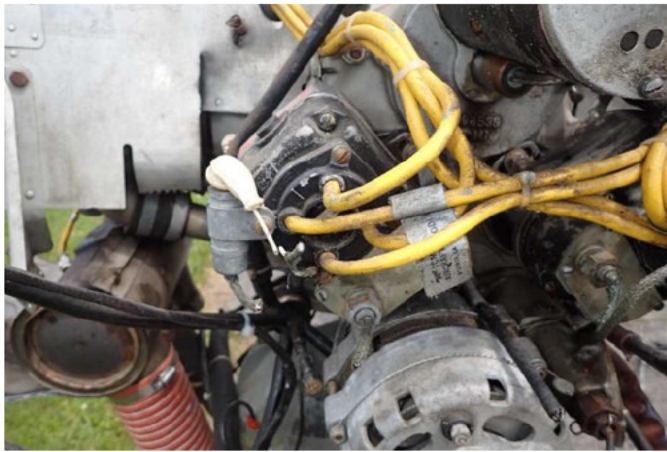
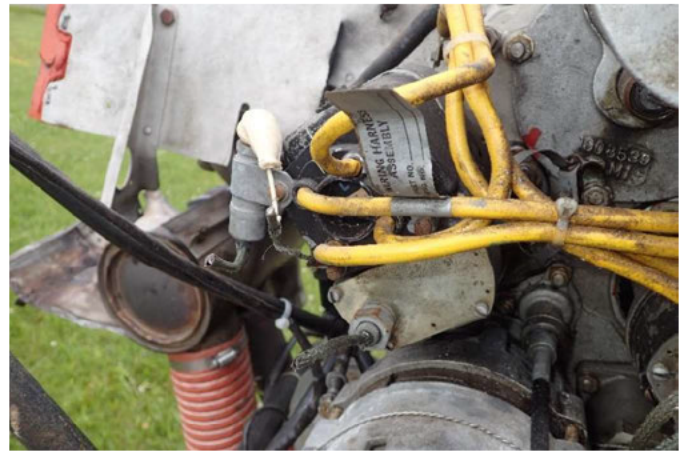
### LEFT MAGNETO

The magneto remained attached to its installation point and was undamaged. During crankshaft rotation it was noted that the impulse coupling would operate for the magneto. During impulse coupling operation it was noted that the magneto was capable of producing a spark to each lead end, in the correct firing order, and was in sync with the right magneto.

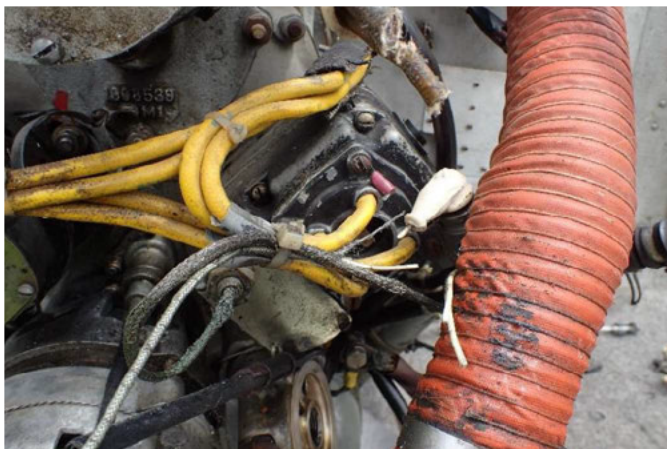
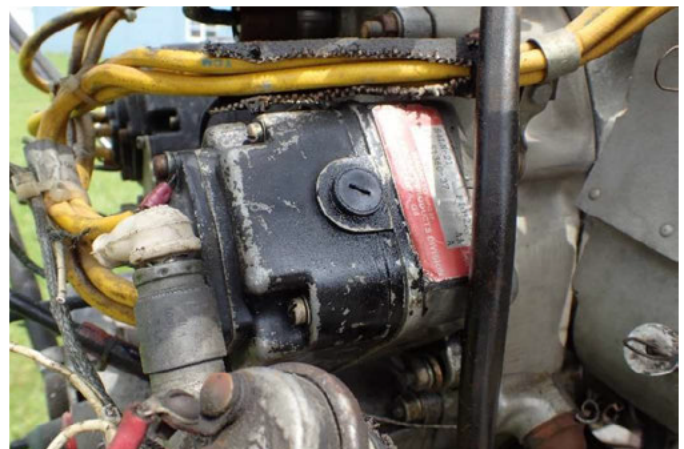
### RIGHT MAGNETO

The magneto remained attached to its installation point and was undamaged. During crankshaft rotation it was noted that the impulse coupling would operate for the magneto. During impulse coupling operation it was noted that the magneto was capable of producing a spark to each lead end, in the correct firing order, and was in sync with the left magneto.

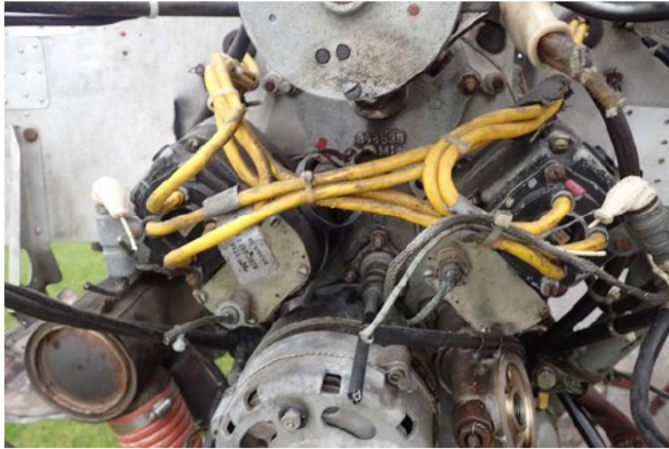
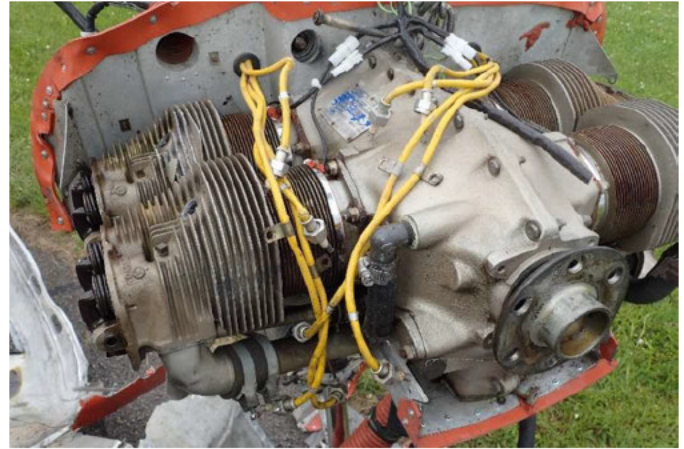
## IGNITION HARNESS

The harness remained attached to both magnetos and to each spark plug and displayed some impact damage to the top #1 and top #3 ignition lead ends. During magneto impulse coupling operation all of the ignition leads were capable of conducting a spark to the lead ends. There were no anomalies noted.

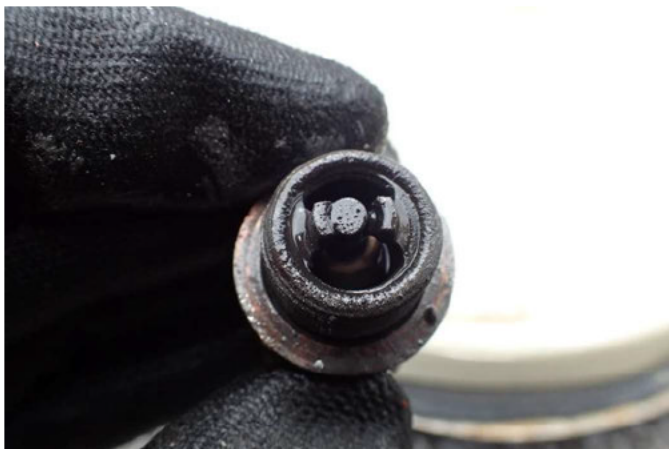
#1 Top Spark Plug

All of the spark plugs remained installed in their cylinders and the #1 top spark plug displayed impact damage signatures and was loose. The top spark plugs were removed and were visually inspected; the bottom spark plugs were inspected using a lighted borescope. It was noted that all of the right-side spark plugs were oil coated consistent with post-accident accumulation. The left side spark plugs were dry and were clear of any signs of combustion deposits. The spark plugs displayed normal wear signatures.

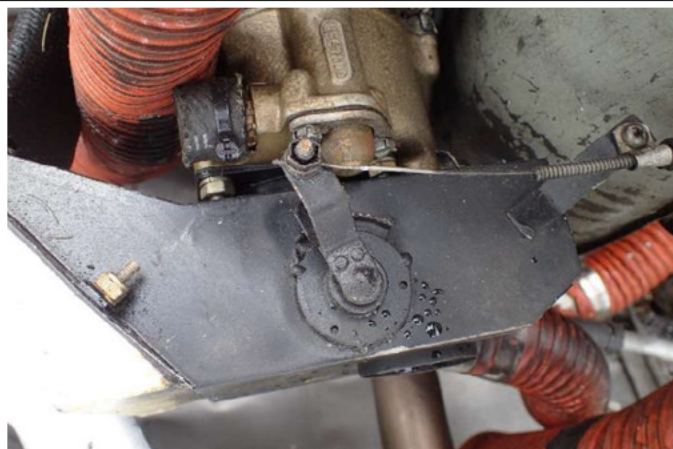
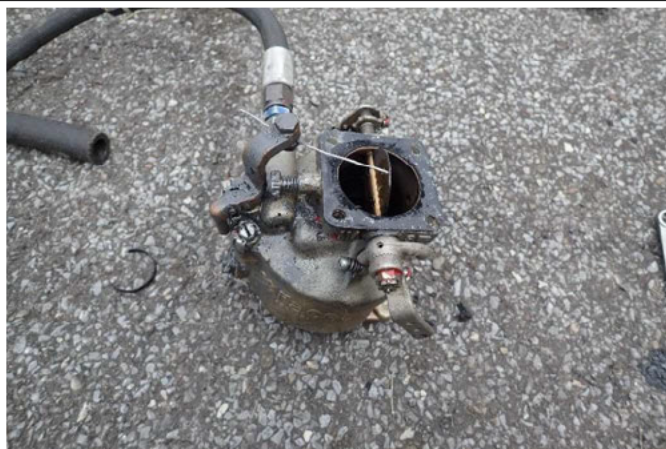
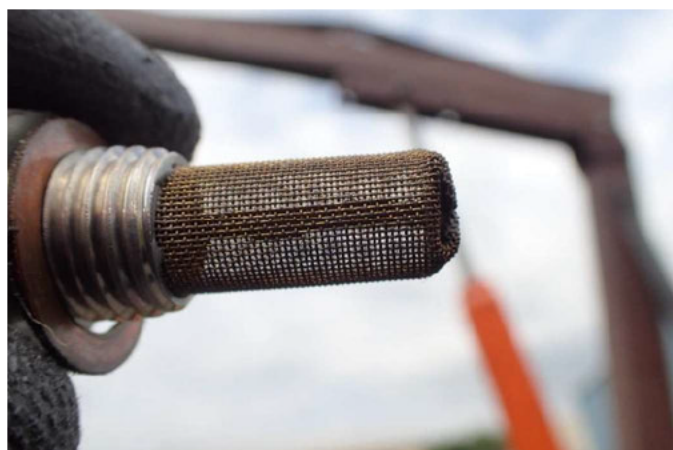
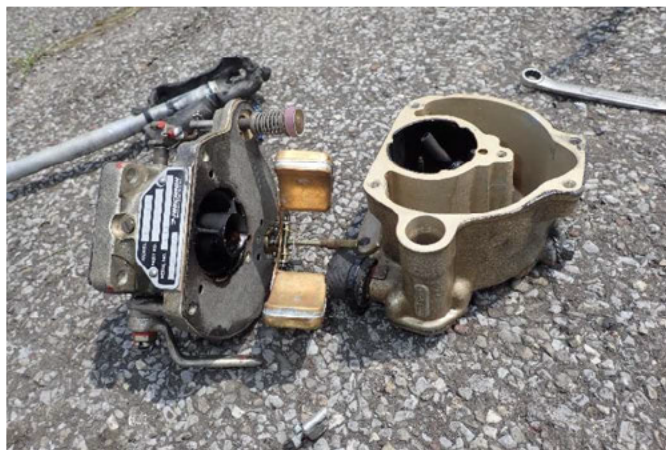
### CARBURETOR

The carburetor remained attached to its installation point and was undamaged. The carburetor was removed and there were no blockages noted in the carburetor throttle body. The throttle and mixture control arms were capable of normal movement and the throttle valve operated normally. The carburetor was disassembled and the internal components were visually inspected; the floats, valve, jets, accelerator pump, and bowl displayed normal operating signatures. It was noted that there was no fuel remaining in the carburetor bowl. The inlet screen was removed and was clear of any contaminants. The screen was reinstalled, and air was blown into the carburetor inlet while actuating the floats and valve; the valve was capable of normal operation. The carburetor airbox was examined; the carburetor heat control arm operated normally and there were no obstructions noted within the airbox. There were no anomalies noted.

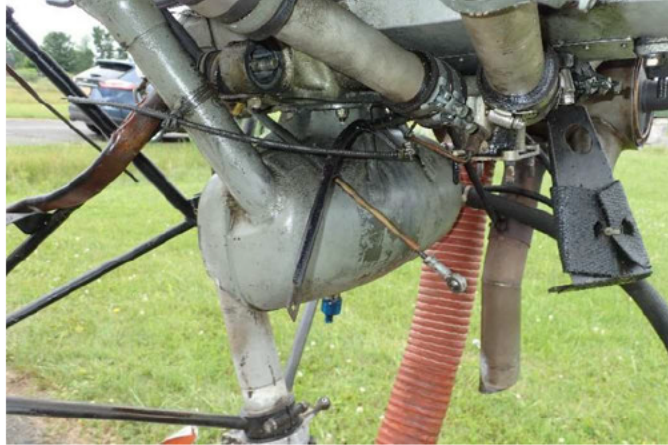
### OIL SUMP

The oil sump remained attached to the engine and was undamaged. There were no anomalies noted.

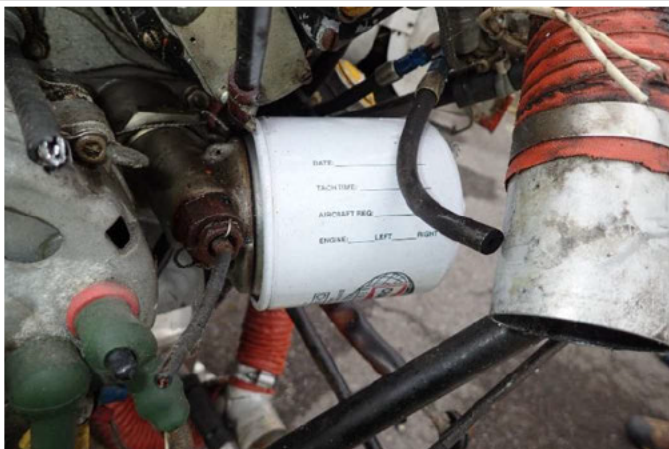
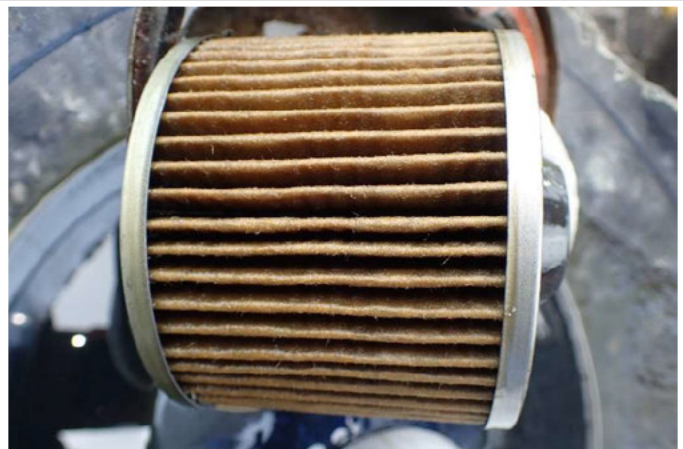
### OIL FILTER

The oil filter remained attached to the adapter and was undamaged. The filter was removed, and the housing was cut open. The filter pleats were visually inspected, and the pleats displayed normal operating signatures and there was no metallic material noted within the pleats.

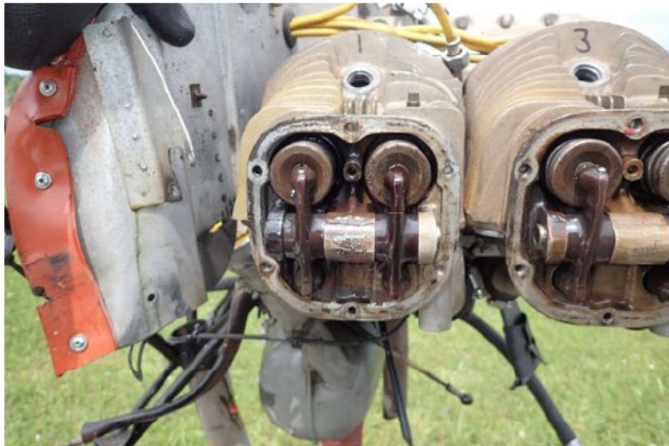
#1 Cylinder Overhead

The cylinders remained attached to their cylinder bays and displayed minor impact damage signatures. While removing the spark plugs it was noted that the #1 cylinder had a significant amount of oil within the cylinder which was consistent with post-accident accumulation. The oil was drained from the #1 cylinder and all of the cylinders were inspected using a lighted borescope. The cylinder bores, piston faces, and valve heads displayed normal operating and combustion signatures. The overhead components (valves, springs, and rocker arms) displayed normal operating and lubrications signatures. During crankshaft rotation all of the cylinders displayed good thumb compression and suction and the overhead components operated normally.

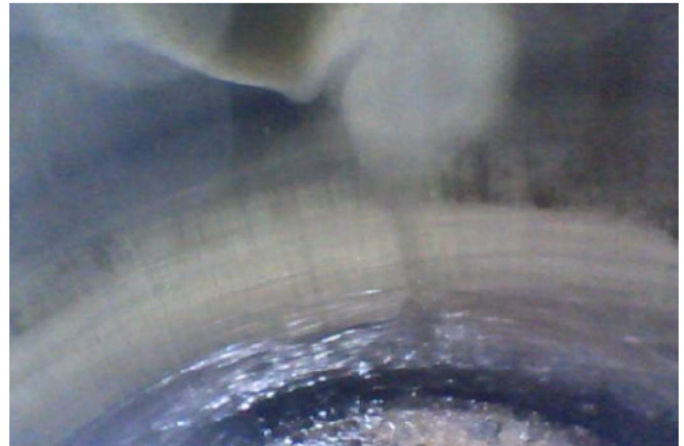
#1 Cylinder Bore (lens partially obscured with oil)

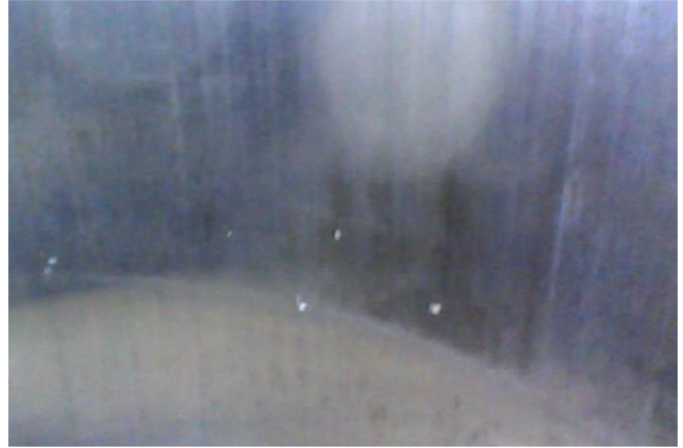
#2 Cylinder Bore (lens partially obscured with oil)

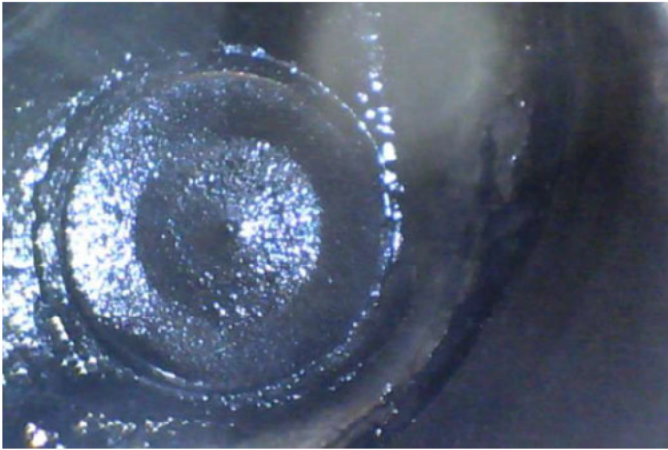
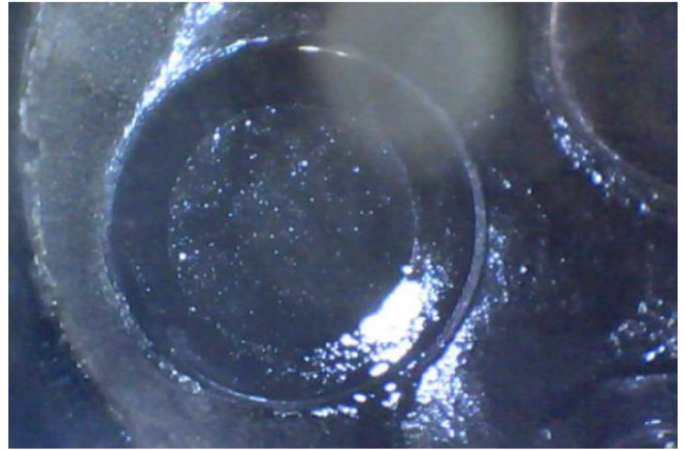
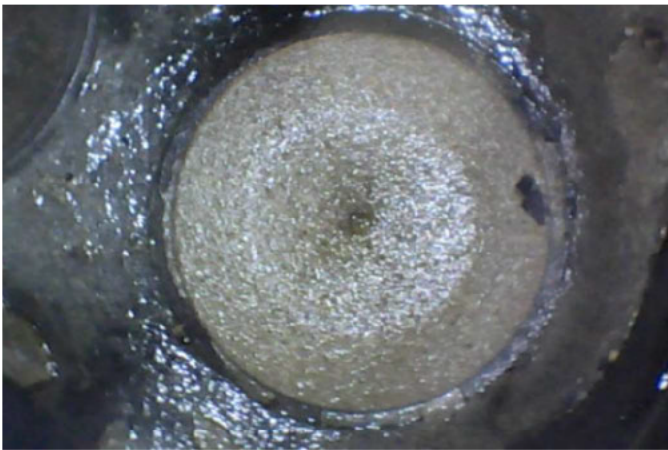
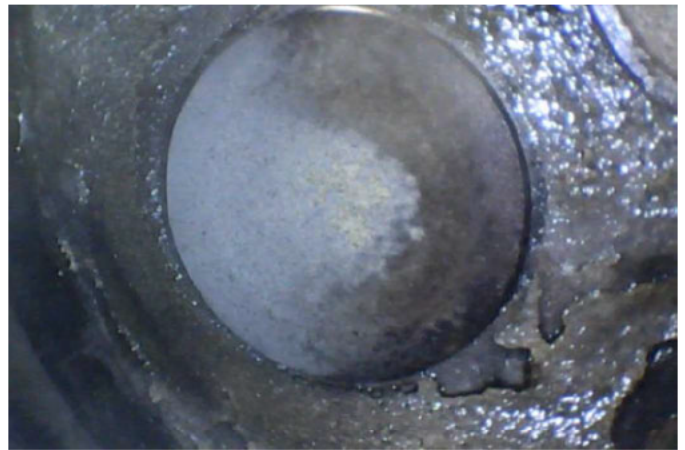
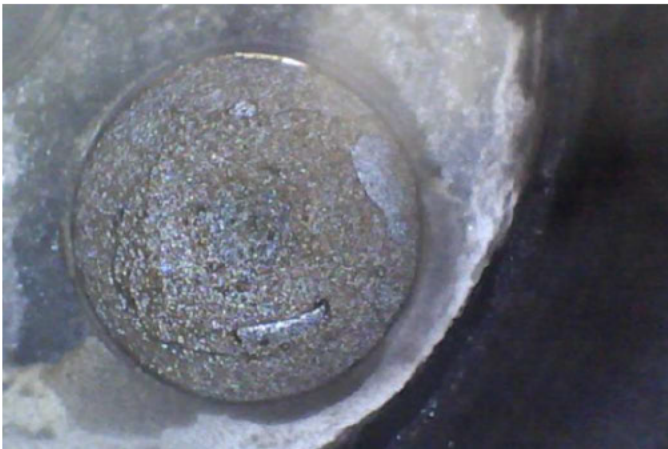
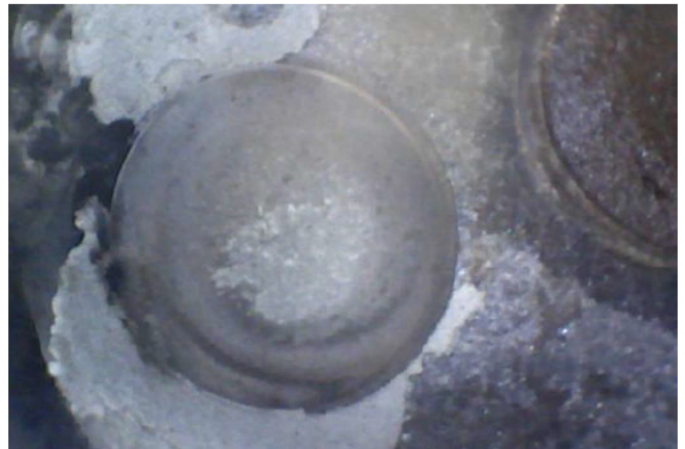
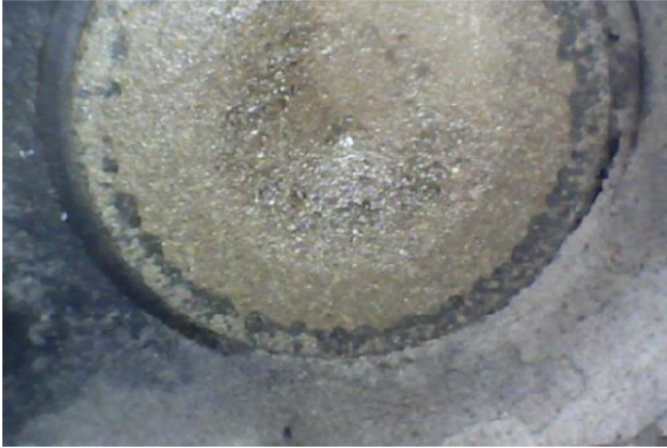
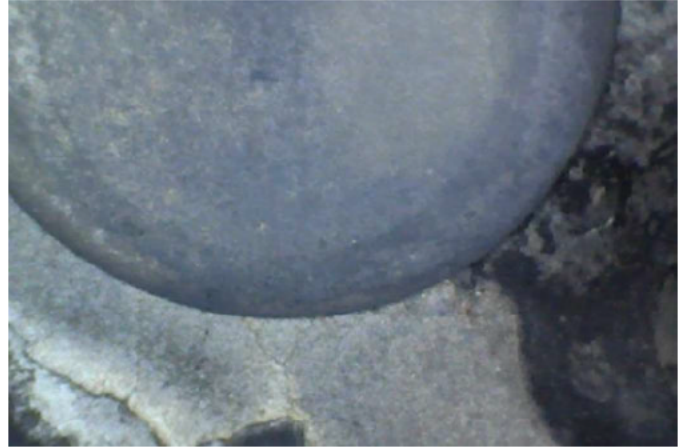
The valve heads were inspected using a lighted borescope; the inspection revealed that all of the valve heads displayed normal operating and combustion signatures. During crankshaft rotation all of the valves operated normally. There were no anomalies noted.

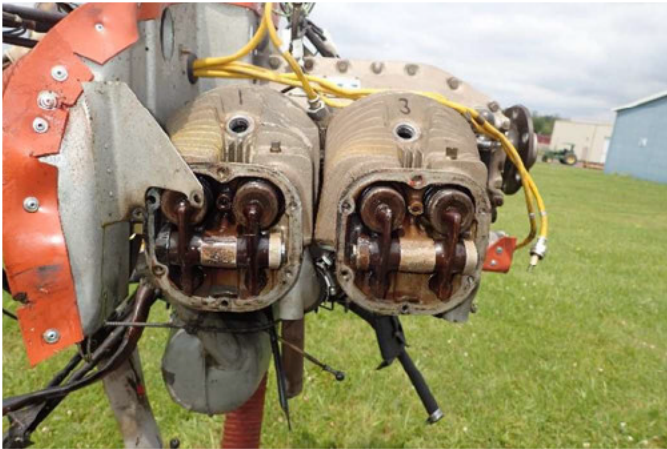
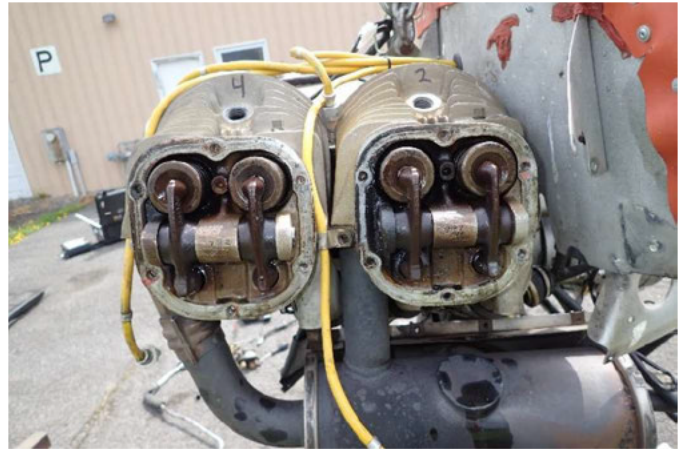
## ROCKER ARMS AND SHAFTS

All of the rocker arms remained attached to their installation points and were undamaged. The rocker arms displayed normal operating and lubrication signatures. During crankshaft rotation all of the rocker arms operated normally.

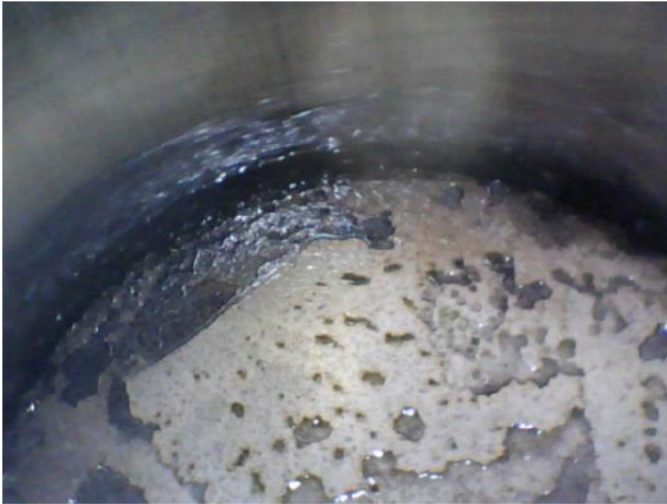
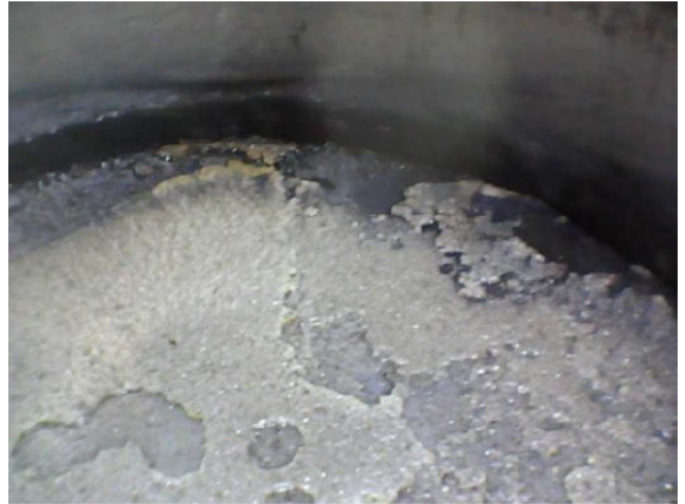
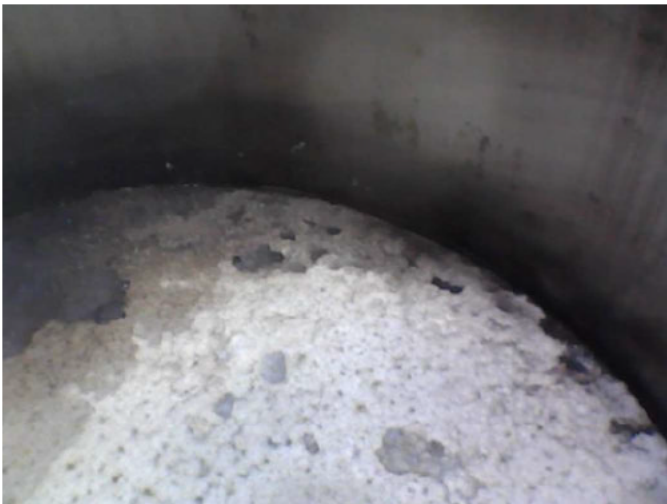
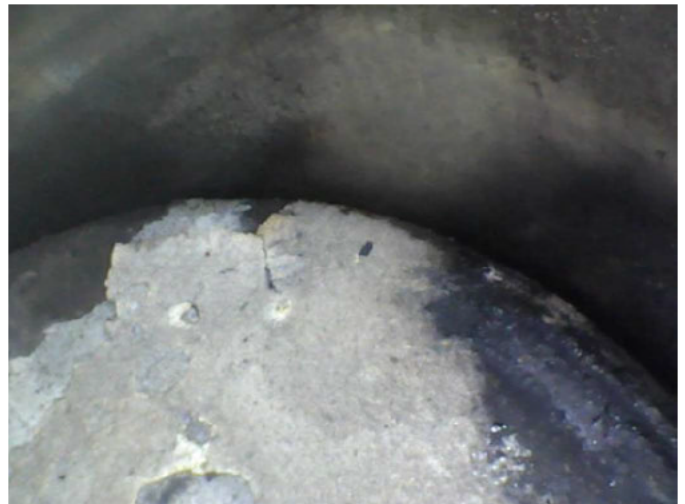
## PISTONS

All of the pistons were inspected using a lighted borescope. The piston faces displayed normal operating and combustion signatures. During crankshaft rotation all of the pistons operated normally.

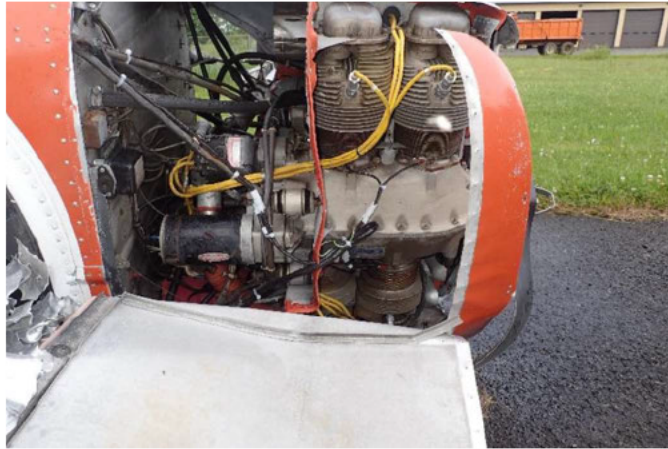
### CRANKCASE ASSEMBLY

| Condition: | The crankcase remained intact and was undamaged. There were no signs indicating a catastrophic internal engine failure. There were no anomalies noted. | | | |

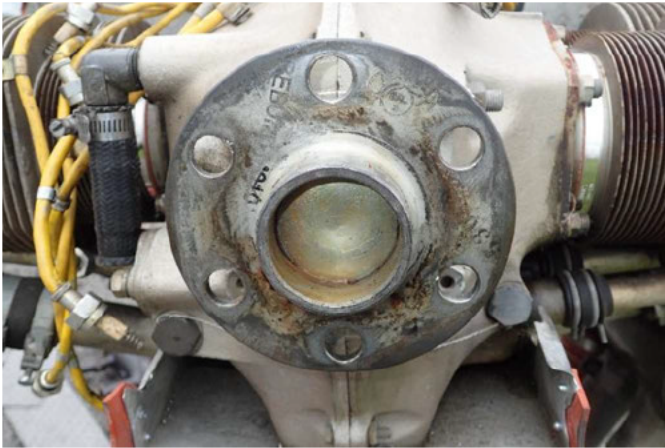
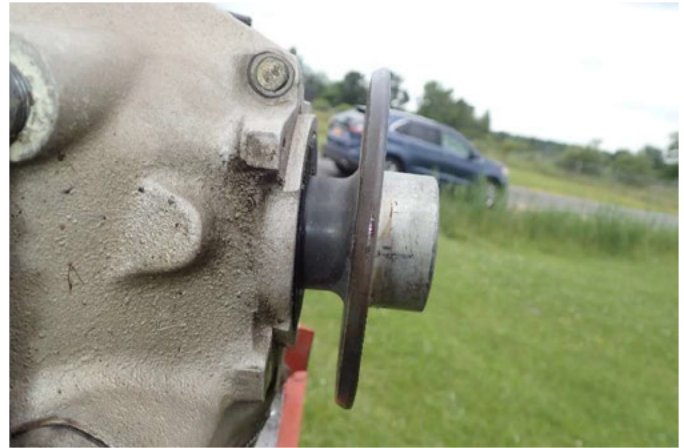
## CRANKSHAFT ASSEMBLY

| CRANKSHAFT | Forging Number:<br>Inaccessible | S/N: Not observed | Heat code: Inaccessible |
|---|---|---|---|
| Condition: | The propeller flange remained attached to the rest of the crankshaft and displayed minor impact damage in the form of bending. The crankshaft was rotated using a hand tool and continuity was established between the crankshaft, camshaft, connecting rods, and associated components. There were no anomalies noted. | | |

Note: Crankshaft propeller nuts removed to facilitate use of crankshaft turning bar

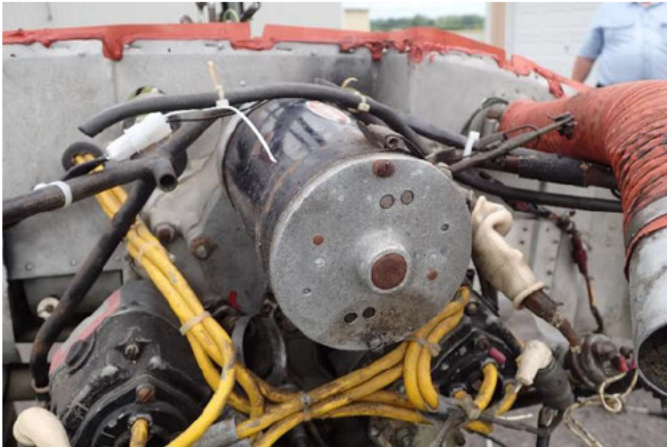
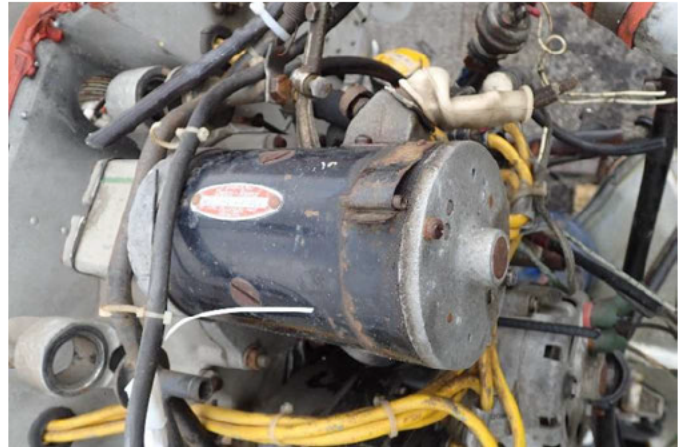
## STARTER

The starter remained attached to its installation point and was undamaged. There were no anomalies observed.

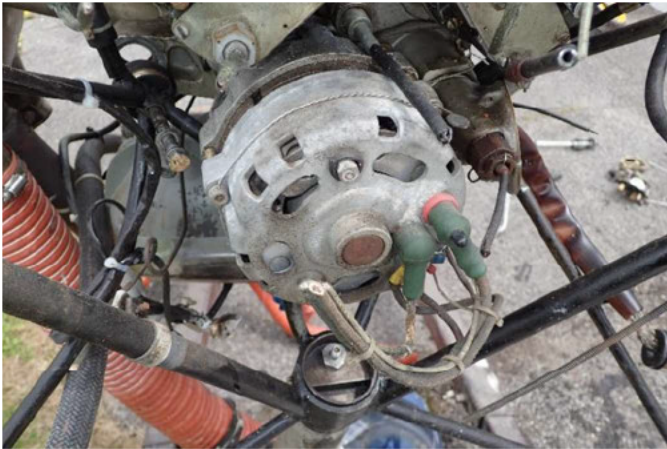
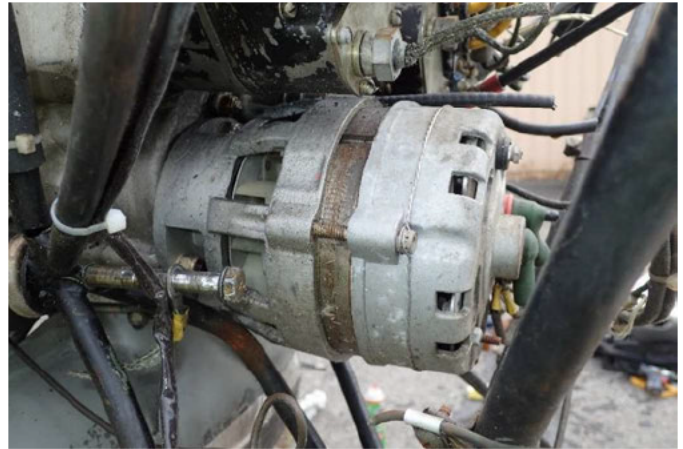
## ALTERNATOR

The alternator remained attached to its installation point and was undamaged. There were no anomalies observed.

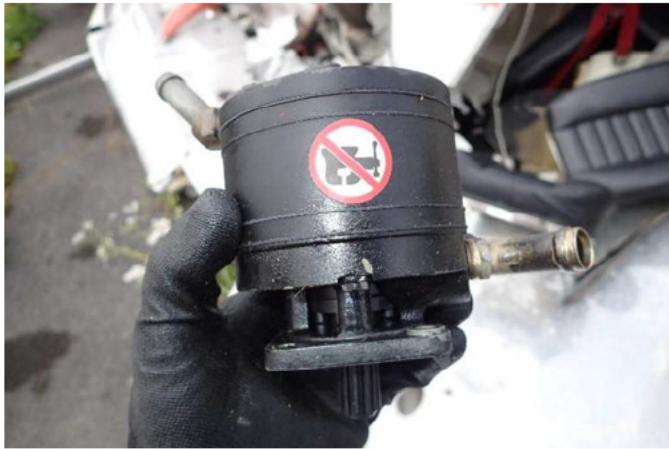
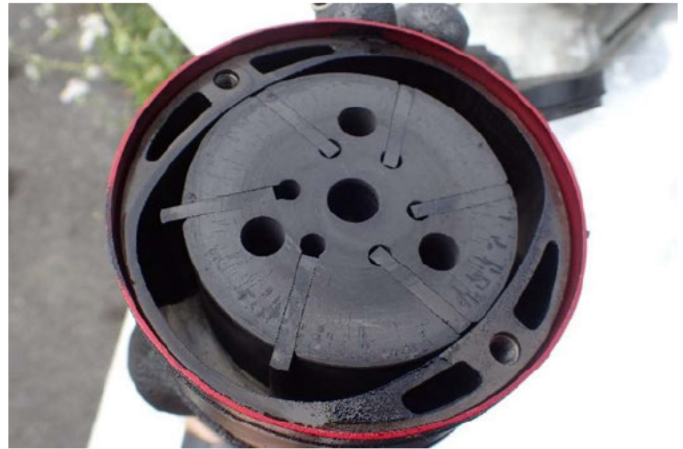
VACUUM  
PUMP

The vacuum pump remained attached to its installation point and was undamaged. The vacuum pump was removed, and it was noted that the drive coupling was intact. The vacuum pump was disassembled and the internal components displayed normal operating signatures. There were no anomalies observed.

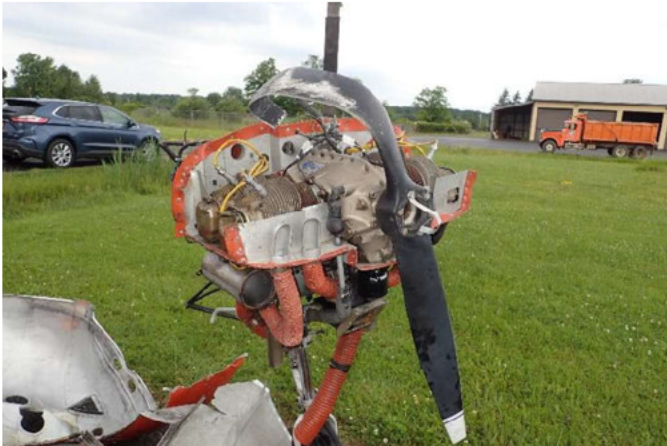
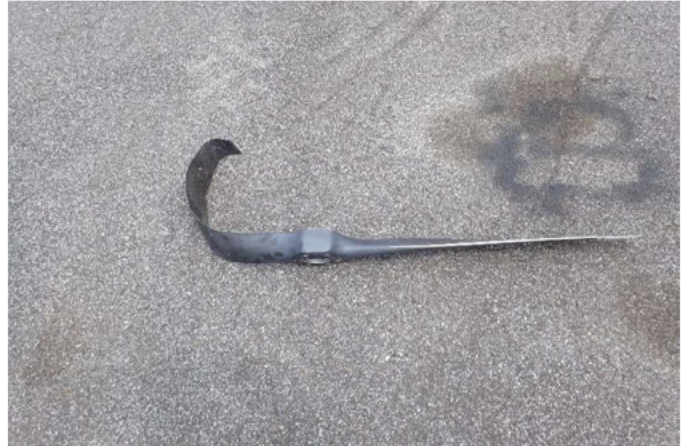
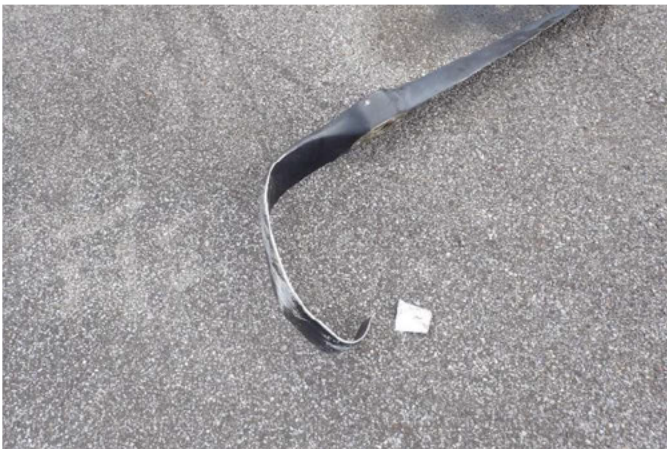
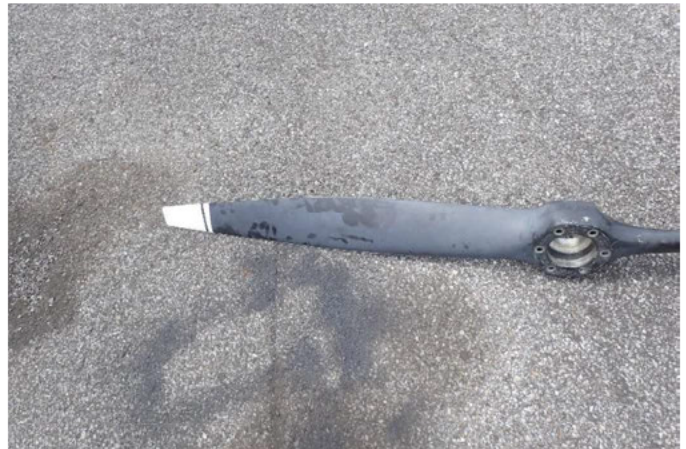
### PROPELLER

The two blade, fixed pitch propeller remained attached to the crankshaft and displayed impact damage signatures. One of the propeller blades displayed significant aft bending, some chordwise scratches, and a small portion of the blade tip had sheared from the rest of the blade. The other propeller blade was undamaged.
