# NATIONAL TRANSPORTATION SAFETY BOARD

## MATERIALS LABORATORY STUDY REPORT

Report No. 20-017

Place : Dublin, GA  
Date : April 15, 2019  
Vehicle : Bell 206, N395AE  
NTSB No. : ERA19LA152  
Investigator : Leah Read (AS-ERA)

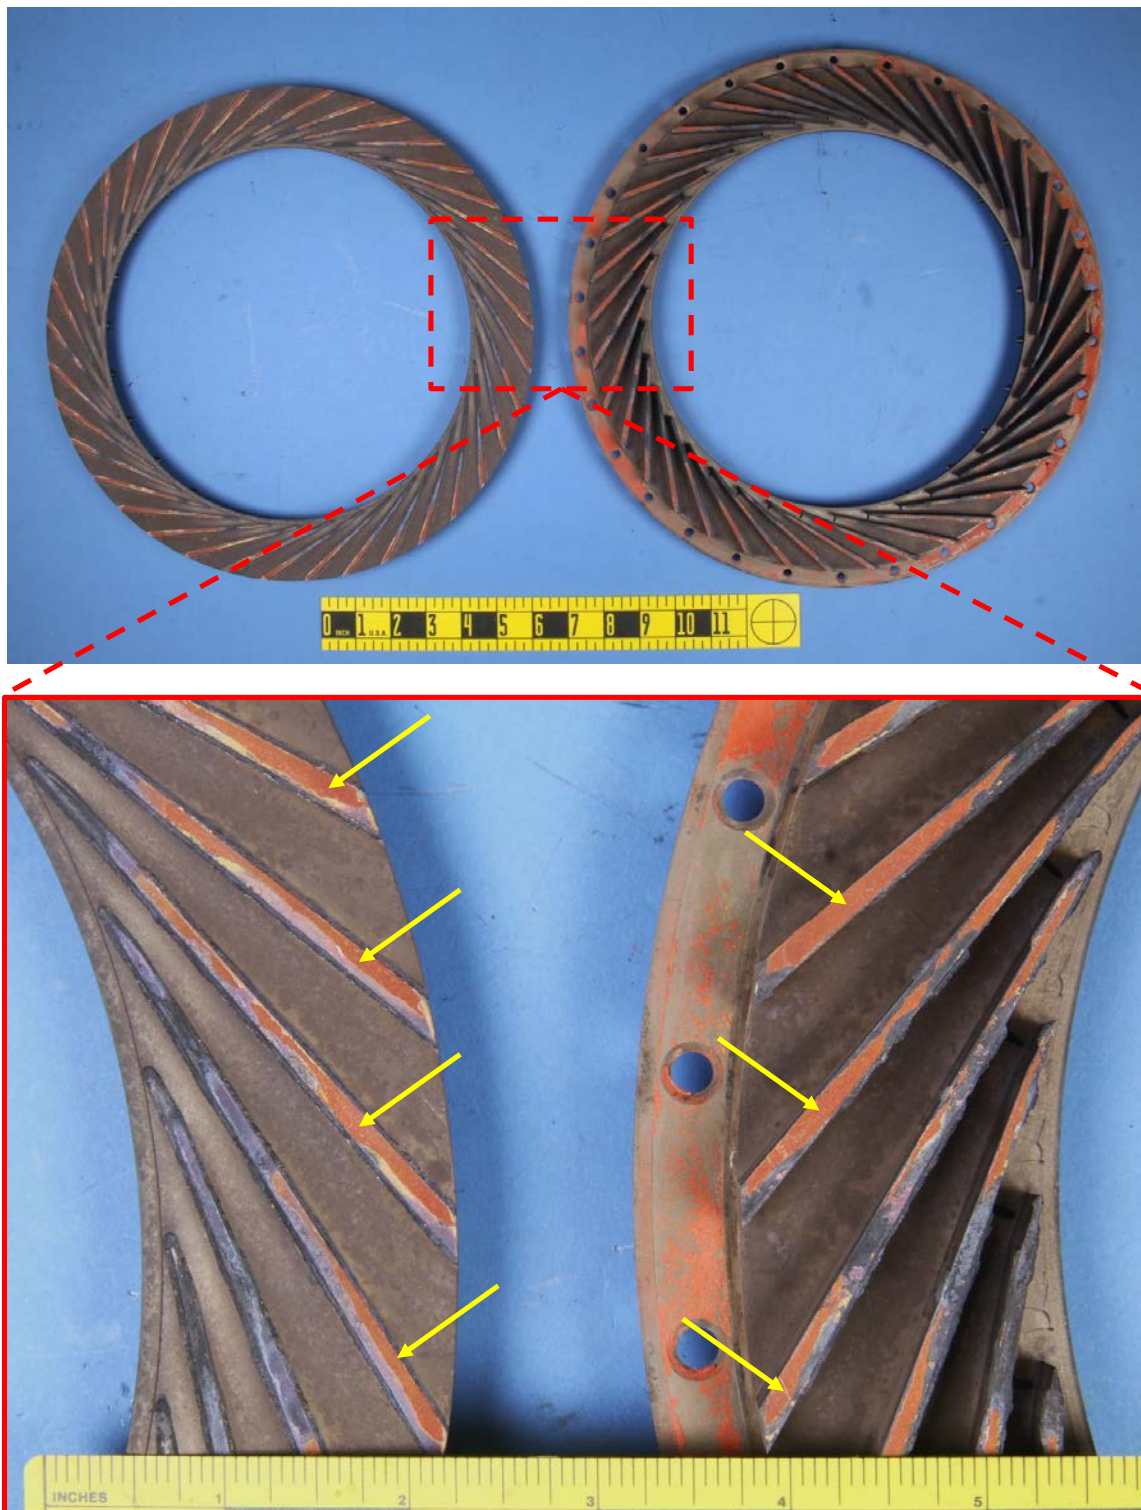
The vane assembly was submitted with the forward ring separated. The ring had separated through the braze joint at the forward interfaces of the vanes, as shown in Figure 1. The yellow arrows point to orange paint observed on the ring and the vane cross-sectional surfaces in locations where the vanes were supposed to be brazed to the ring. As shown in Figure 2, the amount of orange paint observed varied from thin strips only partially penetrating the vane width to almost the entire cross-section of the vane airfoil. Braze filler metal build-up was observed along the edges of some of the vanes (red arrows, Figure 2).

The gaps between the braze metal and the vane surfaces are consistent with incomplete filler metal wetting in the braze joint. The presence of the orange paint on the vane cross-sections indicates areas where the braze metal did not wet the base metal. The separation of the forward ring from the vane assembly was likely due to the large amount of incomplete braze joint surfaces on the vane airfoils. No manufacturer identification markings were observed on the vane assembly pieces.

**Figure 1:** Overall (top) and close-up (bottom) images of the separated mating ring (left) and vane airfoil (right) surfaces. The yellow arrows point to orange paint on the surfaces.

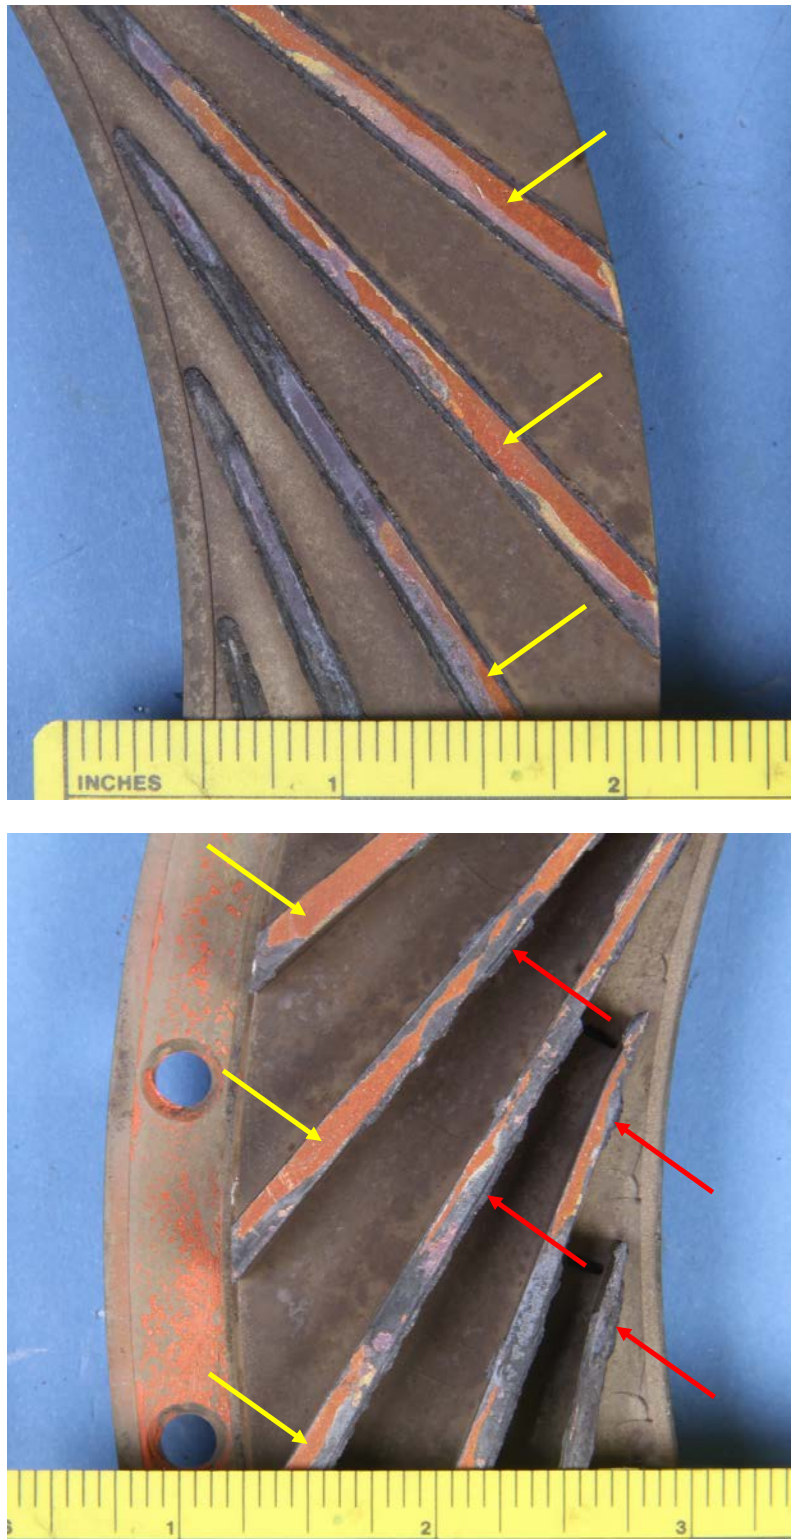
**Figure 2:** Close-up images of the separated mating ring (top) and vane airfoil (bottom) surfaces. The yellow arrows point to orange paint on the surfaces. The red arrows point to braze metal build-up on the edges of some vanes.

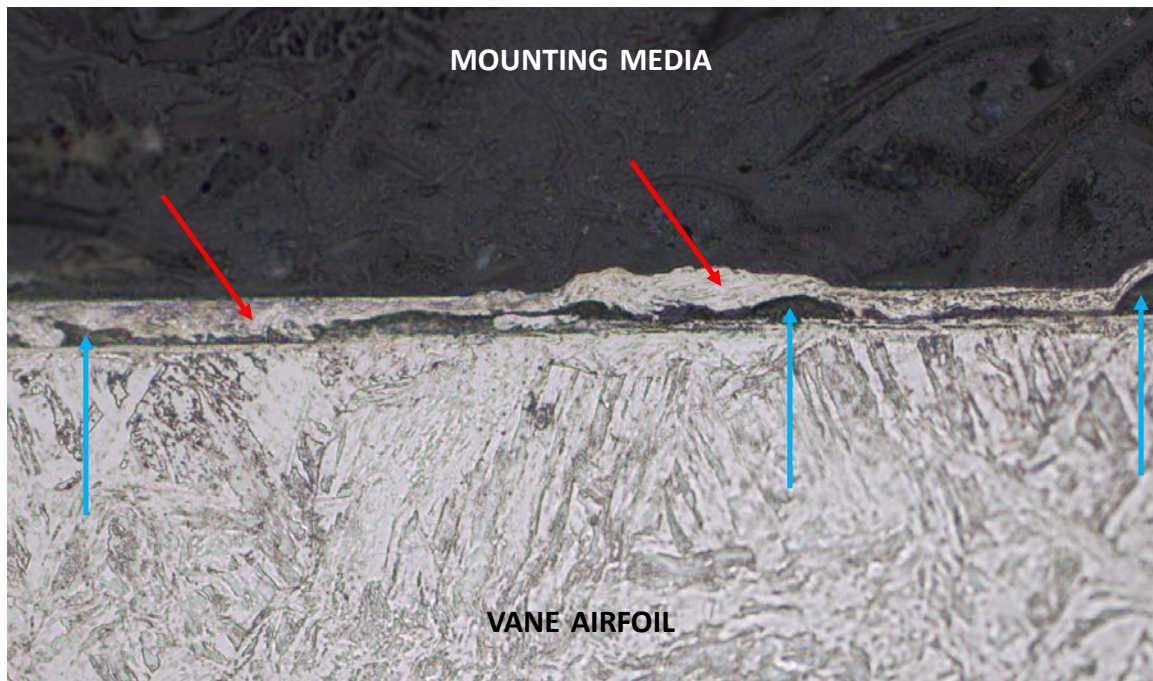
A metallurgical cross-section was prepared perpendicularly through several vane airfoils. A representative area of the forward interface on an exemplar separated airfoil is shown in Figure 3. Gaps (blue arrows) were observed at the interface between the braze metal (red arrows) and the airfoil surface.

**Figure 3:** Brightfield metallographic image of a representative area of the forward interface on an exemplar separated airfoil. The red arrows point to braze filler metal on the airfoil surface. The blue arrows point to gaps at the interface between the braze filler metal and the airfoil surface. (Etchant: Kalling's Reagent)
