# NATIONAL TRANSPORTATION SAFETY BOARD

## MATERIALS LABORATORY FACTUAL REPORT

Report No. 19-077

Place : Newport News, Virginia  
Date : May 9, 2019  
Vehicle : Hawker Siddeley Hunter MK58; N343AX  
NTSB No. : ERA19LA169  
Investigator : Eric Alleyne, AS-ERA

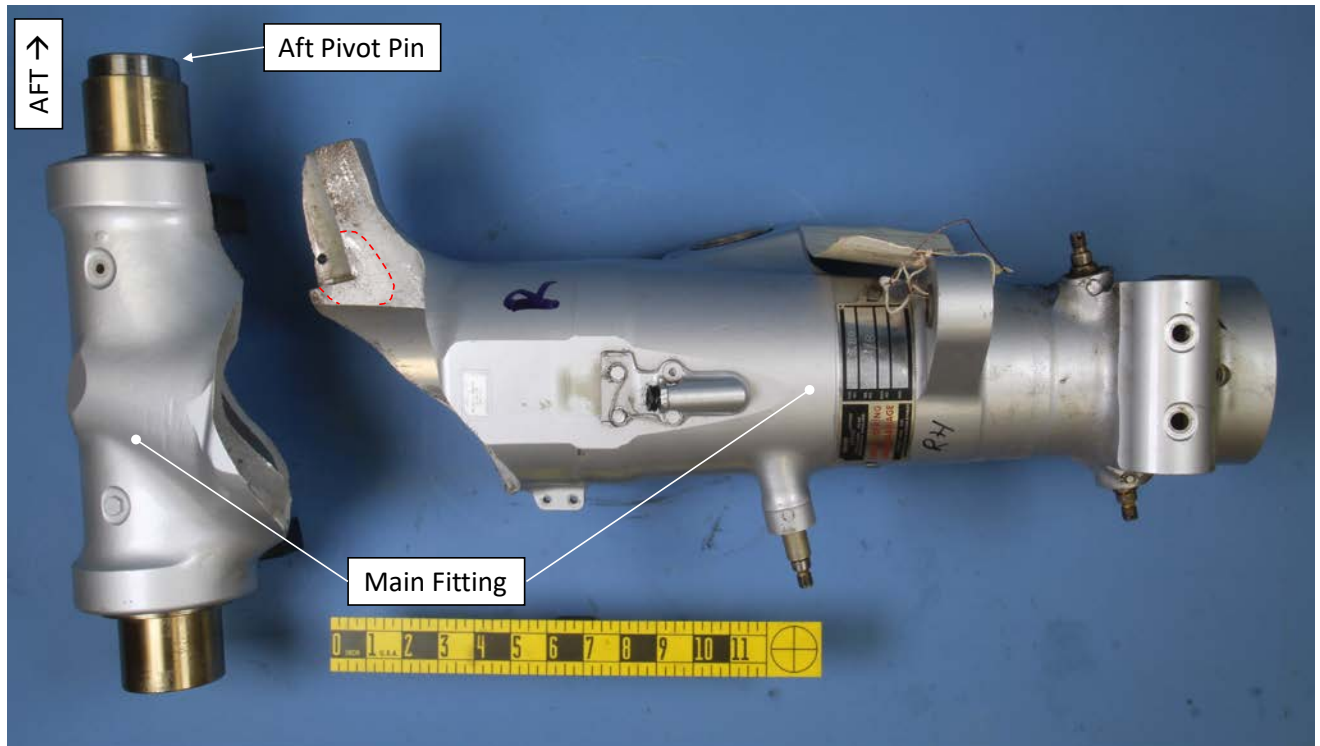
Figure 1 shows the main fitting of the right main landing gear upper trunnion strut, as received with some additional hardware installed including two press-fit 2.25 inch diameter steel pivot pins, one of two retaining bolts for securing the pivot pins, and two bronze flanged bushings with spacers on the pivot pins. The main fitting component, an aluminum alloy forging, fractured into two pieces through the aft pivot pin bore and strut bores. Both pivot pins were retained within the smaller fragment. The aft pivot pin within the fractured bore was dislodged approximately 0.5-0.6 inches axially aft as evidenced by axial scratches on the pin and bore surfaces, misaligned holes for the absent retaining bolt, as well as a deposit of yellow squeeze-out from a faying surface sealant applied between the main fitting bore and pivot pin which indicated the forward-most location of the edge of the pivot pin prior to being dislodged.

Figure 1a: Overall view of the right main landing gear as-received. The component fractured through the aft pivot pin bore of the trunnion and around the strut bore. Both pivot pins were retained in the fitting, however the aft pivot pin was dislodged approximately 0.6 inches. Bronze bushings were still installed over the pivot pins. One of the pre-existing thumbnail crack features (pre-existing crack 1) visible in this view is highlighted by the red dashed line.

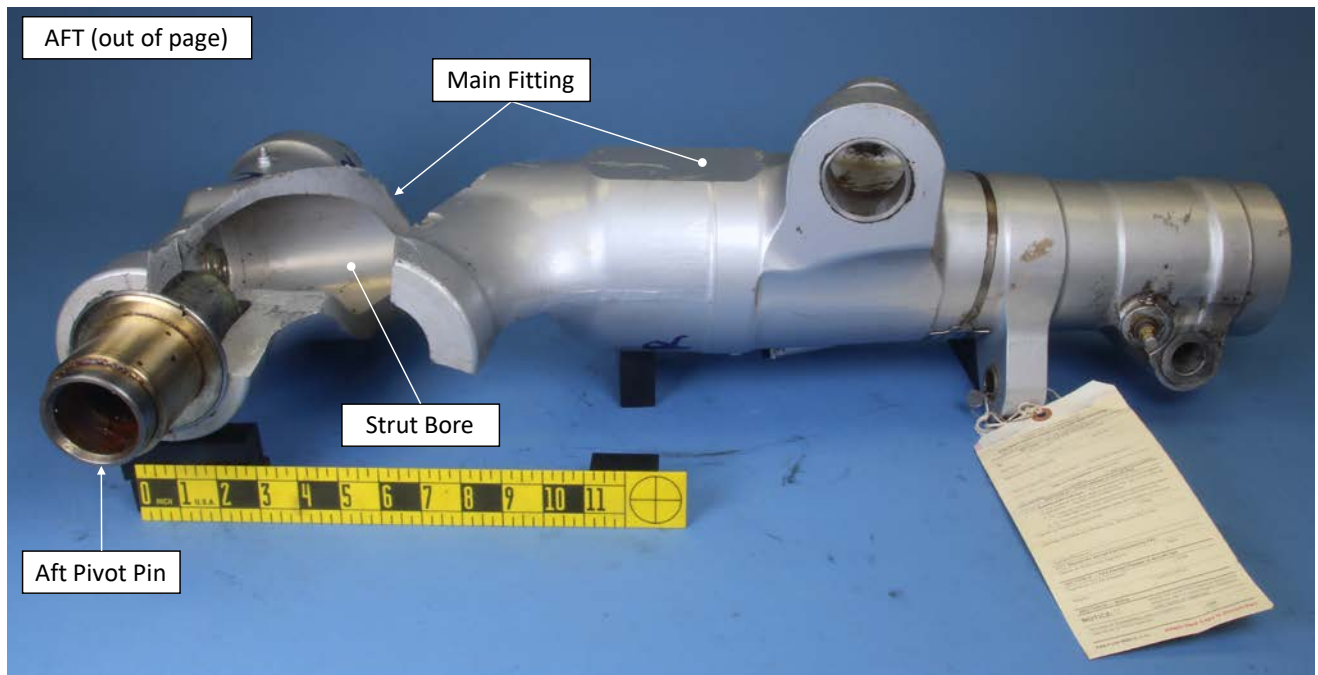
Figure 1b: Forward-Aft view of the fractured right main landing gear as-received. The component fractured through the aft pivot pin bore of the trunnion and around the strut bore. Both pivot pins were retained in the fitting, however the aft pivot pin was dislodged approximately 0.6 inches. Bronze bushings were still installed over the pivot pins. The pre-existing thumbnail crack features are not easily distinguishable from this perspective.

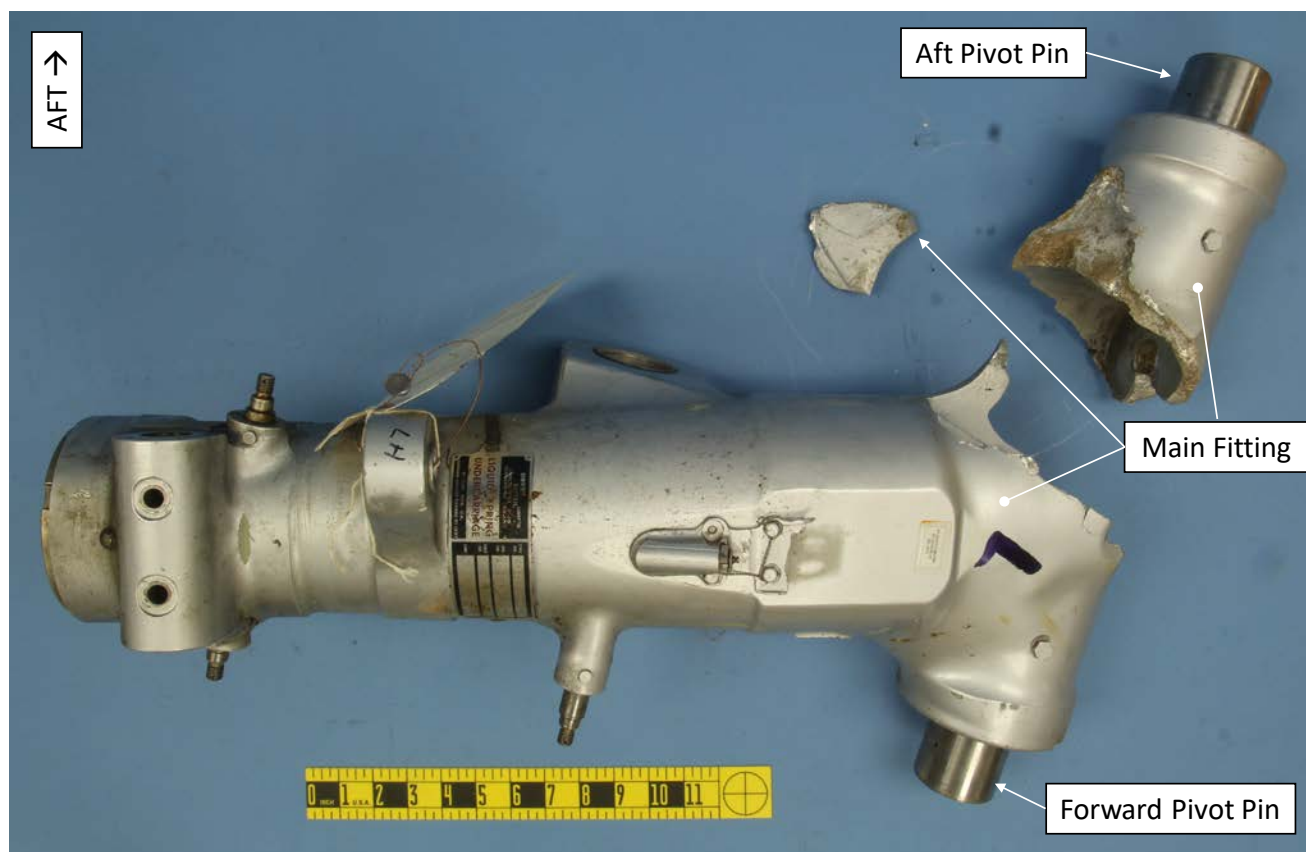
Figure 2 shows the similar left main landing gear, as received, with pivot pins still installed. The left main fitting fractured into two fragments through the top of the strut bore between the pivot pins, with the aft pivot pin retained in the smaller fragment and the forward pivot pin retained in the larger fragment. A small third fragment from the free surface near the strut-to-trunnion radius was also recovered that exhibited evidence of plastic deformation. A single bronze flanged bushing labeled "LH" as shown in figure 2c was submitted with the components and showed evidence of ductile fracture from a notch feature at the edge of the flange which continued into the sleeve through a hole feature and finally arrested at another elongated hole feature approximately 0.75 inches from the base of the flange.

Figure 2a: Overall view of the left main landing gear as-received. The component fractured through the top of the strut bore between the pivot pins, with the aft pivot pin retained in the smaller fragment and the forward pivot pin retained in the larger fragment. Both pivot pins were retained in the fitting and neither appeared to show evidence of being dislodged. A smaller third fragment was recovered and fits the profile of the outer part surface near the strut-to-trunnion run out radius and forging seam. There were no observed pre-existing crack features observed and the fracture surface exhibited dull, rough ridge features, plastic deformation, and shear lip features over majority of the surface.

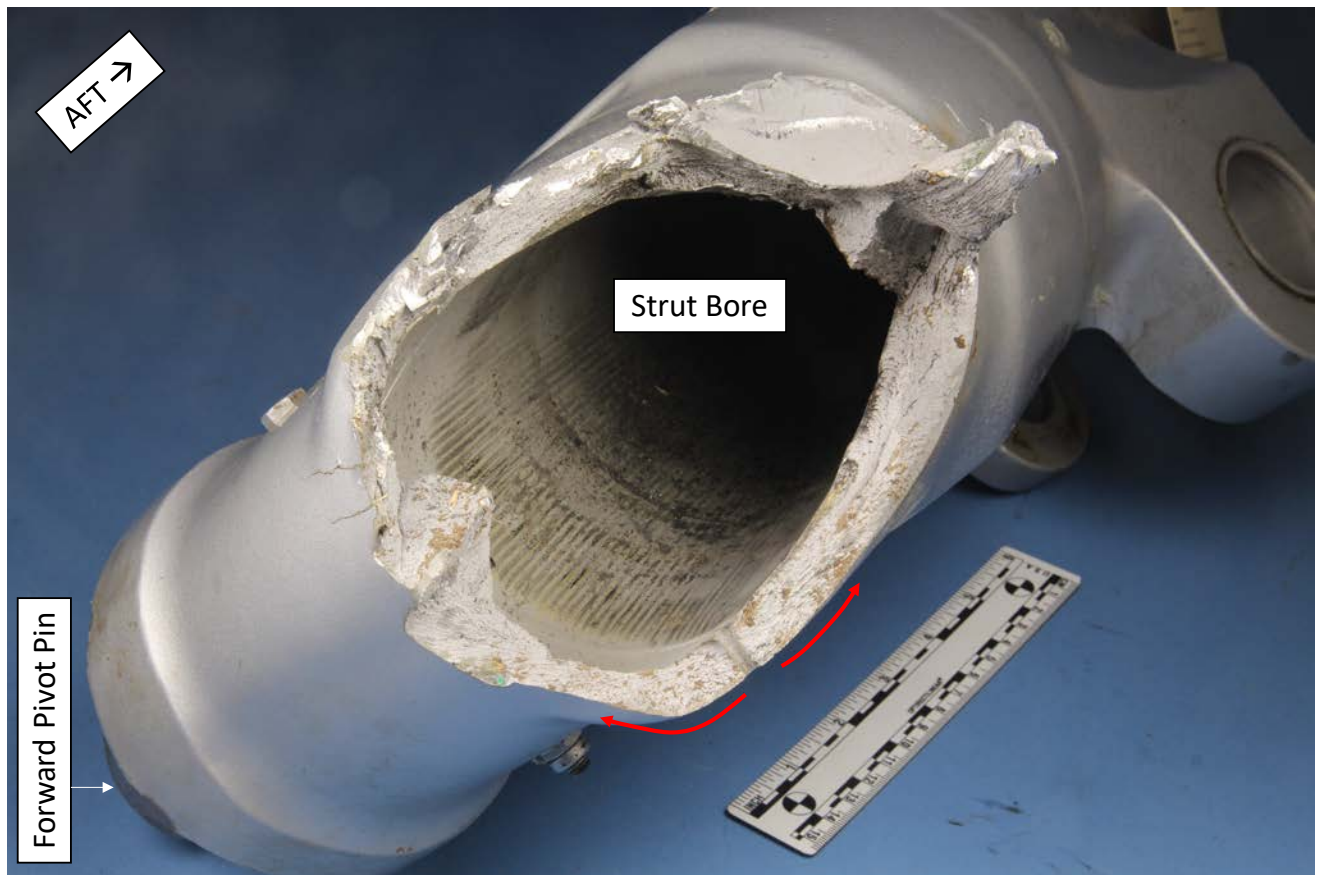
On the left main landing gear component, the fracture surface was rough and exhibited many tear ridges and shear lip features consistent with fracture due to tensile/bending overstress. Pre-existing crack features were not observed.

Figure 2b: View of the left main landing gear fracture surface looking down the strut bore. Dull, rough ridges, chevron marks, and shear lip features observed are consistent with tensile/bending overstress. Red arrows indicate crack propagation direction where evident.

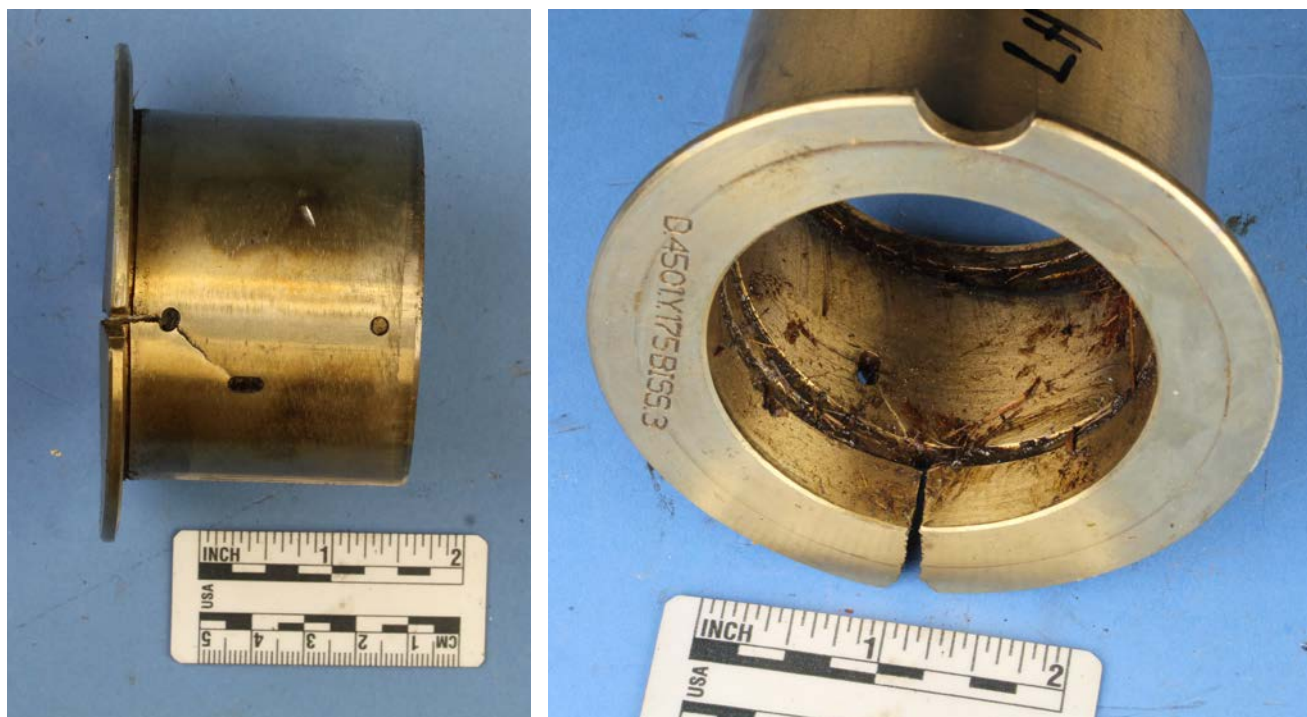
Figure 2c: Photograph of a fractured bronze bushing received with the left main landing gear. The bushing was separate from the landing gear component as-received. The crack began at a notch feature in the flange of the bushing and arrested at an elongated hole feature in the sleeve of the bushing. Plastic deformation of the flange and sleeve is apparent.

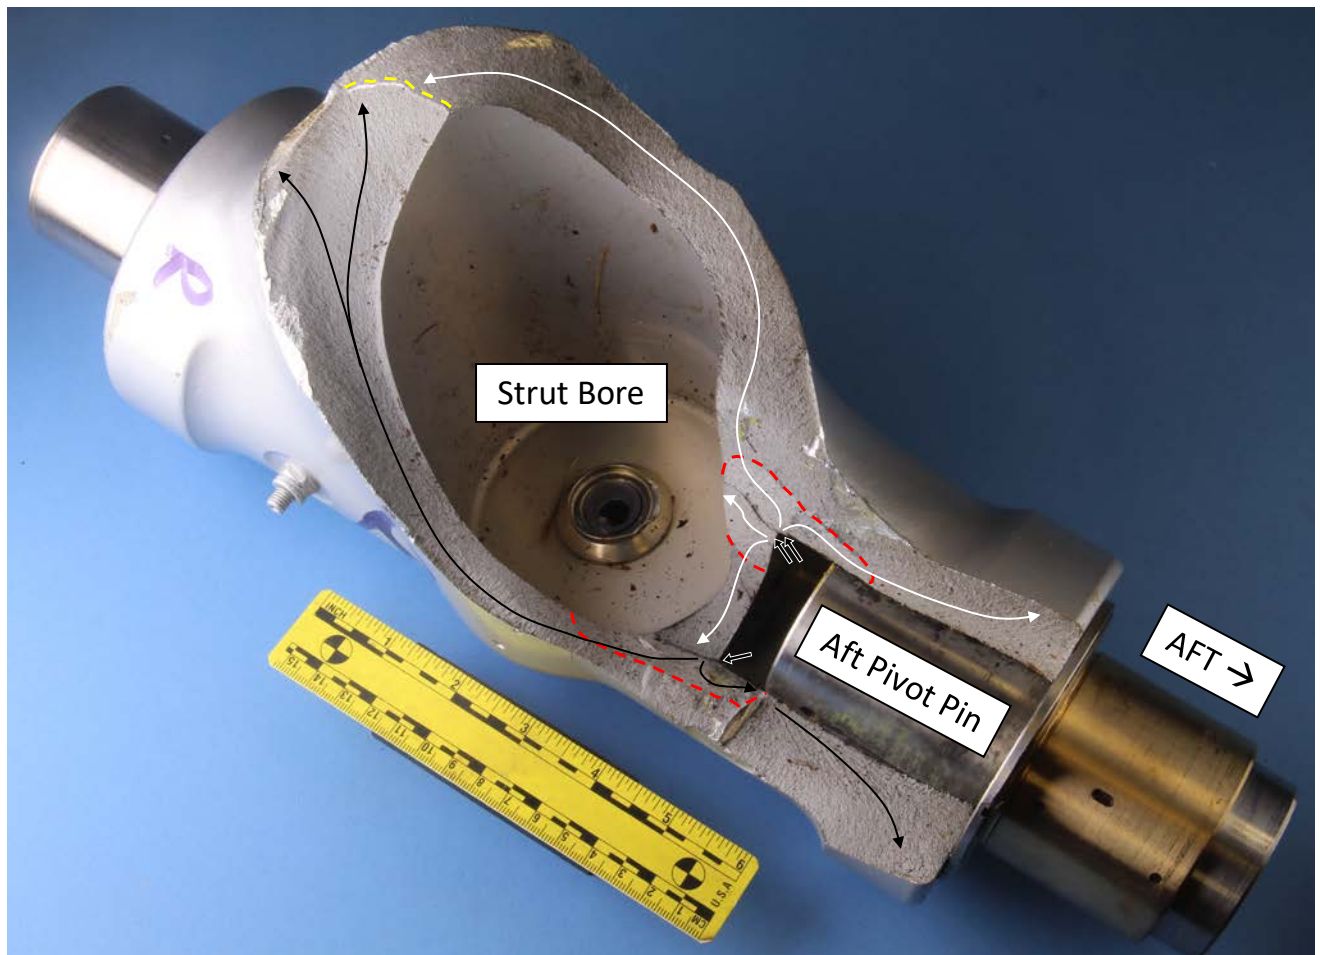
Local post-accident impact damage to the fracture surface of the larger main fitting fragment obscured the pre-existing crack origins so the mating smaller fragment was used for further fractographic evaluation. Figure 4 shows the fracture surface of the smaller fragment of the right main fitting and shows the pre-existing thumbnail crack features with the general direction of crack propagation. The larger of the two pre-existing thumbnail cracks was located on the bottom/inboard (extended/retracted landing gear position respectively) area of the pivot pin bore and progressed along an approximate plane formed by the strut and pivot pin axes. This feature is referred to as "pre-existing crack 1" for the remainder of this report. The smaller of the two thumbnail features was located on the outboard/bottom (extended/retracted landing gear position respectively) area of the pivot pin bore, approximately 90° around the bore in the outboard direction relative to pre-existing crack 1, and progressed approximately normal to the plane formed by the strut and pivot pin axes. This feature is referred to as "pre-existing crack 2" for the remainder of this report. From both pre-existing crack boundaries, fast fracture due to overstress continued to propagate aft along the pivot pin bore to the free edges of the part and forward around both sides of the strut bore with final separation where crack 2 met crack 1 approximately 180° around strut bore, slightly inboard/upward (extended/retracted landing gear position respectively), relative to the origins at the aft pivot pin bore. Shear lips were observed in this area on the free edges of the part. Small shear lips are present along strut outer diameter and inner diameter in the overstress region. Shear lip size increases closer to termination of the overstress region.

Figure 4: Fracture surface of the smaller fragment of the right main fitting containing the trunnion area. The red dashed lines show the approximate boundaries of the pre-existing cracks. Pre-existing crack 1 is oriented above the aft pivot pin in this photo and has white arrows emanating from the origin. Pre-existing crack 2 is oriented below the aft pivot pin in this photo and has black arrows emanating from the origin. These arrows show the direction of propagation. The unlabeled black arrows outlined in white indicate approximate locations of the pre-existing crack origins.

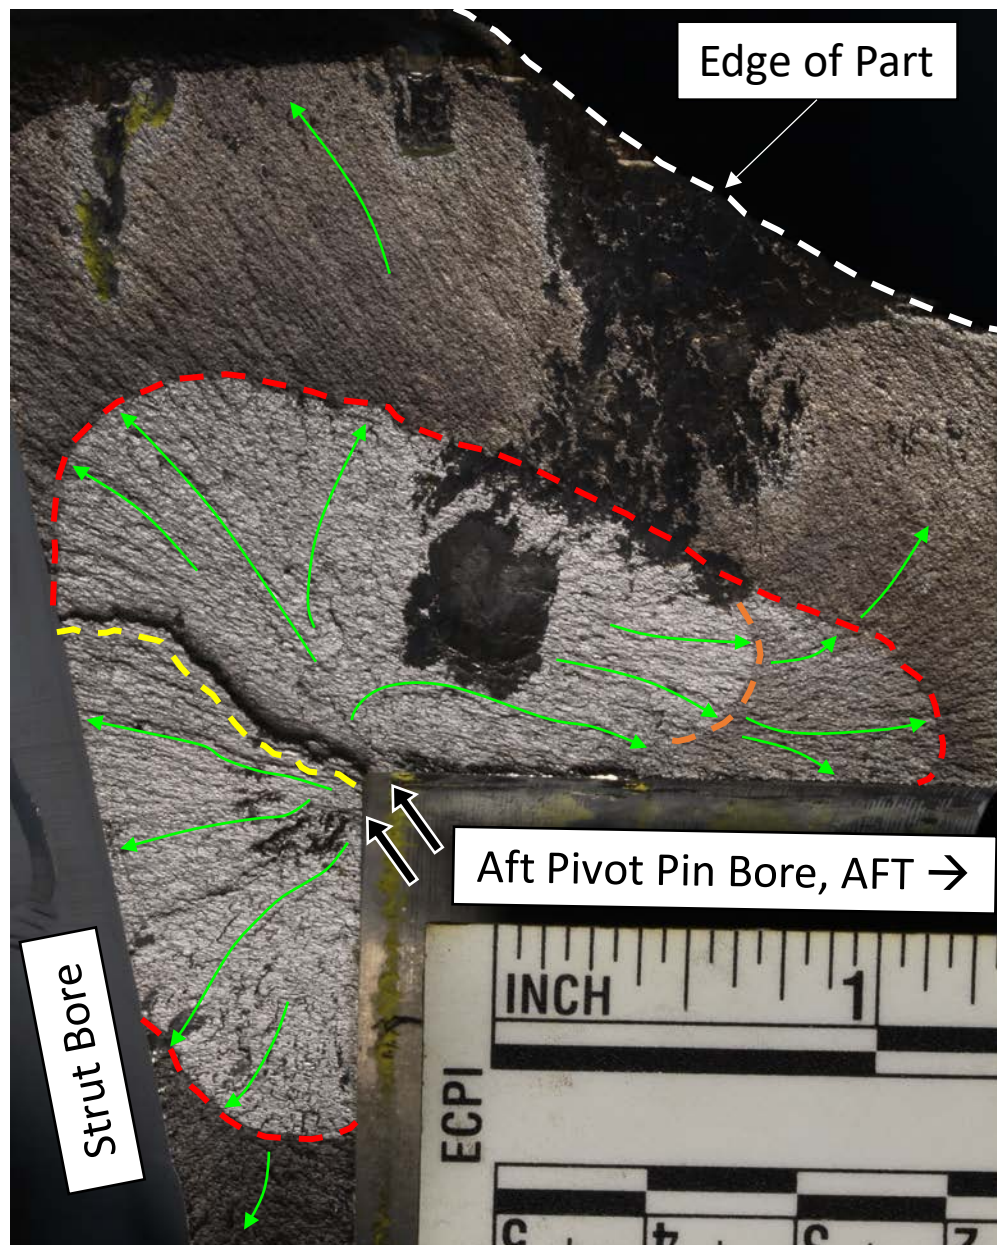
Figure 5 shows an annotated closer view of pre-existing crack 1 from a section excised from the smaller right main fitting fragment using wet abrasive cut-off wheel machines. The excised sample was ultrasonic cleaned using acetone. Pre-existing crack feature 1 exhibited a flat, bright sparkly gray, and somewhat granular surface appearance. Fracture ridges and radial features appeared to emanate from origins near the pivot pin bore corner radius. Pre-existing crack 1 exhibited multiple origins with at least one at the main fitting bore base and another on the sidewall, both near the shared corner radius. A feature similar to a fatigue crack ratchet mark between these origins spanned the ligament between the corner radius of the pivot pin bore and the sidewall surface of the strut bore. The pre-existing crack measured approximately 1.4 inches along the pivot pin bore sidewall, 1.0 inches maximum depth from the sidewall, 0.9 inches along the pivot pin bore base, 0.8 inches maximum depth from the base, and a maximum depth of approximately 1.1 inch from the pivot pin bore corner radius into the main fitting. A crack arrest line or

beach mark, as highlighted in figure 5, was observed from approximately 0.5 – 1.0 inch along sidewall where the crack front progressed aft along the pivot pin bore sidewall. A topographical difference was demarcated at this feature, as the thumbnail appearance is slightly darker and rougher after the beach mark as compared to the preceding crack morphology. Outside of pre-existing crack 1, the fracture surface topography was dull, rough, and exhibited chevron mark features consistent with fast fracture due to overstress.

Figure 5: A closer photograph of pre-existing crack location 1 using oblique lighting to highlight fracture features. The red dotted line indicates the visible boundary of the pre-existing progressive crack feature. The bold black arrows outlined in white indicate the approximate location of the crack origins. The green arrows highlight the approximate direction of crack propagation. The yellow dotted line highlights a ratchet mark feature. The orange dotted line indicates a beach mark feature and a topographical demarcation in the pre-existing crack front.

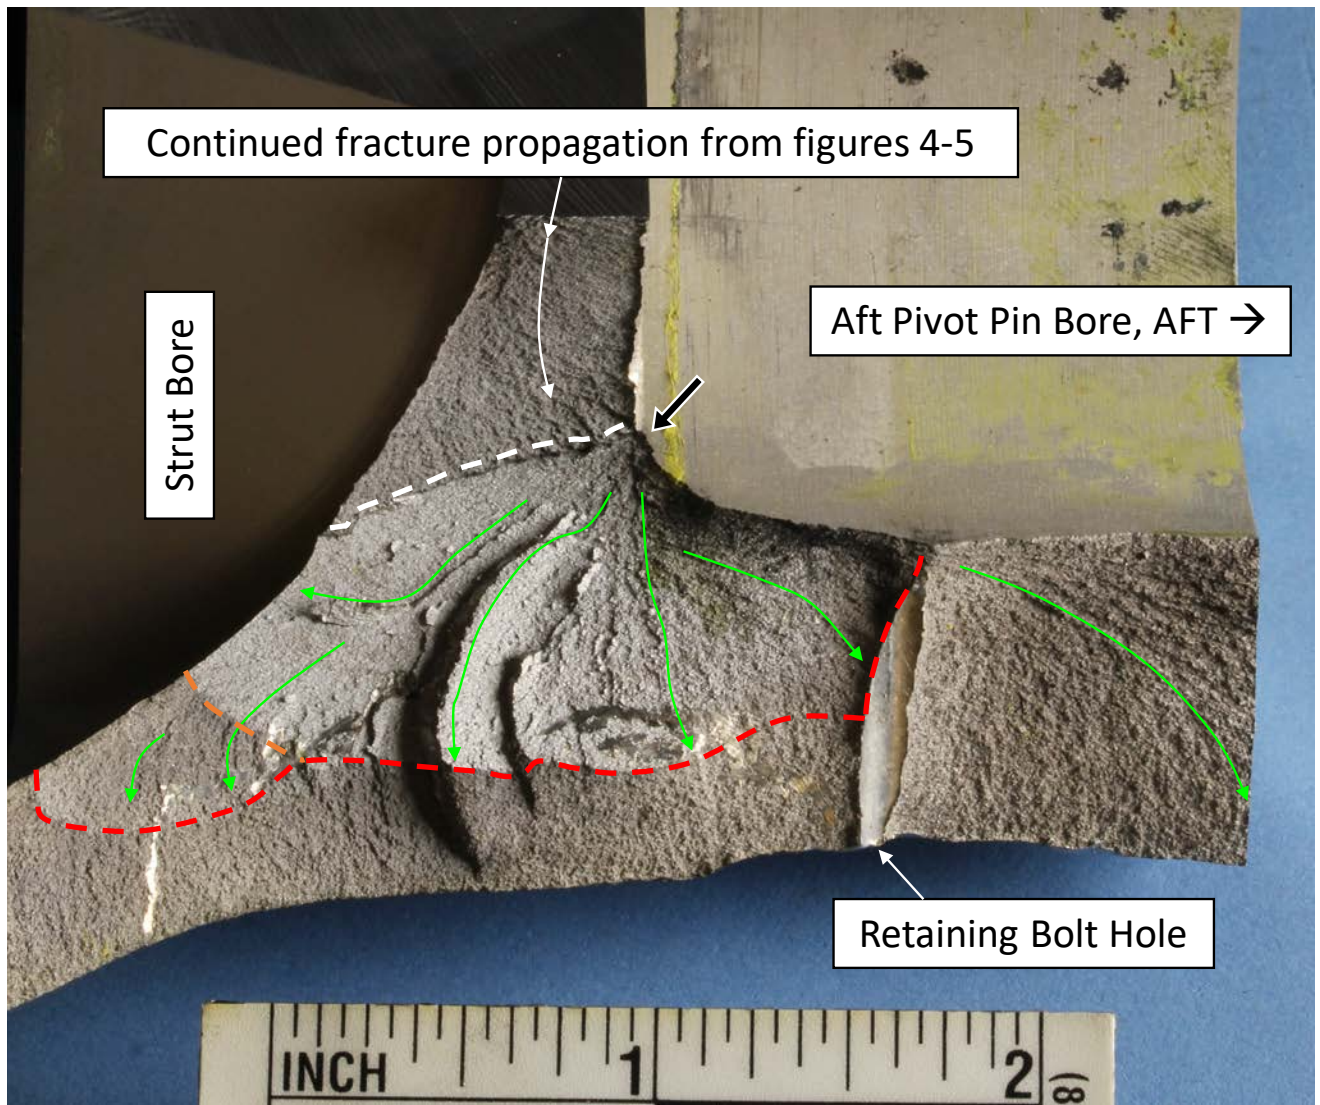
Figure 6 shows an annotated closer view of pre-existing crack 2 from a section excised from the smaller right main fitting fragment using wet abrasive cut-off wheel machines. The excised sample was ultrasonic cleaned using acetone. Pre-existing crack feature 2 exhibited a similar flat and bright gray appearance to pre-existing feature 1 although with slightly less granular texture. Outside of this feature, topography was dull and rough, consistent with fast fracture due to overstress. Several fracture ridges and radial features emanated from what appears to be a single origin point at the corner radius of the pivot pin bore base. The bright gray pre-existing crack measured approximately 1.7 inches wide by 0.9 inches in depth relative to the origin at its largest point. The crack front progressed from the corner radius of the pivot pin bore base towards the free outer surface of the main fitting. The pre-existing crack front never reached the outer surface of the main fitting but did arrest along the surface of the interior strut bore at depths of approximately 0.9 inches and 1.4 inches from the origin. Two visible crack arrest features or beach marks demarcating a slightly darker gray topography (still noticeably brighter than subsequent fast fracture region) were observed extending the crack along the strut bore surface another 0.2 and 0.3 inches, respectively. Secondary cracks parallel to the fracture surface were observed on the adjacent pivot pin bore corner radius and top surface of the strut bore.

Figure 6: A closer photograph of pre-existing crack location 2 using oblique lighting to highlight fracture features. The red dotted line indicates the visible boundary of the pre-existing progressive crack feature. The bold black arrows outlined in white indicate the approximate location of the crack origins. The green arrows highlight the approximate direction of crack propagation. The orange dotted line indicates a beach mark feature and a topographical demarcation in the pre-existing crack front. The white arrow and dotted line highlight the direction and termination of the fracture originating from pre-existing crack 1.

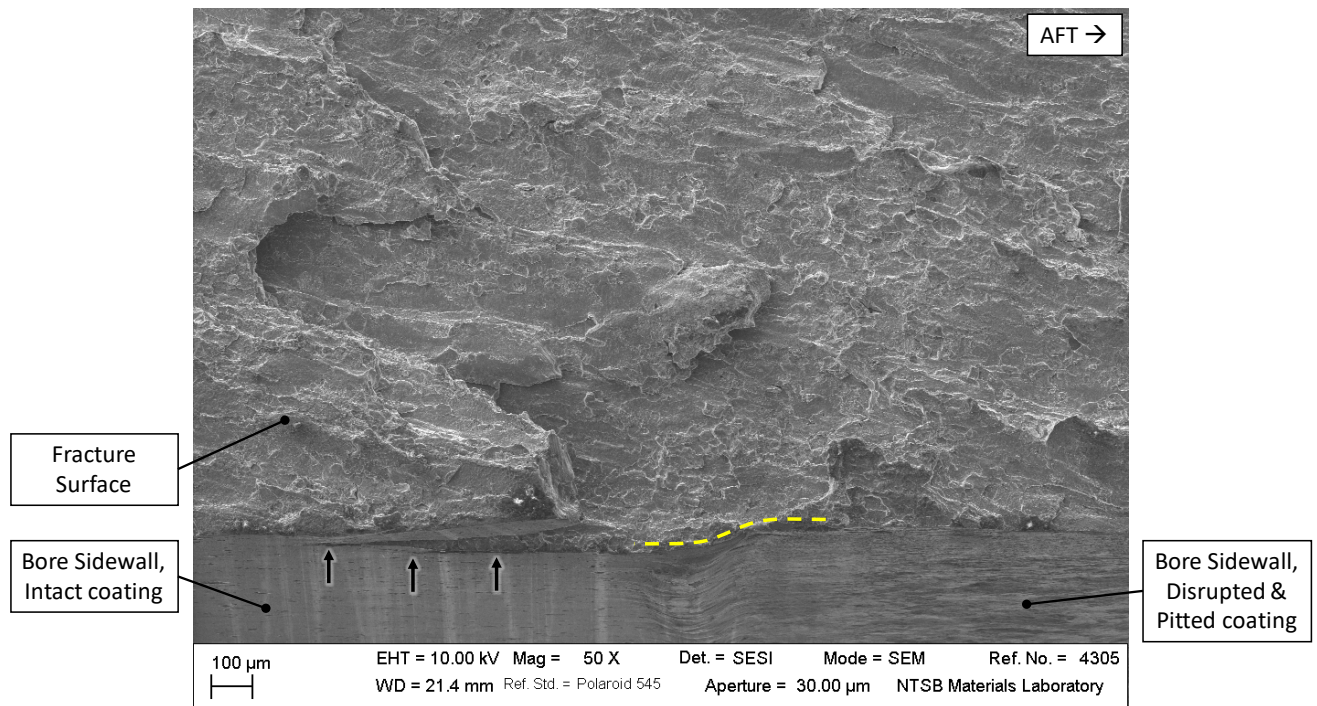
The fracture surfaces of the cleaned specimens were examined using a Zeiss Auriga field emission scanning electron microscope (SEM). The micrograph shown in Figure 7 was taken near an origin of pre-existing crack 1 at the pivot pin bore sidewall. Topography was relatively flat and consisted primarily of planar features. Intergranular features were observed within the pre-existing crack boundaries especially near the origins as viewed in figure 8. Outside of the pre-existing crack front, the topography was less planar and exhibited equiaxed dimple features consistent with tensile overstress. Micrographs shown in figures 9 and 10 were taken at the pre-existing crack border and show a transition from planar/intergranular fracture to a dimpled fracture consistent with tensile overstress. Although crack arrest features were visually observed within the pre-existing cracks, no evidence of fatigue striations were observed at higher magnification during SEM examination.

Figure 7: A scanning electron micrograph of the pre-existing crack 1 fracture surface at the pivot pin bore sidewall. Fracture topography was relatively flat and consisted primarily of planar features. The jog of locally deformed pivot pin bore sidewall surface highlighted with the yellow dashed line corresponded with the location of the inserted edge of the pivot pin prior to being dislodged. To the right of the jog was disrupted anodic coating and local pitting corrosion of the sidewall. To the left of the jog were secondary cracks in the sidewall oriented parallel to the fracture surface as indicated by the unlabeled arrows.

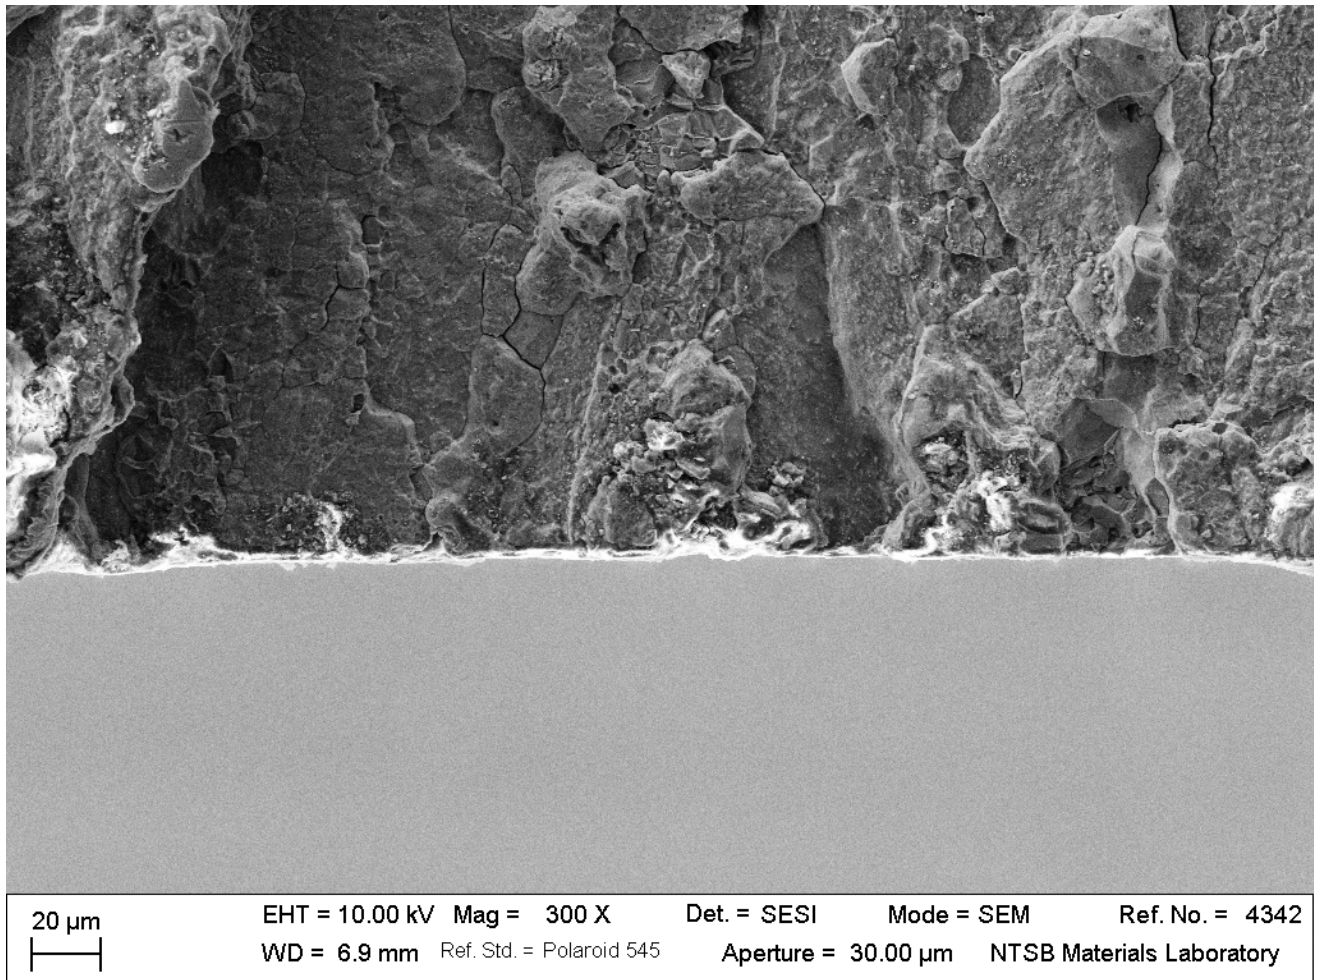
Figure 8: A higher magnification scanning electron micrograph of pre-existing crack 1 fracture surface near origin showed intergranular fracture features.

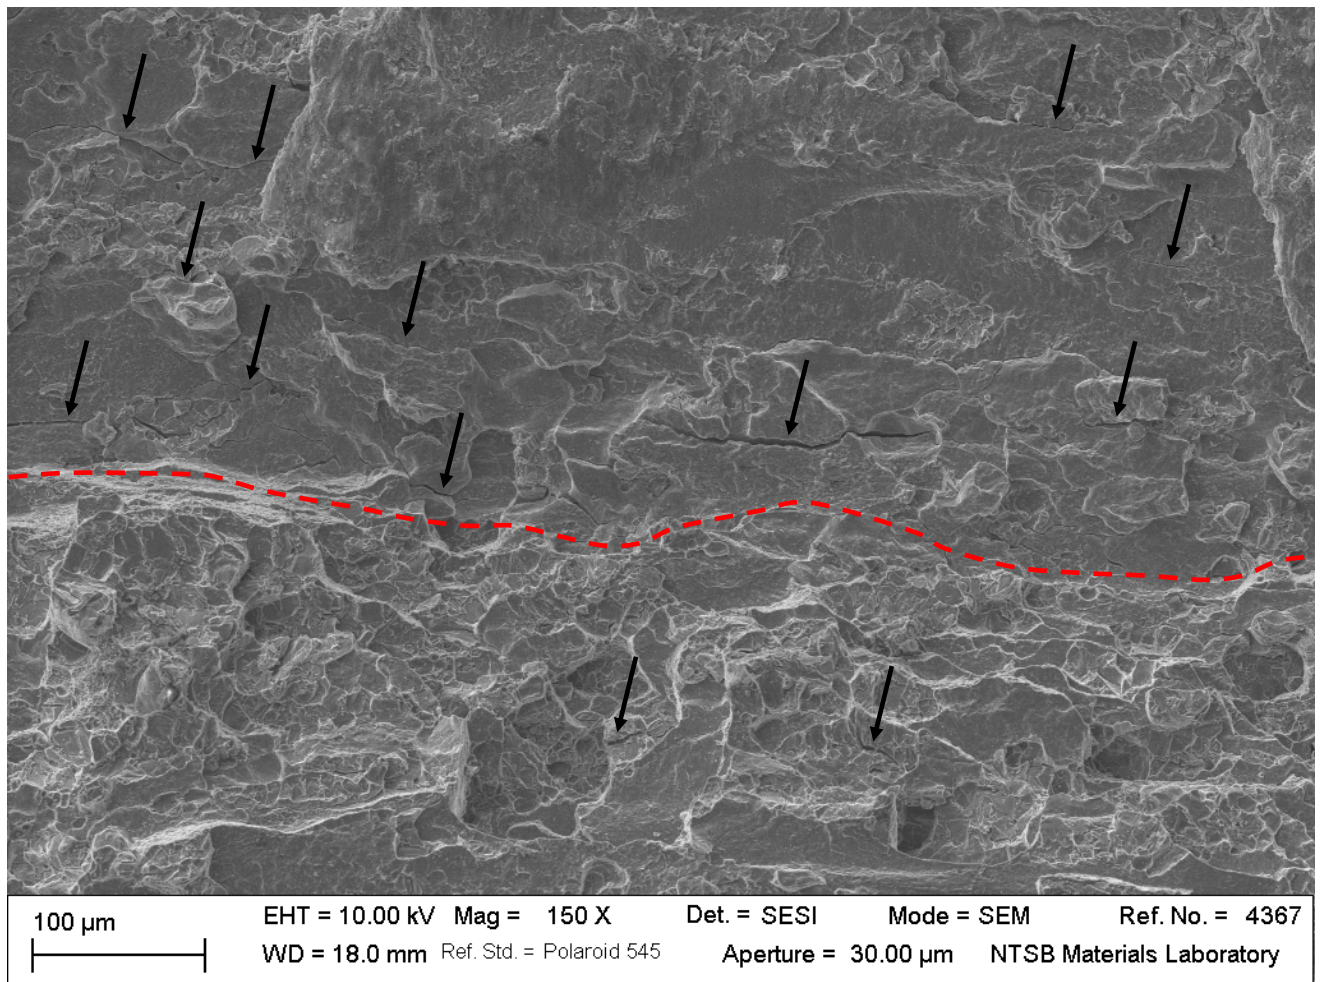
Figure 9: Scanning electron micrograph of the pre-existing crack boundary demarcated by a red dashed line. Above this line was inside of the crack front and below this line was outside of the crack front. Secondary cracks consistent with intergranular branched cracking were observed as identified by unlabeled arrows. Immediately outside of the crack front showed significantly less secondary cracking and more evidence of ductile dimples consistent with tensile overstress.

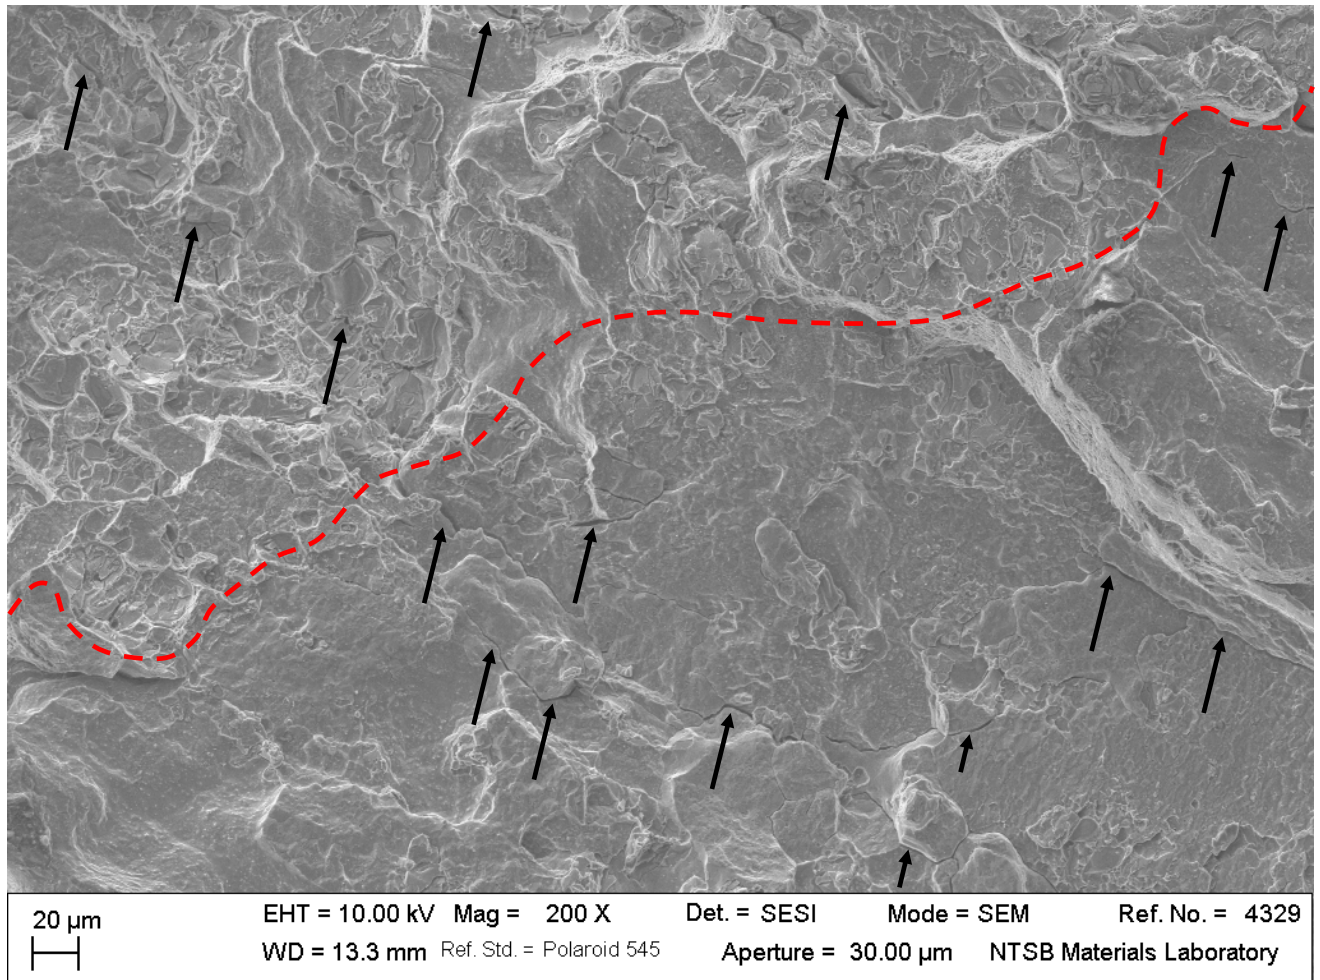
Figure 10: Another scanning electron micrograph of the pre-existing crack boundary at a different location relative to figure 9 demarcated by a red dashed line. below this line was inside of the crack front and above this line was outside of the crack front. Secondary cracks consistent with intergranular branched cracking were observed as identified by unlabeled arrows. Immediately outside of the crack front showed significantly less secondary cracking and more evidence of ductile dimples consistent with tensile overstress.

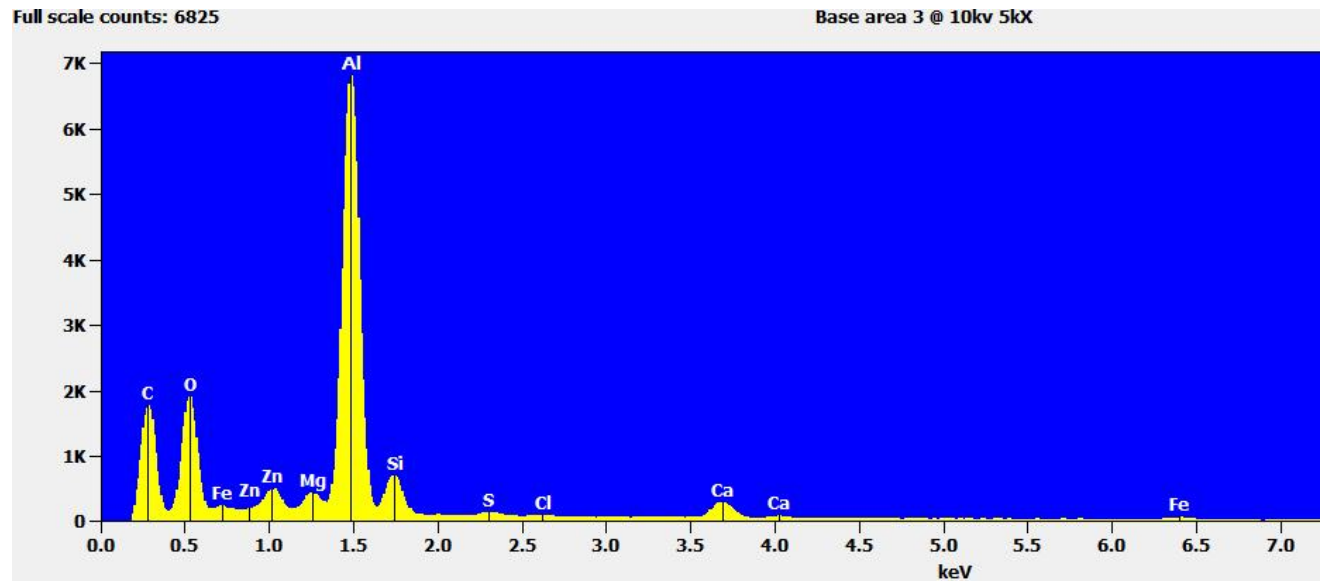
In conjunction with SEM examination, energy dispersive x-ray spectroscopy (EDS) was used to identify chemical constituents near the fracture origin. Major peaks of Aluminum, Zinc, Magnesium, and Oxygen were detected consistent with 7xxx series aluminum alloys and aluminum oxide corrosion product. Minor peaks of Carbon, Calcium, Silicon, and Sulfur were also detected which is consistent with some residual amount of organic matter, soil, and/or aircraft lubricants that remained on the fracture surface post cleaning. Trace Chlorine peaks were detected in local areas near fracture origins,

consistent with a corrosive media required to initiate stress corrosion cracking. The EDS spectrum that was recorded is shown in figure 11.

Figure 11: EDS spectrum acquired near pre-existing crack origins showed the presence of trace amounts of chlorine.

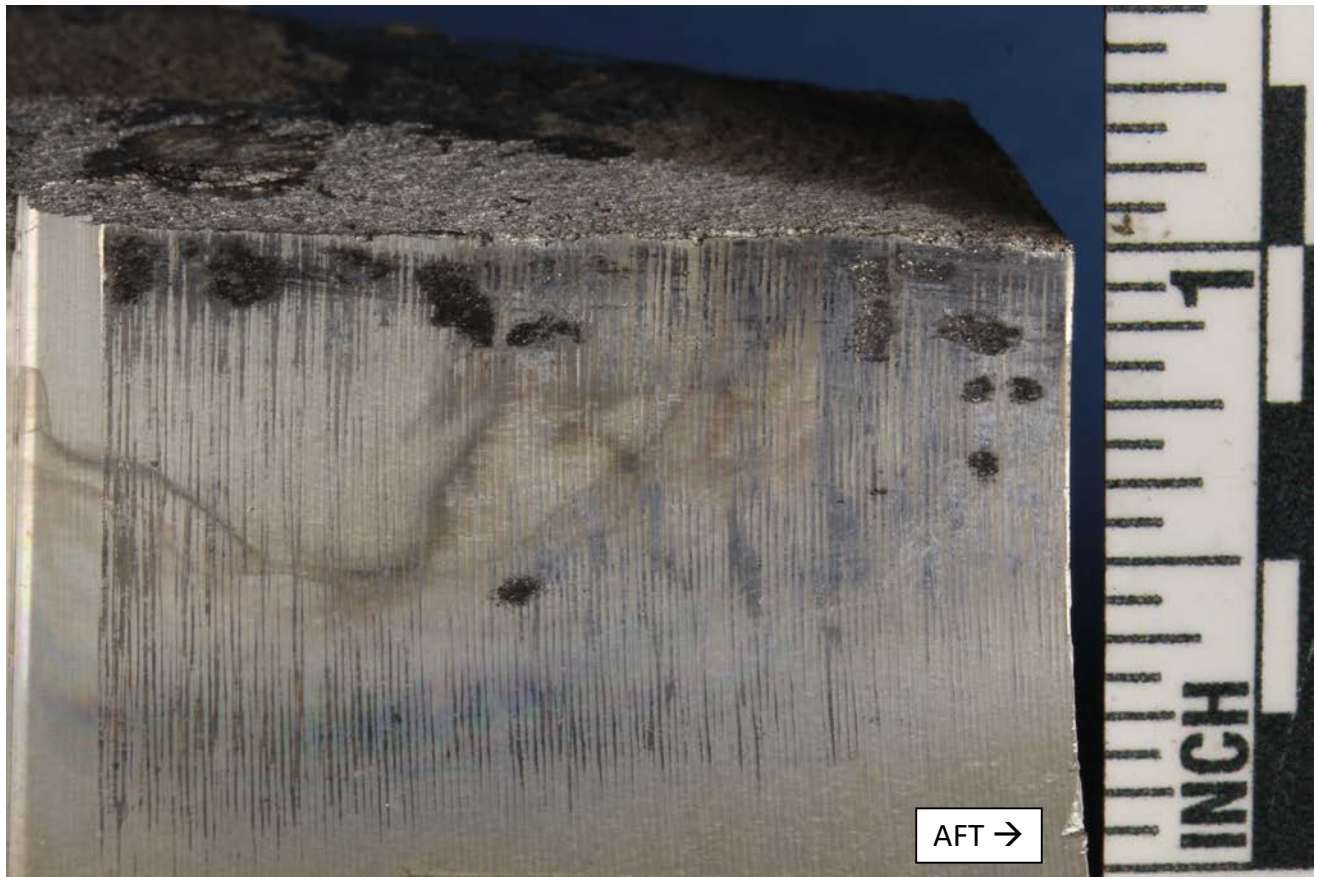
The aft pivot pin bore surface of the fractured right main fitting was examined. The sidewall surface adjacent to pre-existing crack 1 had areas of corrosion pitting as shown in figure 12. Three larger circular sites approximately 0.10 to 0.15 inch diameter, two elliptical sites approximately 0.10 by 0.05 inches, and one site less than 0.05 inches in diameter occupied an area less than 0.15 inch below the fracture surface spanning from 0.12 to 0.90 inch from the corner radius of the pivot pin bore. Another grouping of similarly sized corrosion sites was observed 1.3 to 1.6 inches aft of the pivot pin bore base on the sidewall surface within 0.35 inch of the fracture surface. Comparable localized corrosion sites were observed at the mating fracture pivot pin bore sidewall, however, measurement at this area was difficult due to post fracture smearing and deformation damage to the fracture and adjacent sidewall surfaces at this location.

An anodic coating was specified for the main fitting component. There was a section of disrupted coating along the pivot pin bore sidewall, as visible in figures 12 and 13. The section of disrupted coating was observed approximately 0.12 inches from the bore base, consistent with the location of the inserted edge of the aft pivot pin prior to being dislodged, and spanned approximately 90° around the bore sidewall circumference centered about the fracture surfaces of pre-existing crack 1. The area of disrupted coating extended from this location aft approximately 2.5 inches, tapering slightly toward the bore opening. The area of disrupted anodic coating was consistent with a circumferential machining pattern on the bore sidewall surface as the coating was still intact in machine tool grooves, however the peaks were shiny and smeared to reveal exposed bare metal. The missing coating is consistent with localized relative motion and wear between the pivot pin and the main fitting bore sidewall. There was another location on the pivot pin bore base where anodic coating was missing approximately 0.2 square inches in area. This was confirmed with a contact resistance measurement using a DM-350A digital multi-meter. The area appeared visibly off-color relative to surrounding areas and registered a low electrical resistance (missing coating) where surrounding areas registered an infinite resistance (intact coating). This area did not exhibit any evidence of wear or relative motion between surfaces observed in this area.

The area contained within and adjacent to the disrupted anodic coating contained flowing stain features consistent with evidence of fluid ingress, puddling/retention, and subsequent evaporation/egression. These features were on the sidewall and base areas of the bore as shown in figures 12a and 12b. Ultrasonic cleaning using acetone did not remove these features.

Figure 12a: A photograph of the pivot pin bore sidewall at pre-existing crack 1. On the sidewall surface near the fracture surface at the top of the image there were local corrosion sites visible as dark, round, rough features. A local area of disrupted anodic coating resembled the circumferential machining pattern of the bore surface where relative motion between the pivot pin and bore faying surfaces removed portions of the coating. Flowing stained lines were observed which were consistent with evidence of fluid ingress, puddling, and egression. Scratches approximately 0.5 – 0.6 inches long as measured forward to aft were observed beginning at corrosion sites which indicated corrosion sites were present at the time the pivot pin was dislodged.

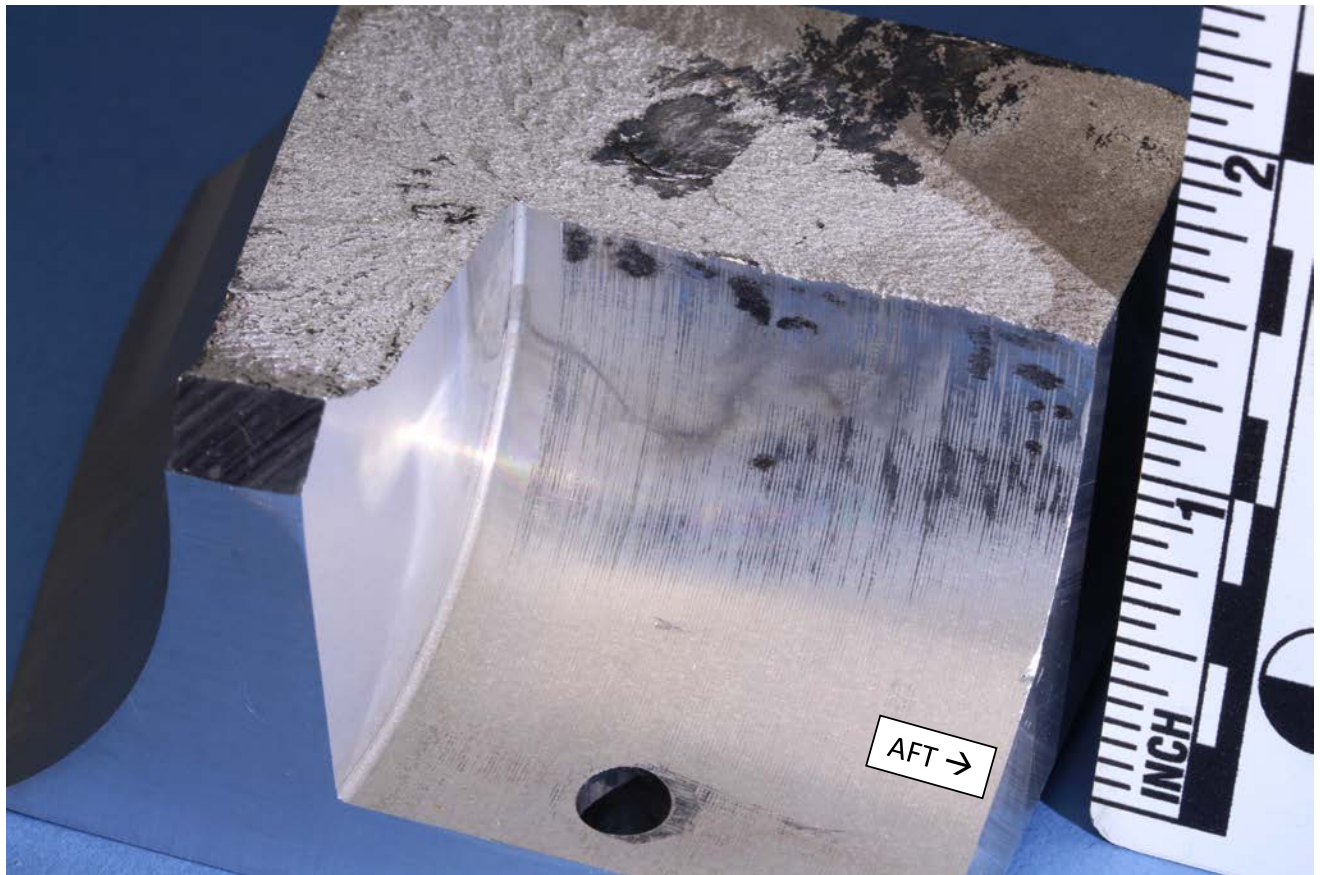
Figure 12b: A photograph similar to figure 12a but showing an isometric view of the pivot pin bore section near pre-existing crack 1.
