# NATIONAL TRANSPORTATION SAFETY BOARD

## MATERIALS LABORATORY FACTUAL REPORT

Report No. 19-077

Place : Newport News, Virginia  
Date : May 9, 2019  
Vehicle : Hawker Siddeley Hunter MK58; N343AX  
NTSB No. : ERA19LA169  
Investigator : Eric Alleyne, AS-ERA

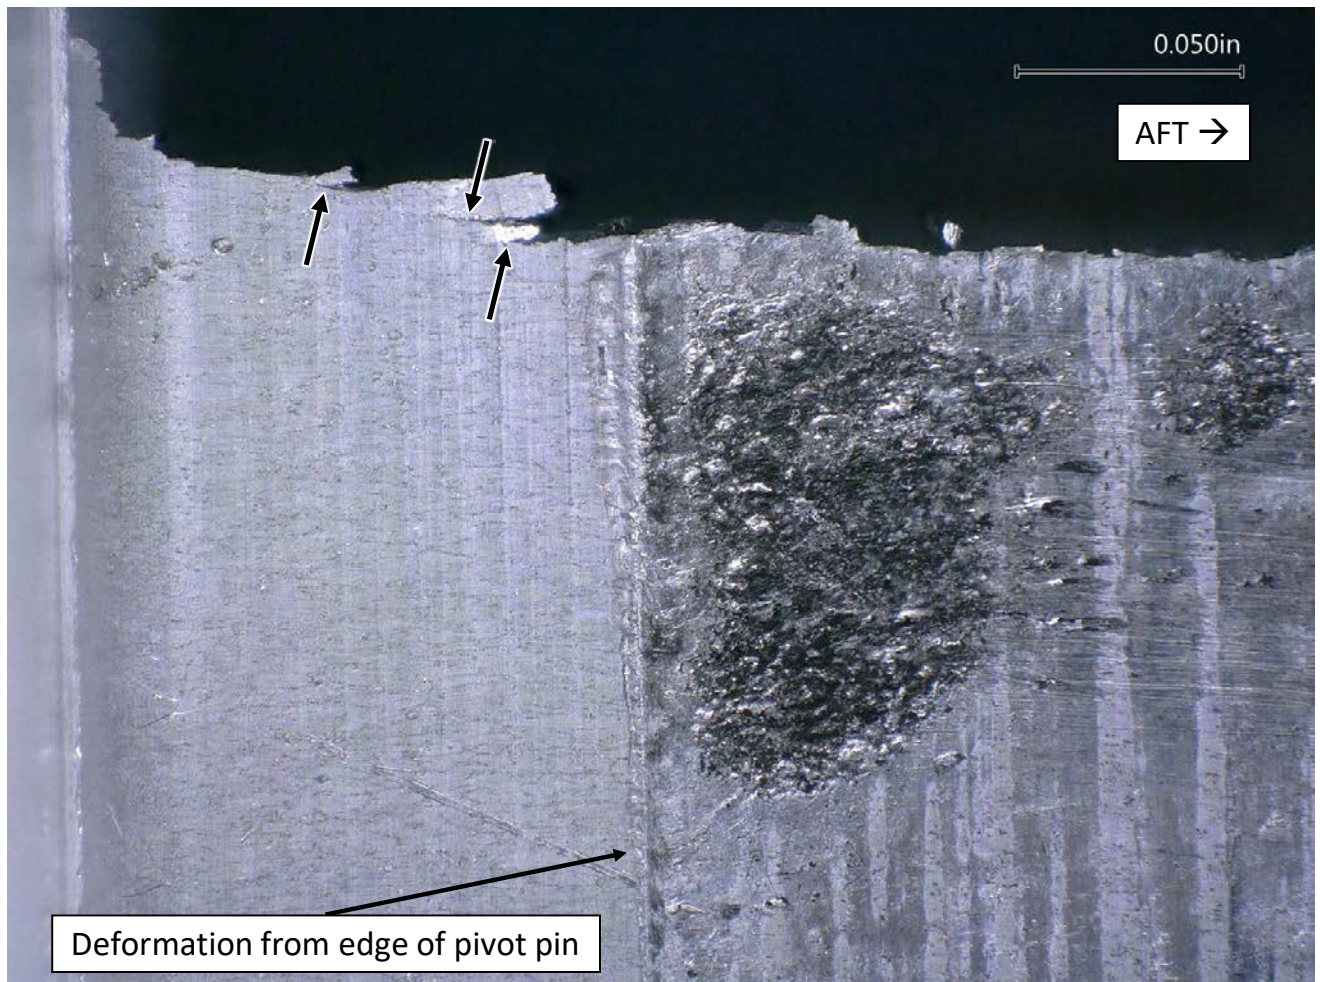
Figure 13 shows a digital micrograph taken normal to the aft pivot pin bore sidewall surface adjacent to the fracture surface at pre-existing crack 1. The pivot pin bore base and corner radius is visible on the left side of the image and the fracture surface is at the top of the image. Small secondary cracks oriented parallel to the fracture surface were observed on the sidewall surface just below the fracture surface. These flaky, layered features were consistent with features typical of stress corrosion cracking.

Figure 13: A digital micrograph of the aft pivot pin bore sidewall at pre-existing crack 1 near the corner radius at the base of the bore. A flaky, layered appearance of secondary cracks adjacent and parallel to the fracture surface was observed as indicated with unlabeled arrows. The local sidewall deformation from the inserted edge of the pivot pin was apparent from the fracture surface down to the location indicated. This feature also demarcated the boundary between intact (left side) and disturbed (right side) anodic coating. The dark pitted corrosion sites were also observed where the steel pivot pin contacted the bore sidewall near the fracture surface.

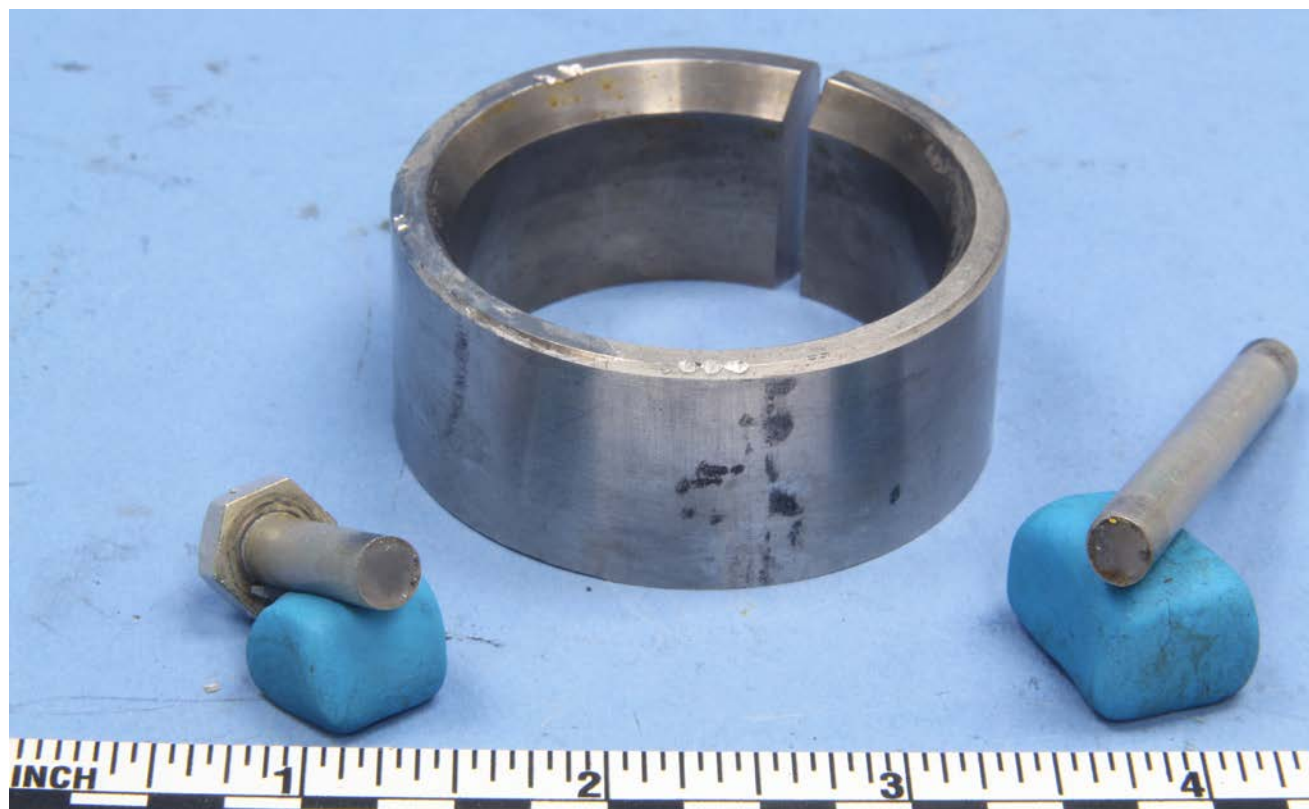
Figure 14 shows a photograph of the forward section of the aft pivot pin that was removed from the fractured bore as the pre-existing crack features were excised. Local areas of staining which closely resembled the corrosion sites observed on the faying surface of the pivot pin bore were observed on the steel pin at the location of pre-existing crack 1. These features observed on the steel pin were not removeable with ultrasonic cleaning in acetone. The faying surface of the pin contained residual yellow sealant that was also present on the pivot pin bore sidewall surface. The fractured retaining bolt fragments submitted are also shown in this photograph. One fragment contained the hex head and a portion of the shank of length consistent with the main fitting thickness at the location of the bolt hole. The other fragment contained a portion of the shank of length consistent with the pivot pin outer diameter. The remainder of the pin containing a portion of the shank and threaded nut end was not recovered. The fragment sizes and fractures were consistent with shear fracture and indicate the bolt was present at the time the pivot pin was dislodged.

Figure 14: A photograph of the forward section of the aft pivot pin that was removed from the fractured bore. The staining observed on the outer surface of the pivot pin correlated with the corrosion sites on the bore sidewall surface near the fracture surface of pre-existing crack 1. Of the fractured retaining bolt fragments shown, the hex head portion had length consistent with the main fitting thickness at the location of the bolt hole and the shank fragment had length consistent with the pivot pin outer diameter. The fragment sizes and fractures were consistent with brittle shear fracture.
