## MEMORANDUM FOR RECORD

**Subject:** N9422F, Hughes 269B, 05/15/19, Hampton, Georgia, NTSB Investigation ERA19LA173. Information provided by FAA Inspector Steven Newcomer of the Atlanta, Georgia Flight Standards District Office.

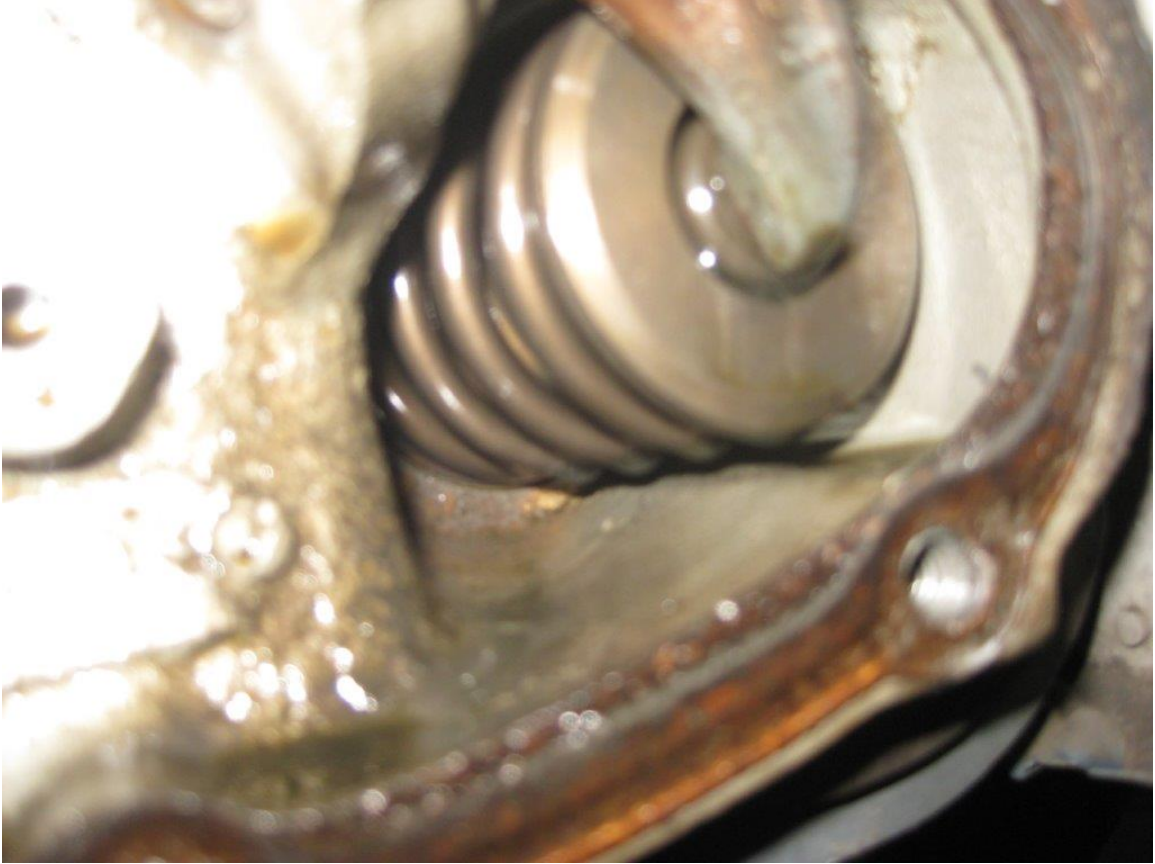
Mr. Newcomer examined the helicopter and found the tail boom sheared/broken from the fuselage just aft the brackets that support the tail boom. The tail rotor appeared undamaged. The "blue" main rotor blade damaged at the attach point for the blade damper and the blade damper arm. The bracket that held the blade damper arm was broken. blade damper attach point. The main rotor flight controls appeared to have continuity. The No. 3 cylinder exhaust valve pushrod was slightly bent, and the "cap for the exhaust valve" was missing.

A photograph of the No. 3 exhaust valve spring shows the upper valve spring retainer in place, though it is unclear if the lower valve spring retainer was present.

*Figure 1 No. 3 Exhaust Valve/Spring*
