## **MEMORANDUM for RECORD**

**Date: September 12, 2019**  
**Wreckage Examination**  
**NTSB Accident Number: ERA19LA173 – Hampton, Georgia**

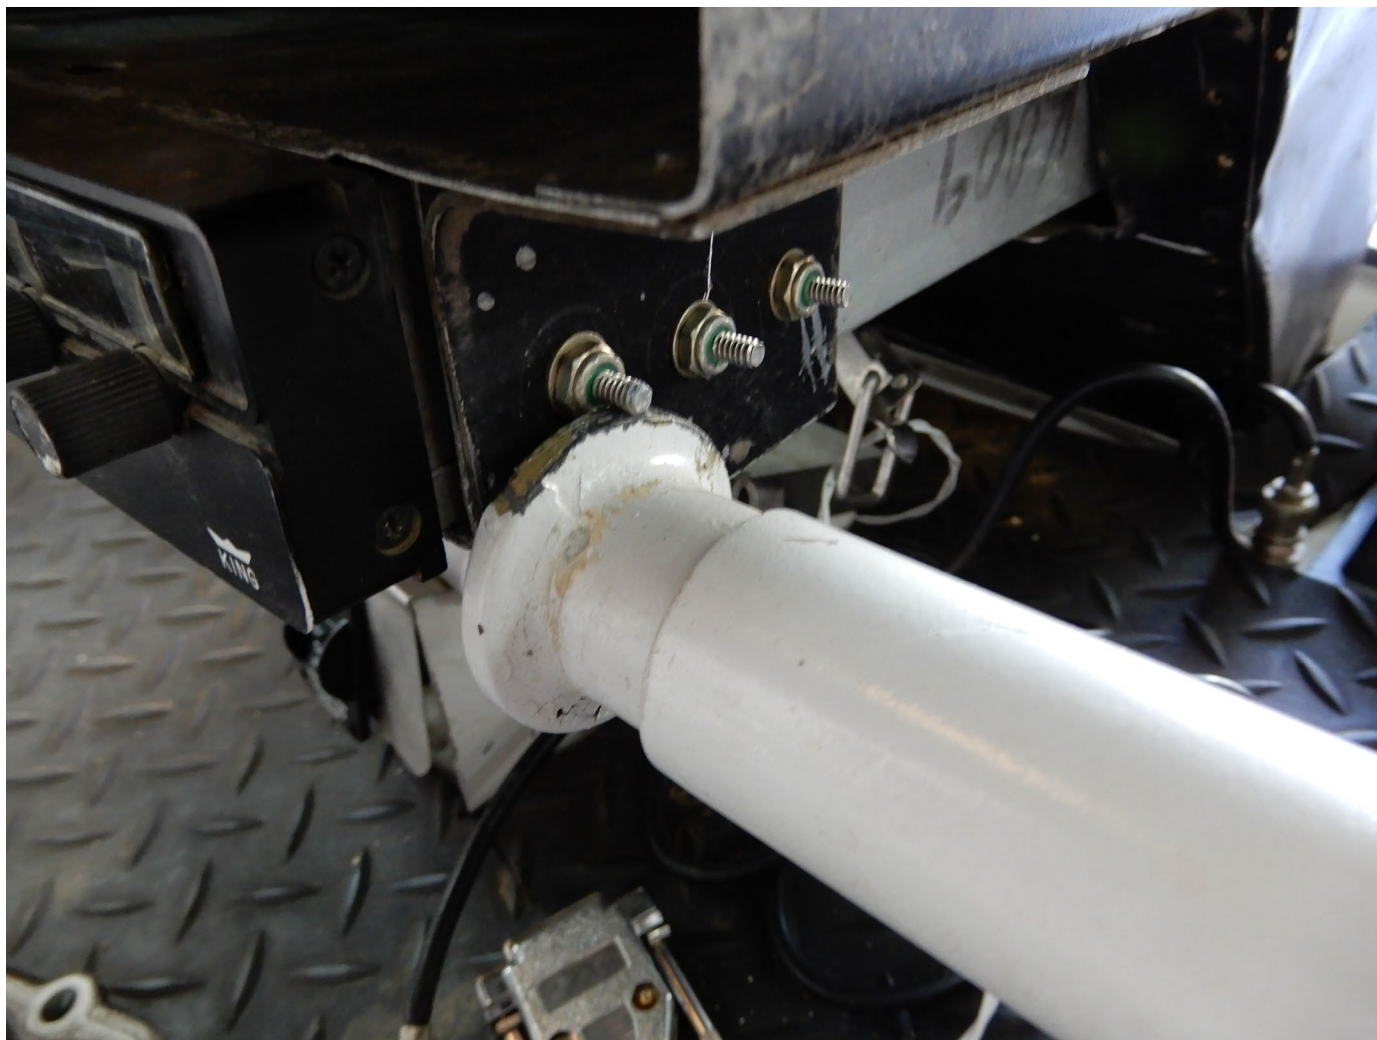
The flight controls were manipulated manually using the cockpit controls. The cyclic controls remained attached up to the main rotor mast. The cyclic operated normally with no restrictions or binding. The collective control was operated manually. It remained attached up to the main rotor mast and operated normally with no restrictions or binding. The tail rotor drive shaft and tail rotor pitch control tube were fractured at the tail boom fracture area. The pitch control tube was continuous to the cockpit anti-torque pedals. When the antitorque pedals were moved manually, the left pedal at the right cockpit seat contacted the threaded end of a through-bolt on the center instrument console. Missing paint and scraping signatures on the pedal surface were consistent with continued interference for an extended amount of time. See Photo 1, below.

Photo 1 – Left Antitorque Pedal Interference with Through Bolt

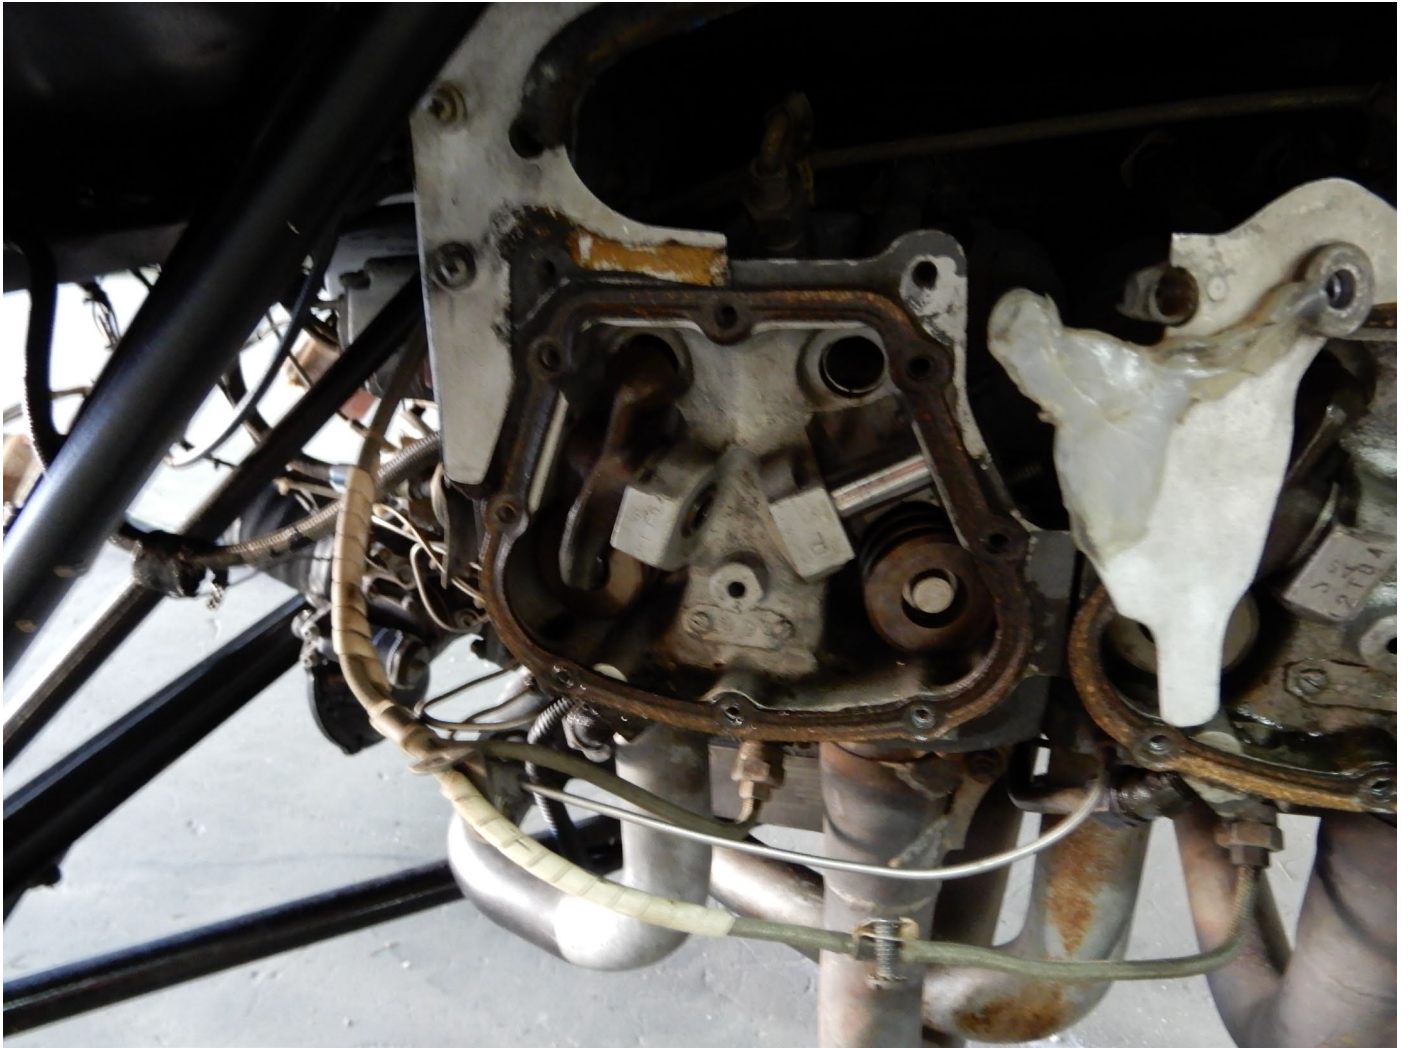
The engine was examined. The bottom spark plugs were removed; all plugs exhibited normal wear and color when compared to a Champion Check-a-Plug chart. The engine was rotated manually at the crankshaft extension at the V-belt drive section. The cylinder rocker covers were removed prior to the examination and were inside the cockpit area. The #3 cylinder exhaust valve rocker arm was missing; presumably from a previous inspection (see Photo 2). With the exception of the #3 cylinder, suction and pressure were observed on all cylinders when the engine crankshaft was rotated. No internal binding or unusual noise was noted.

Photo 2 – Number 3 Cylinder, Note Exhaust Valve Rocker Arm Missing

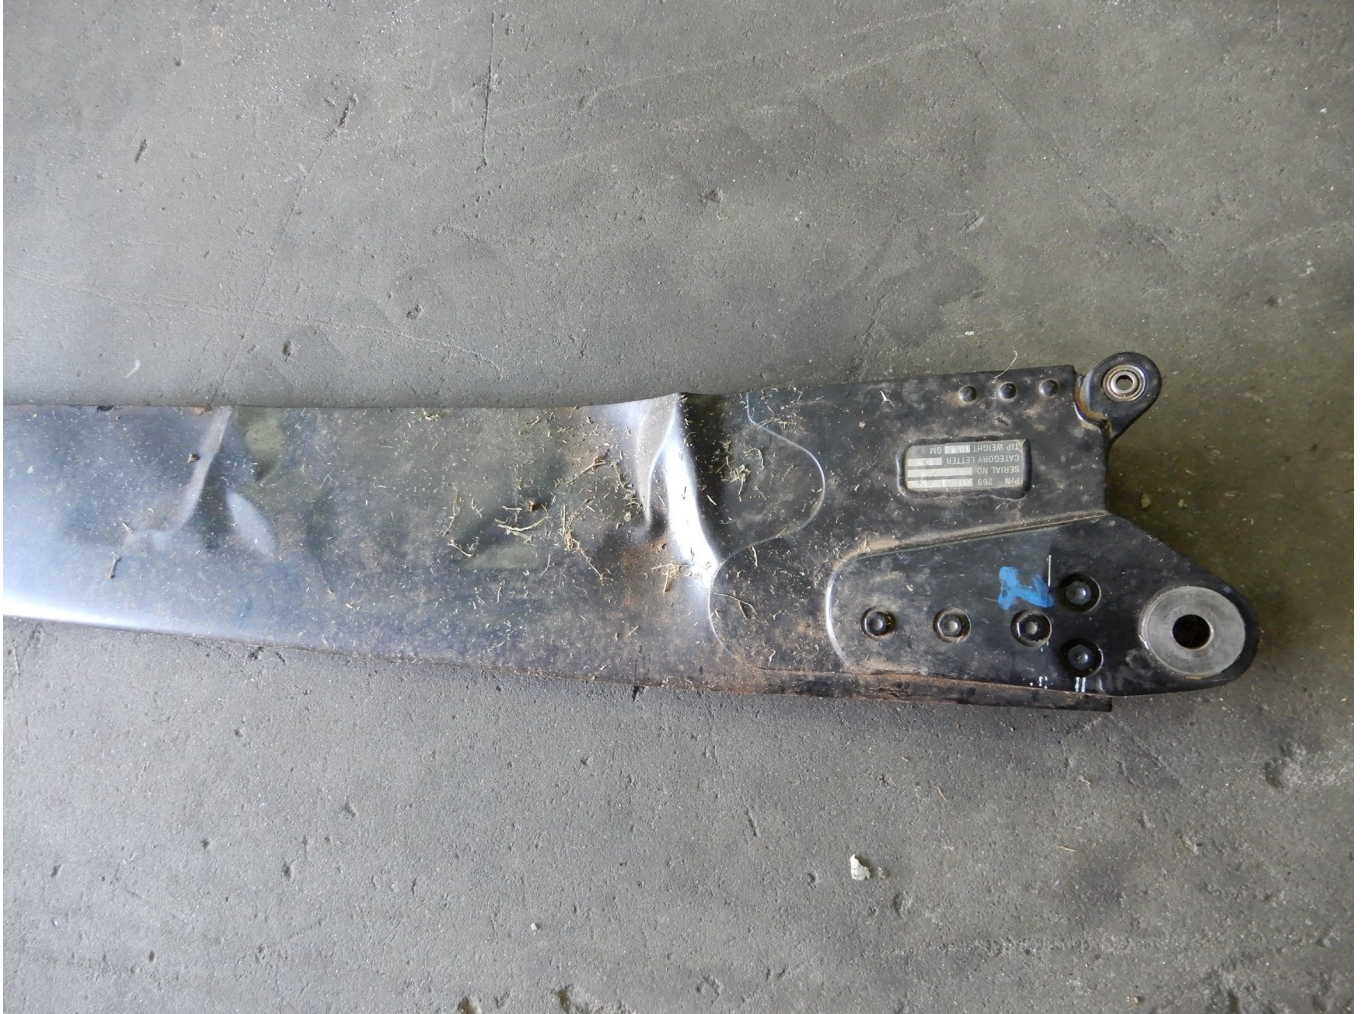
Photo 3 – Main Rotor Blade “1”

The main rotor blades were removed by recovery personnel prior to the examination. Each blade was buckled about 1 to 2 ft from the blade root.
