## MEMORANDUM FOR RECORD

**Subject:** N7833D, Piper PA22-150, 07/14/19, Hastings, Florida, NTSB Investigation ERA19LA227. Wreckage Examination.

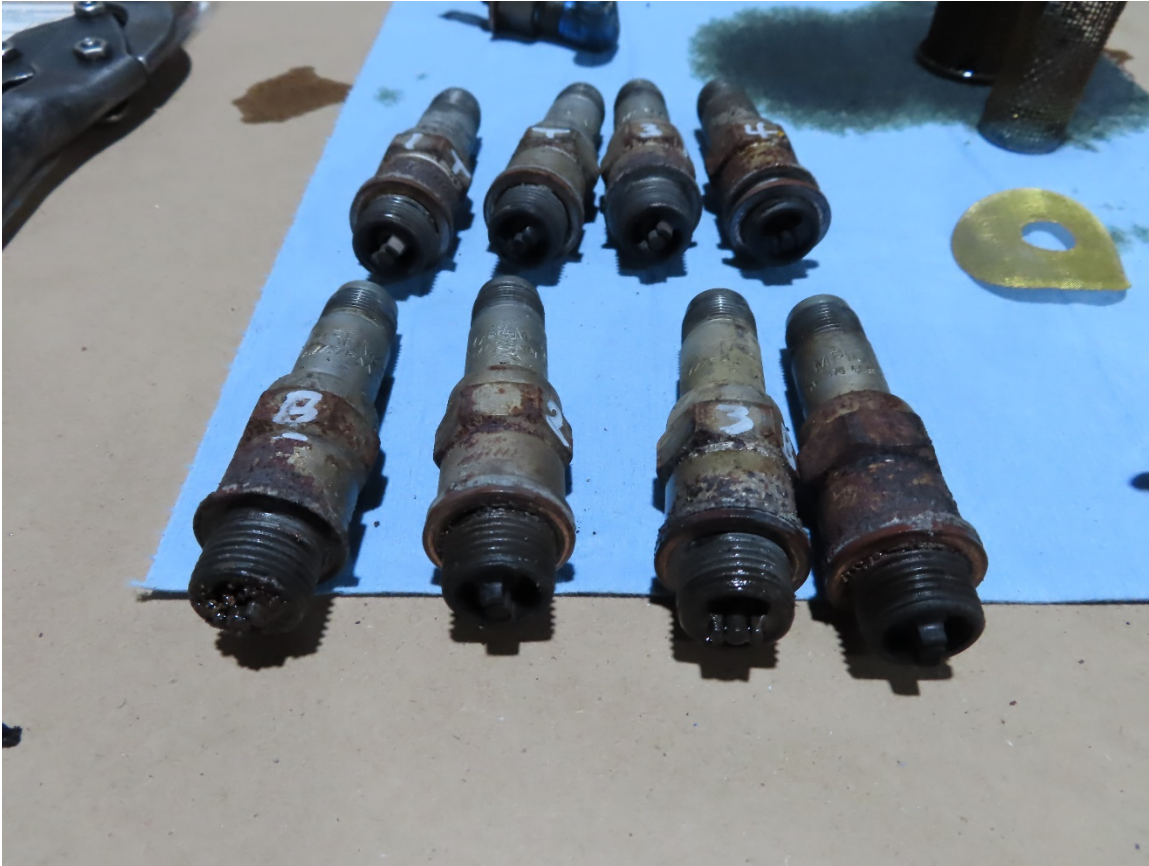
*Figure 1 - Spark Plugs*

The spark plug electrodes were black in color and appeared sooty. The bottom spark plugs from the Nos. 1 and 3 cylinders were oil soaked.

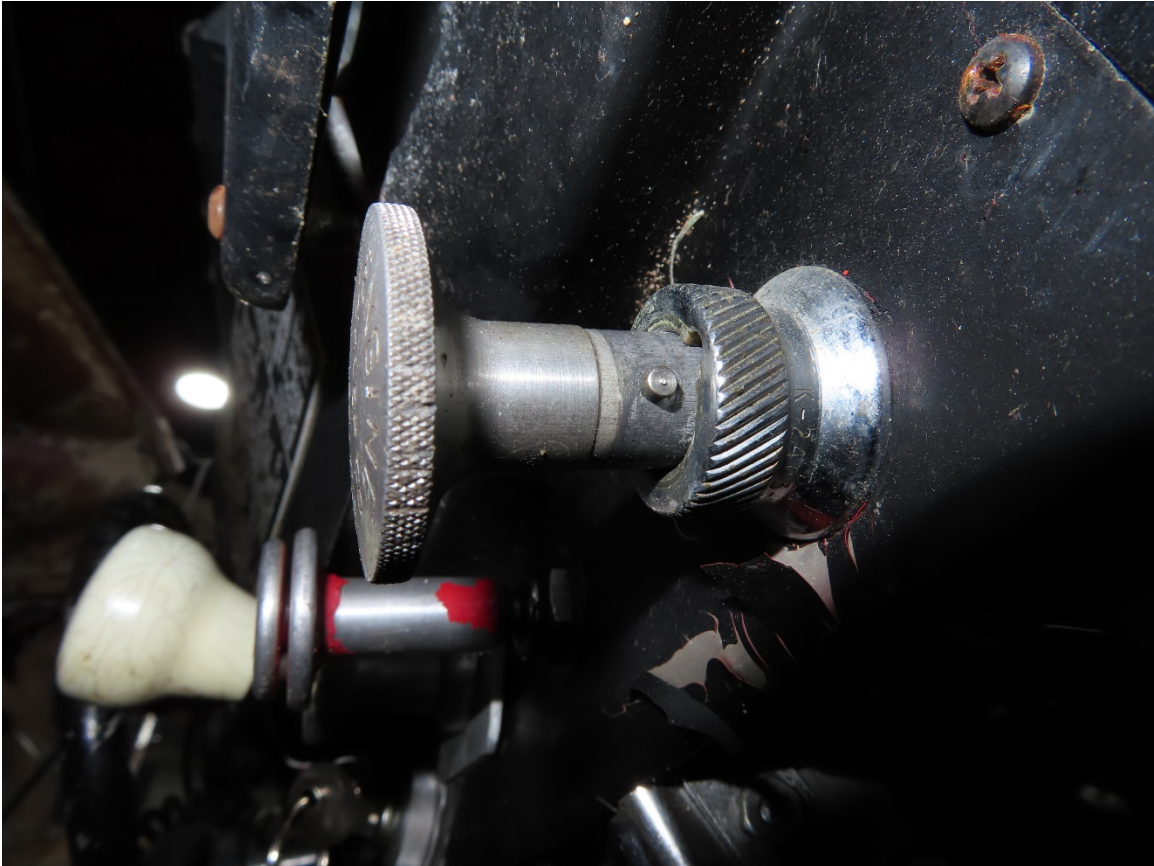
*Figure 2 - Primer Control*

The primer was found unlocked and open about  $\frac{1}{4}$ - $\frac{1}{8}$  inch. The primer system was plumbed to all four cylinders.

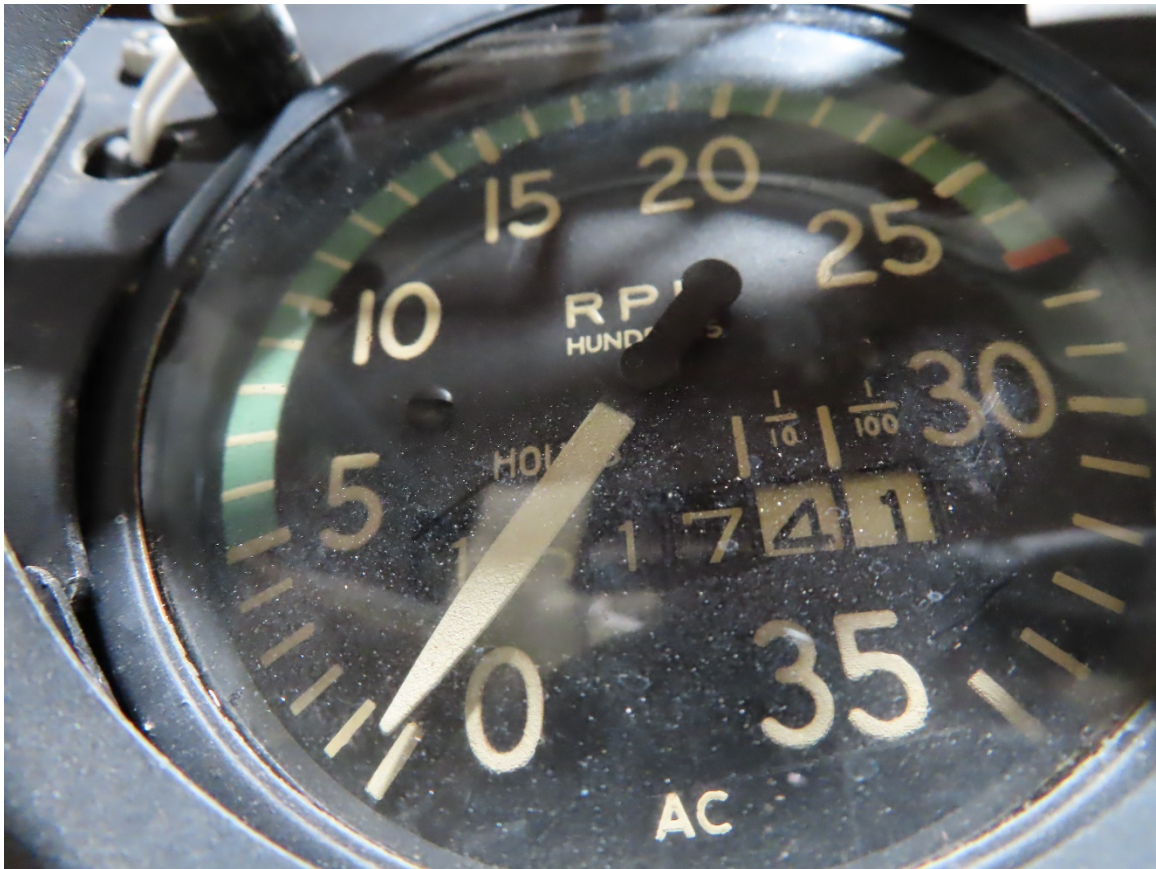
*Figure 3 - Engine Tachometer*

The upper end of the green range on the engine tachometer was 2,700 RPM.
