# Continental Motors

## ENGINE RUN REPORT

| ENGINE MODEL | TSIO-550-C (1B) |
| FILE NUMBER | 19-050 |

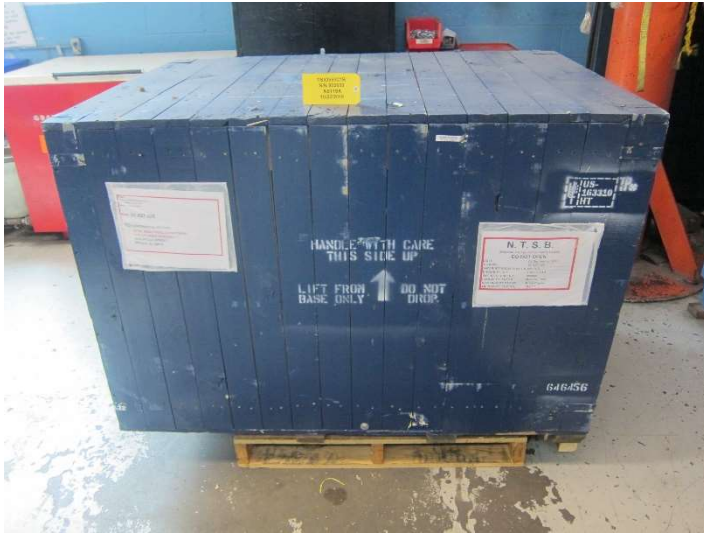
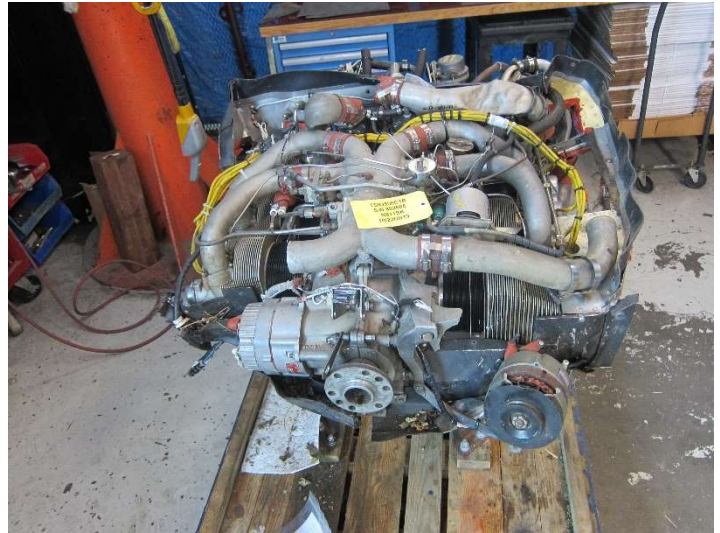
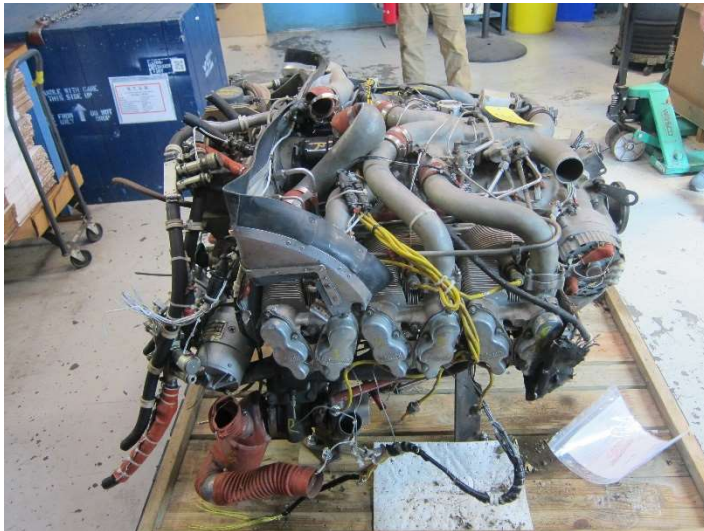
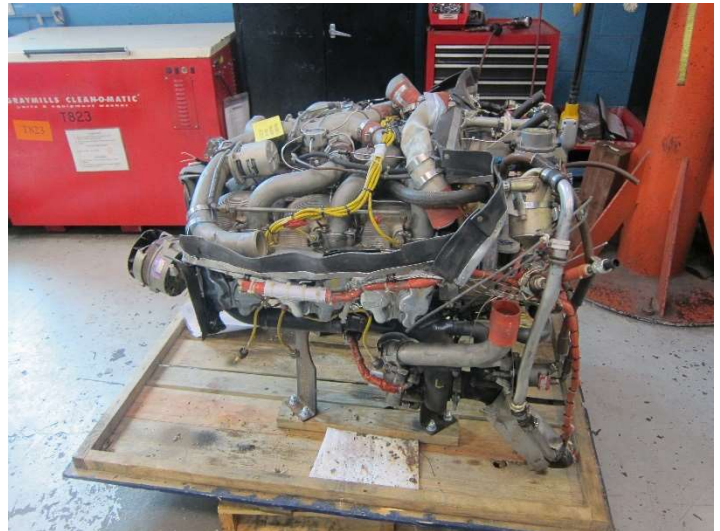
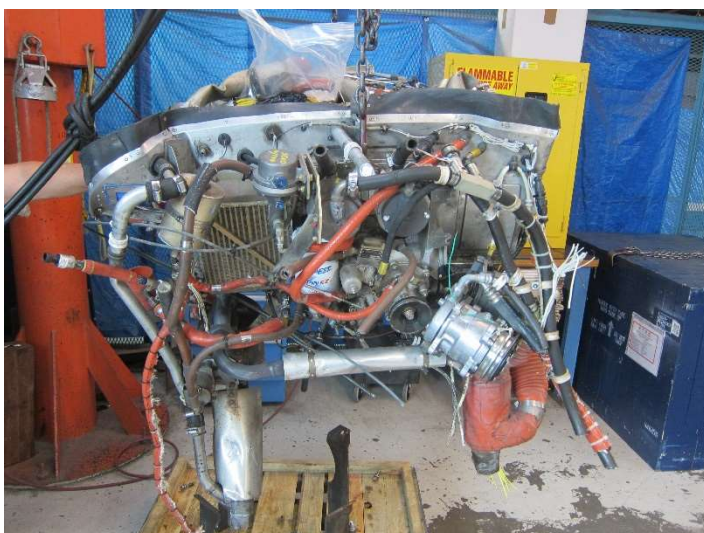
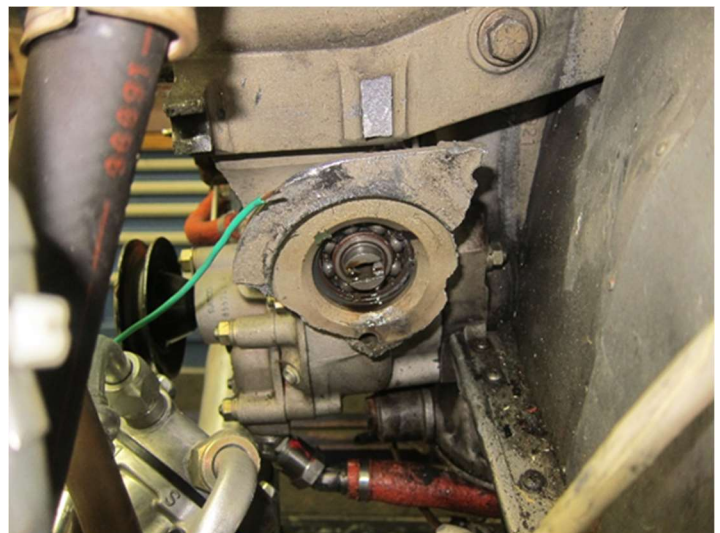
The engine was removed from the shipping crate in the presence of the NTSB Investigator and a visual inspection indicated that the engine exhibited impact damage to induction components, turbochargers, oil sump and starter adapter. The rocker cover for cylinder 6 exhaust rocker arm was impact damaged as was the rocker cover for cylinder # 5, Intake rocker arm.

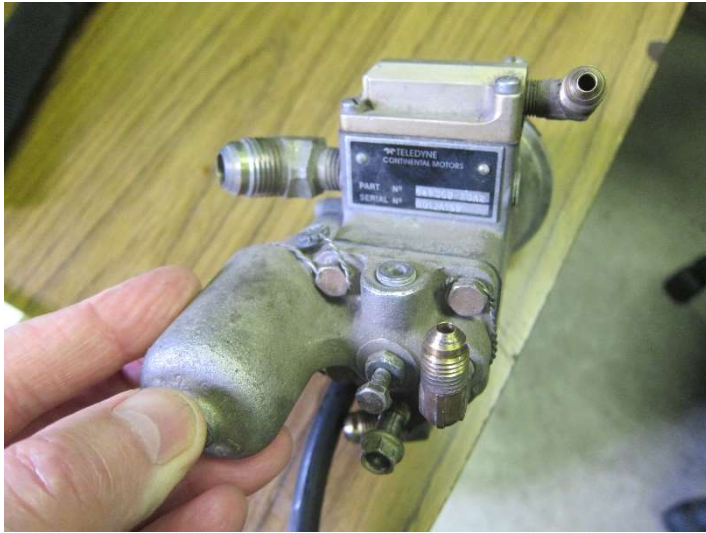
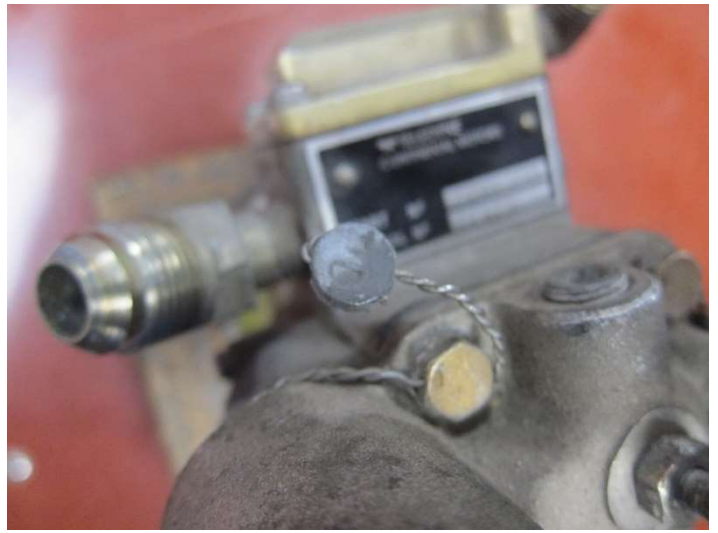
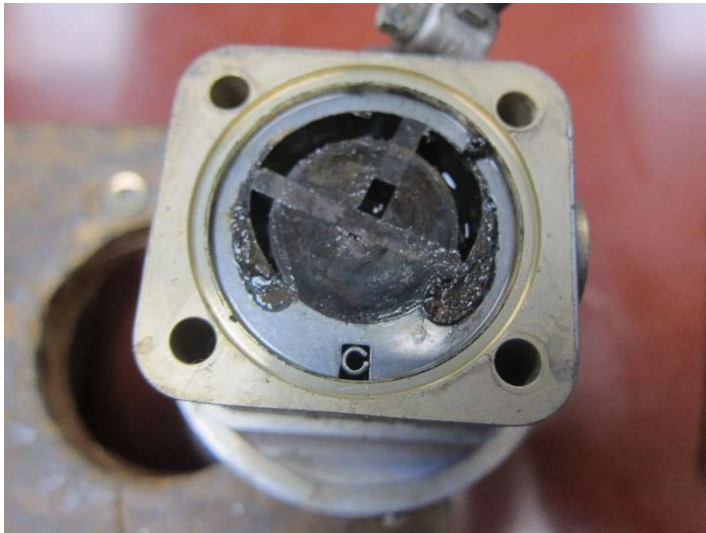
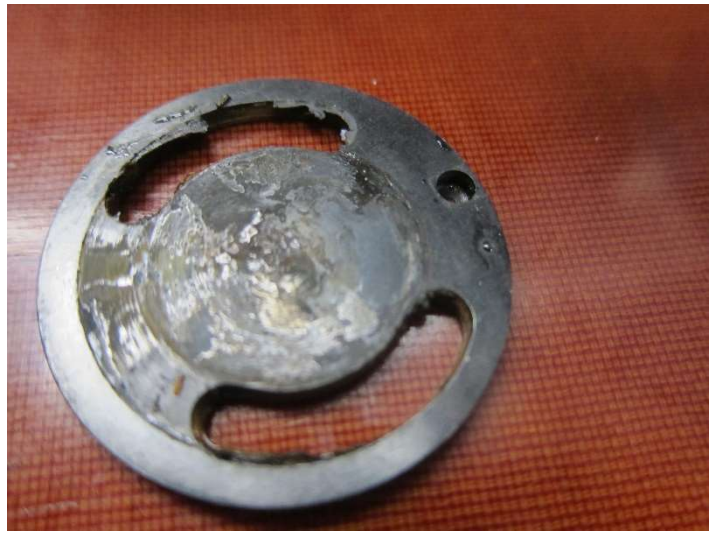
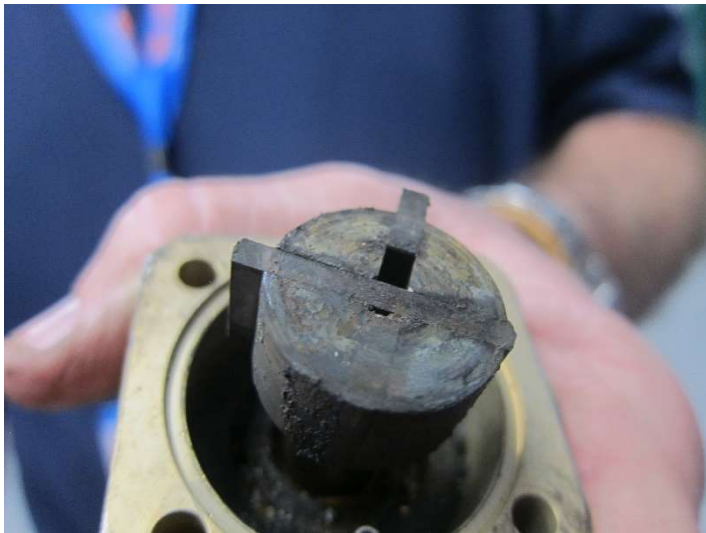
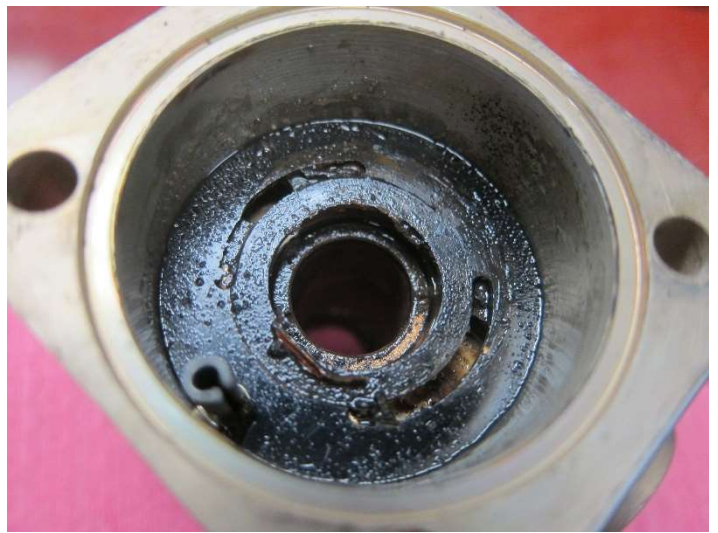
Further examination of the engine-driven fuel pump identified corrosion and contamination throughout the interior of the fuel pump, preventing the pump from rotating. The corrosion is consistent with moisture collecting in the fuel system during post-accident storage while exposed to the environment. The corrosion prevented the pump from rotating damaging the drive coupling. All interior pump components were intact.
