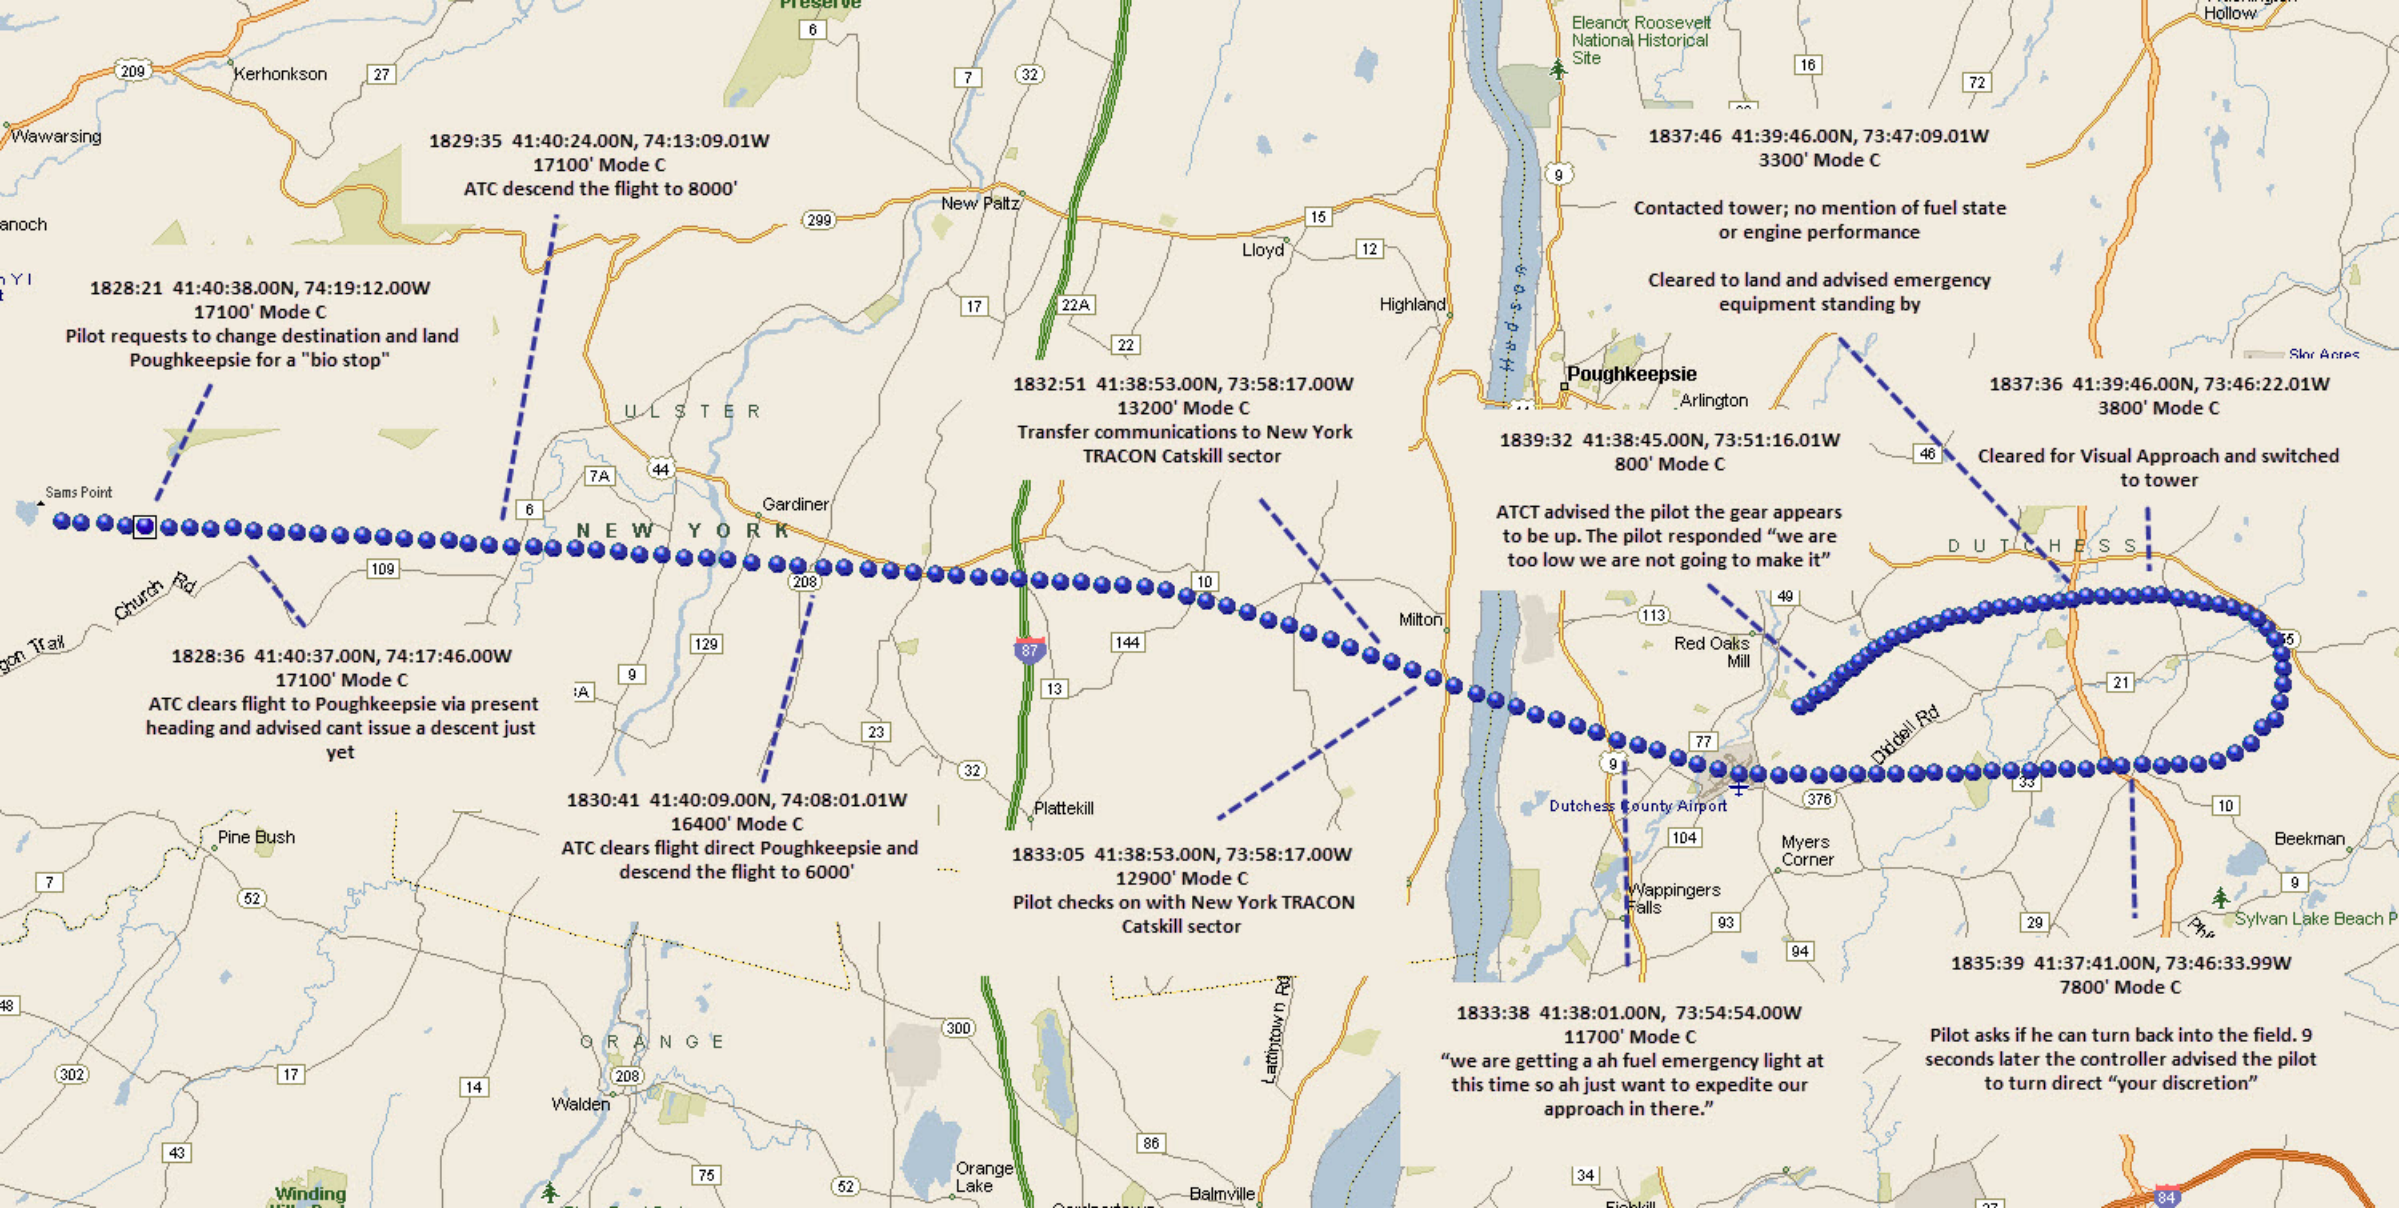
1829:35 41:40:24.00N, 74:13:09.01W  
17100' Mode C  
ATC descend the flight to 8000'

1828:21 41:40:38.00N, 74:19:12.00W  
17100' Mode C  
Pilot requests to change destination and land  
Poughkeepsie for a "bio stop"

1828:36 41:40:37.00N, 74:17:46.00W  
17100' Mode C  
ATC clears flight to Poughkeepsie via present  
heading and advised cant issue a descent just  
yet

1830:41 41:40:09.00N, 74:08:01.01W  
16400' Mode C  
ATC clears flight direct Poughkeepsie and  
descend the flight to 6000'

1832:51 41:38:53.00N, 73:58:17.00W  
13200' Mode C  
Transfer communications to New York  
TRACON Catskill sector

1833:05 41:38:53.00N, 73:58:17.00W  
12900' Mode C  
Pilot checks on with New York TRACON  
Catskill sector

1837:46 41:39:46.00N, 73:47:09.01W  
3300' Mode C

Contacted tower; no mention of fuel state  
or engine performance

Cleared to land and advised emergency  
equipment standing by

1837:36 41:39:46.00N, 73:46:22.01W  
3800' Mode C

Cleared for Visual Approach and switched  
to tower

1839:32 41:38:45.00N, 73:51:16.01W  
800' Mode C

ATCT advised the pilot the gear appears  
to be up. The pilot responded "we are  
too low we are not going to make it"

1835:39 41:37:41.00N, 73:46:33.99W  
7800' Mode C

Pilot asks if he can turn back into the field. 9  
seconds later the controller advised the pilot  
to turn direct "your discretion"

1833:38 41:38:01.00N, 73:54:54.00W  
11700' Mode C  
"we are getting a ah fuel emergency light at  
this time so ah just want to expedite our  
approach in there."
