**NATIONAL TRANSPORTATION SAFETY BOARD**

**Computed Tomography Specialist's Factual Report**

ERA19LA231

Location: Poughkeepsie, NY  
Date: July 19, 2019  
Time: 1440 eastern daylight time  
Airplane: Piper PA46-310P, N811SK

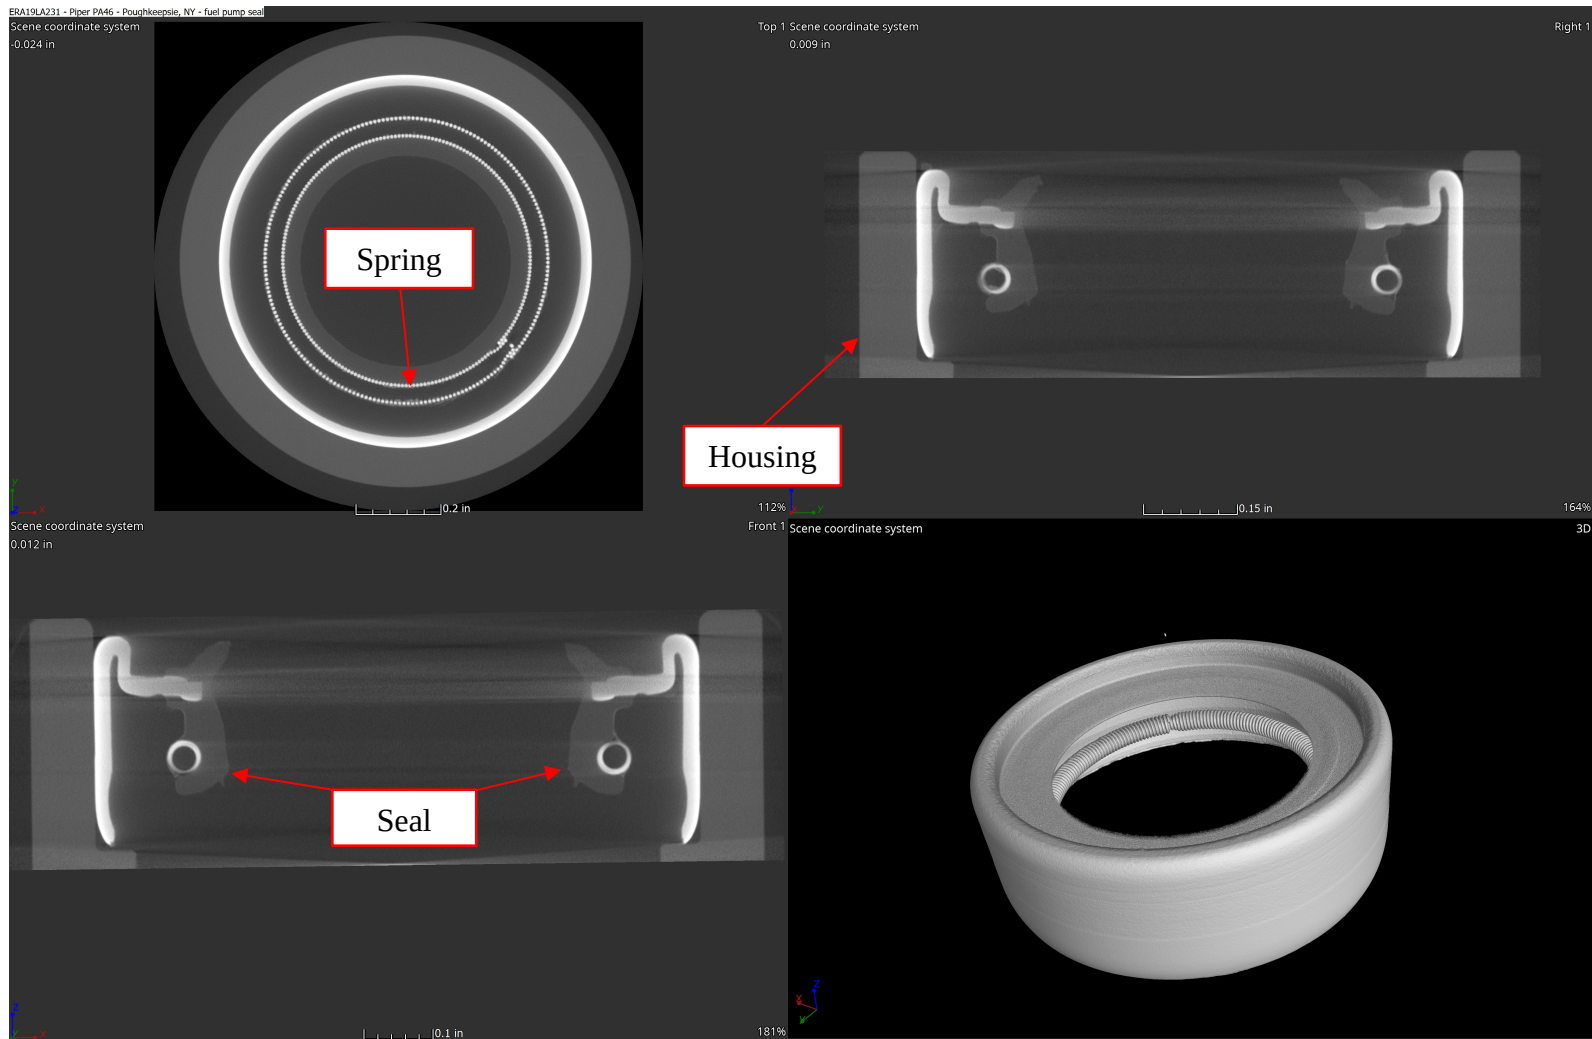
Figure 1  
Engine driven fuel pump seal - overview

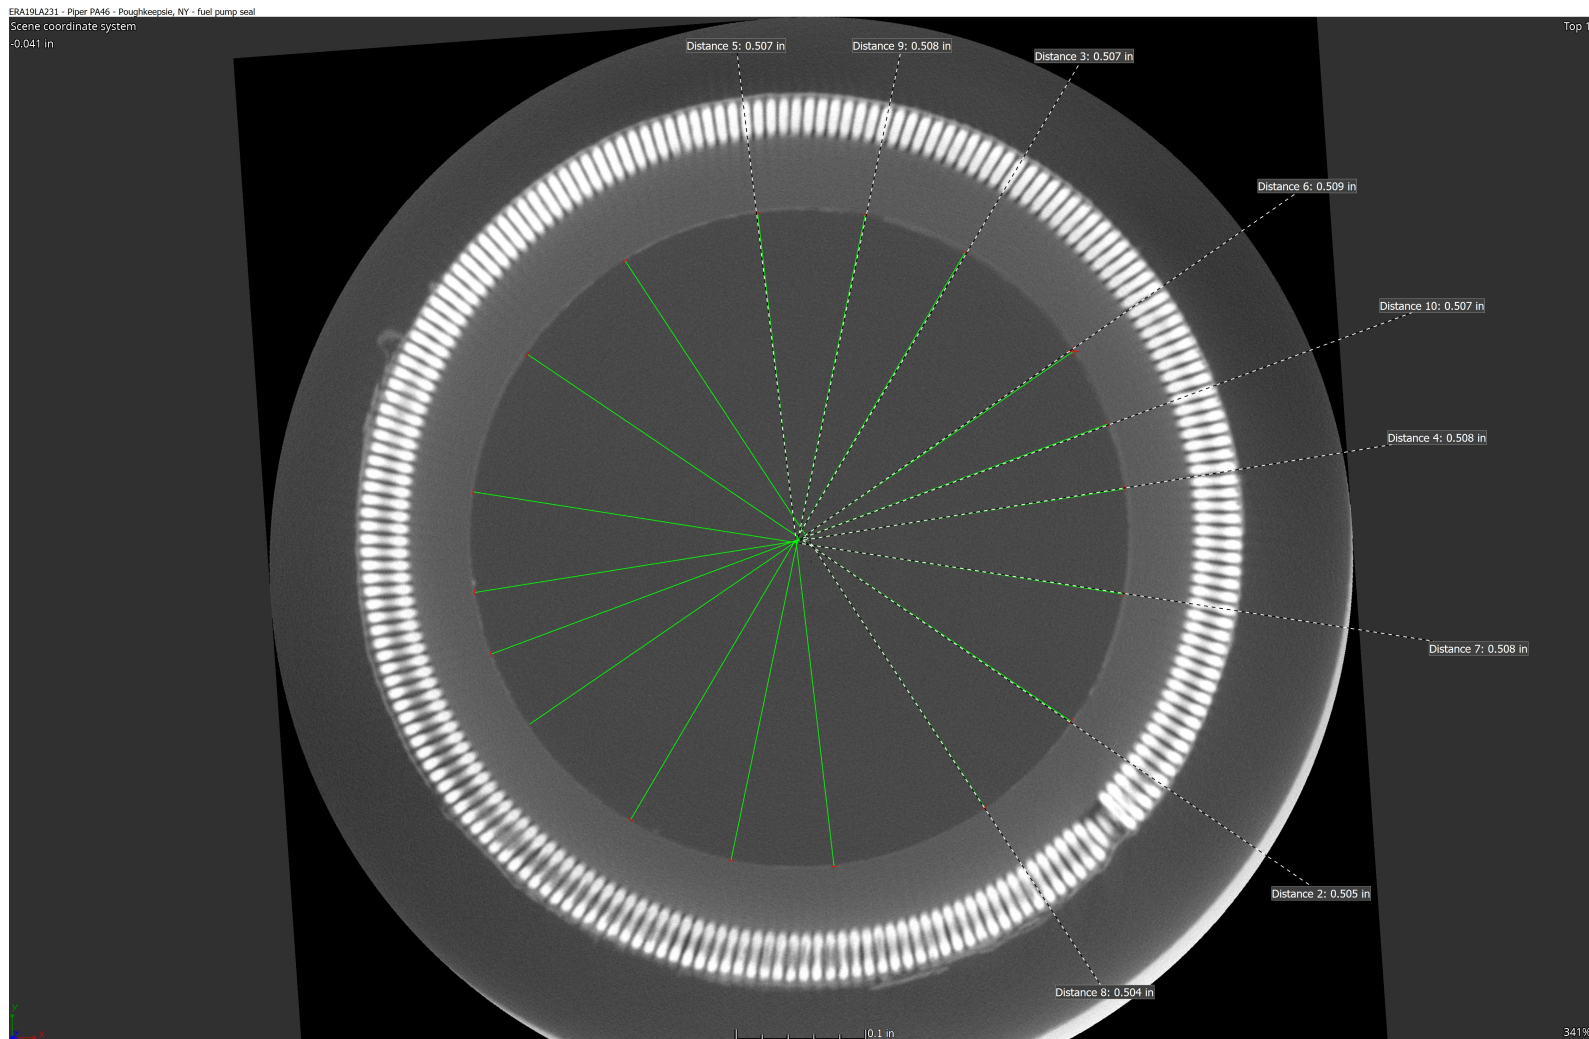
Figure 2  
Engine driven fuel pump seal – seal opening diameters

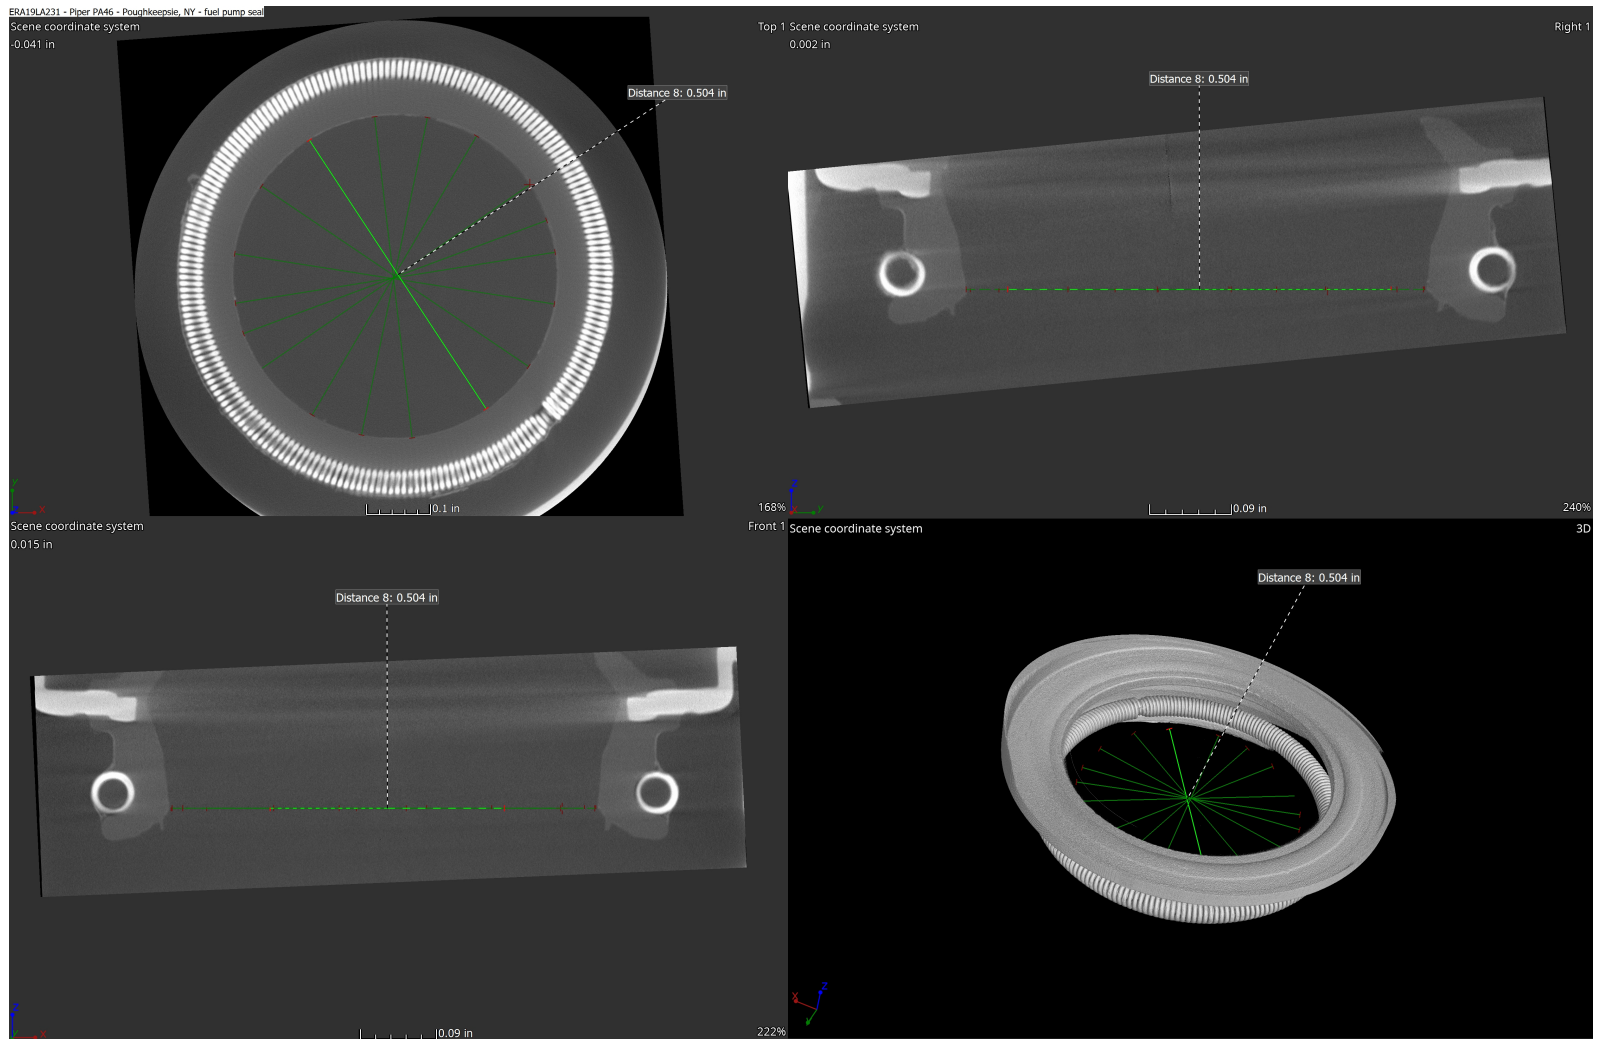
Figure 3  
Engine driven fuel pump seal – minimum seal opening diameter

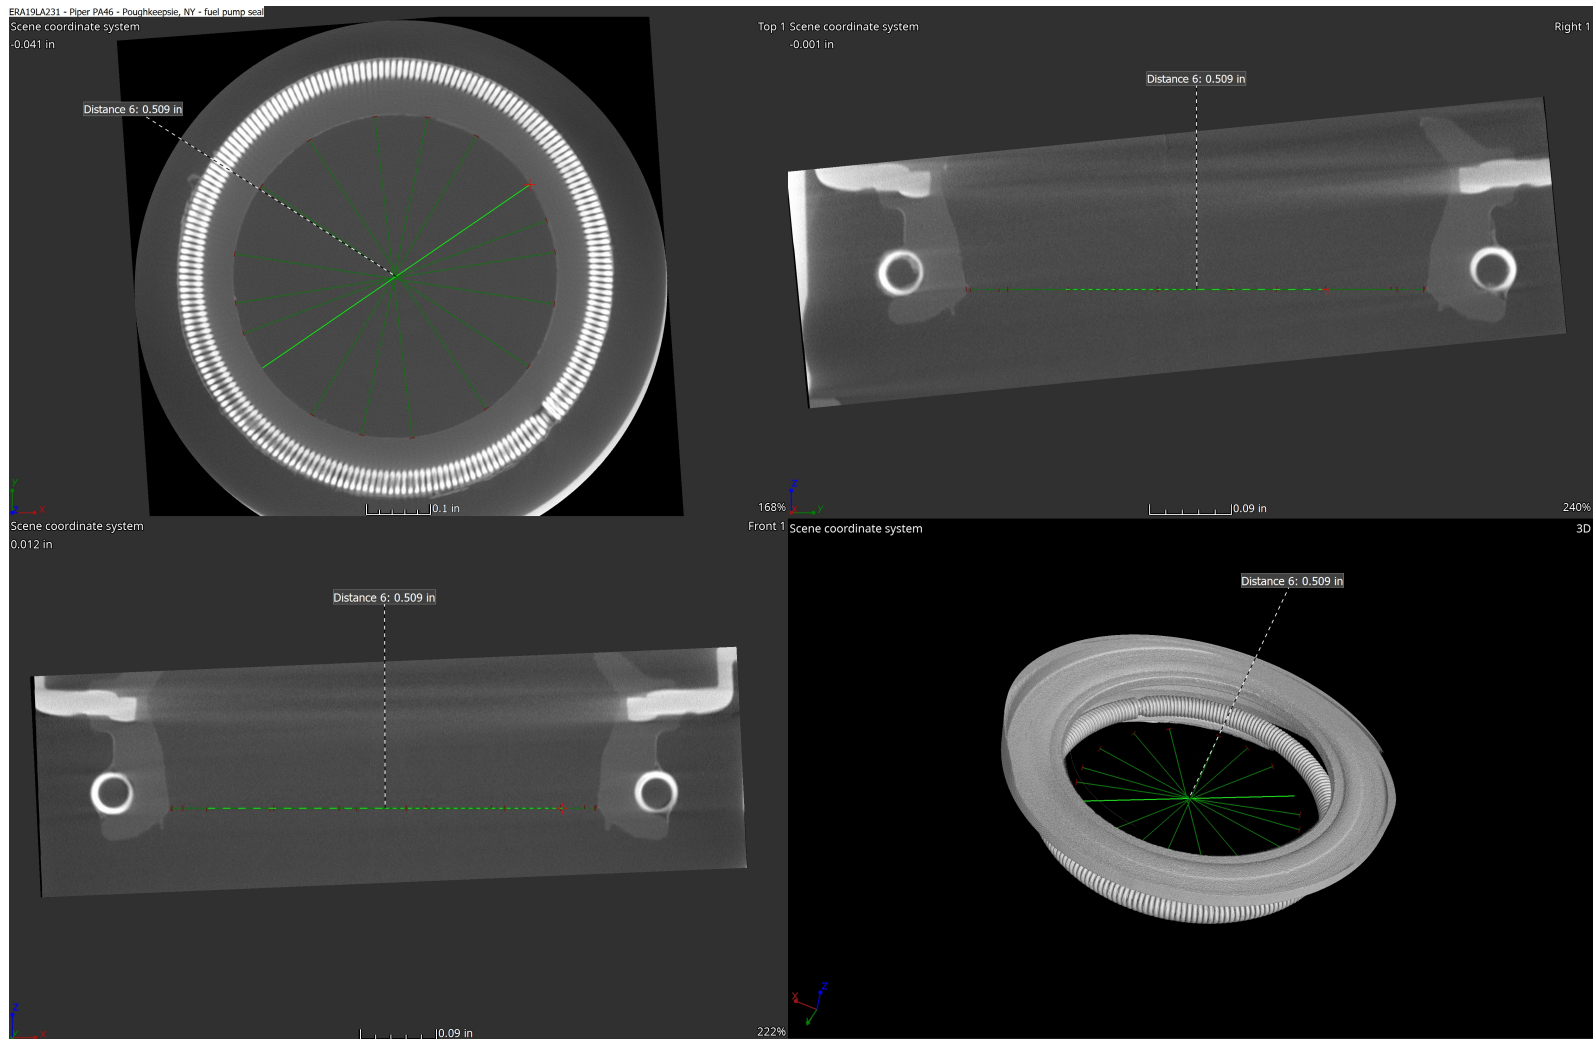
Figure 4  
Engine driven fuel pump seal – maximum seal opening diameter

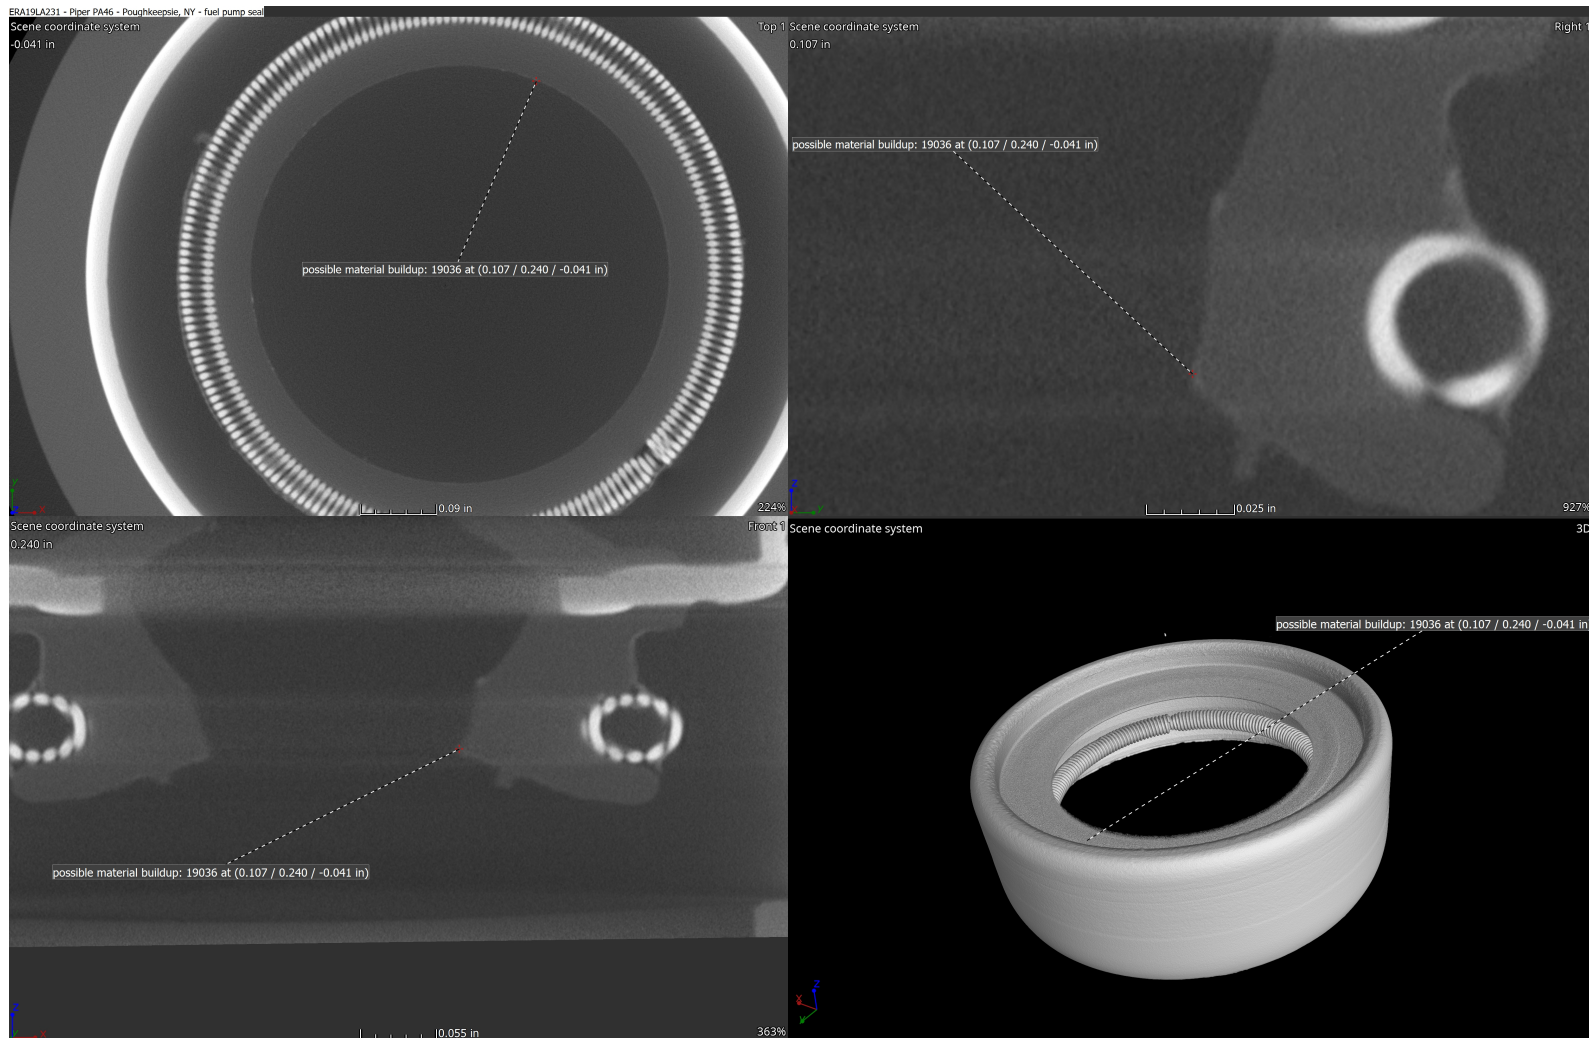
Figure 5  
Engine driven fuel pump seal – possible material buildup 1

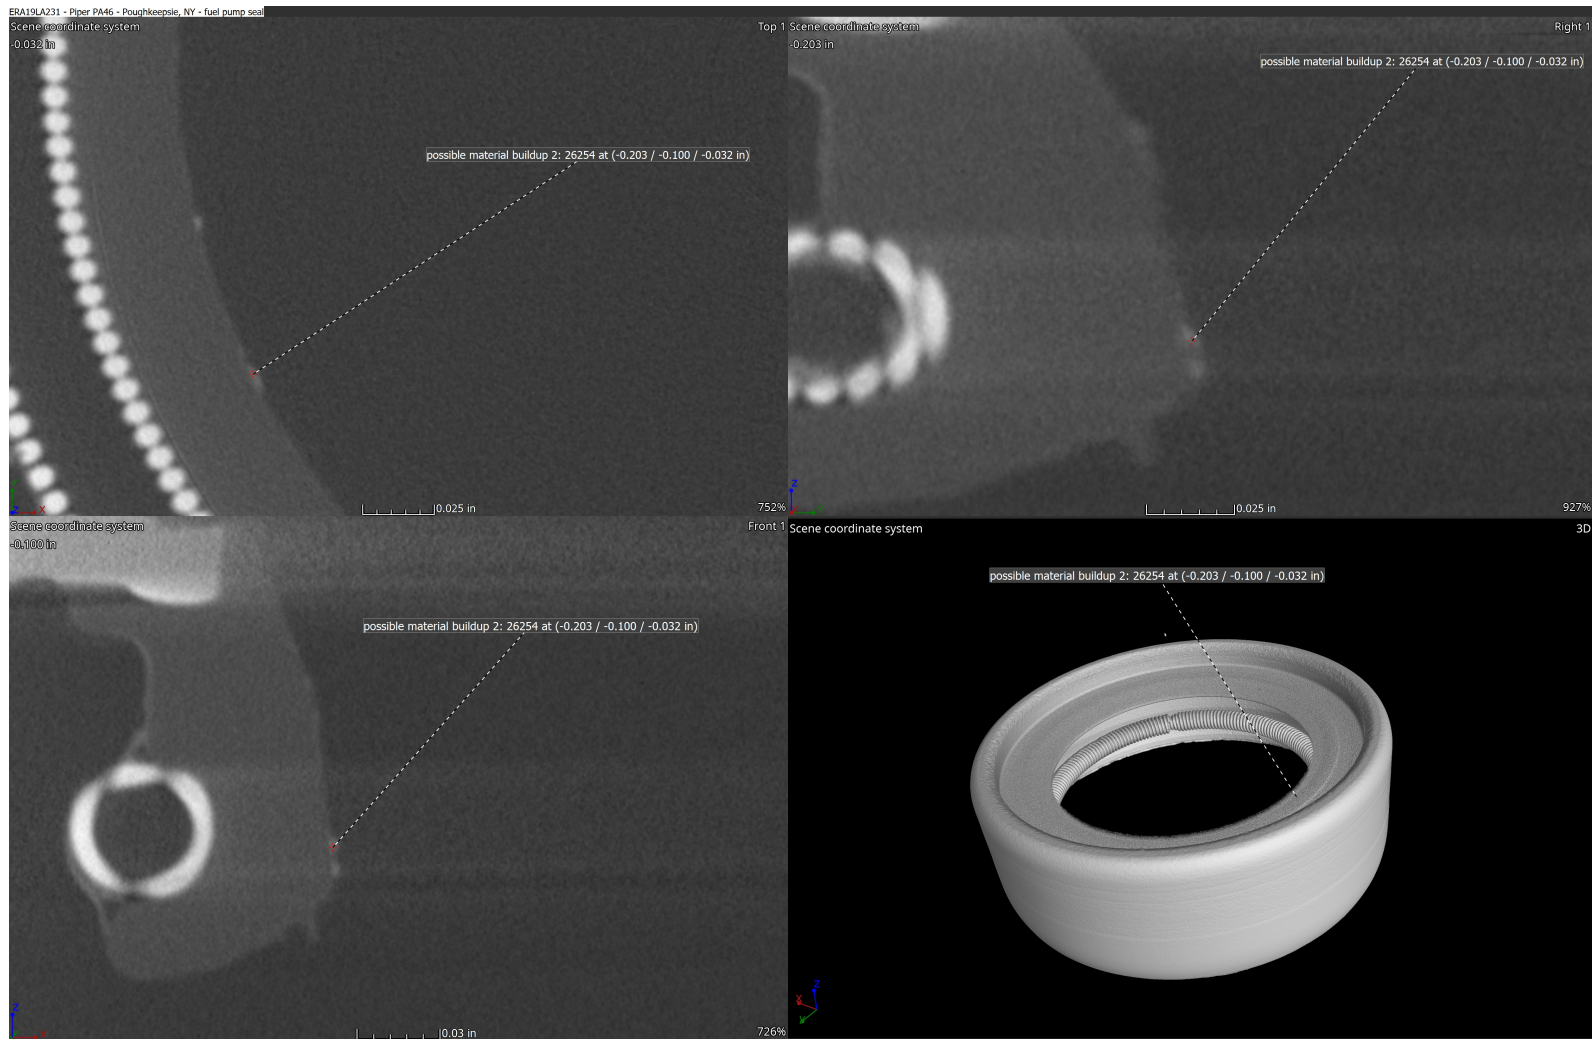
Figure 6  
Engine driven fuel pump seal – possible material buildup 2

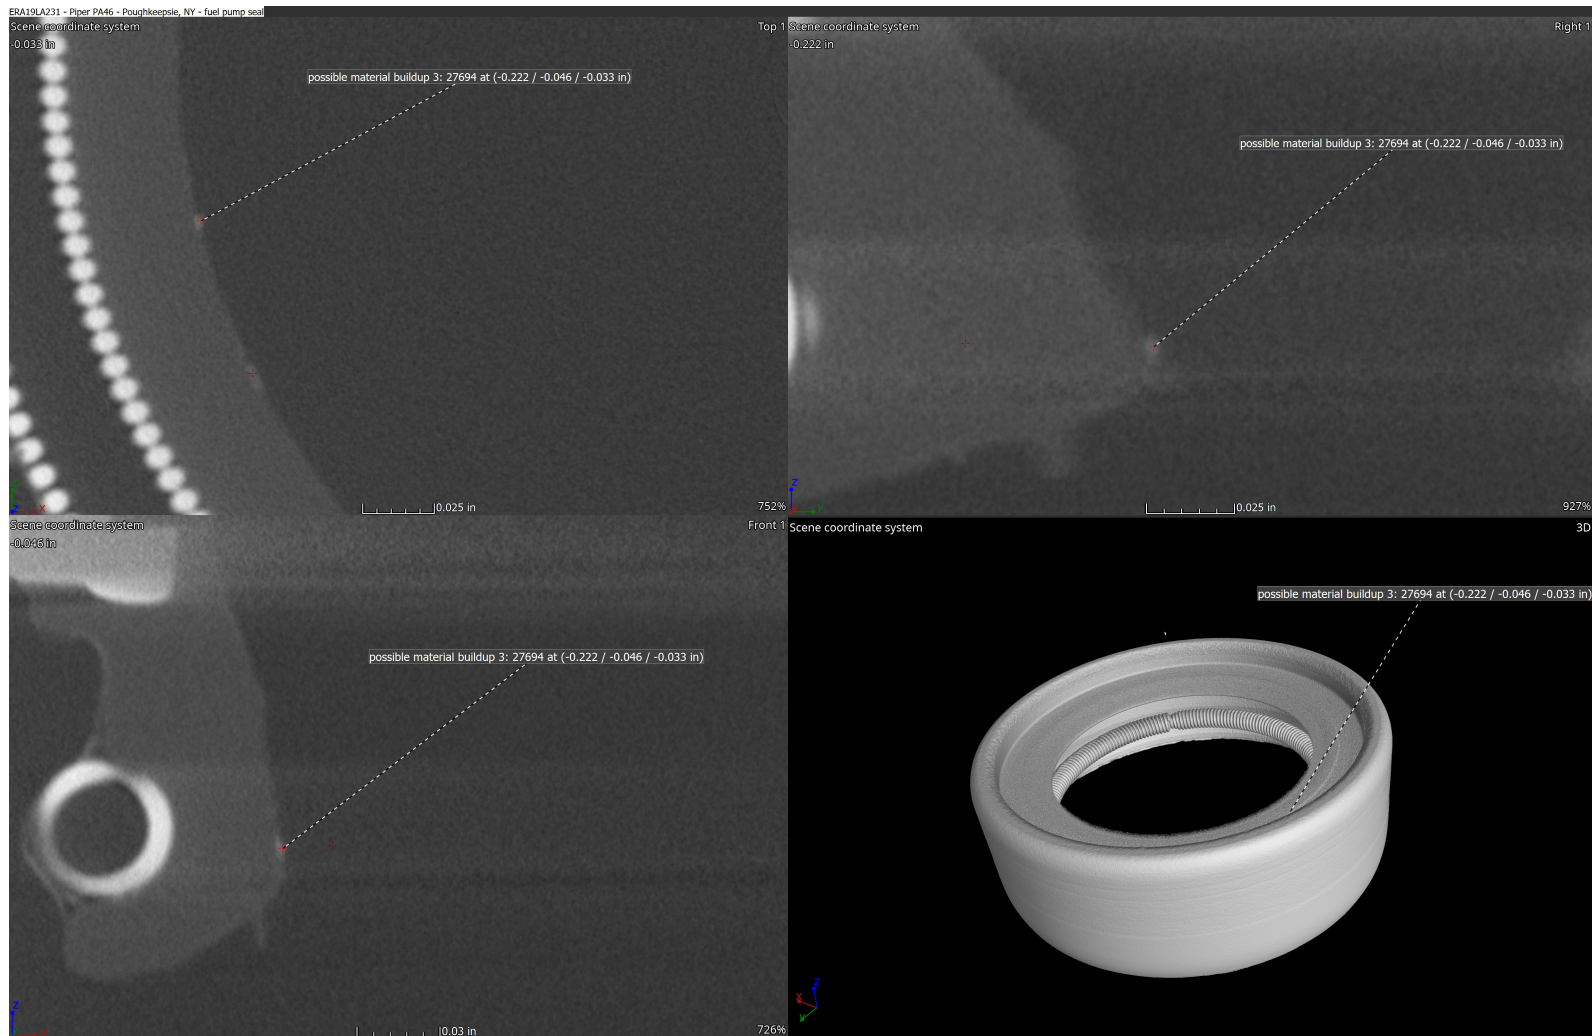
Figure 7  
Engine driven fuel pump seal – possible material buildup 3
