----- SYSTEMS GROUP CHAIRMAN'S FACTUAL REPORT -----

Location: Poughkeepsie, New York  
Date: July 19, 2019  
Time: About 1440 eastern daylight savings time (EDT)  
Aircraft: Piper PA46-310P  
Serial Number: PA46-8508046  
Registration: N811SK

## 3 SUMMARY:

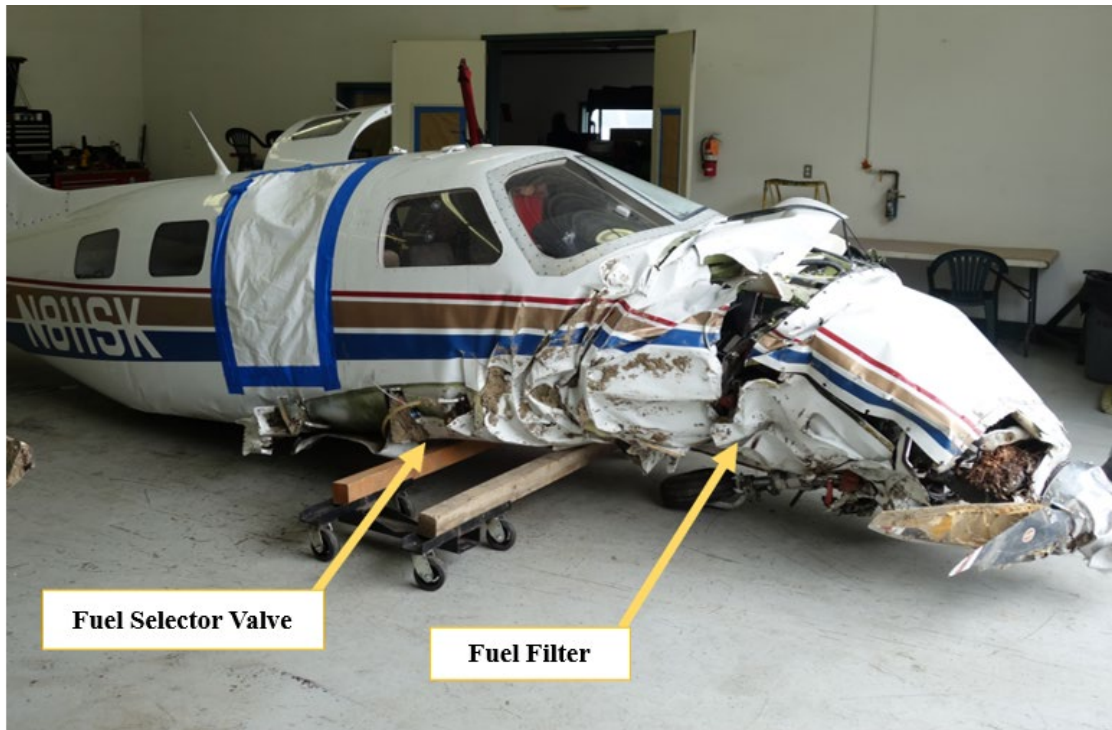
**Figure 2 - Aircraft fuselage at wreckage facility prior to engine removal (photo courtesy of Piper Aircraft)**

- The fuselage was intact and exhibited crush damage on the forward section with buckling also noted in the airframe, see Figure 2.
- Fuel was noted in the fuel line to the fuel manifold valve.

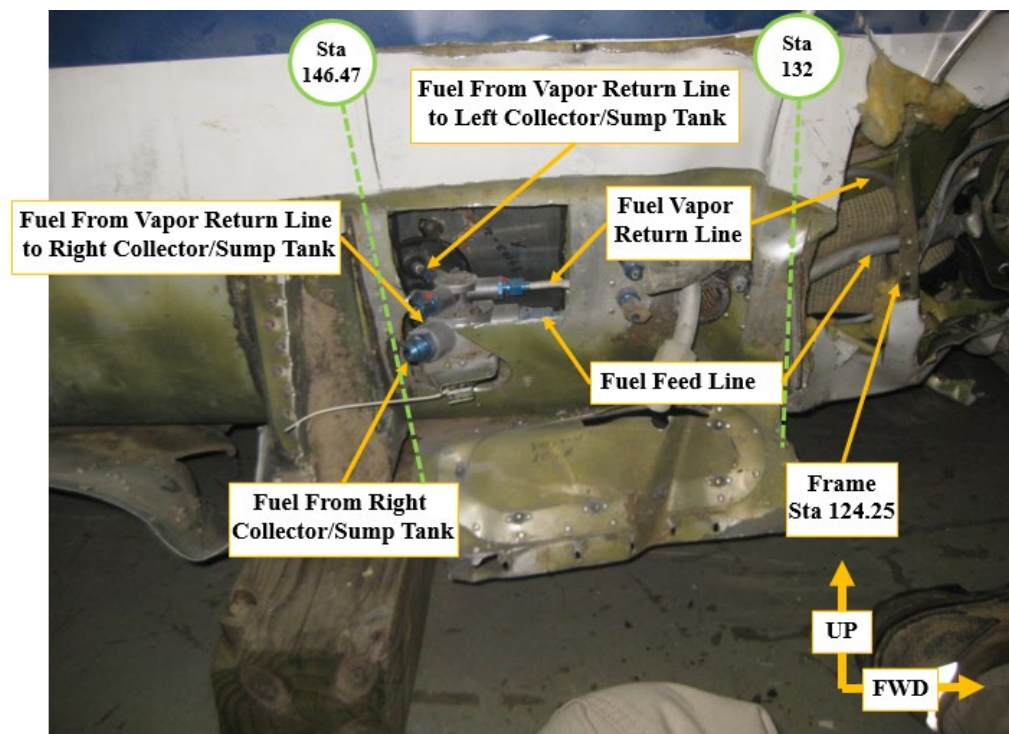
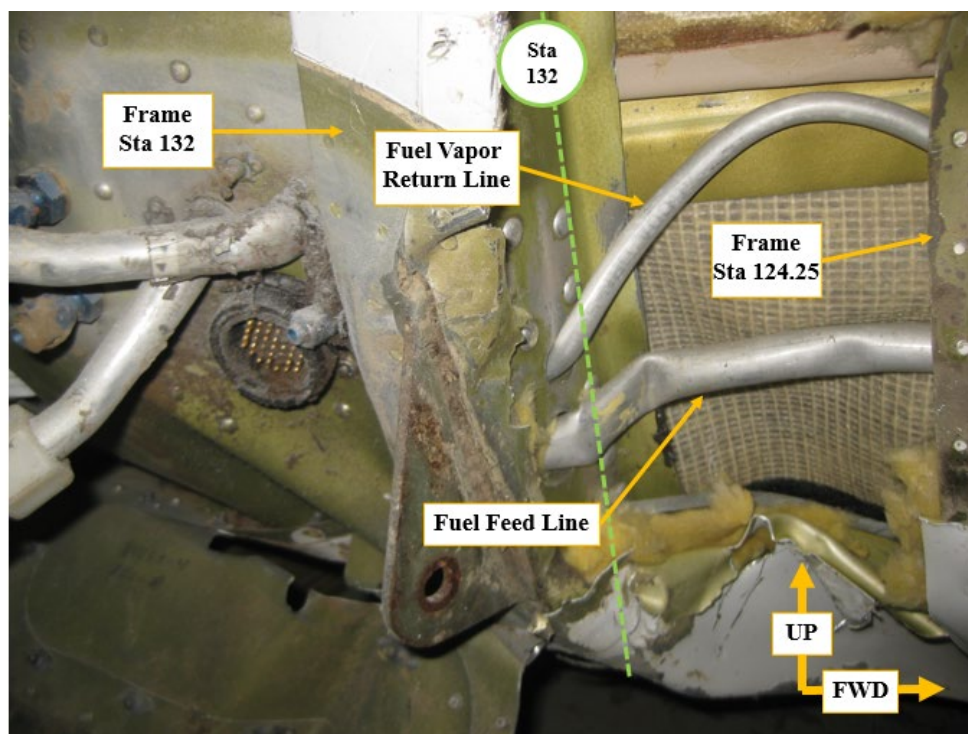
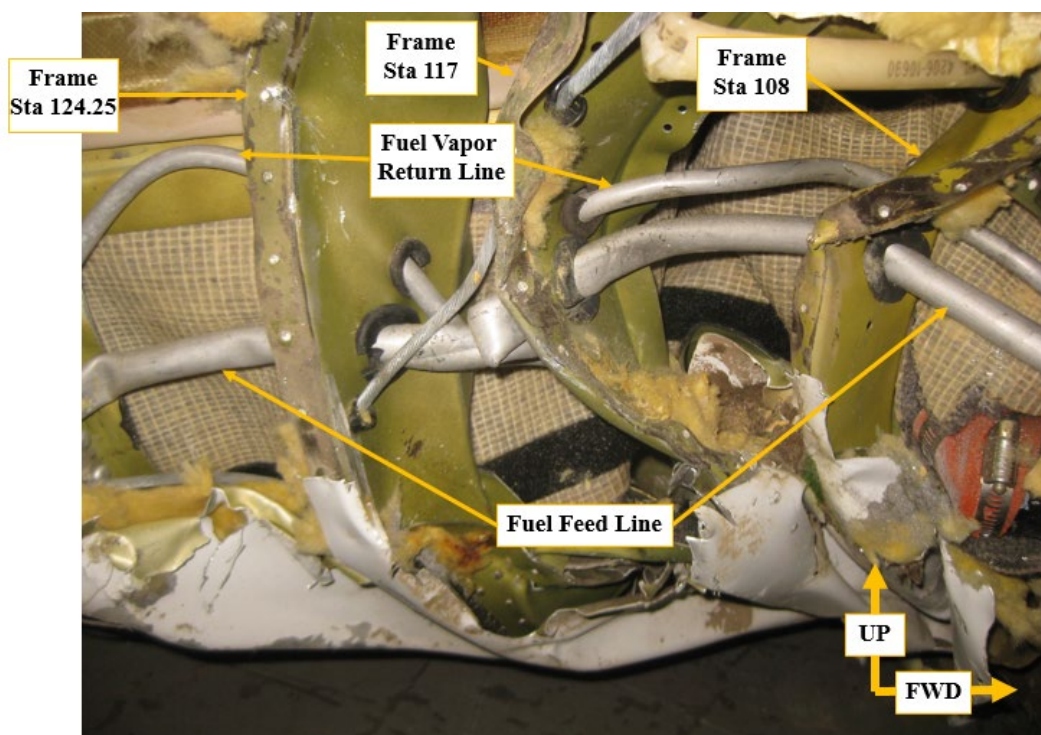
To provide access to the fuel selector valve and fuel supply/return tubing, a hole was cut in the fuselage skin to allow for a visual inspection, ref Figure 3, Figure 4 and Figure 5. Areas of displacement to the fuel feed and vapor return lines, consistent with impact damage, were visible along various portions of the fuselage. There were no indications of leaked fuel around the fuel selector valve, fuel tubing or surrounding structure.

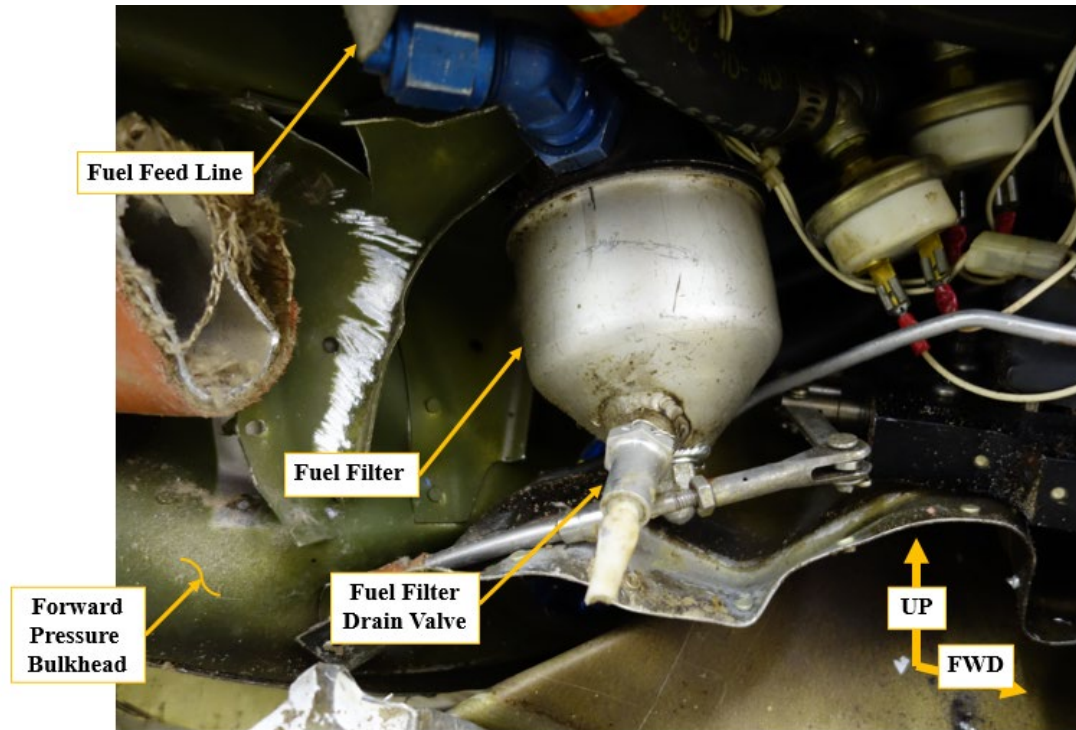
**Figure 6 - Fuel filter prior to removal from aircraft, during initial examination (photo courtesy of Piper Aircraft)**

The area in the forward pressure bulkhead where the fuel filter was installed showed damage consistent with impact. The fuel filter mounting brackets were displaced but the fuel filter was intact, Figure 6. There were no indications of leaked fuel around the fuel filter, fuel tubing or surrounding structure.

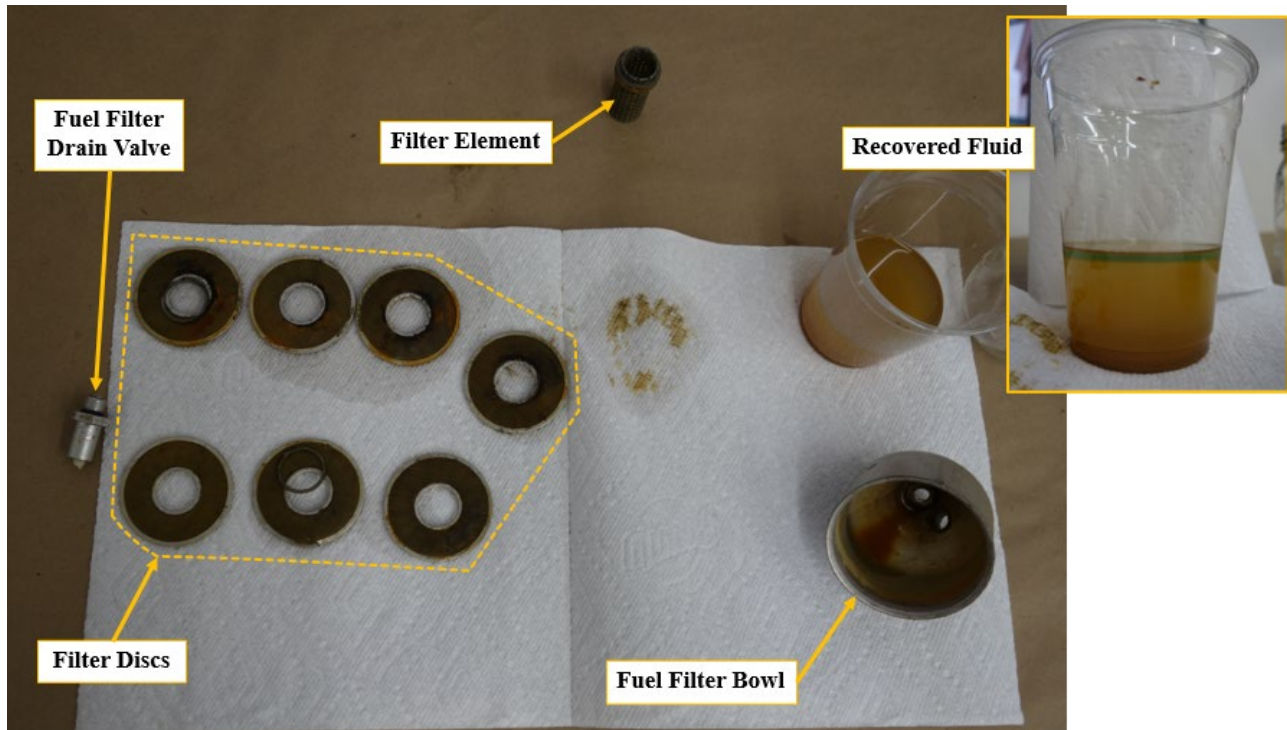
- 6 oz. of fluid was drained from the fuel filter bowl. About 1 oz. was similar in appearance to 100LL aviation fuel.
- The engine was removed for shipping and testing at the engine manufacturer.

During the initial wreckage examination, the fuel filter bowl and filter media was inspected. As stated in 4.5.1.1, fluid was drained from the filter bowl. Figure 7 shows the contents of the fuel filter after the filter bowl and filter media was removed. No additional testing of the fuel filter was performed.

Figure 7 - Disassembled fuel filter and fluid found in filter. (Courtesy of Piper Aircraft)

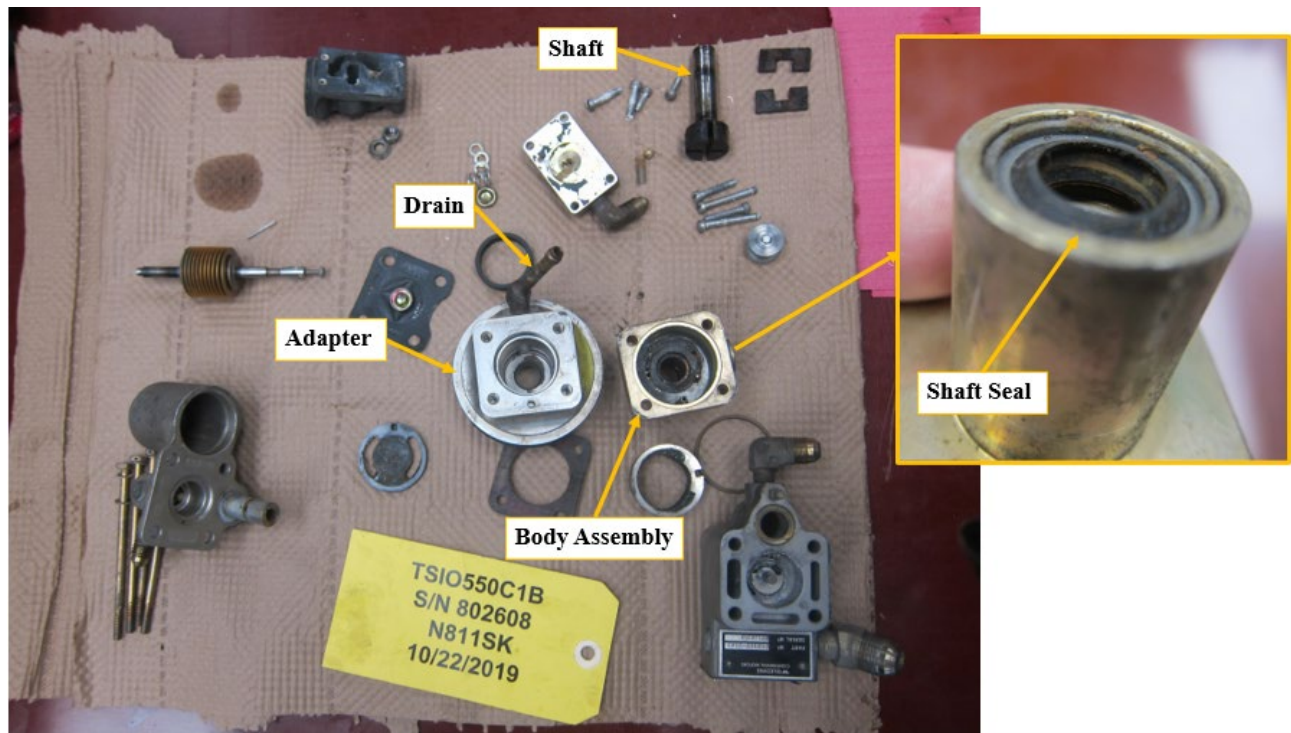
“The engine experienced a normal start on the first attempt but would not continuing running without the use of the test cell boost pump. The engine driven fuel pump was removed, and the drive coupling was damaged.”<sup>3</sup>

At the engine examination, the engine driven fuel pump was disassembled and was noted to contain debris and corrosion throughout the pump which precluded the pump from rotating normally. The pump coupling was damaged.

Figure 8 - Disassembled fuel pump and close-up view of shaft seal (Courtesy of TCM)
