**ERA19LA232**

**Ocean City, Maryland**

**Vans RV-7A N849GS**

**NTSB ENGINE EXAMINATION REPORT**

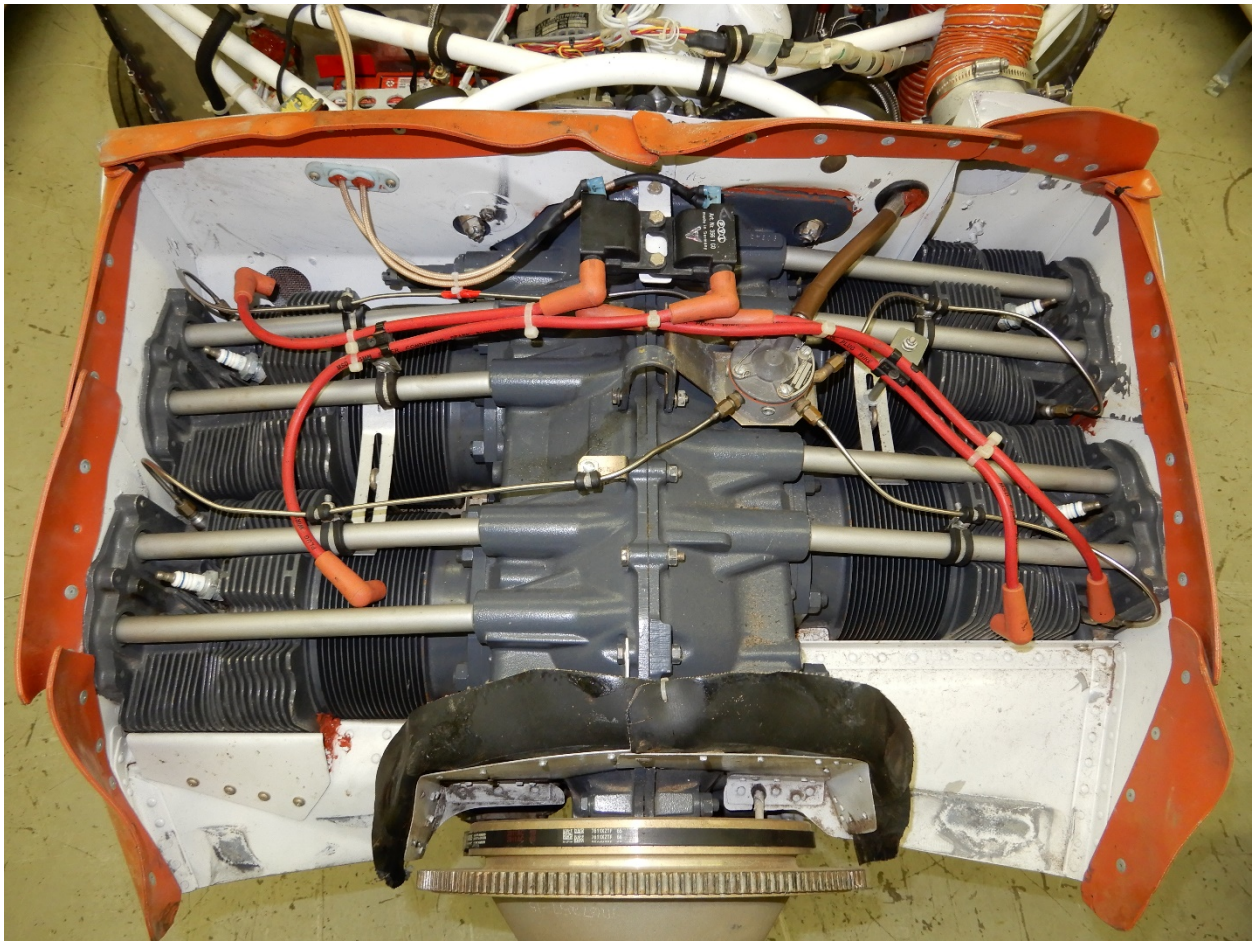
Figure 2. View of engine as found.

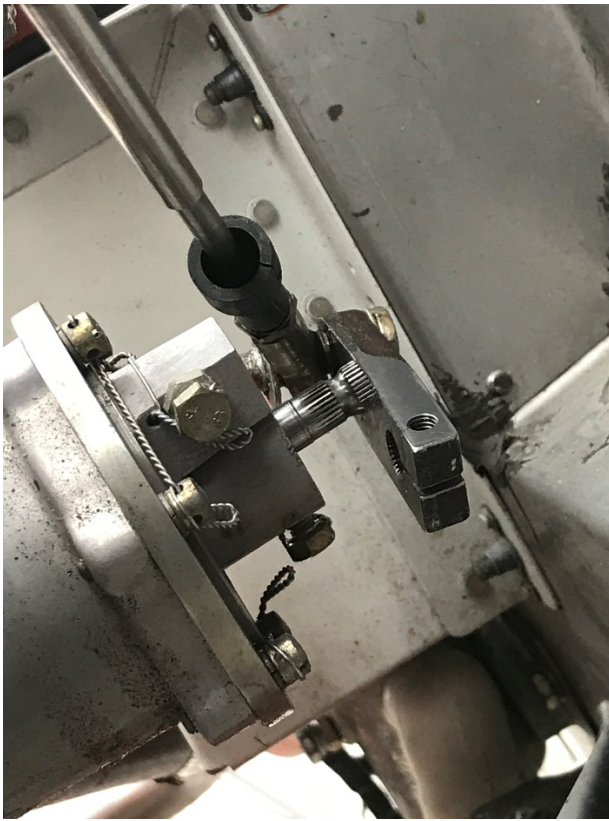
- The governor control arm was disconnected from the propeller governor and the control arm locking bolt was missing. In addition, the secondary control arm/spacer was not located, nor was the spring. Furthermore, the governor control arm pin that slid into the secondary control arm/spacer was not sheared and remained intact.

Figure 3. View of control arm not attached to propeller governor.

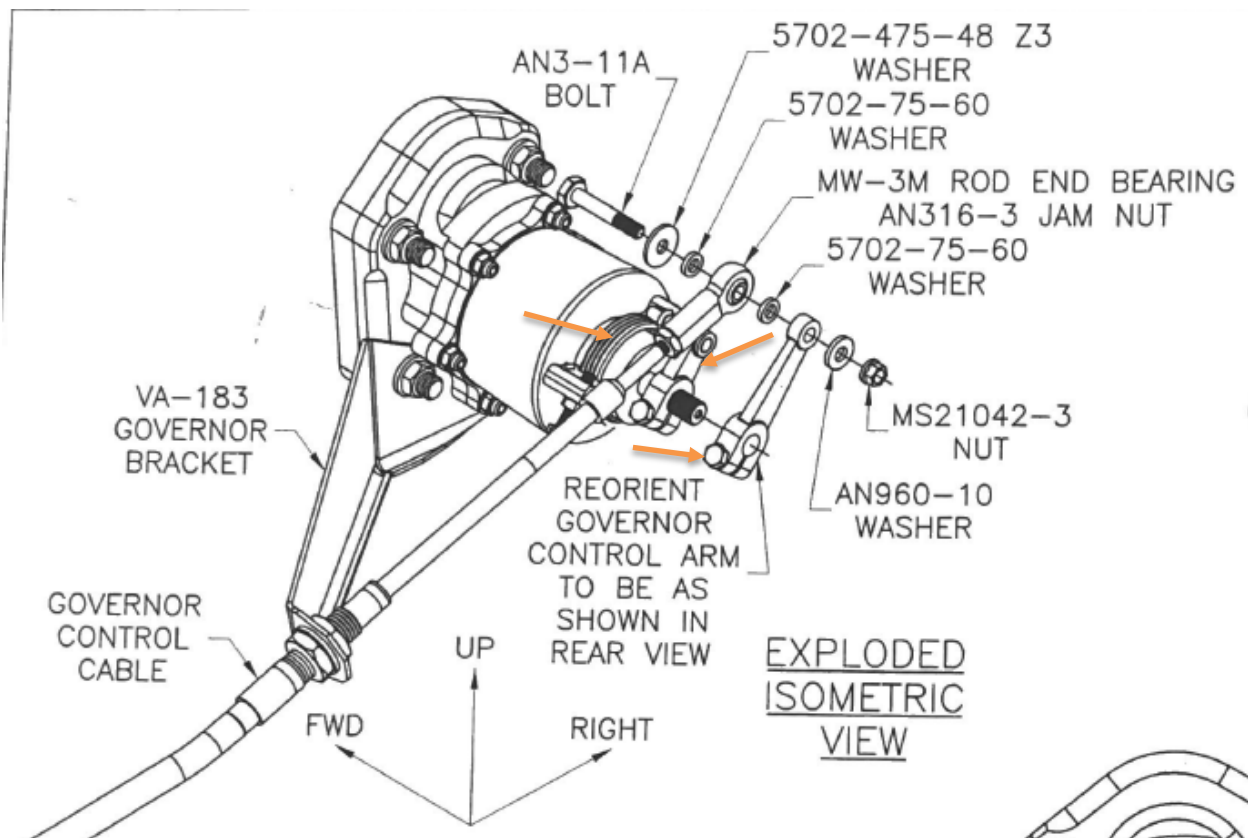
Figure 4. Propeller Governor Parts Drawing with orange arrow pointing to missing parts.
