# NTSB MEMORANDUM OF RECORD

**Summary of Landing Gear System Examination at Chattanooga Aero Services**  
**Date of Examination: August 13, 2019**  
**Overseen by Neal R. Thorne, Aviation Safety Inspector, FAA**  
**Accident Number: ERA19LA239**

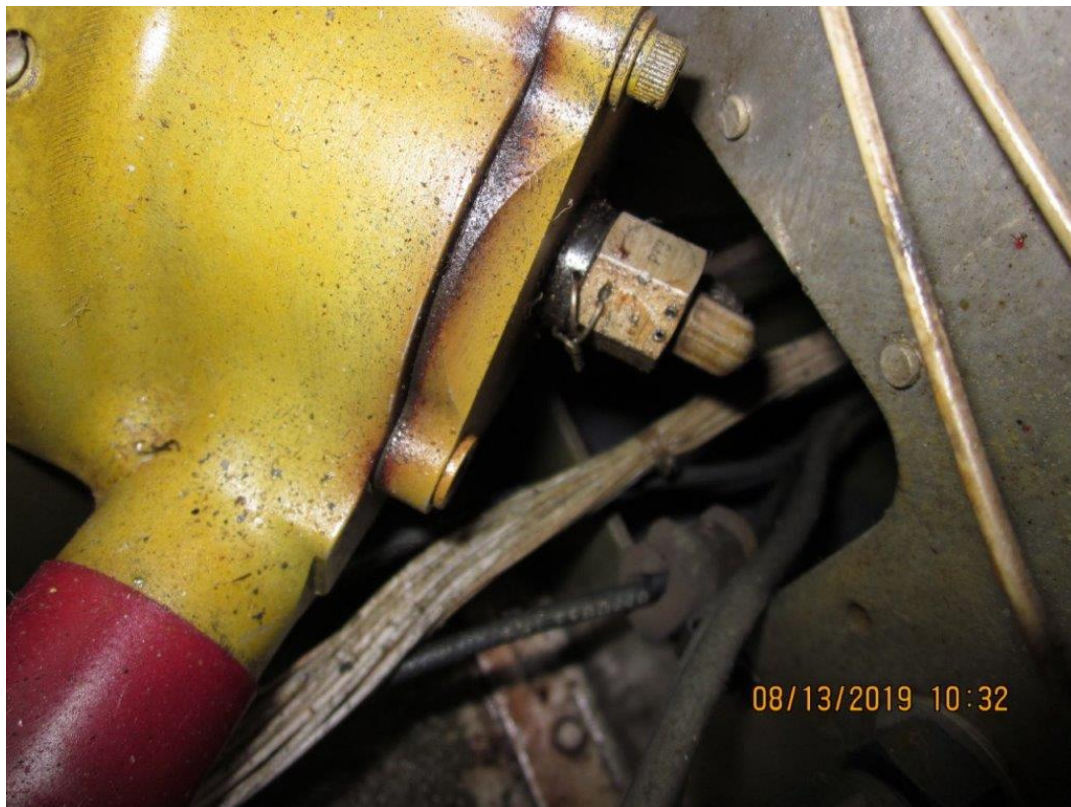
- The left actuator was broken possibly from operation with air in the hydraulic system or during impact.
- Inspector Thorne was able to operate the hand pump and create pressure however it was impossible to get positive movement from the left actuator due to damage. The hand pump felt abnormal as if trying to pump air and fluid.

- Examination of the actuator end cap revealed a sheared screw head. There should be three screws holding this together; however, the left actuator only has one screw left intact.

*Figure 1: Sheared Screw Head from the Actuator End Cap (Photo Courtesy of FAA)*
