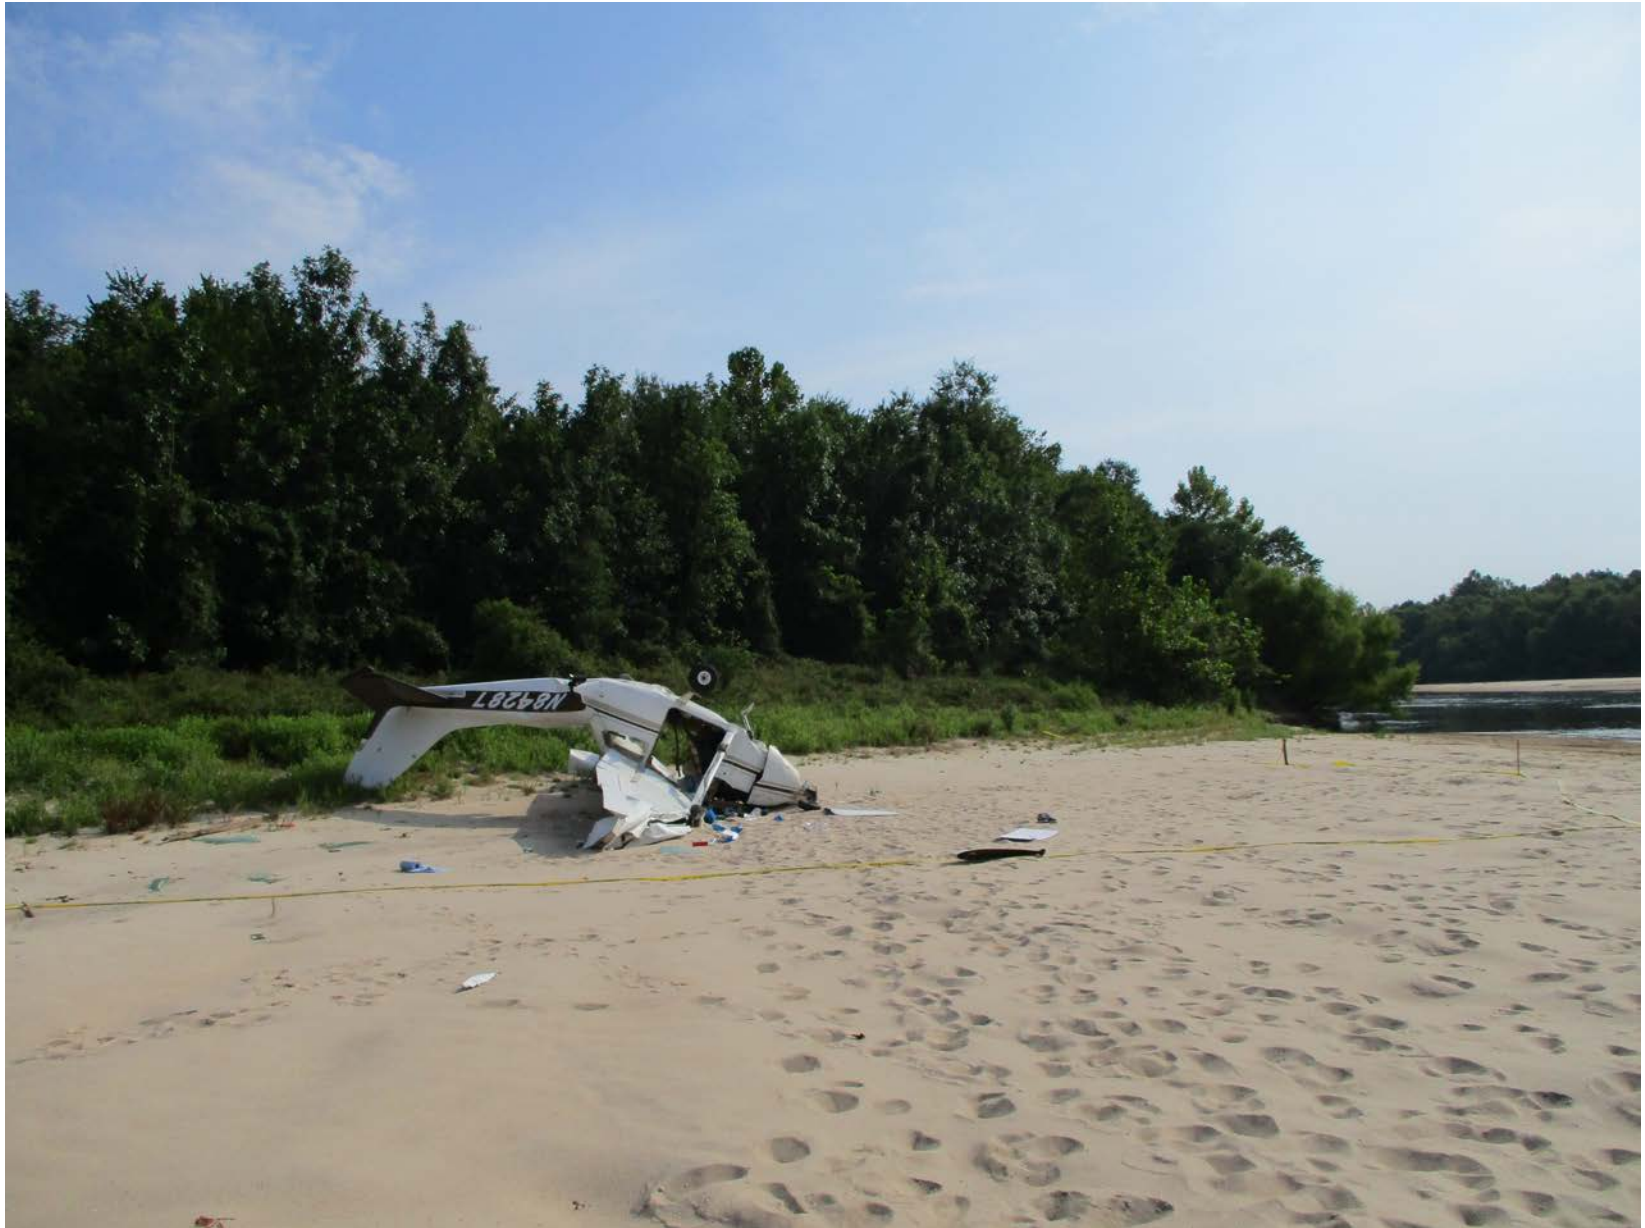
**Photo 1 – Profile view of inverted airplane on the sandbar. (Courtesy of FAA)**

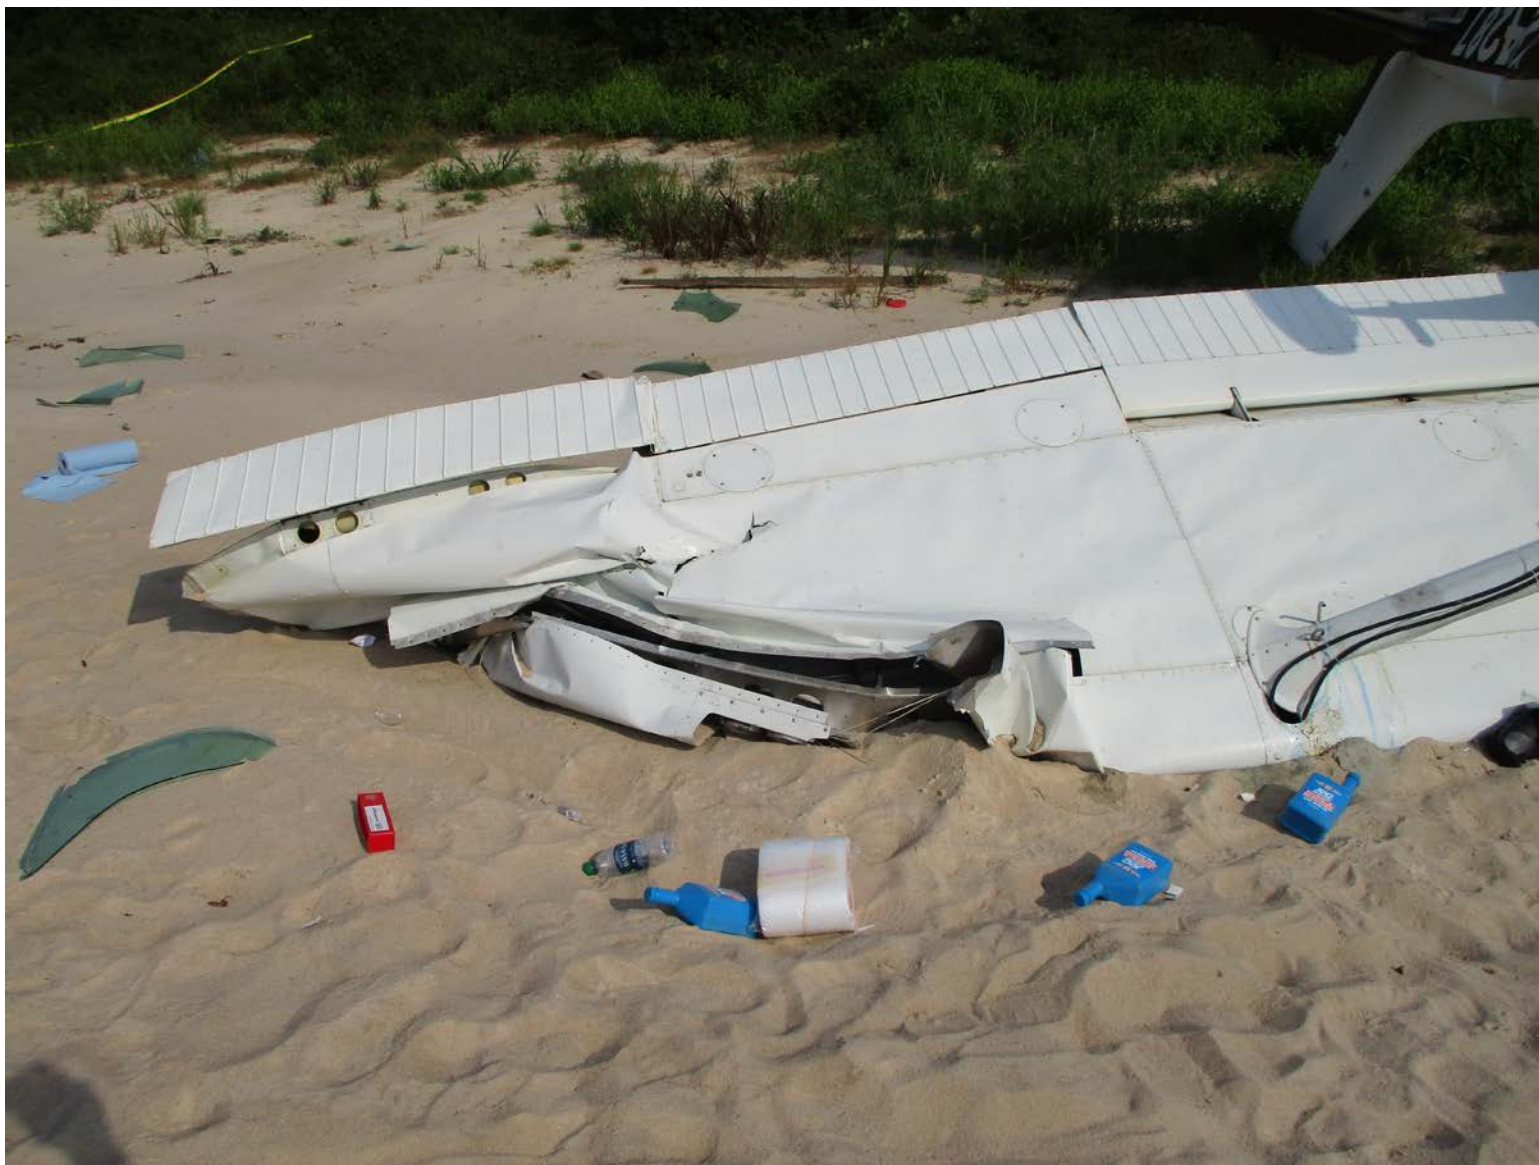
**Photo 2 – Close up view of left wing damage. (Courtesy of FAA)**

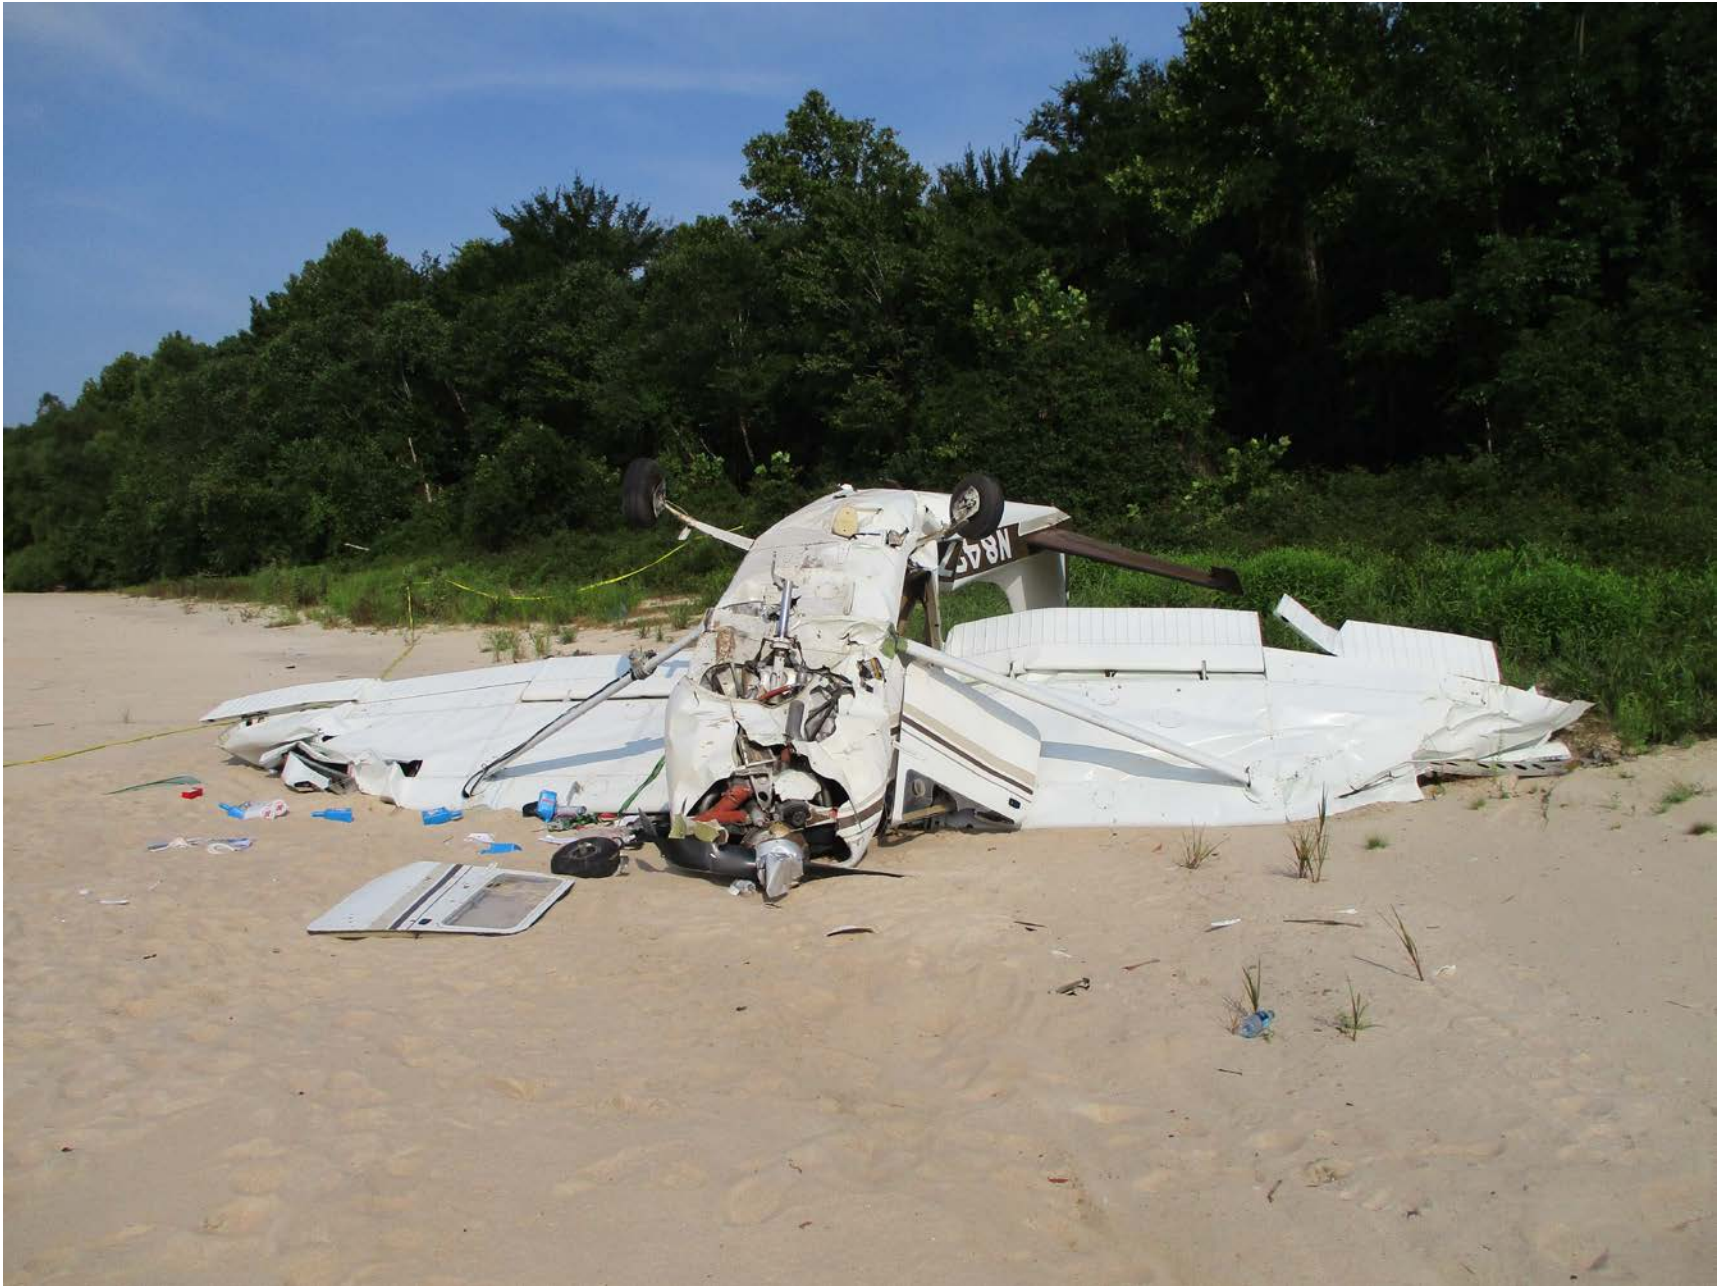
**Photo 3 – Airplane inverted on the sandbar showing damage to both wings and fuselage. (Courtesy of FAA)**

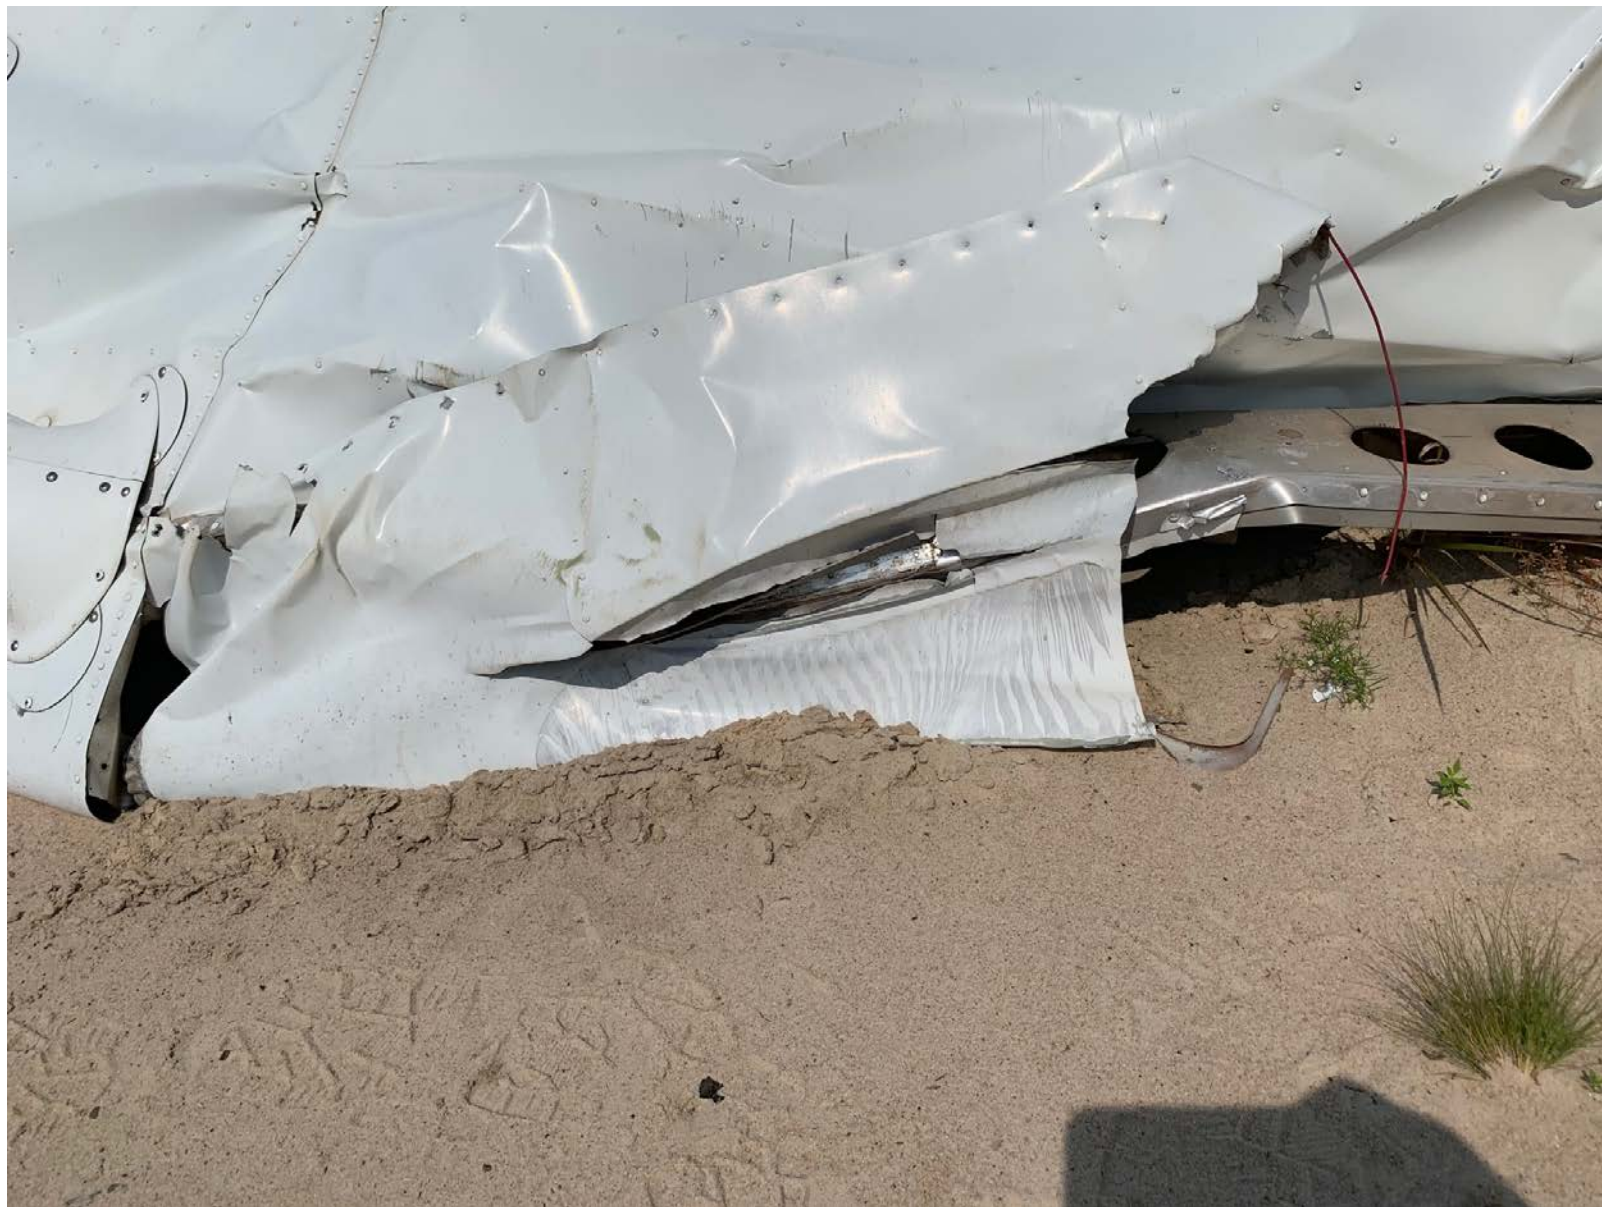
**Photo 4 – Close up view of right wing leading edge damage. Note powerline polishing & scrape marks. (Courtesy of FAA)**

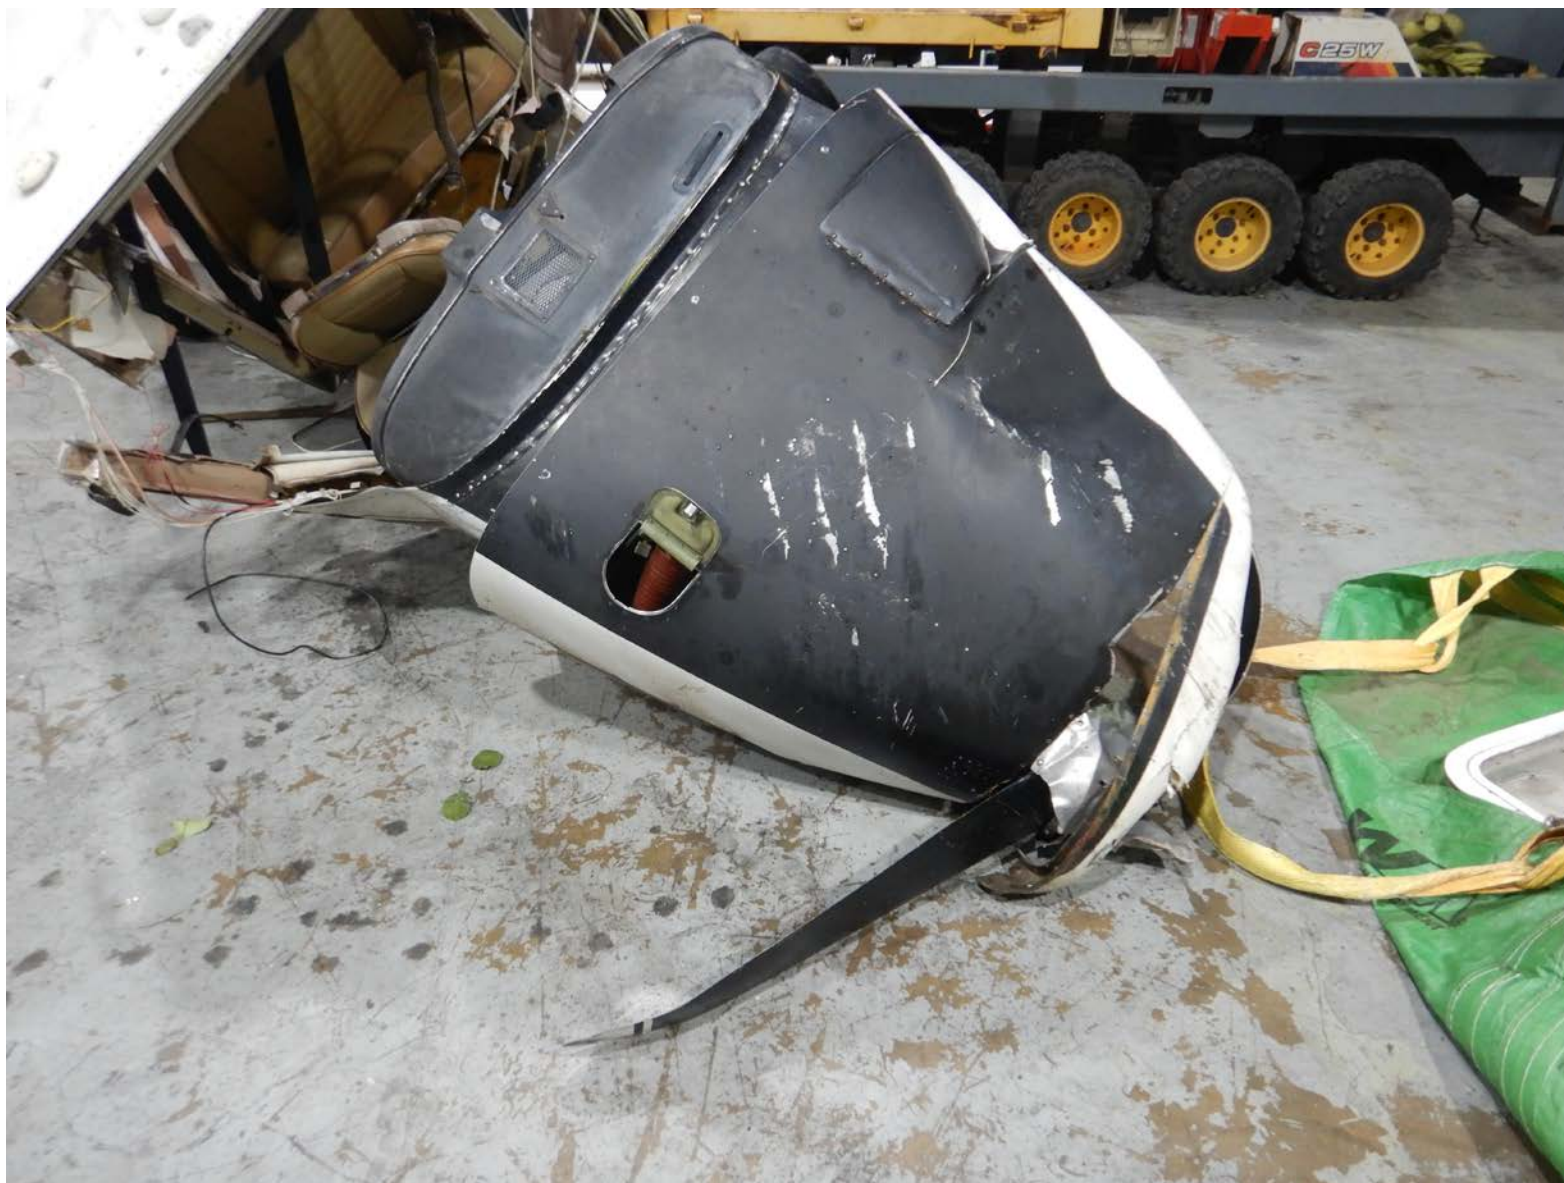
**Photo 5 – Top of engine cowl and propeller damage. Note the six polished scrapes in the paint. (Courtesy of Lycoming)**

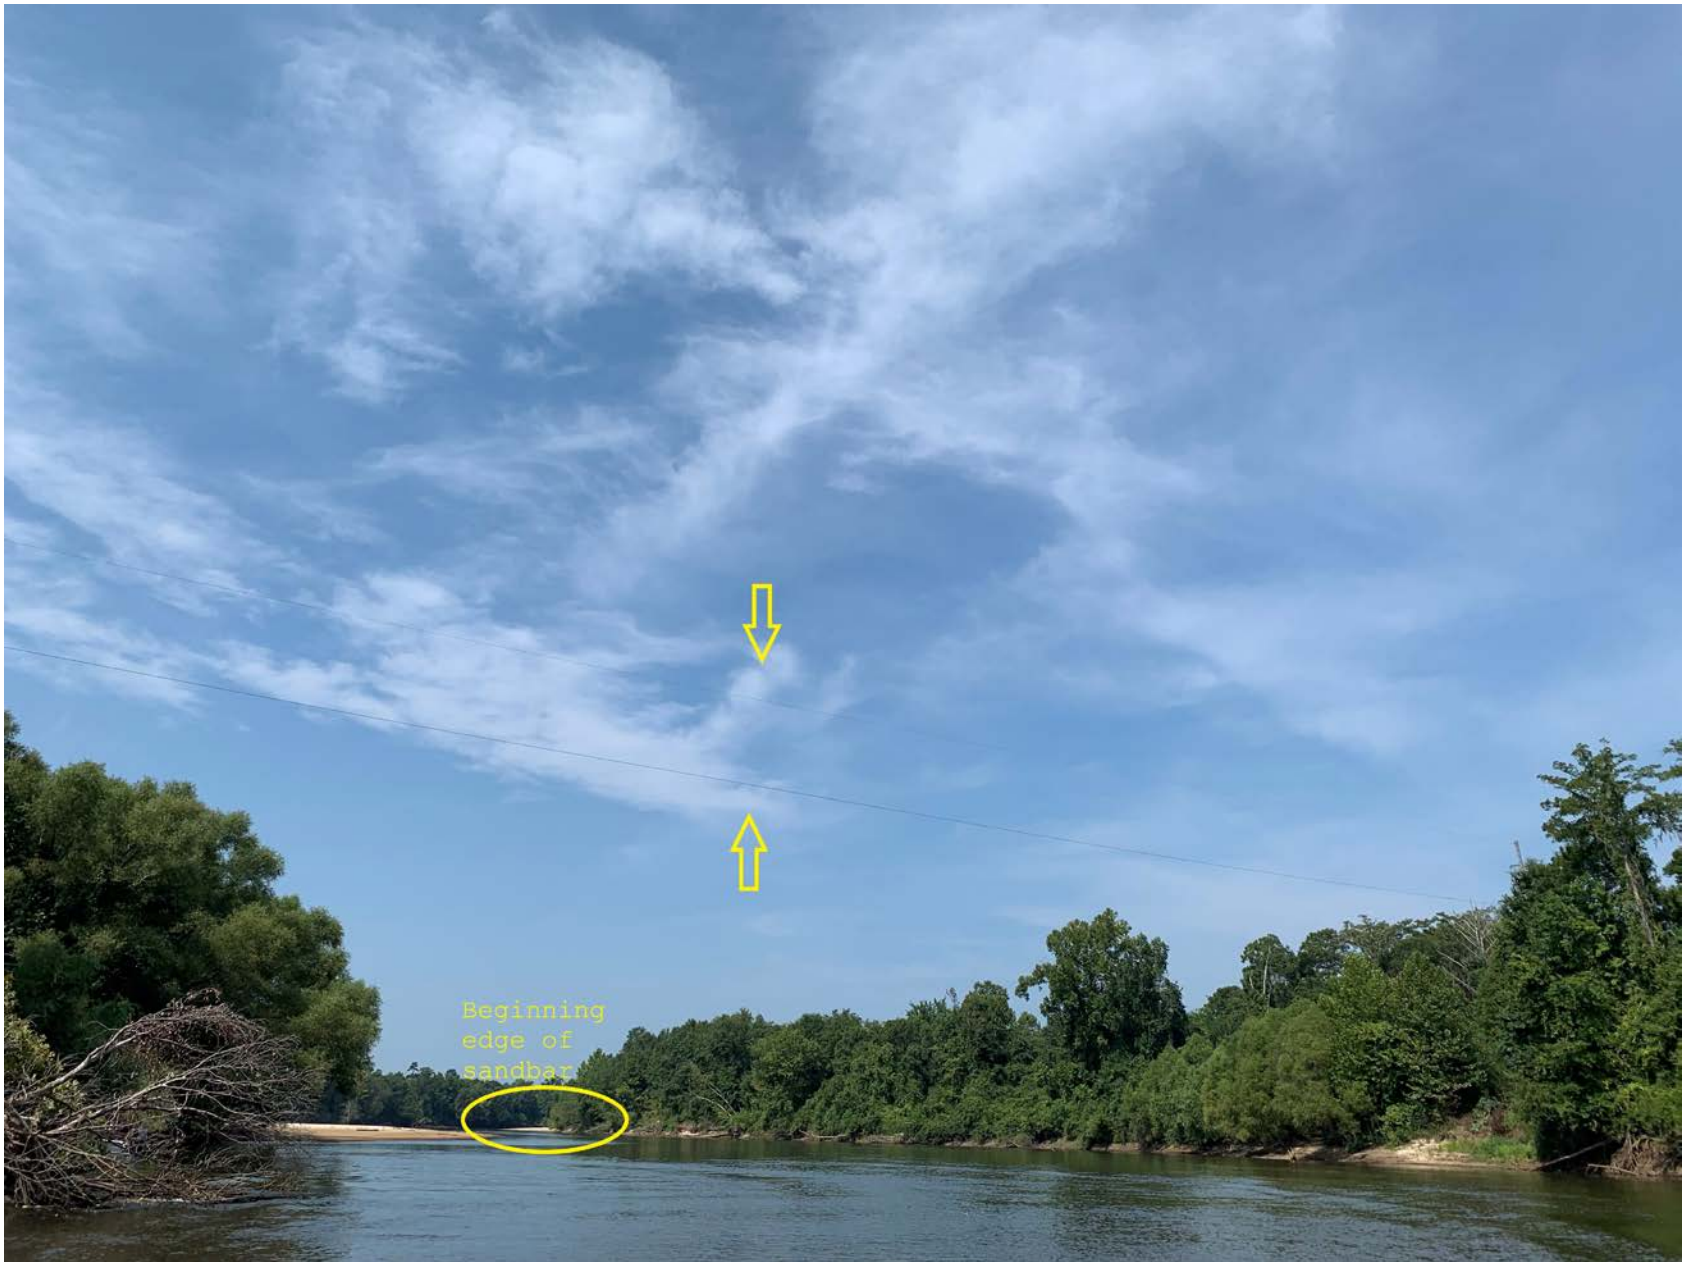
**Photo 6 – Photograph of transmission lines over the river with the accident site in the distance. (Courtesy of FAA)**

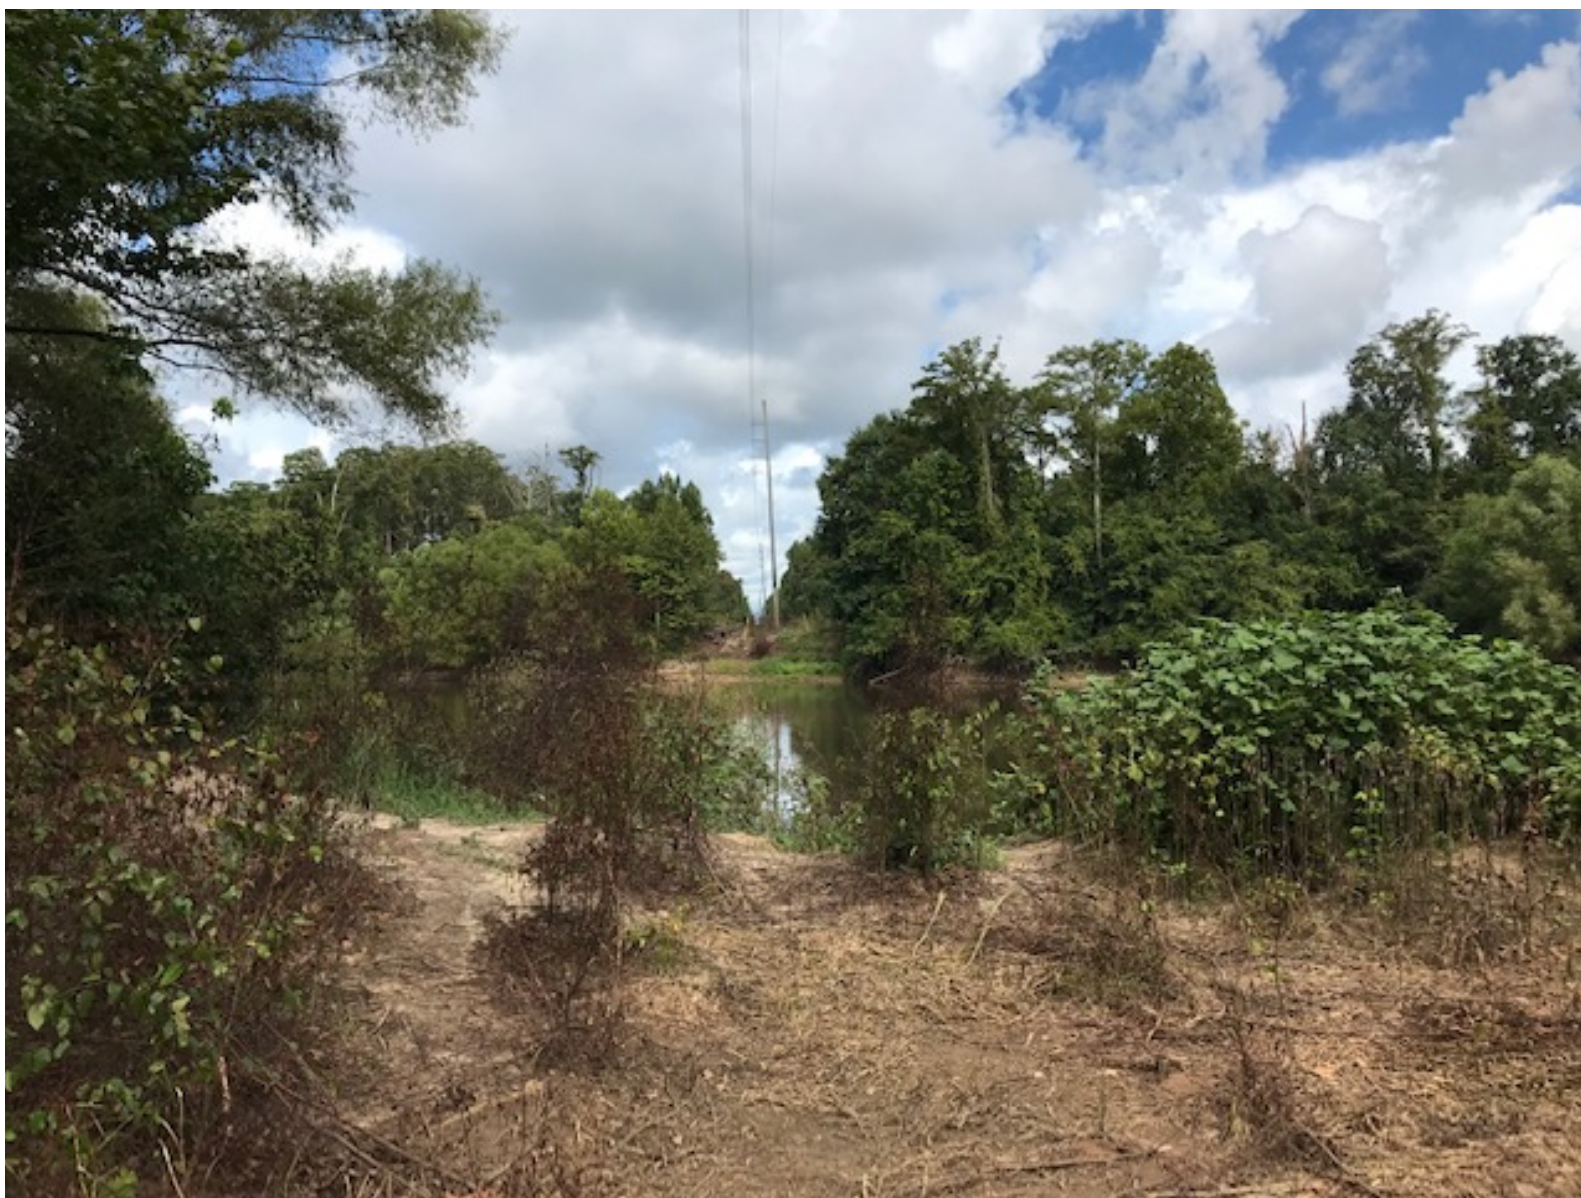
**Photo 7 – Photograph of transmission lines over the water looking west from the bank of the river. (Courtesy of Maverick Natural Resources, LLC)**
