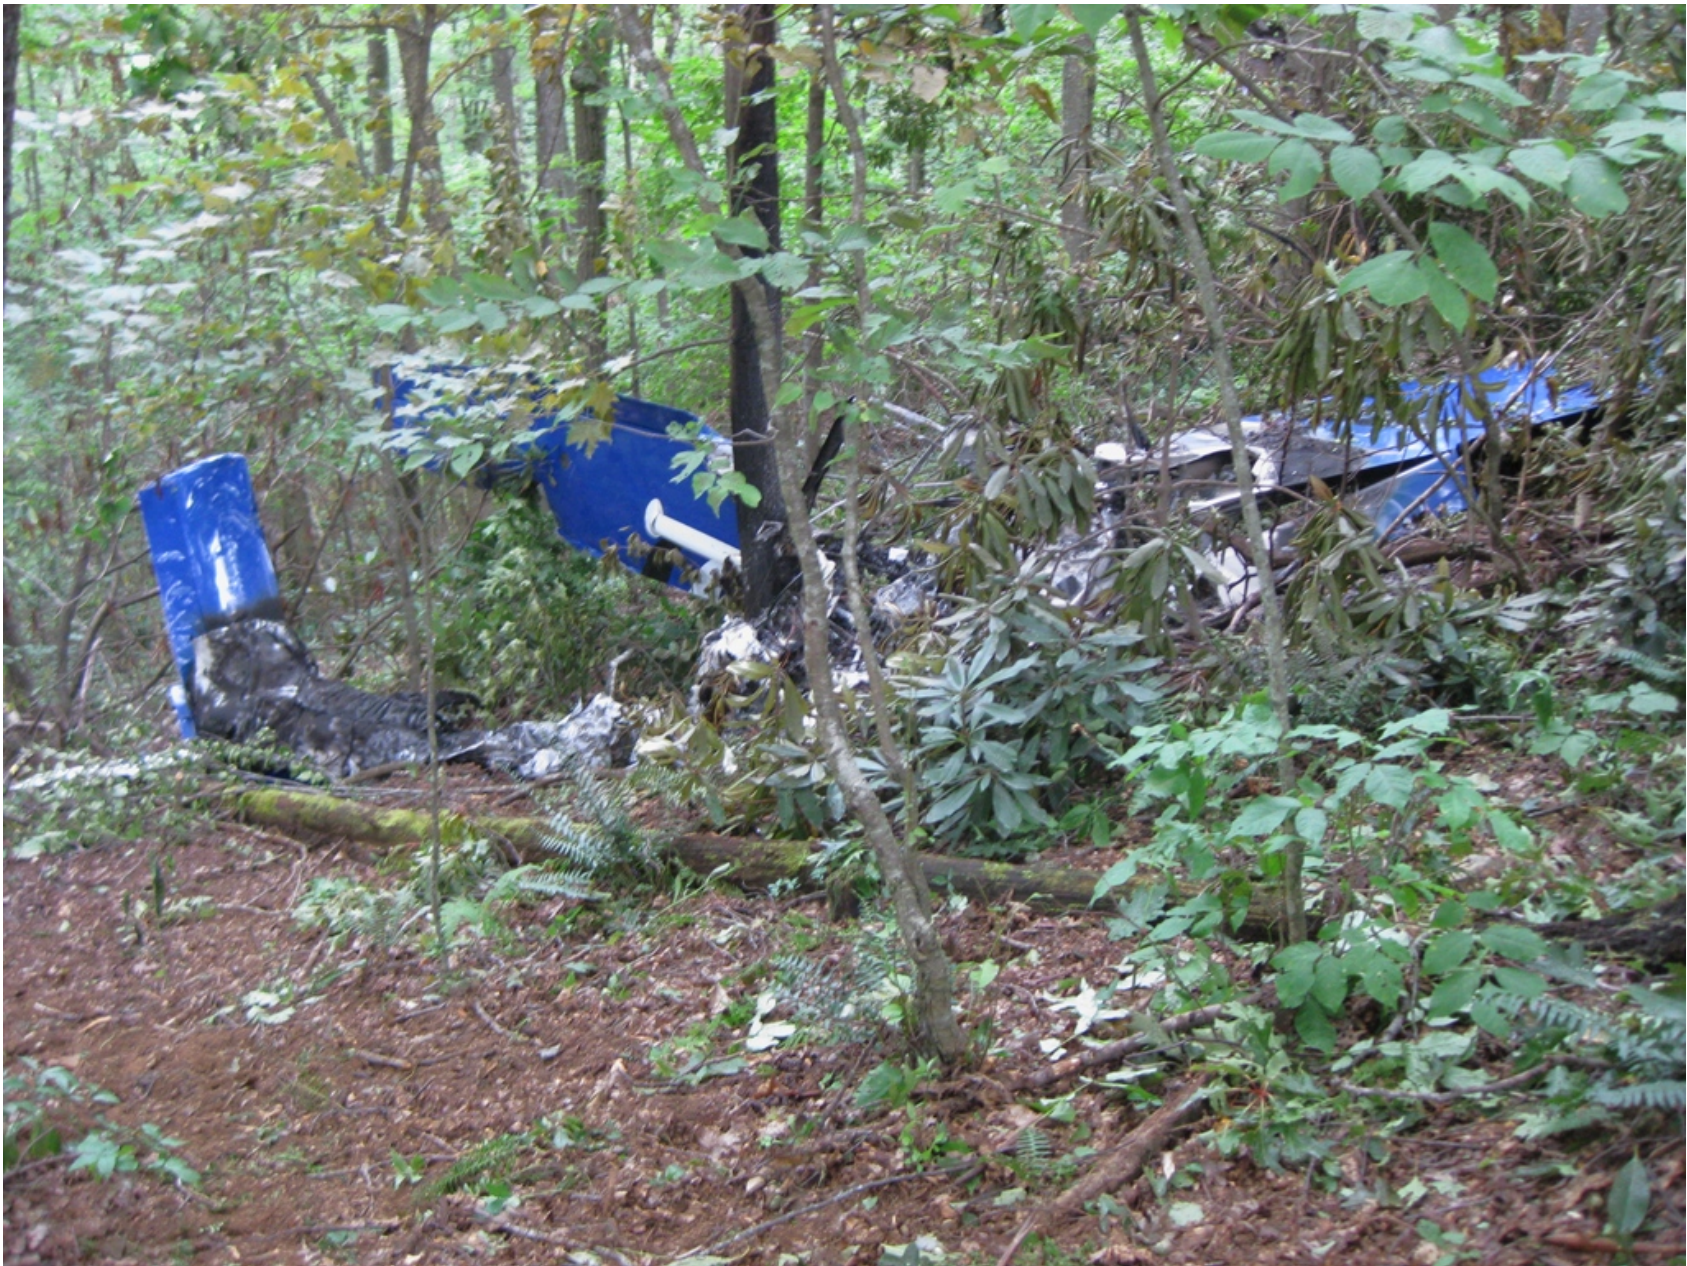
**Photo 1 – FAA Digital Photograph. View of the Wreckage At the Accident Site.**

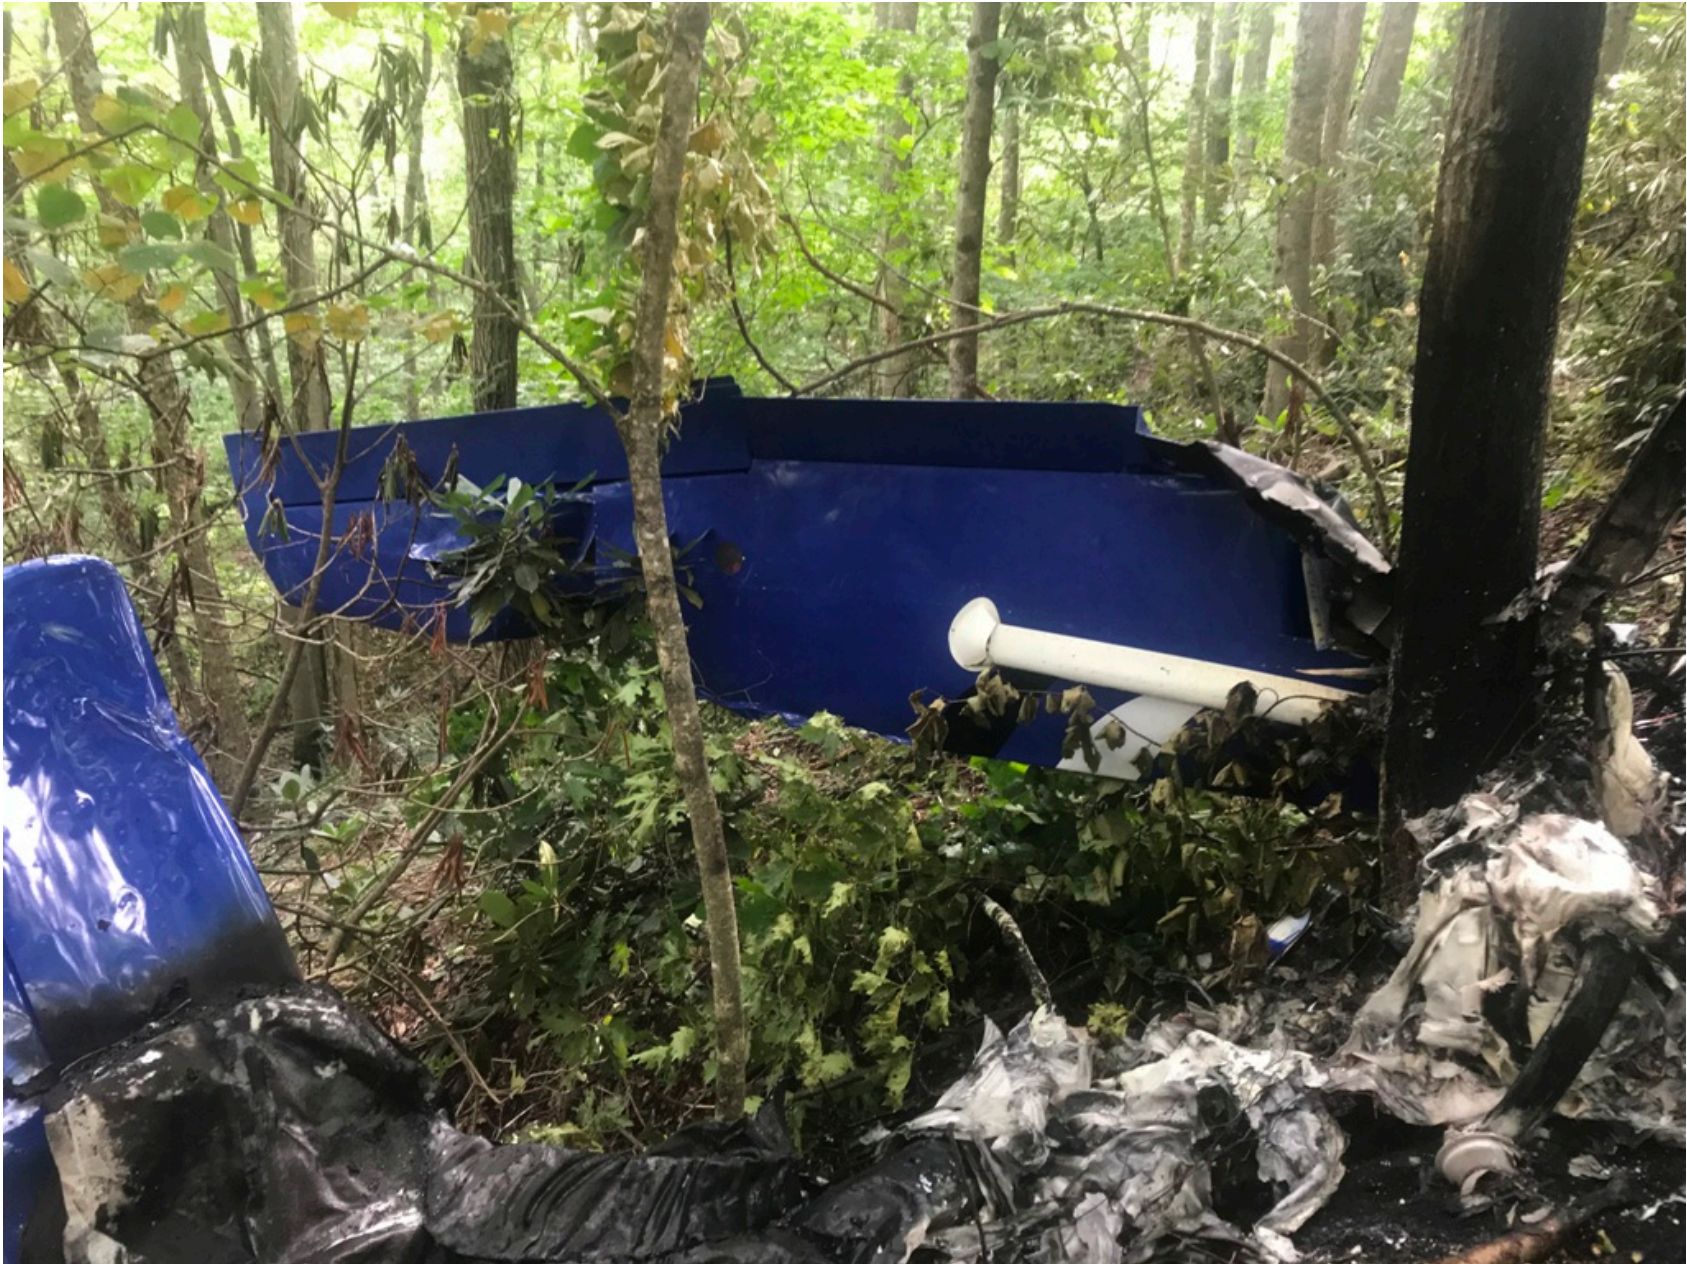
**Photo 2 – NC State Highway Patrol Photograph. Aft Side View of the Left Wing. Note the Impact Damage to the Leading Edge.**

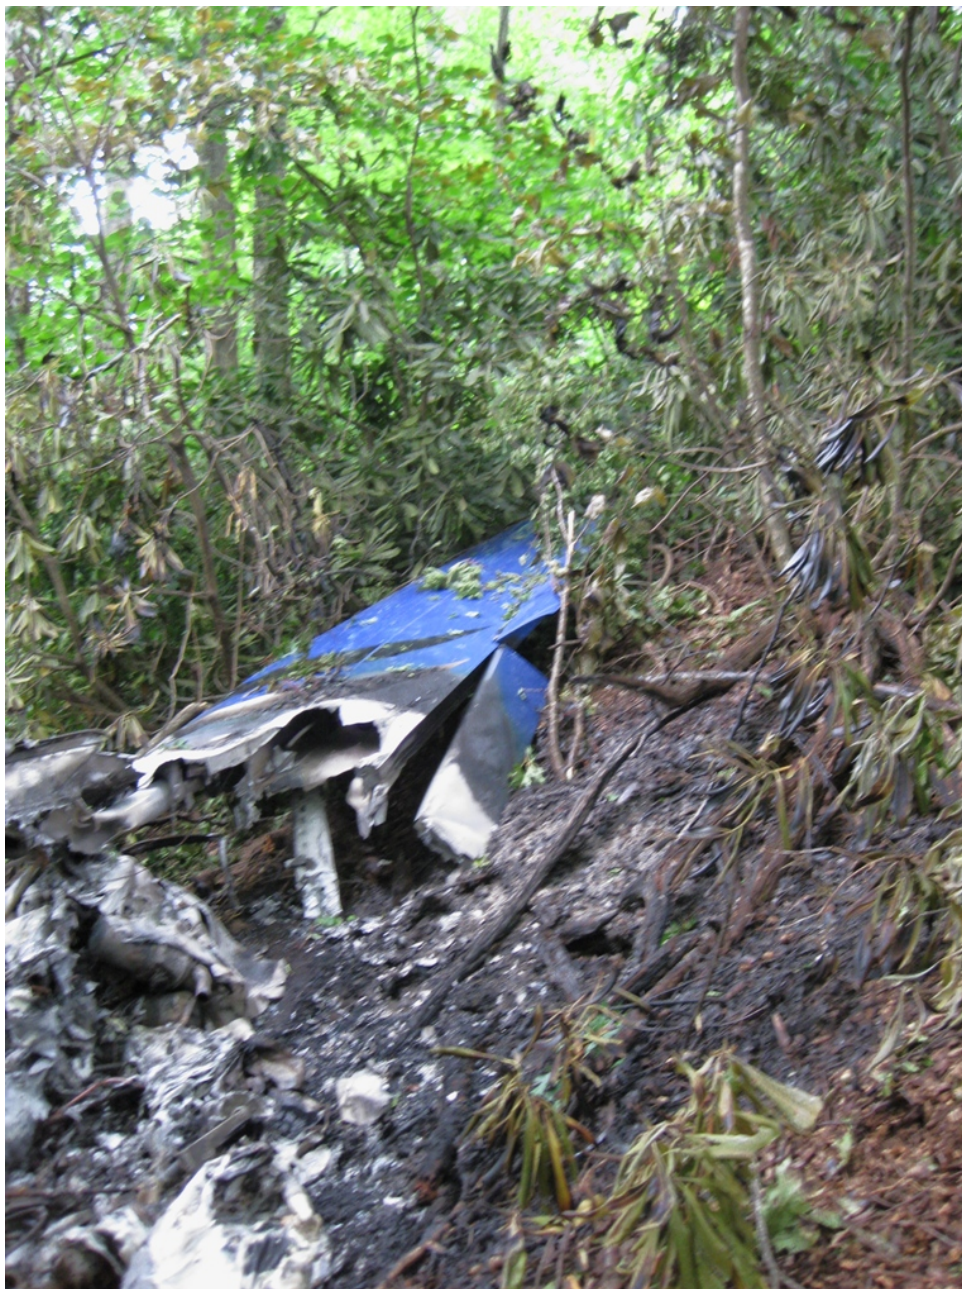
**Photo 3 - FAA Digital Photograph. Aft Side View of the Right Wing. Note the Fire Damage to the Inboard section of the Wing.**

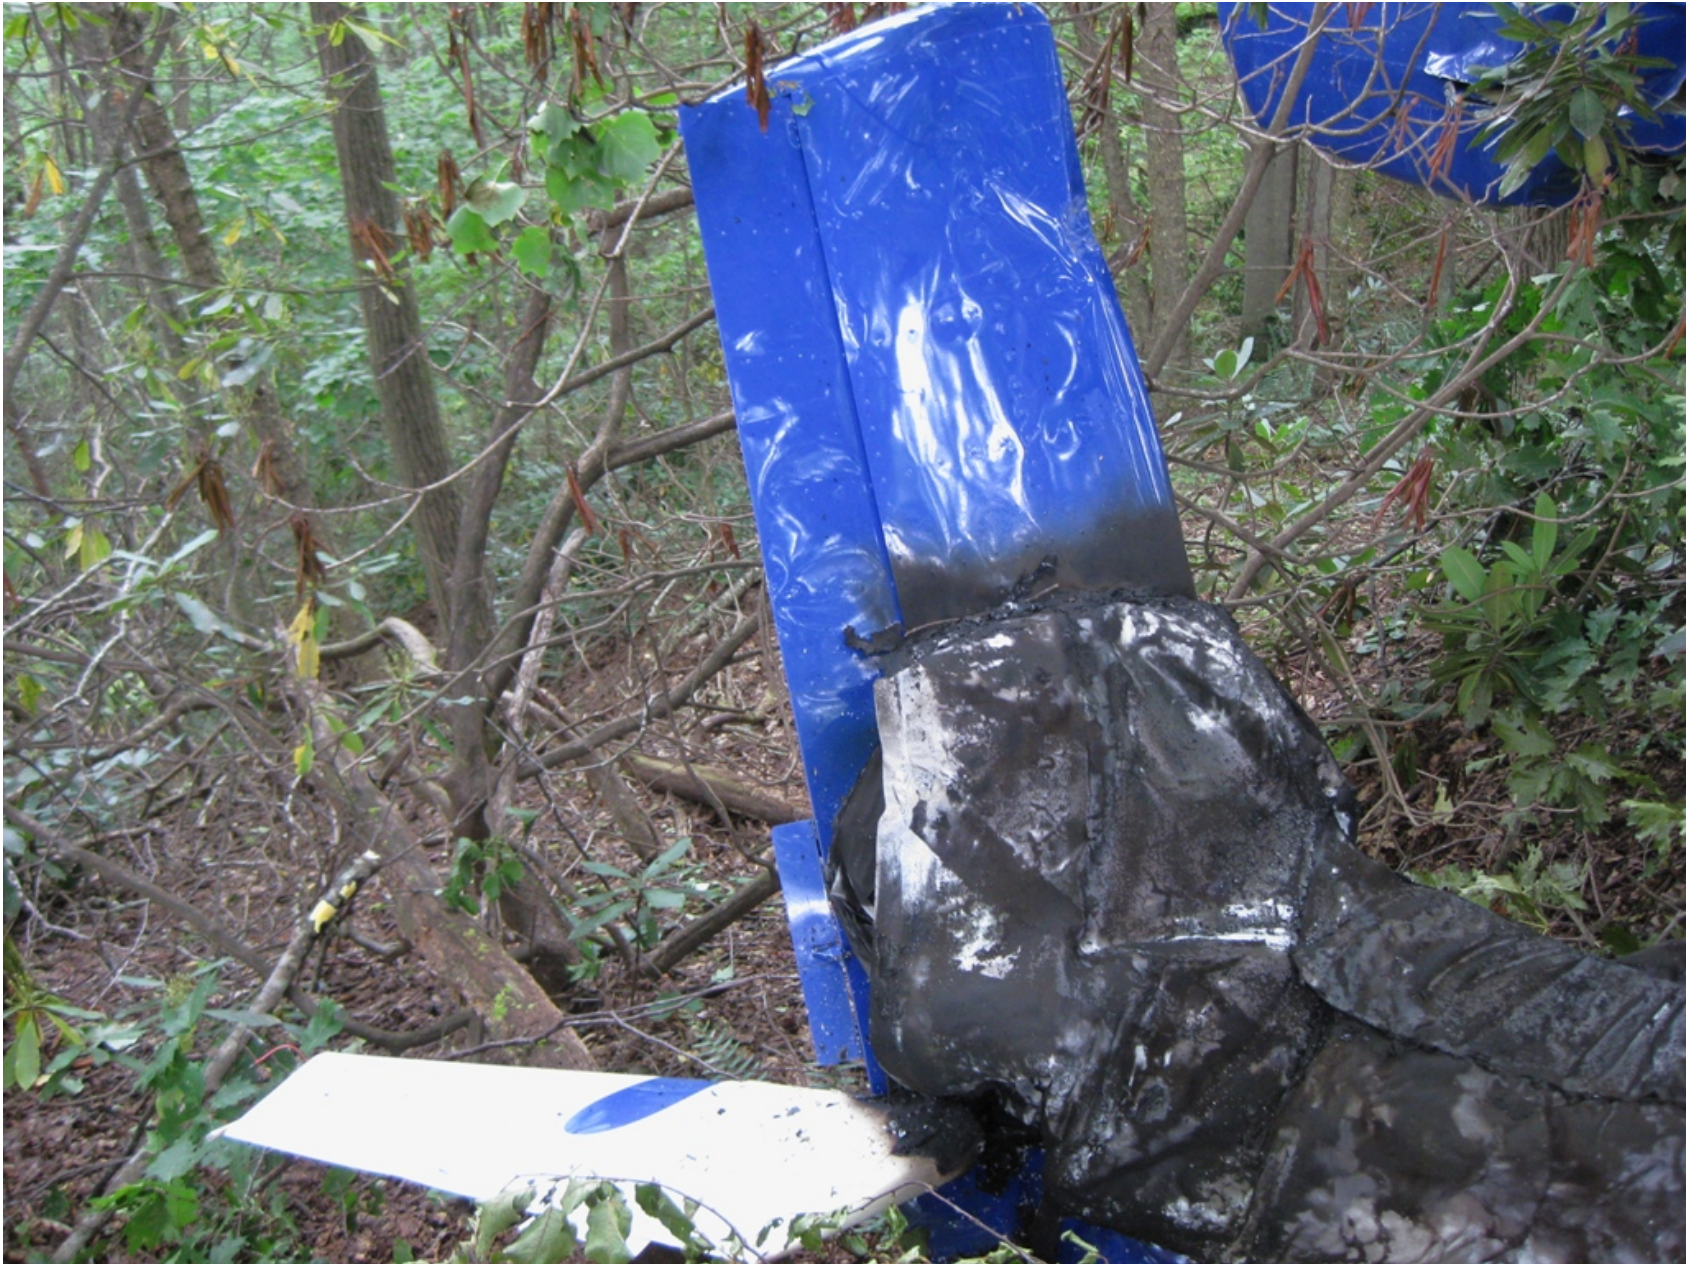
**Photo 4 - FAA Digital Photograph. Right Side View of the Upper Portion of The Vertical Stabilizer, Right Stabilizer and Elevator, and Partially Attached Rudder.**

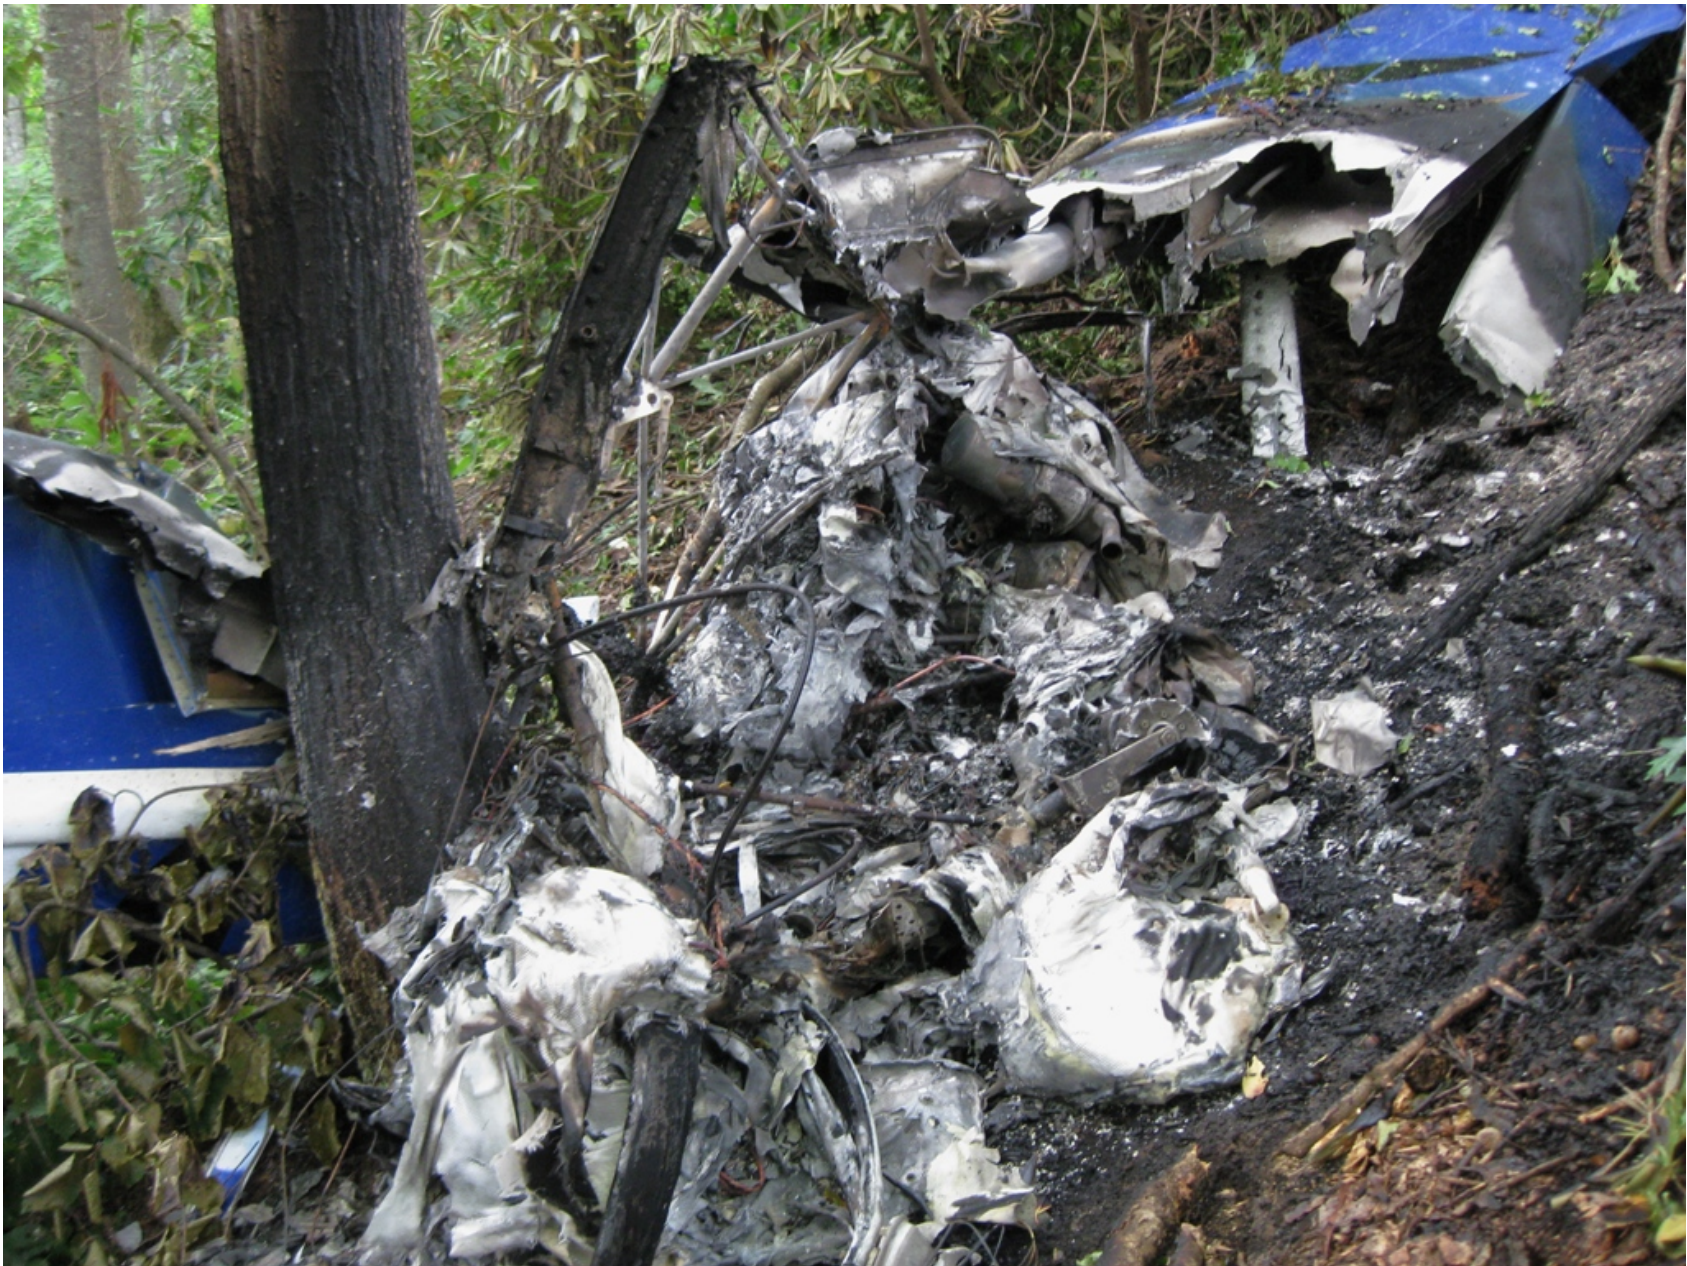
**Photo 5 - FAA Digital Photograph. View of the Cockpit. Note the Extensive Fire Damage.**

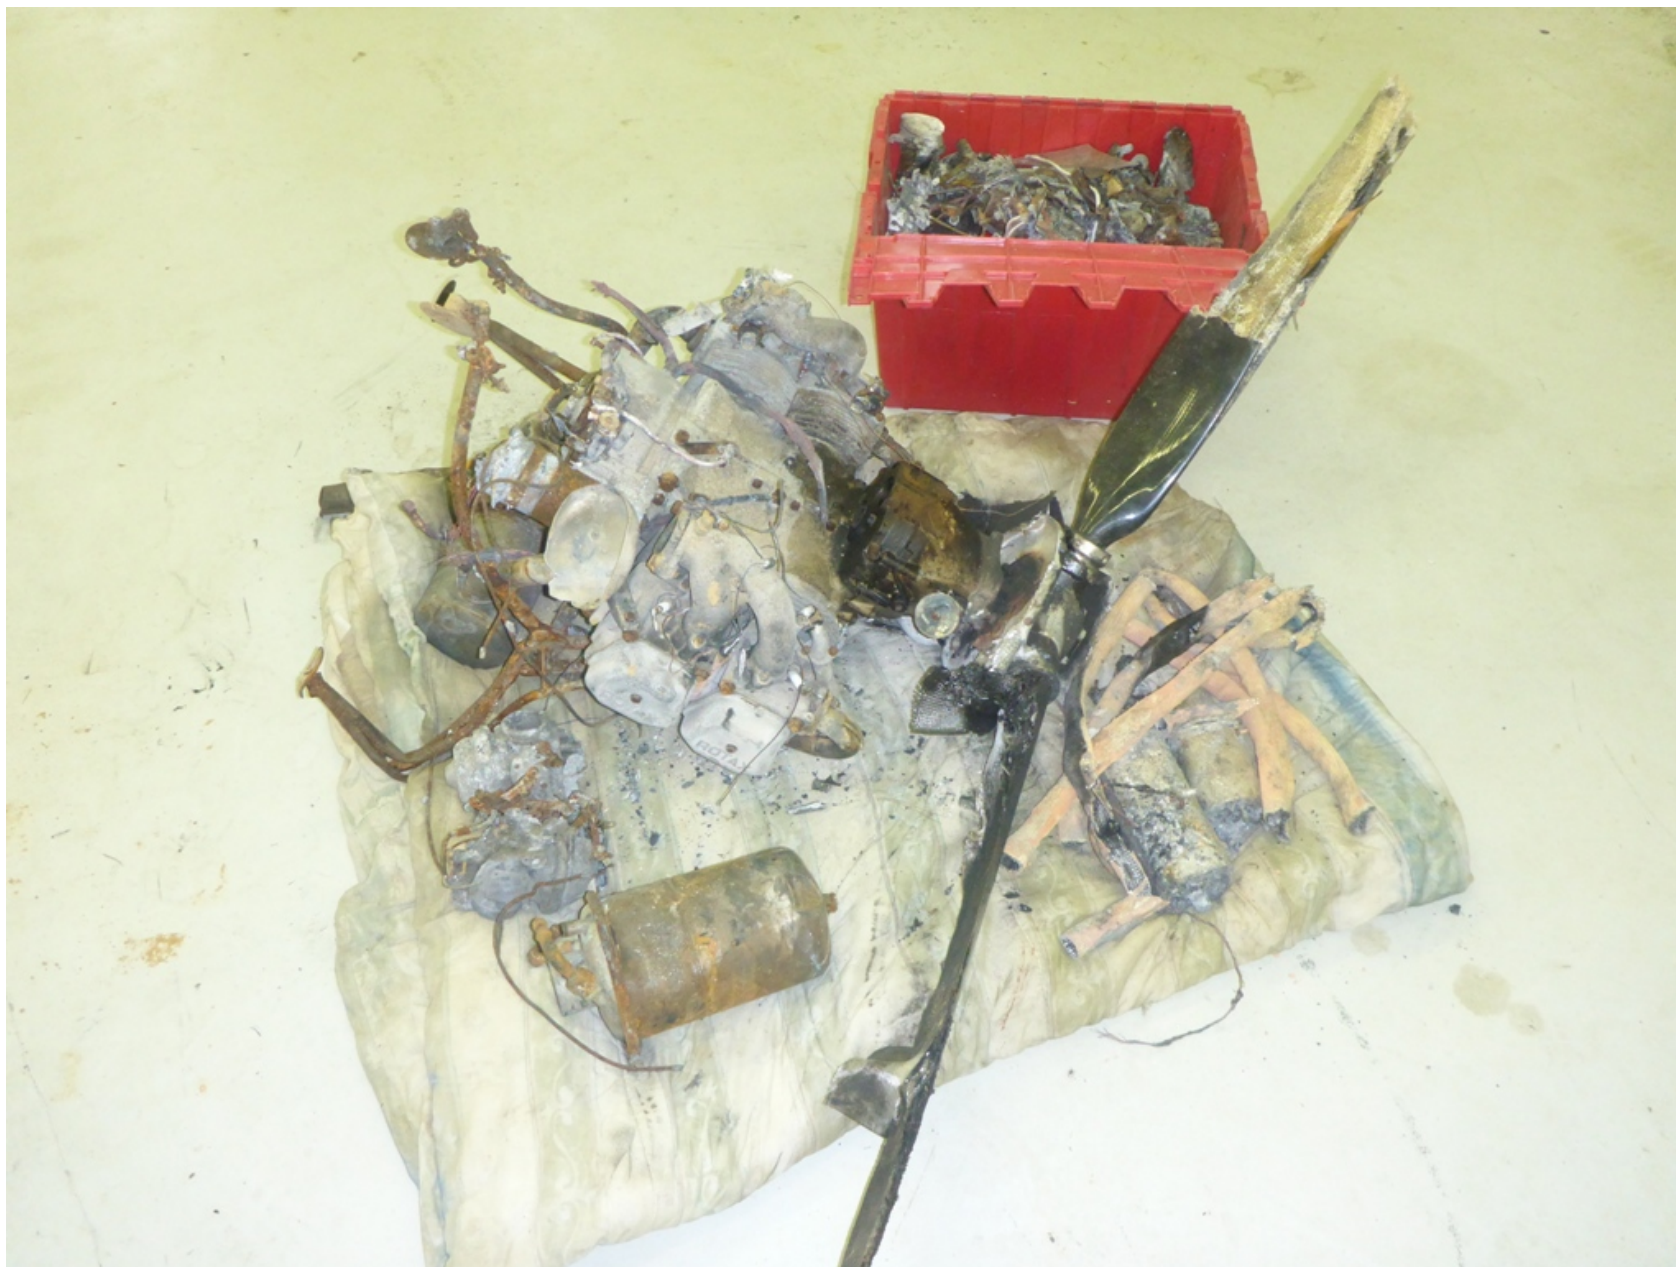
**Photo 6 – Rotax Digital Photograph. Right Side View of the Engine and Propeller Assembly Following Recovery. Note the Extensive Fire Damage.**
