NATIONAL TRANSPORTATION SAFETY BOARD  
Office of Aviation Safety  
Washington, DC 20594

**SURVIVAL FACTORS SPECIALIST'S FACTUAL REPORT**

Airplane : Velocity XL-5 [N735D]  
Location : Kissimmee, FL  
Date : August 21, 2019  
Time : 0852 eastern daylight time (EDT)<sup>1</sup>  
NTSB # : ERA19LA253

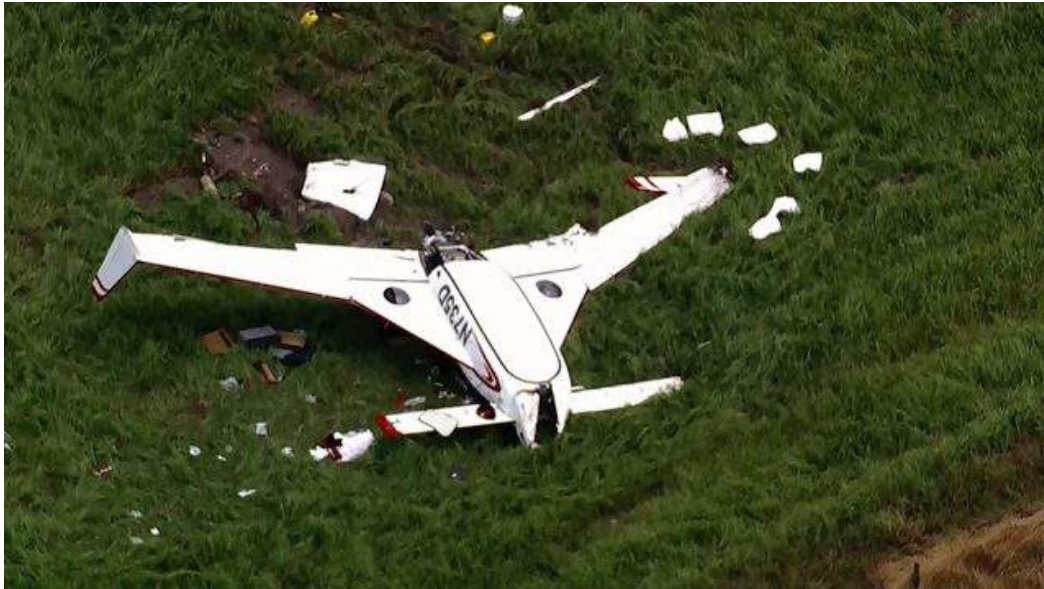
The pilot reported that he departed from Kissimmee Gateway Airport (ISM) and about 0840 and was destined for the Sebastian Municipal Airport (X26), Sebastian, Florida. Shortly after takeoff, at an altitude of 2,000 ft, the engine and electrical system failed simultaneously. The pilot tried several times to restart the engine, but it did not restart. He feathered the propeller and made a forced landing to an open field. The airplane flipped over during landing resulting in substantial damage to the airframe and both wings.

**Photo 1. Aerial photograph of the accident airplane. (Courtesy: WKMG Sky 6)**

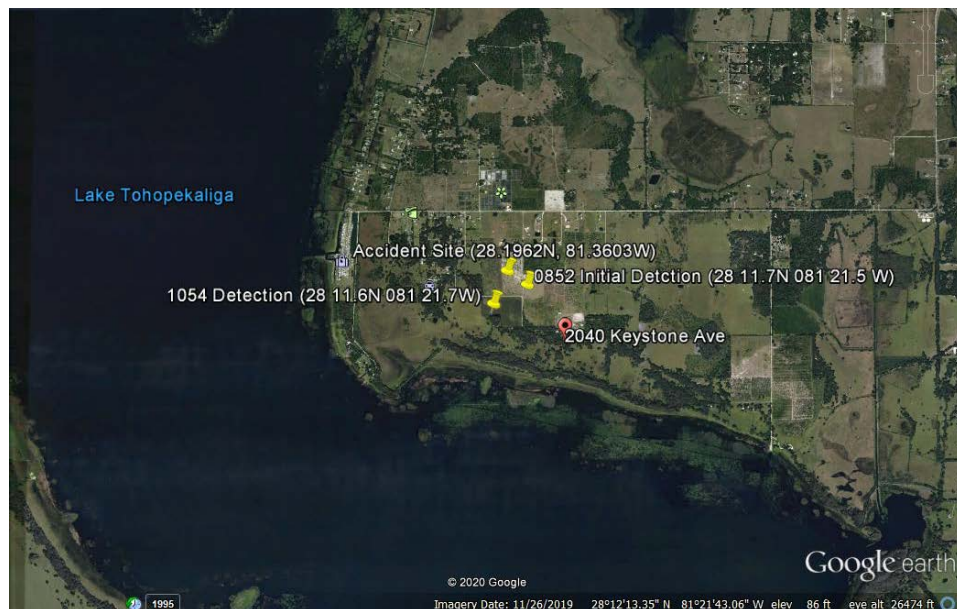
About 15 minutes later (1001) FTW called AFRCC and reported information from the ISM owner, that “the aircraft is flying without a flight plan.” The AFRCC log contained an entry for a 1054 satellite detection of the beacon at 28 11.6N 081 21.7W, about 0.2 nautical miles south-southwest of the accident site and 0.2 nautical miles southwest of the initial 0852 detection. No further entries were made in the AFRCC log until 1217 and 1218 where the controller closed the incident with both JAX and FTW, respectively. A log entry at 1317 indicated that the controller called the Osceola County Sheriff’s Office (OCSO) and “transferred all of the data of the registration and requested a call back on the result of a wellness check.”

**Figure 5. Locations of the accident site and ELT detections at 0852 and 1054.**

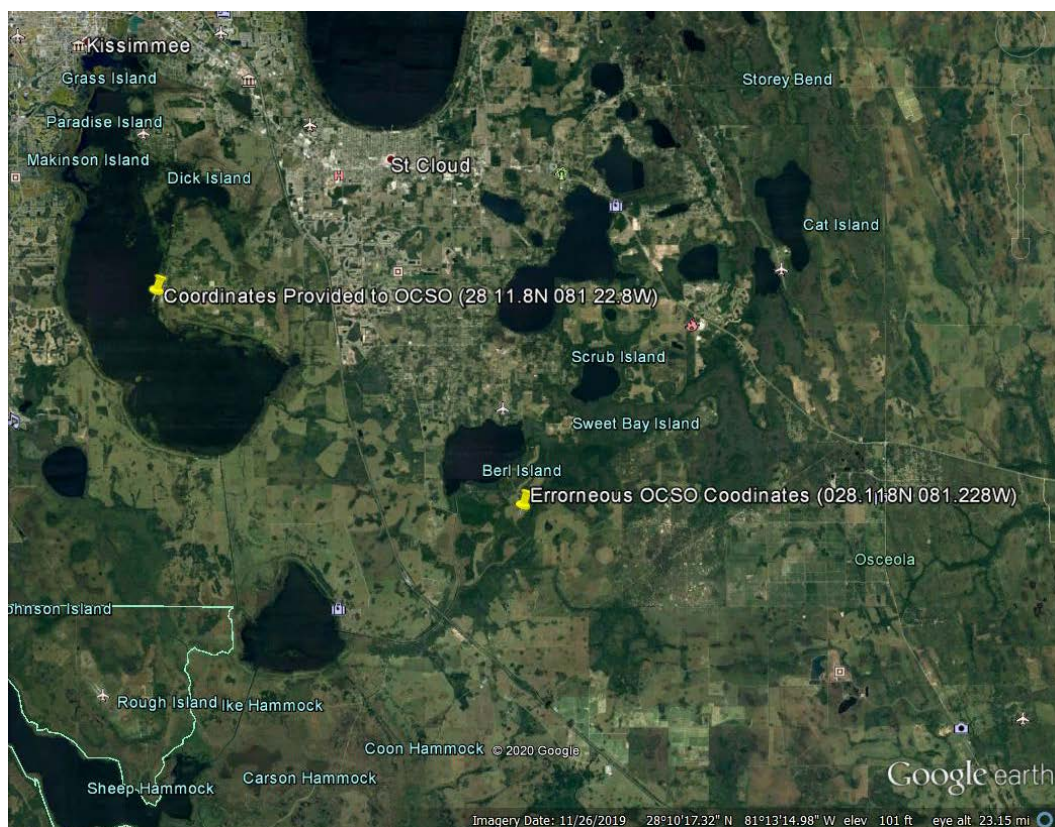
**Figure 6. Google Earth image showing the coordinates provided to OCSO by AFRCC and the erroneous coordinates plotted by the OCSO dispatcher.**

<sup>3</sup> This readback of the coordinates provided by the AFRCC controller contained an error. Rather than 28 11.8N 081 22.8W, the OCSO dispatcher provided 28.118N 081.228W, which was not recognized or corrected by the AFRCC controller. These erroneous coordinates plot about 9 nautical miles SE of the original coordinates, just SE of Lake Gentry, FL (see figure 6).

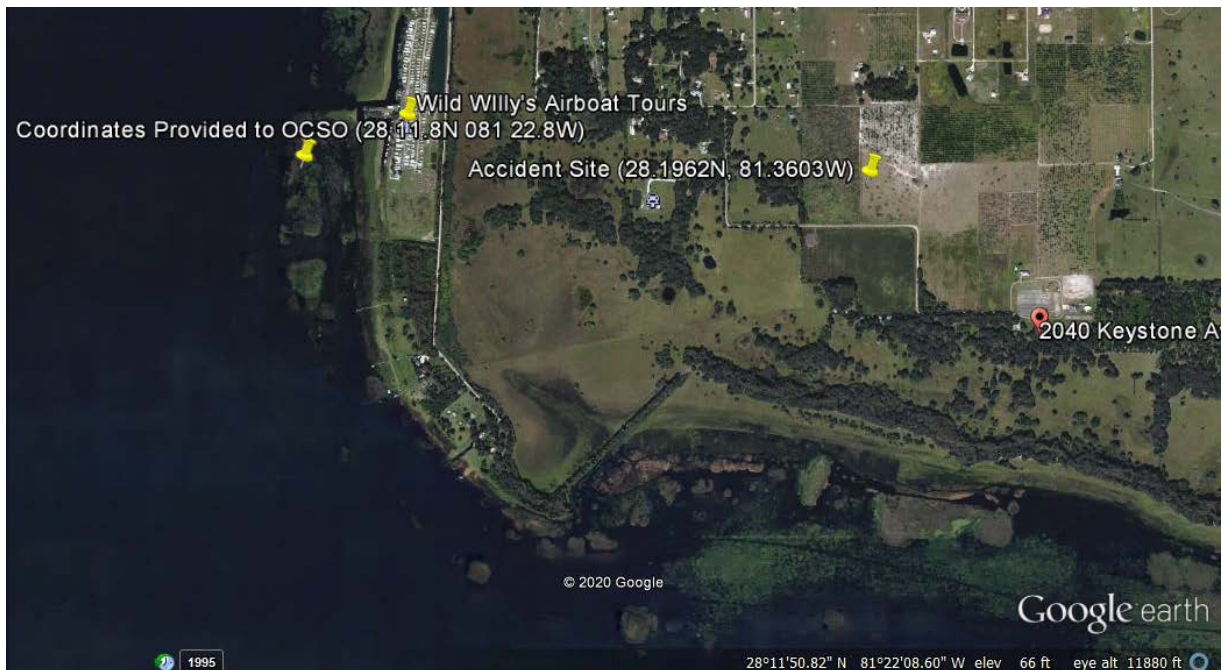
**Figure 7. Locations of AFRCC coordinates provided to OCSO, Wild Willy's Airboat Tours, and the accident site.**
