## ENGINE EXAMINATION REPORT

| ENGINE MODEL | IO-550-N |
| AIRCRAFT MAKE & MODEL | Velocity XL-RG-5 |
| AIRCRAFT REGISTRATION | N735D |

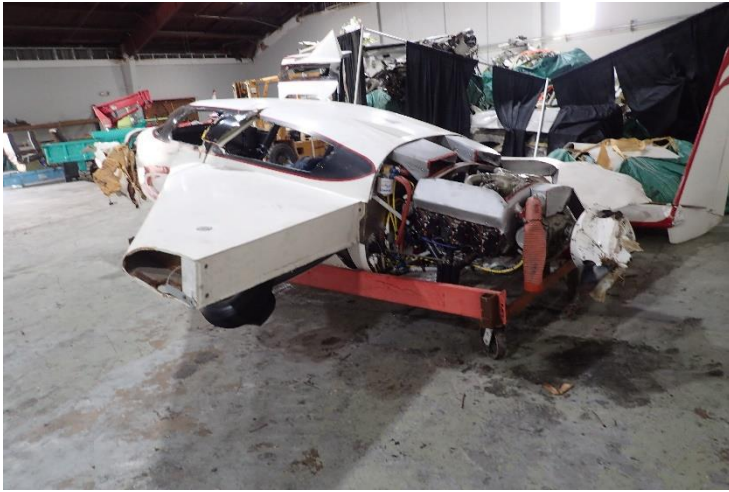
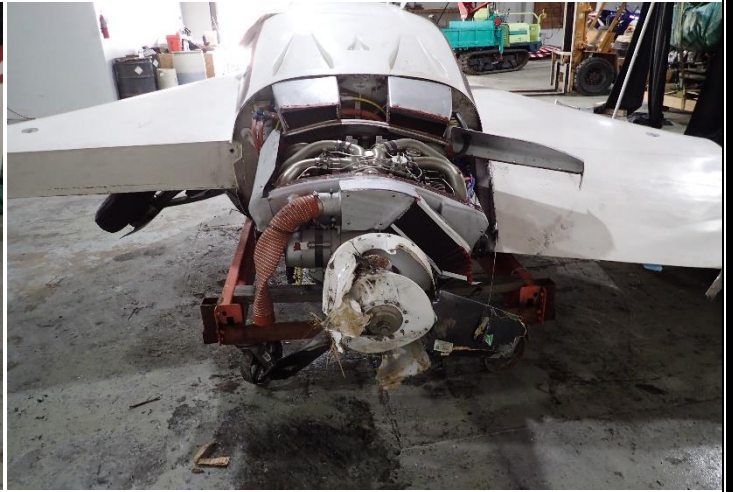
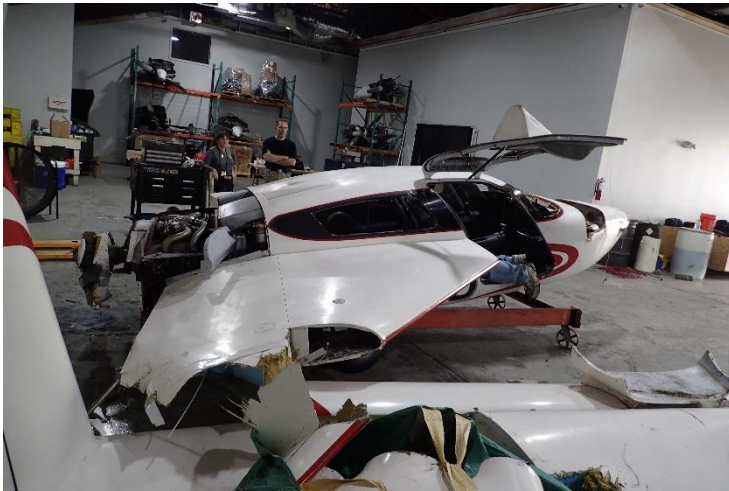
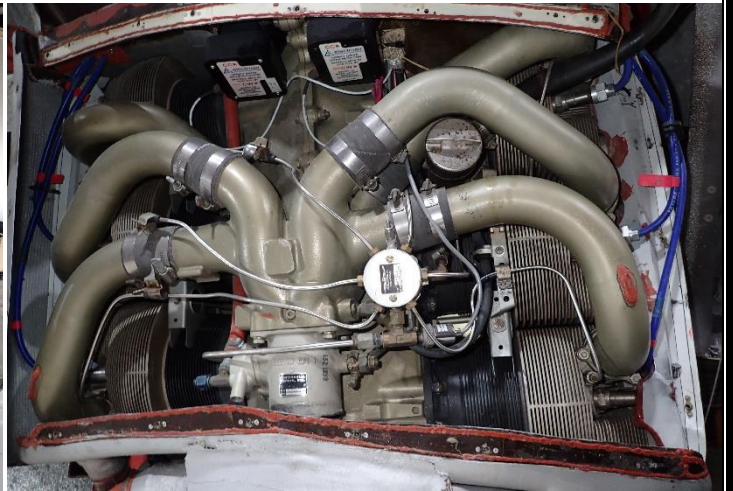
The engine remained attached to the airframe and displayed minor impact damage signatures. The crankcase remained intact and there were no holes in the crankcase that would indicate a catastrophic internal engine failure. All six cylinders remained attached to their cylinder bays and the #3 and the #4 cylinders displayed impact damage to the rocker box covers. The three-blade, constant speed propeller remained attached to the crankshaft and displayed impact damage; portions of all three propeller blades had broken free from the propeller hub. The crankshaft remained intact and there were no visible cracks noted in the crankshaft.

The engine was equipped with an electronic ignition system that required electrical power in order to operate. There was no magneto backup or a separate battery backup installed on the aircraft. The ignition harness remained intact and was undamaged. All of the spark plugs remained installed in their cylinders and were undamaged.

The fuel pump remained attached to its installation point and was undamaged. The mixture control cable rod end remained attached to the control arm and was capable of movement. It was observed that one of the large gauge wires was not properly secured and would interfere with the mixture control arm movement. The throttle and metering assembly remained attached to its installation point and was undamaged. The throttle control cable rod end remained attached to the throttle control arm and the control arm was secured to its shaft. The throttle control was capable of normal movement. The fuel manifold valve, fuel lines, and nozzles remained attached to their installation points and were undamaged. There were no signs of fuel leaks observed around the engine fuel components; however, there was blue staining noted around the airframe boost pump fuel lines as well as the left-wing fuel tank.

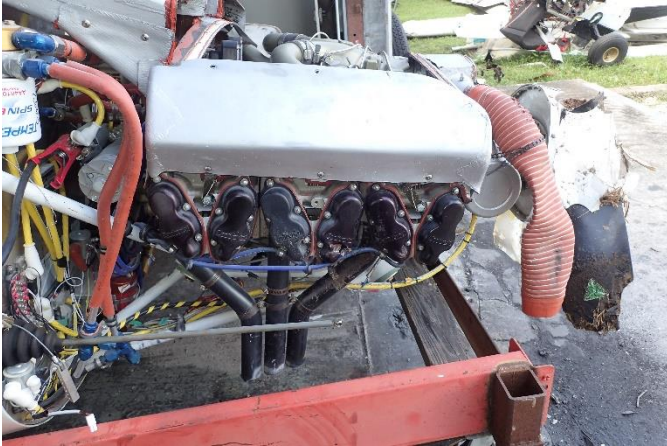
Condition: The exhaust system remained attached to the engine and was undamaged. There were no signs of exhaust leaks observed

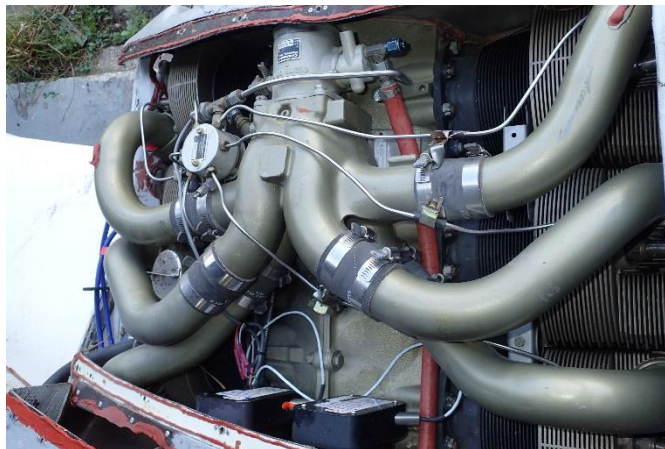
Condition: The induction system remained attached to the engine and displayed impact damage signatures to the inlet airbox. There were no signs of intake leaks or blockages observed.

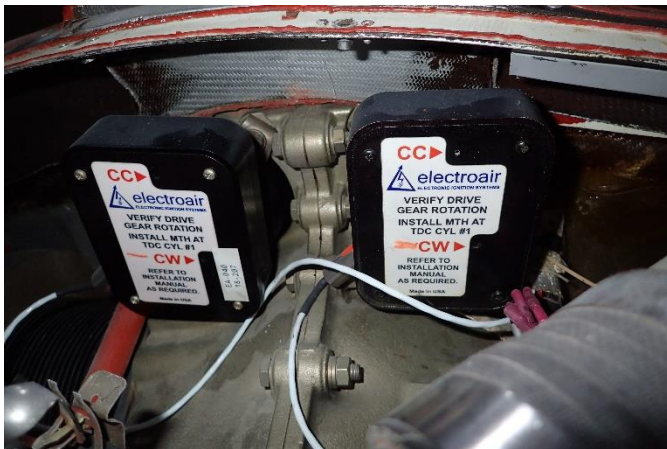
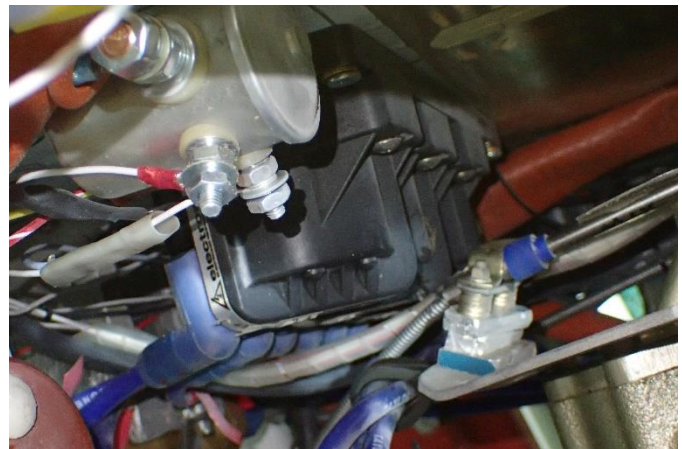
Both battery terminals were found to be improperly crimped and the wires were pulled out of the terminals. The engine used electronic ignition that requires electrical power to operate; there was no magneto backup for ignition.

The aircraft was equipped with an electronic ignition system and there was no magneto backup. The electronic ignition system appeared to be undamaged. Examination of the main battery terminals revealed that neither the positive or negative terminals were properly crimped, and the terminals had fallen off the wires.

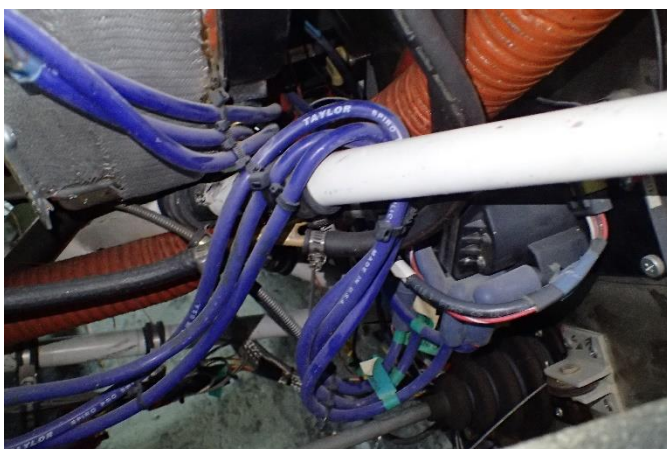
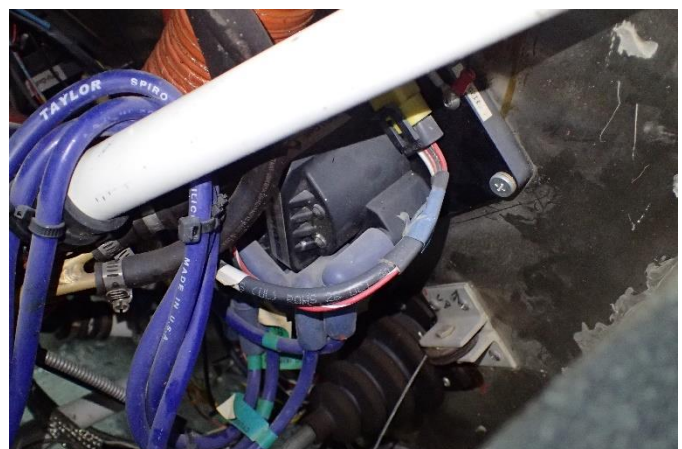
The ignition harness was undamaged and was connected to the electronic ignition system and to each spark plug. There were no anomalies observed.

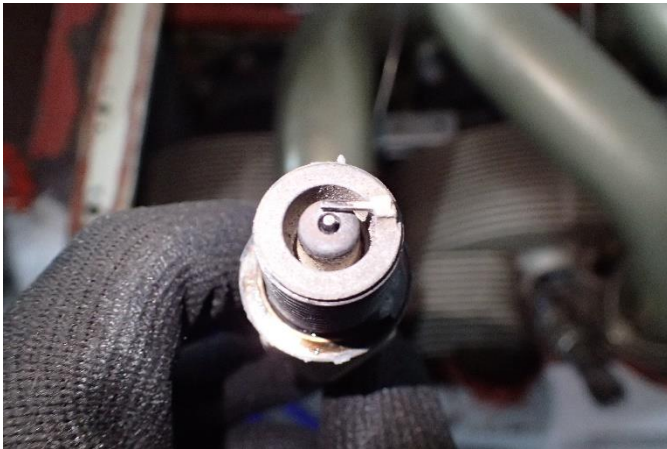
#1 Top Spark Plug

The spark plugs remained installed in their cylinders and were undamaged. The top spark plugs were removed for examination and the bottom spark plug electrodes were examined using a lighted borescope. The electrodes displayed normal operating and wear signatures.

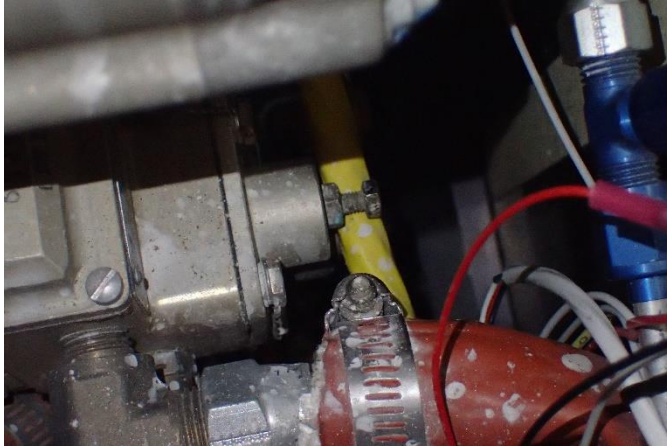
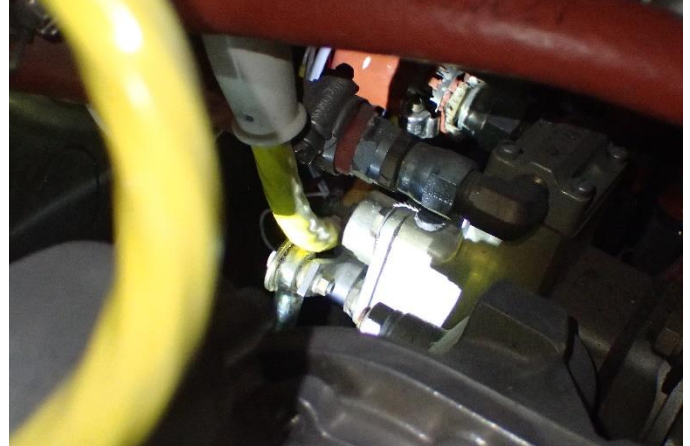
The fuel pump remained attached to its installation point and was undamaged. It was noted that the routing of one of the large gauge electrical wires would interfere with the mixture control movement. It was observed that the mixture control rod end was secured to the control arm and the control arm remained secured to the shaft.

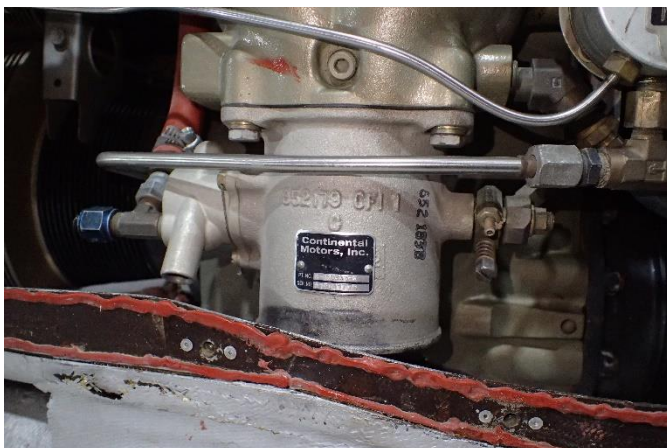
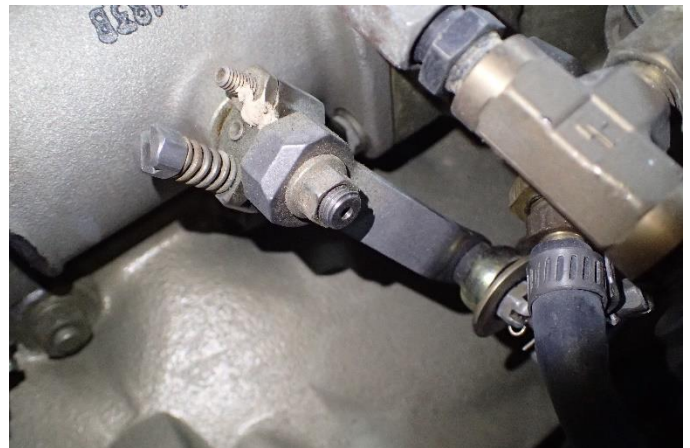
The throttle and metering assembly remained attached to its installation point and was undamaged. The throttle control rod end remained attached to the control arm and was capable of normal movement. There were no anomalies observed

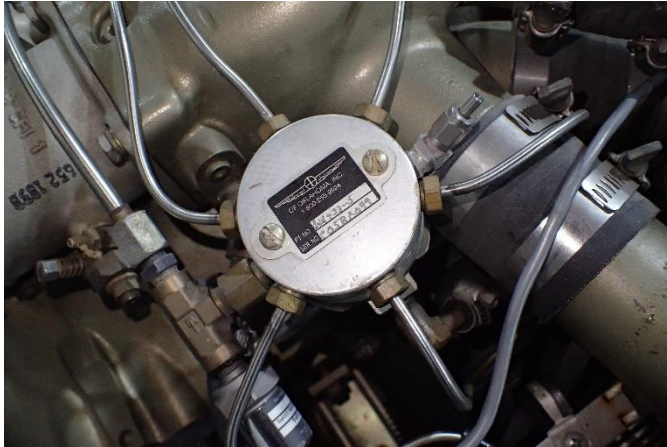
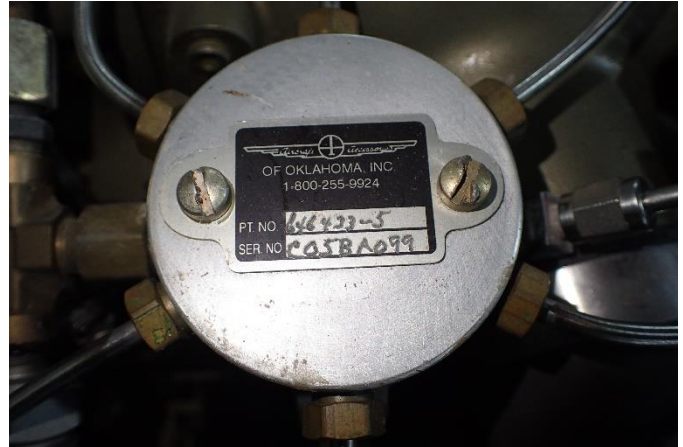
The fuel manifold valve remained attached to its installation point and was undamaged. There were no fuel leaks noted around the manifold valve.

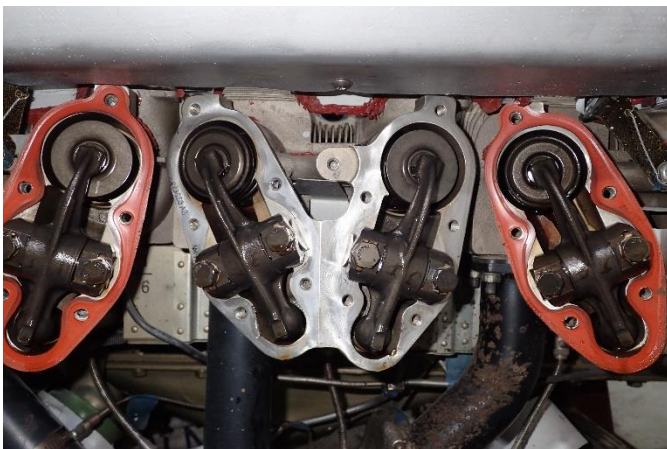
#3 Cylinder Overhead

All six cylinders remained attached to their cylinder bays and the #3 and the #4 cylinders displayed impact damage to the rocker arm box covers; the rest of the cylinders were undamaged. The cylinders were inspected using a lighted borescope; the cylinder bores and valve heads displayed normal operating and combustion signatures. The #3 piston face was noted to have a semicircular impression consistent with a valve strike; it was noted that the #3 cylinder intake rocker arm box cover had impact damage and was pushing against the rocker arm. The rest of the piston faces displayed normal operating and combustion signatures. During crankshaft rotation the cylinders displayed good thumb compression and suction and after removing the rocker arm box covers, all of the rocker arms and valves operated normally.

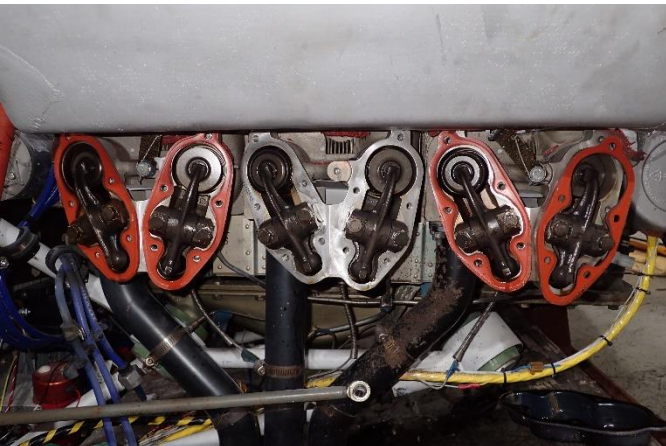
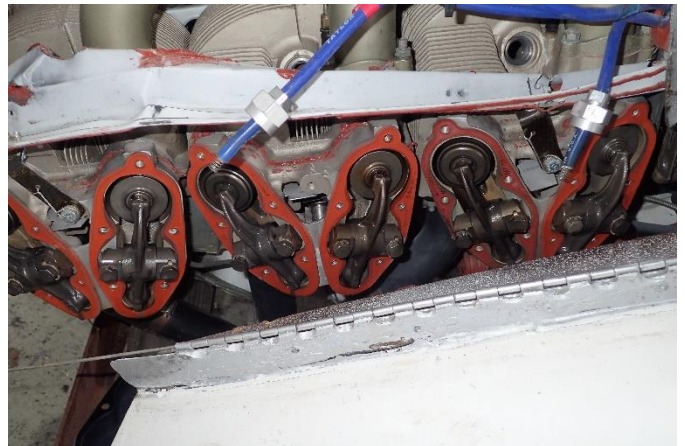
The rocker arms displayed normal operating and lubrication signatures. During crankshaft rotation all of the rocker arms operated normally.

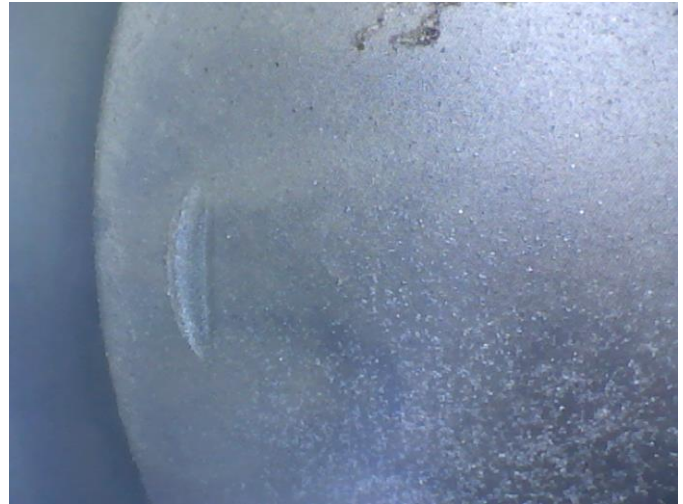
The piston faces were inspected using a lighted borescope. The #3 cylinder was observed to have a small semicircular impression consistent with a valve strike; it was noted that the intake rocker box cover was impact damaged and pressing against the rocker arm. The rest of the cylinders displayed normal operating and combustion signatures and all of the pistons operated normally during crankshaft rotation.

#3 Piston (with indentation consistent with a valve strike)

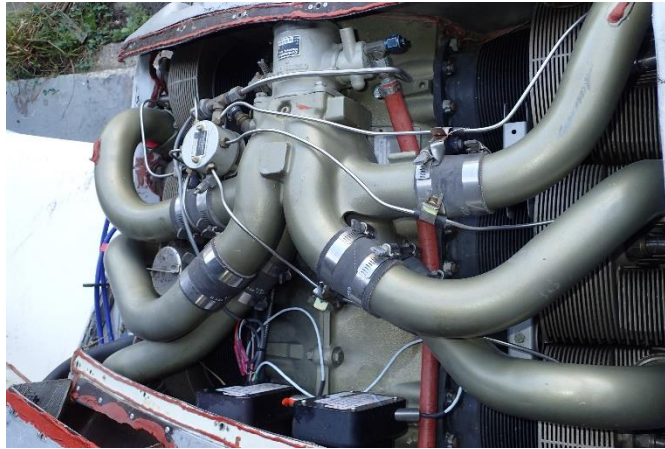
| Condition: | The crankcase remained intact and was undamaged. There were no holes in the crankcase that would indicate a catastrophic internal engine failure. | | | |

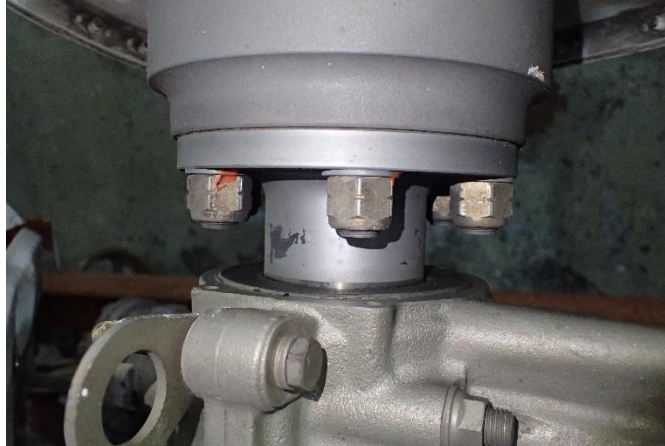
The crankshaft remained intact and there were no visible signs of impact damage. The crankshaft was rotated using both the starter as well as by rotating the propeller; continuity was established between the crankshaft, camshaft, connecting rods, and associated components. There were no anomalies noted with the crankshaft.

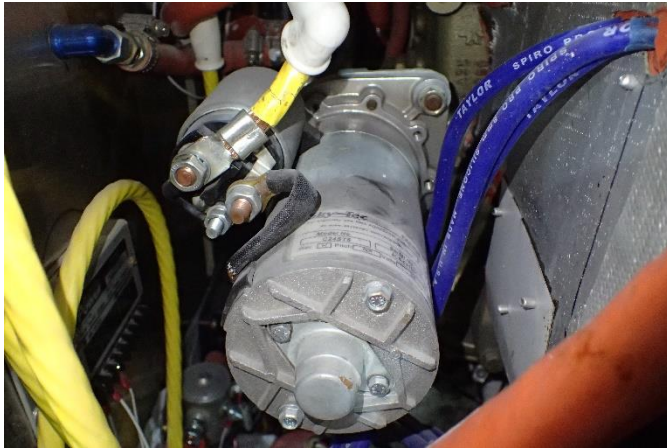
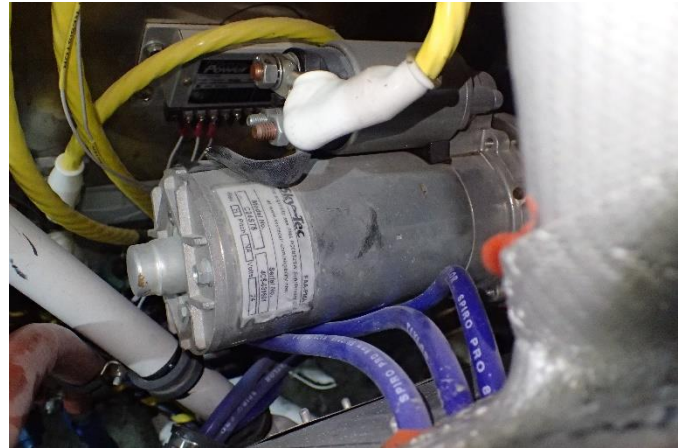
The starter remained attached to the starter adapter and was undamaged. The power was turned onto the aircraft's electrical system and it was noted that the starter button would not engage the starter which was consistent with the impact damage to the wiring harnesses. A jumper switch was placed on the starter solenoid and was actuated; the starter operated normally.

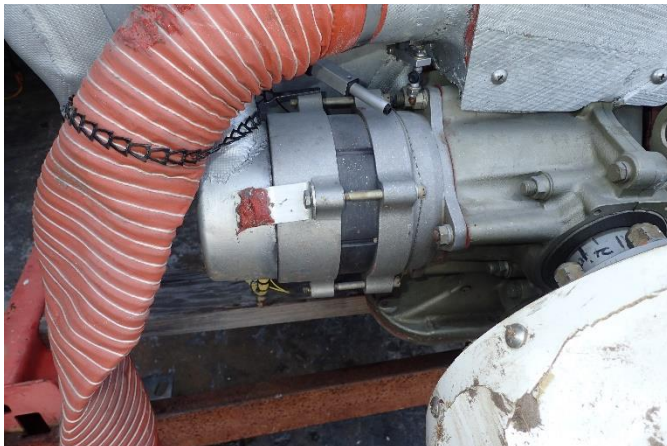
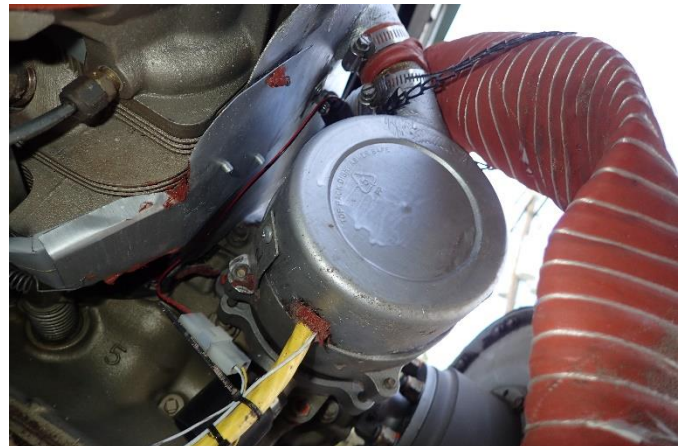
The alternator remained attached to its installation point and was undamaged.

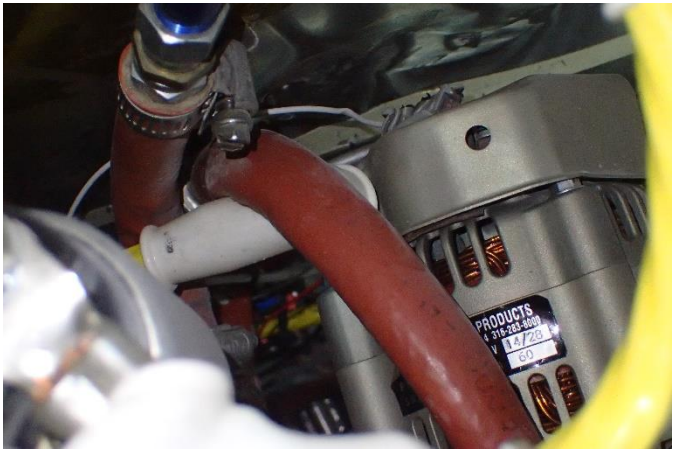
| Condition: | The standby alternator remained attached to its installation point and was undamaged. It was noted that the primary wire was loose on the terminal. | | |

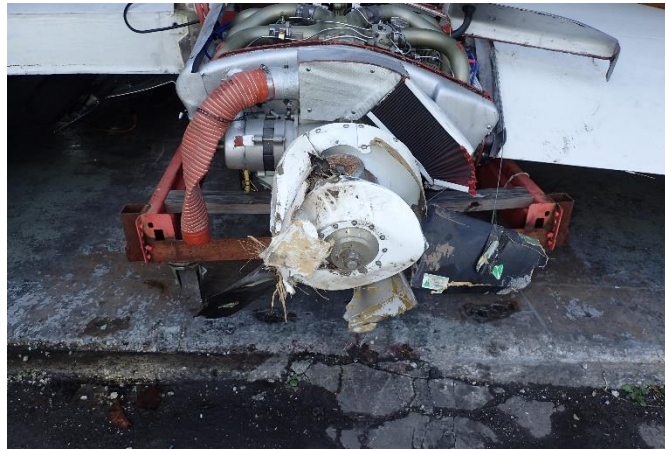
| Condition: | The three-blade, constant speed propeller remained attached to the propeller flange; however, all three propeller blades were broken. Only a small portion of each propeller blade root remained attached to the propeller hub and the remaining portions of the blades were not observed. | | |
