# ENGINE EXAMINATION REPORT

| ENGINE MODEL | IO-550-B |
| AIRCRAFT REGISTRATION | N80WH |
| FILE NUMBER | 19-072 |

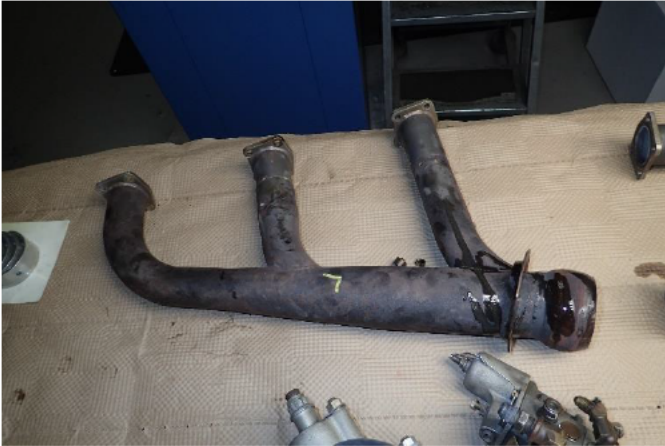
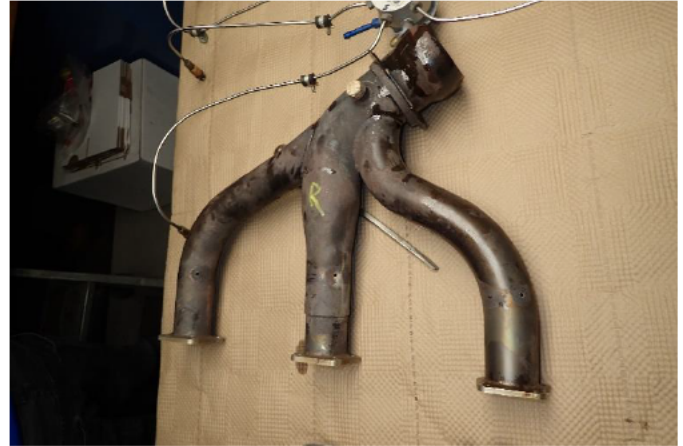
Condition: The exhaust system remained attached to the engine and the returned portions of the exhaust were undamaged. There were no exhaust leaks or blockages observed with the returned exhaust system components.

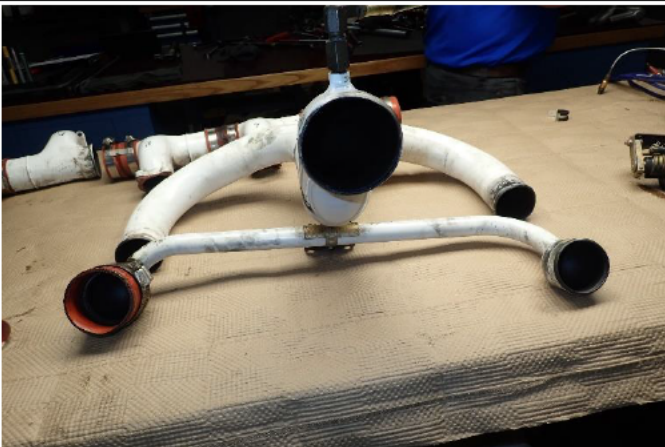
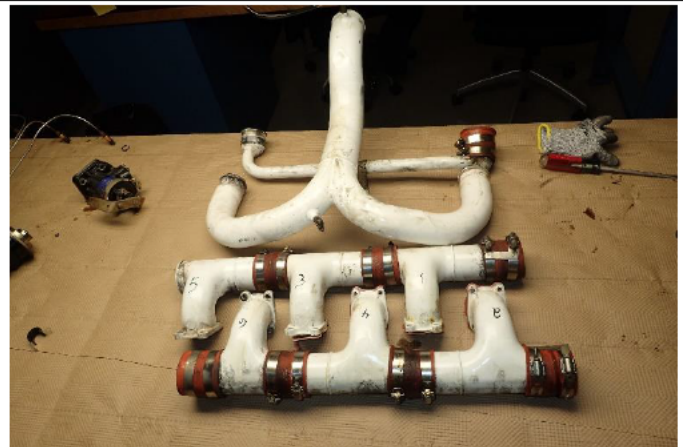
Condition: The induction system remained attached to the engine and displayed minor impact damage to the Y-pipe. There were no signs of induction leaks or blockages observed.

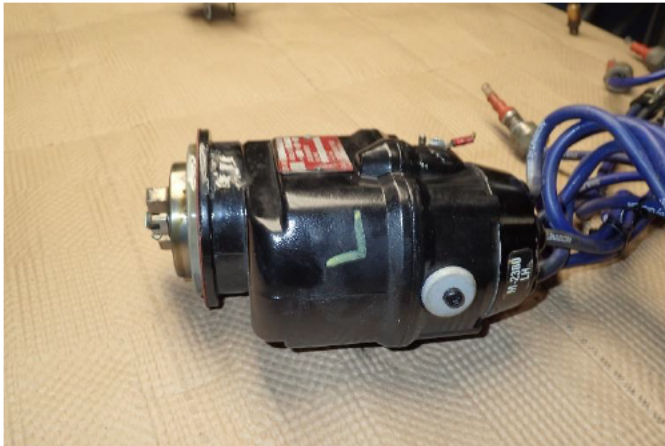
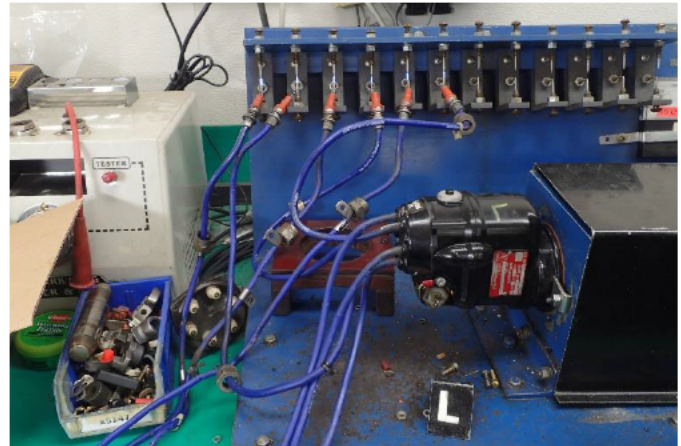
**Condition:** The magneto remained attached to its installation point and was undamaged. The magneto was removed and placed on a test bench. The magneto was capable of producing a spark to the end of each ignition lead in the correct firing order and at various RPM settings.

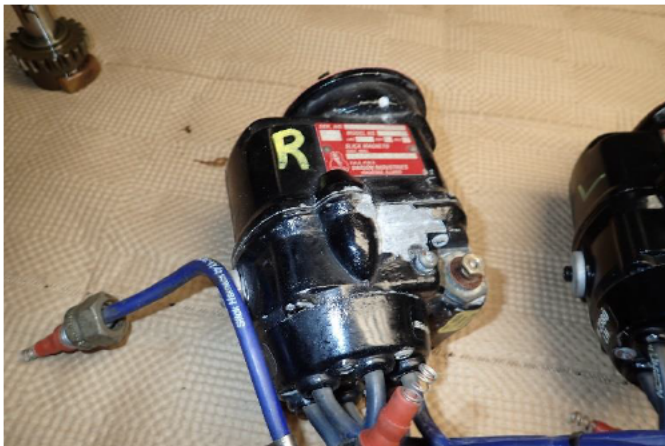
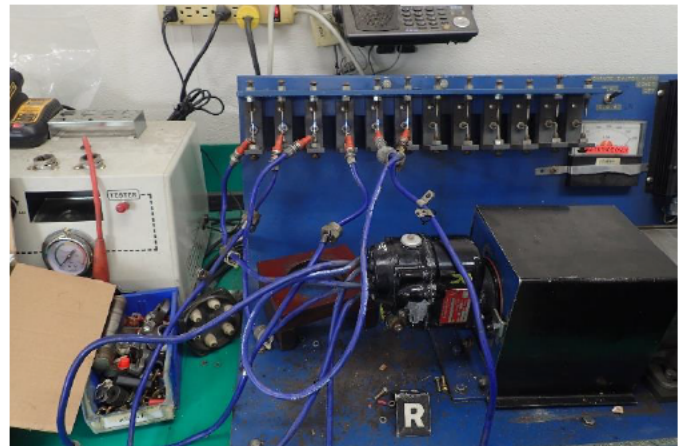
**Condition:** The magneto remained attached to its installation point and was undamaged; however, the magneto was corroded. The magneto was removed and placed on a test bench. The magneto was capable of producing a spark to the end of each ignition lead in the correct firing order and at various RPM settings.

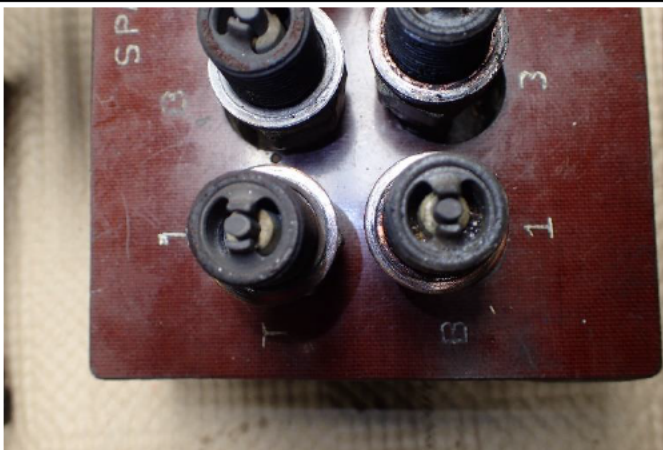
#1 Spark Plugs

Condition: The spark plugs remained installed in their cylinders and were undamaged. The spark plugs were removed, and the electrodes were visually inspected. All of the electrodes were in a worn-out condition and several of the electrodes were extremely worn out.

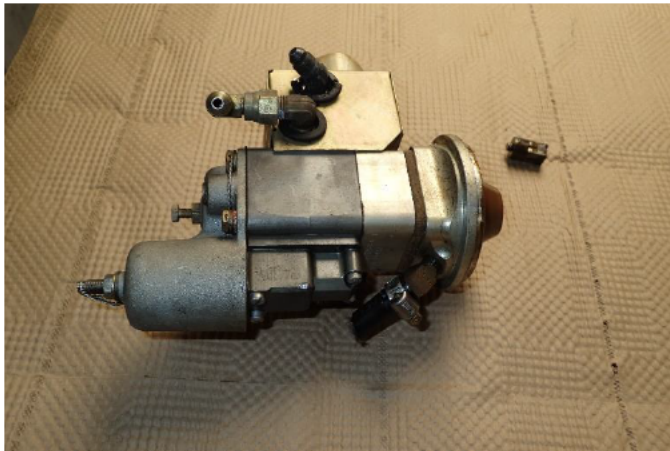
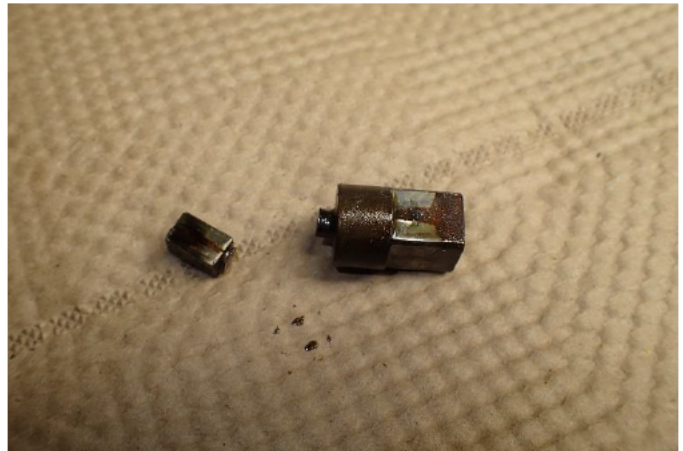
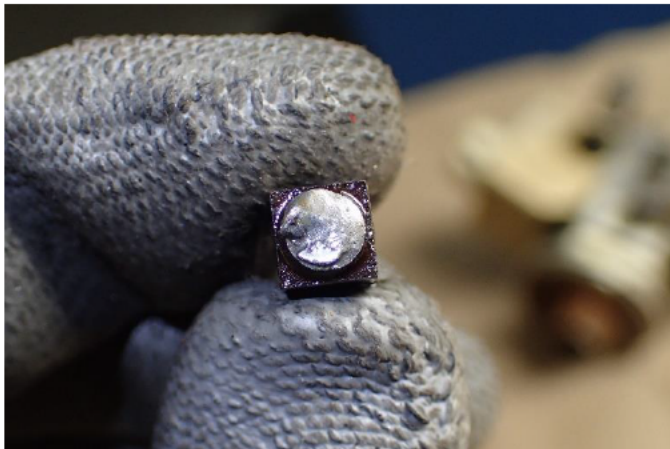
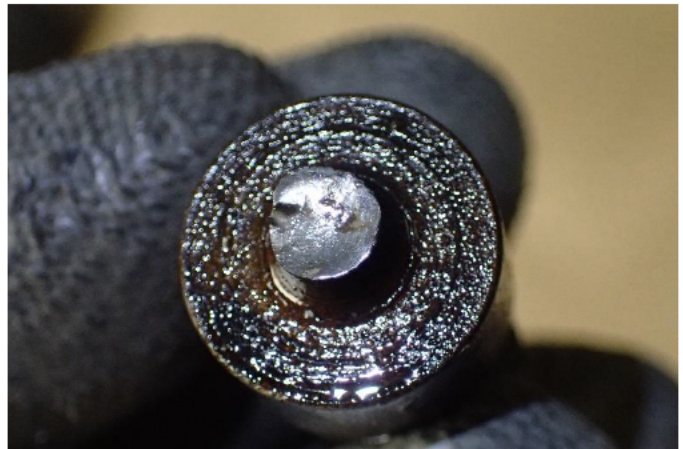
Condition: The fuel pump remained attached to its installation point and was undamaged. The fuel pump was removed and it was noted that the fuel pump drive coupling was broken; it was noted that the drive coupling is installed in the back of the crankshaft and the rear portion of the crankshaft had shifted from its normal position. The fuel pump drive was capable of normal rotation and there were no signs of fuel leaks around the fuel pump.

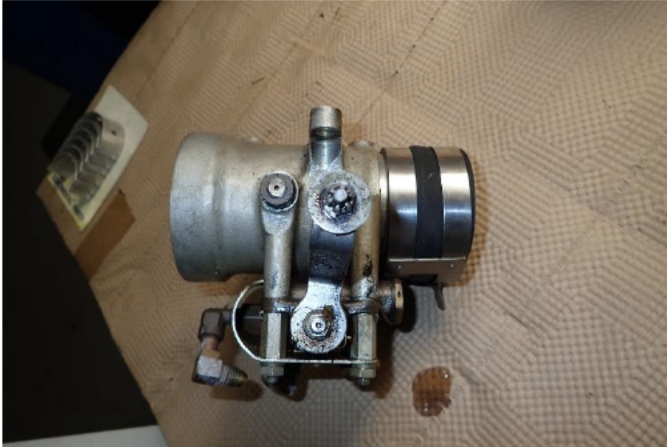
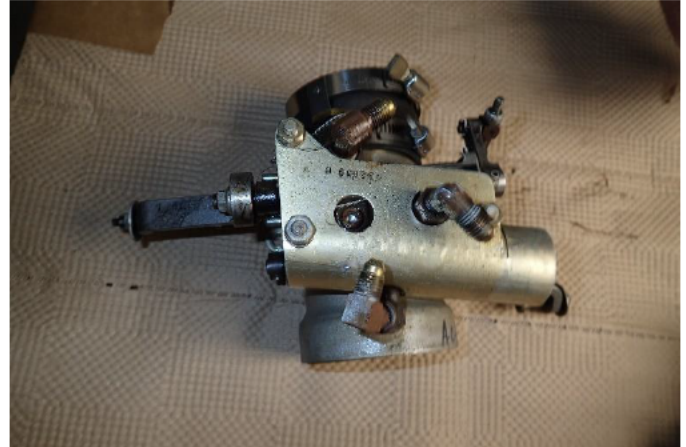
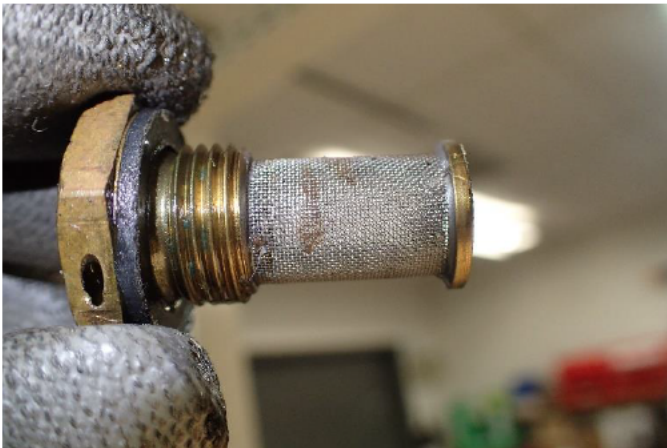
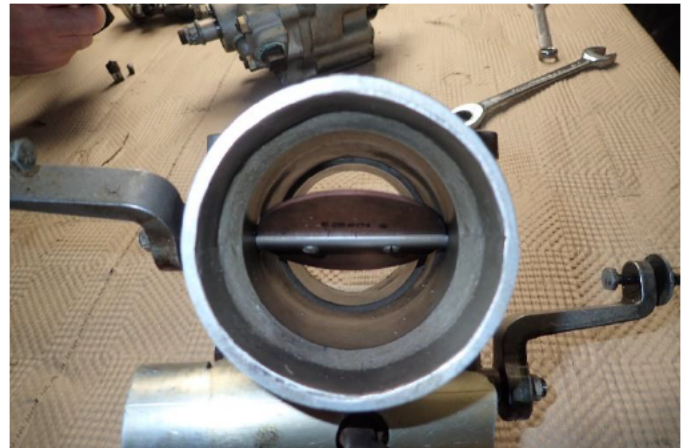
The throttle and metering assembly remained attached to its installation point and was undamaged. The assembly was removed and it was observed that the throttle and mixture control arms remained secured to their shafts. The fuel inlet screen was removed and it was noted to be clear of contaminants.

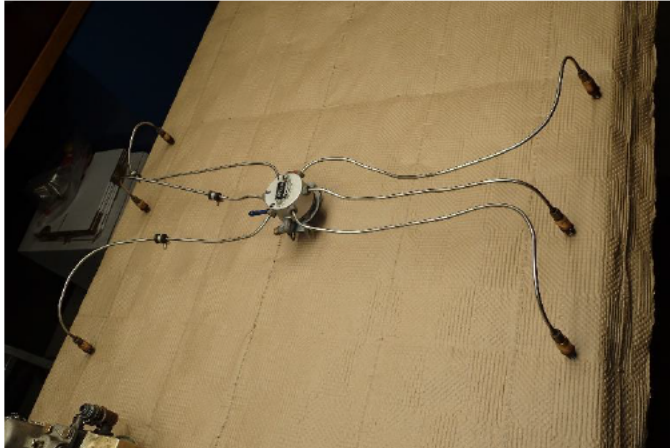
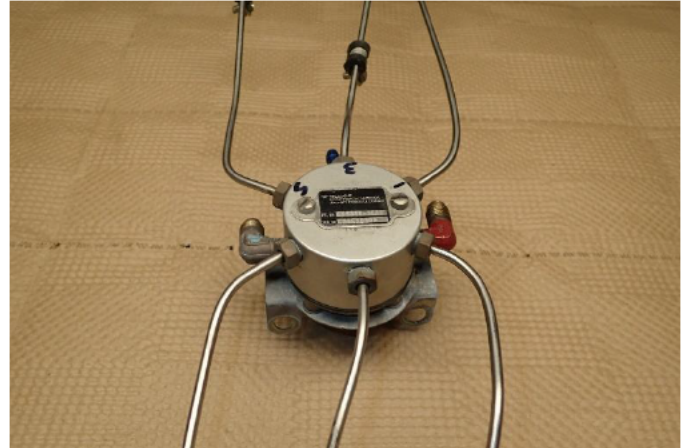
Condition: The fuel manifold valve remained attached to its installation point and was undamaged. There were no signs of fuel leaks observed and all of the fuel lines were secure.

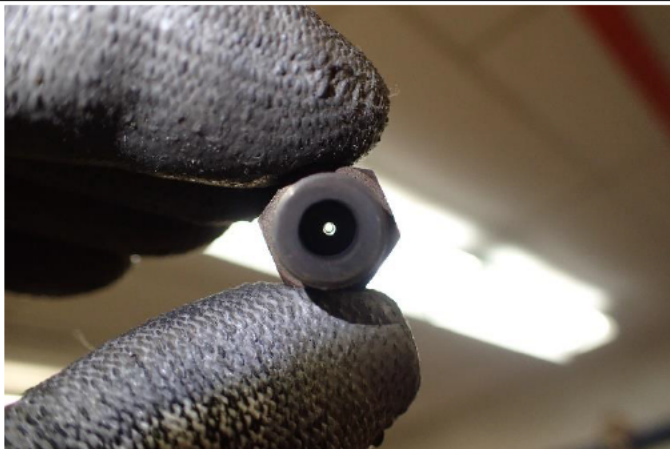
#1 Nozzle

Condition: The nozzles remained installed in their cylinders and were undamaged. The nozzles were removed and checked for obstructions. All of the nozzles were noted to be clear of any obstructions.

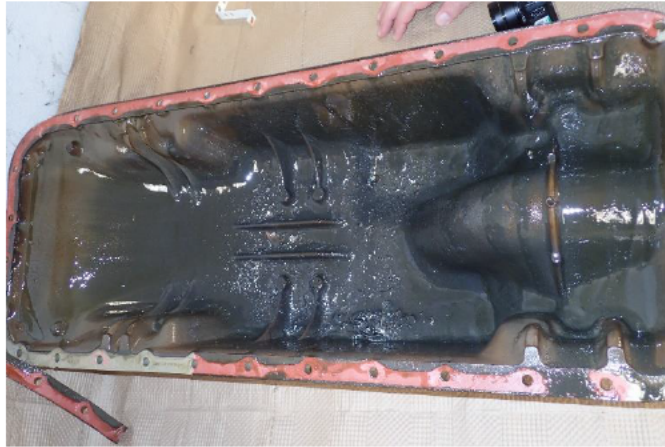
Condition: The oil sump remained intact and was undamaged. The oil sump was removed and it was noted there were several large pieces of loose metal in the oil sump; some of the material was consistent with bearing material.

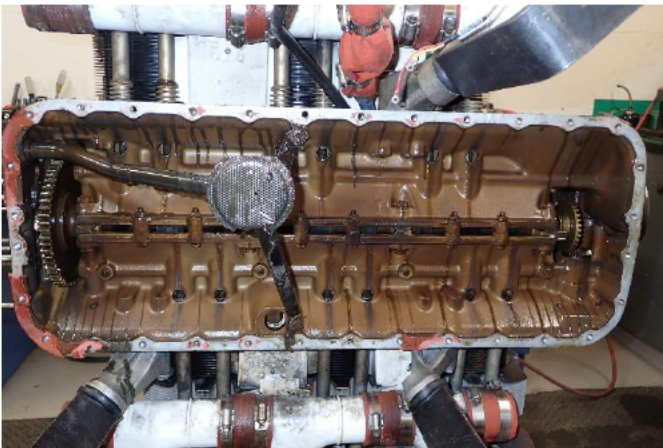
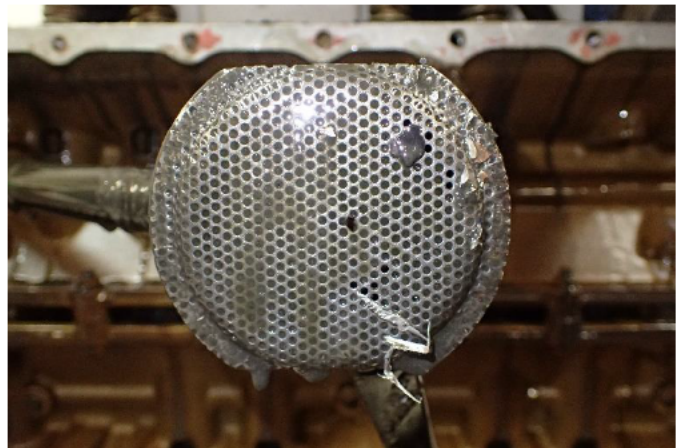
Condition: The oil pick-up tube and screen remained attached to its installation point and was undamaged. The oil pick up screen had several pieces of metallic material within the screen.

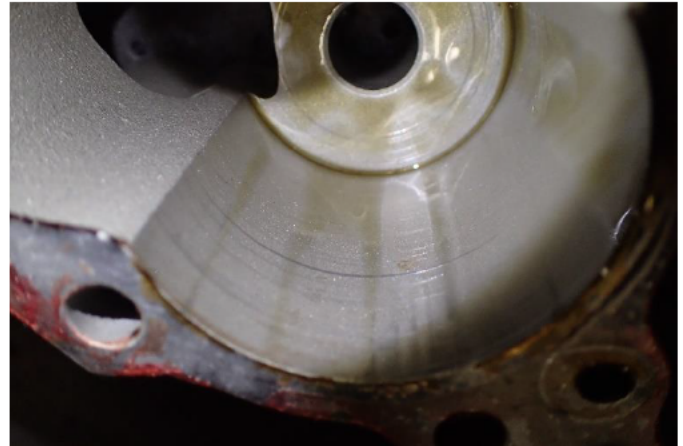
The oil pump remained attached to its installation point and was undamaged. The oil pump was removed and disassembled. The oil pump housing displayed scoring consistent with hard particle passage. The oil pump gears and pressure relief valve displayed normal operating signatures.

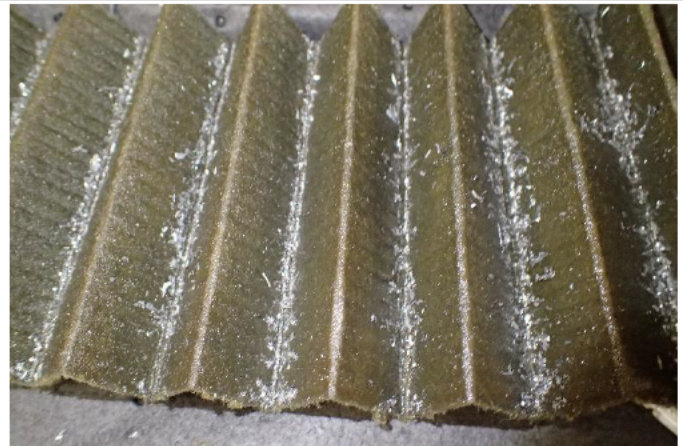
The oil filter was removed and the filter housing was cut open. The filter pleats were visually inspected and it was observed that there was a significant amount of metallic material within the filter pleats.

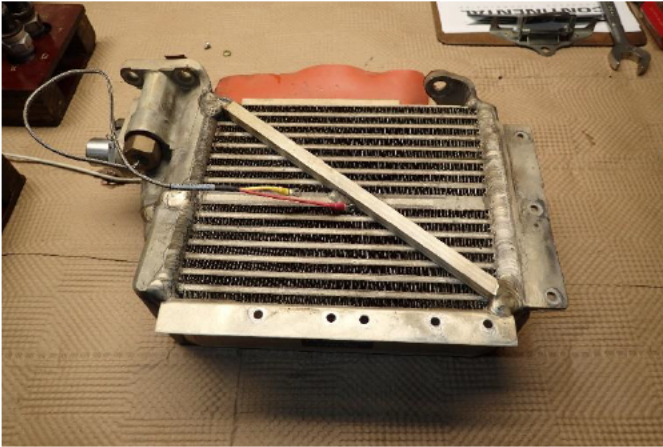
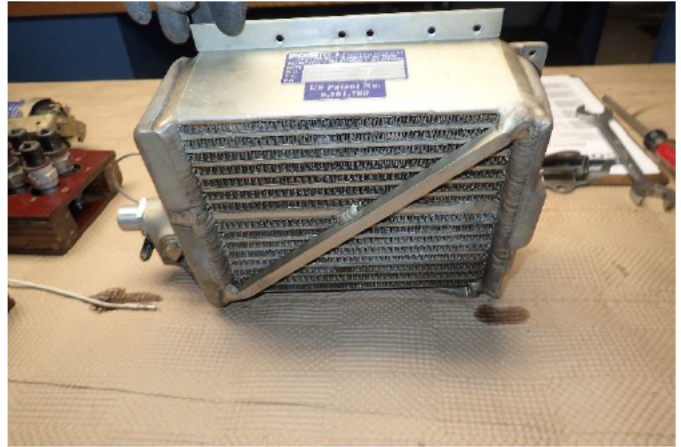
Condition: The oil cooler remained attached to its installation point and was undamaged. There were no signs of oil leaks observed around the oil cooler.

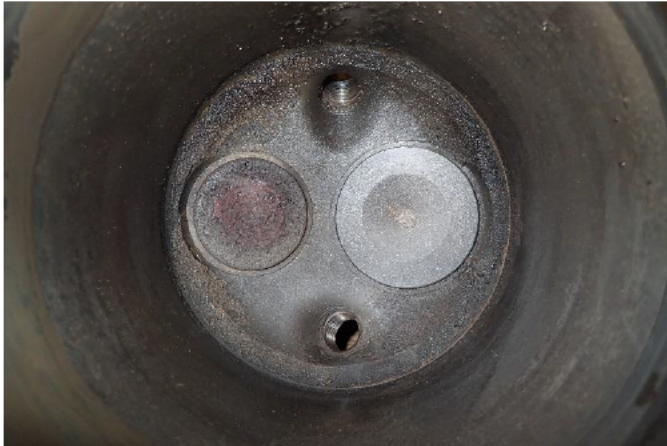
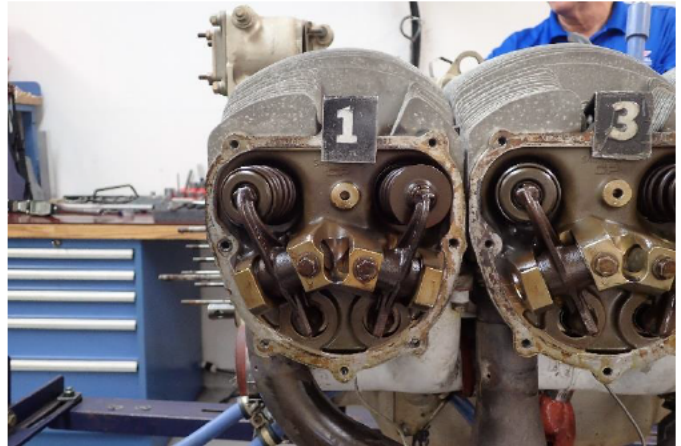
#1 Cylinder (S/N: 29524)

The cylinders remained attached to their cylinder bays and there were no signs of impact damage. The cylinders were removed and visually inspected. The #1, #2, and the #4 displayed mechanical damage to the cylinder skirts. The cylinder bores and valve heads displayed normal operating and combustion signatures. The cylinder overhead components (valves, springs, and rocker arms) displayed normal operating and lubrication signatures.

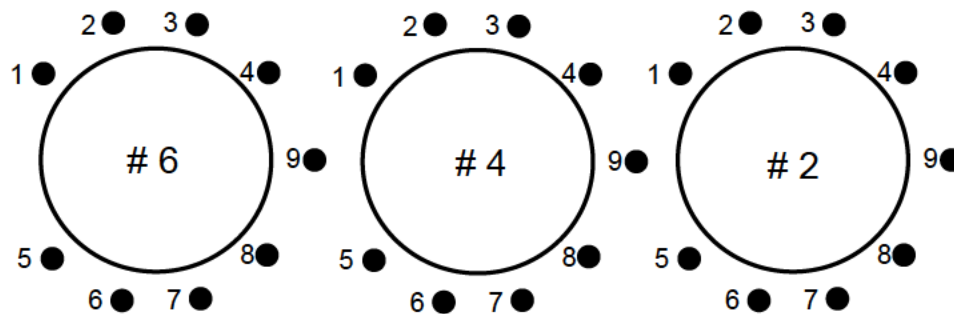
## Cylinder Through-Bolt and Deck Stud Break-Away (Tightening/Loosening) Torque Measurements (in-lbs)

| | Bolt 1 | Stud 2 | Stud 3 | Stud 4 | Bolt 5 | Stud 6 | Stud 7 | Stud 8 | Stud 9 |
|---|---|---|---|---|---|---|---|---|---|
| Cylinder # 1 | 1069/888 | 778/688 | 860/744 | 202/0 | 996/846 | 752/713 | 952/831 | 670/645 | 778/642 |

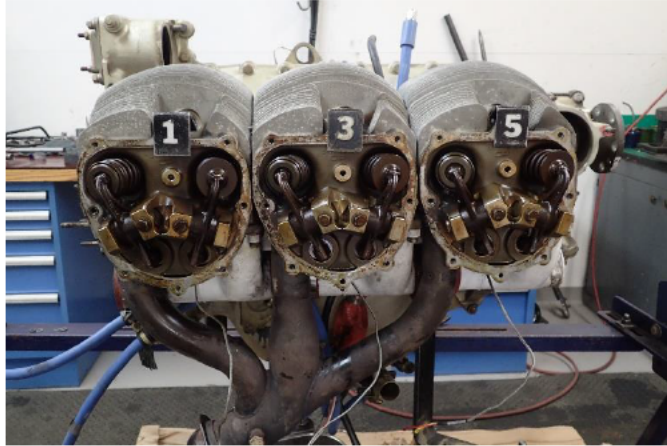
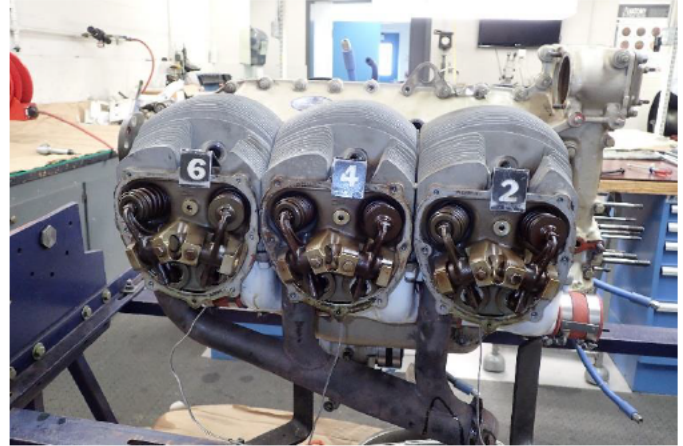
Condition: The valve heads displayed normal operating and combustion signatures. The valve stems, guides, and springs displayed normal operating and lubrication signatures.

Condition: The rocker arms remained intact and were undamaged. The rocker arms displayed normal operating and lubrication signatures.

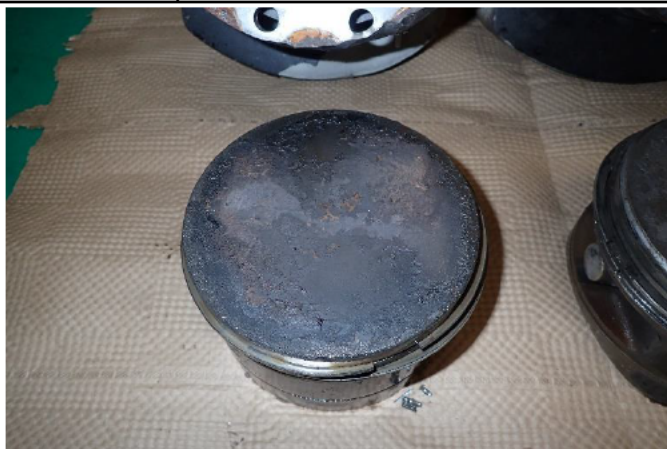
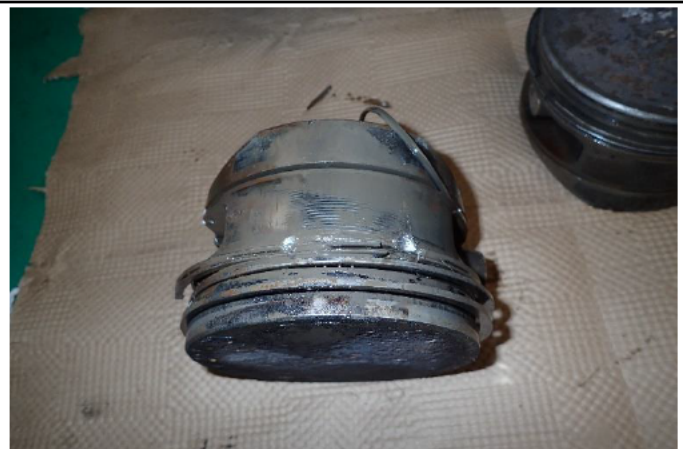
#1 Piston

Condition: All six pistons remained attached to their connecting rods. The #1 and the #2 pistons displayed mechanical damage and had broken piston rings. The #4 piston face displayed a semicircular impression consistent with a valve strike. The rest of the pistons displayed normal operating and combustion signatures. There were no signs of detonation or preignition observed.

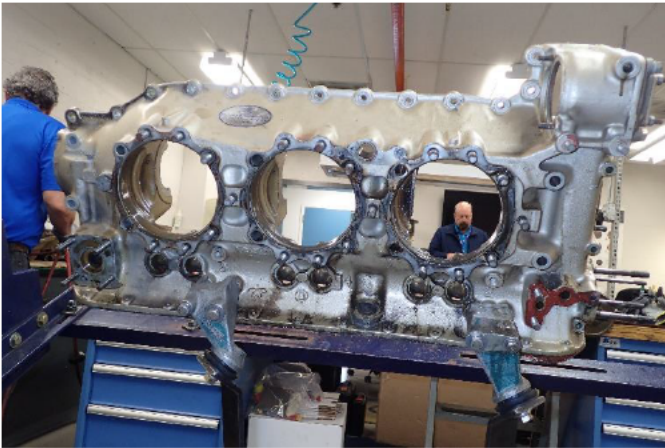
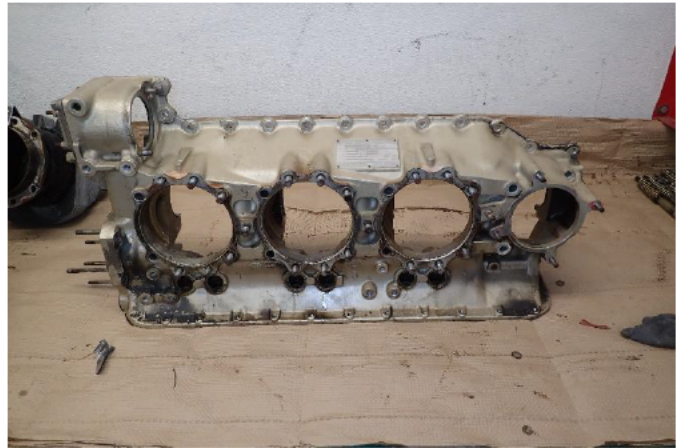
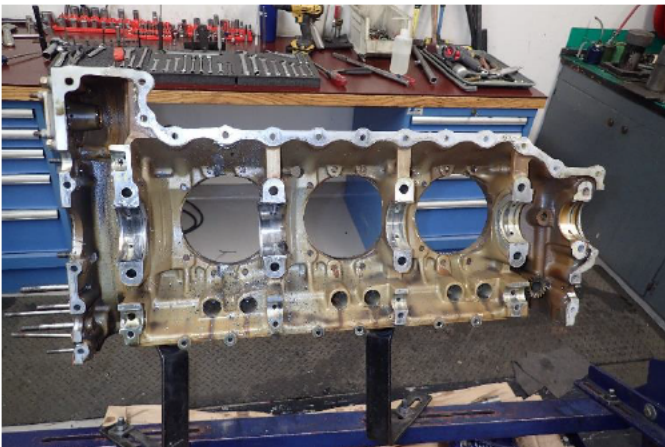
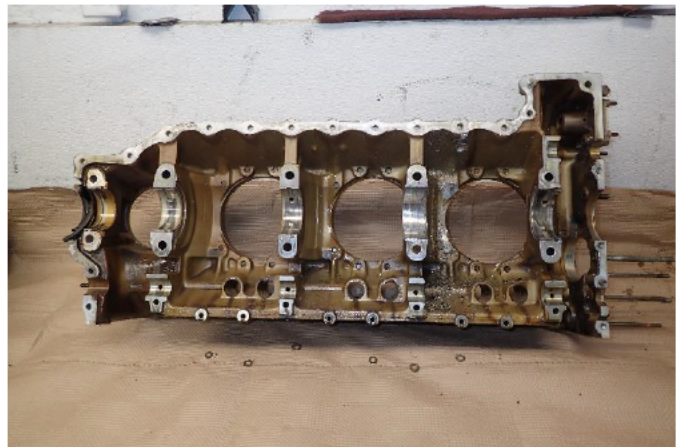
The crankshaft was found to be broken into two pieces and the engine displayed a bearing shift event at the #2 main bearing. The bearing support mating surfaces displayed fretting. It was also observed that the crankcase backbone mating surfaces displayed unapproved sealant material and there was no sign of a silk thread.

The crankcase remained mostly intact; there was a large crack observed on both crankcase halves on the top rear portion of the crankcase. The crankcase halves were split and the internal portions of the crankcase were examined. The #1 and the #2 bearings displayed bearing shift signatures with the #2 bearing displaying the most movement; the #2 bearing had been extruded from the bearing support. The bearing support mating surfaces for the #1, #2, #3, and the #4 displayed varying amounts of fretting with the #1 and the #2 mating surfaces displaying the most fretting. It was also observed that along the outer mating surfaces of the crankcase was material that was not consistent with approved sealant and there were no signs of a silk thread along the outer mating surfaces.

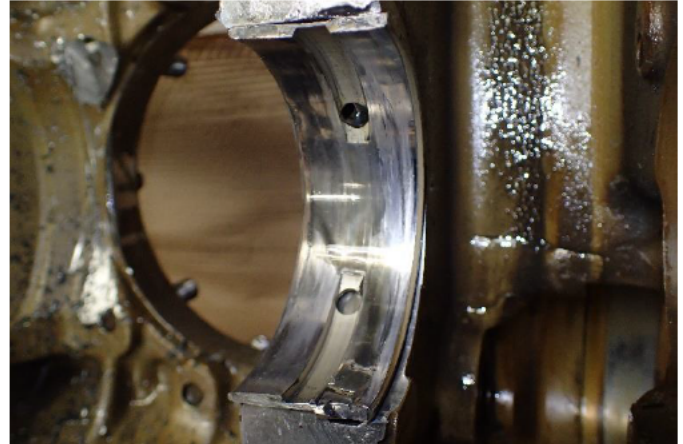
The bearing support mating surfaces displayed significant fretting. The bearing support displayed minor lock tab elongation and the bearing had slightly shifted. There were no signs of lubrication distress.

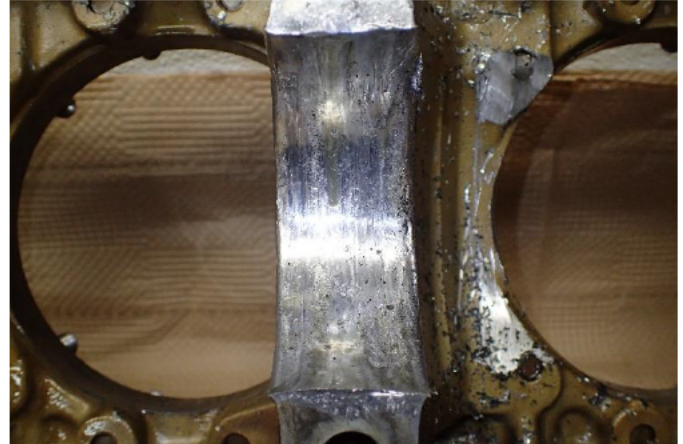
The bearing displayed significant bearing shift signatures and a large portion of the bearing had extruded from the bearing support. The bearing support mating surfaces displayed fretting and the lock tab had completely worn away.

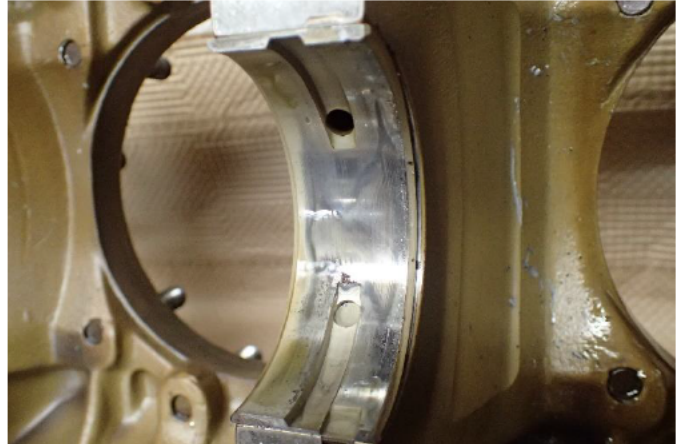
The bearing remained within the bearing support and displayed normal operating and lubrication signatures. The bearing support mating surfaces displayed minor fretting at the bottom mating surfaces.

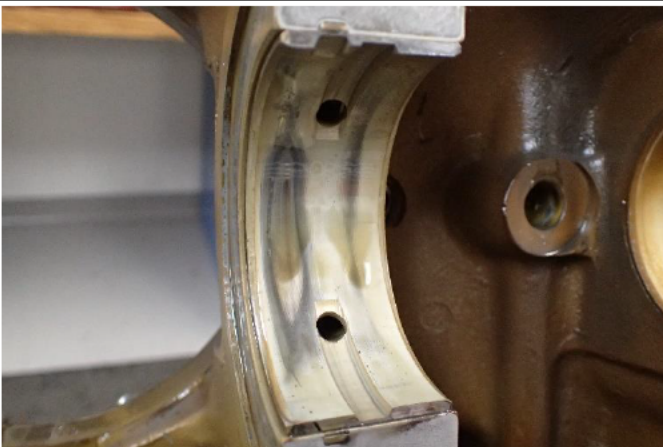
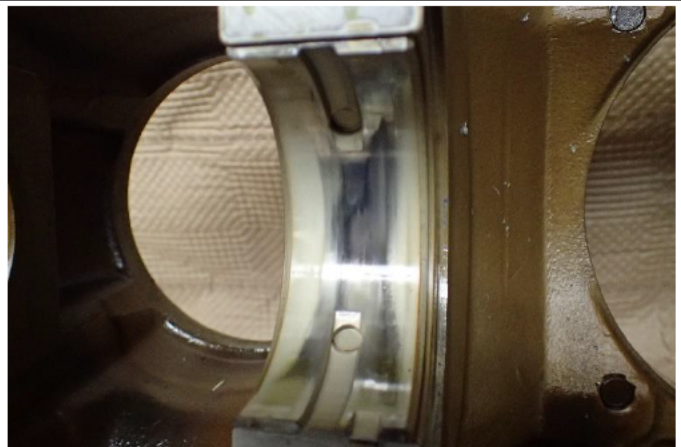
The bearing remained within the bearing support and displayed normal operating and lubrication signatures. The bearing support mating surfaces displayed minor fretting at the bottom mating surfaces.

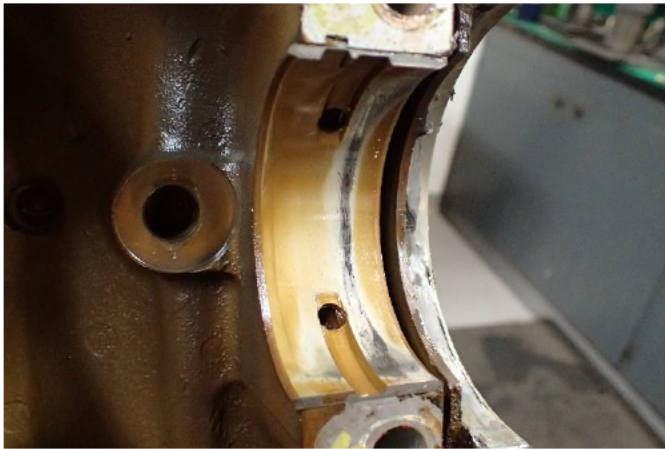
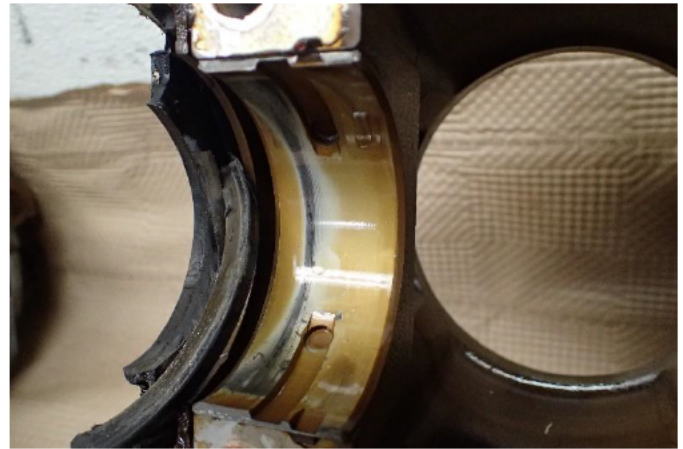
The bearing remained within the bearing support and displayed normal operating and lubrication signatures. There was no fretting observed at the bearing support mating surfaces.

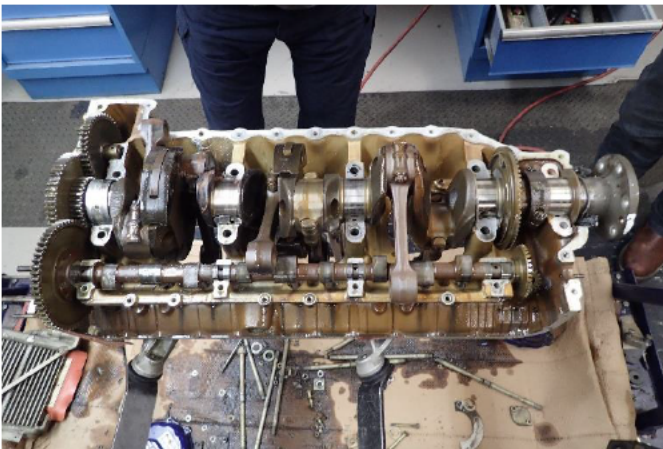
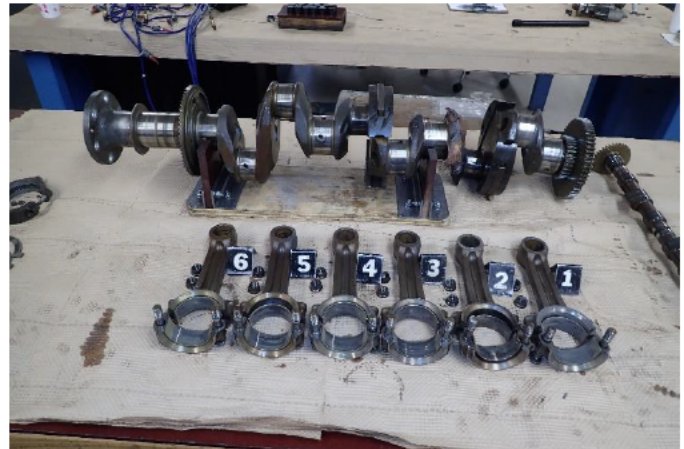
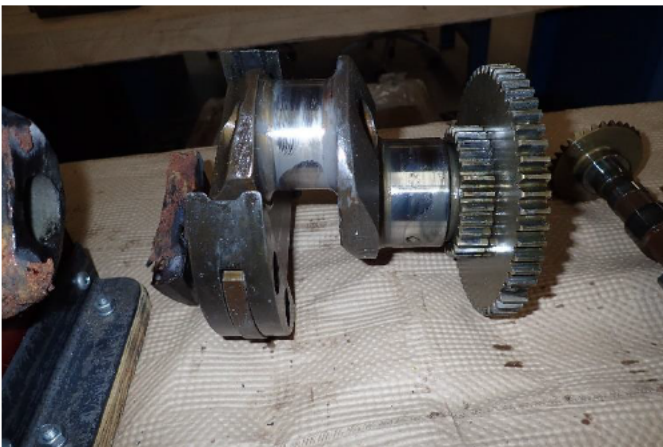
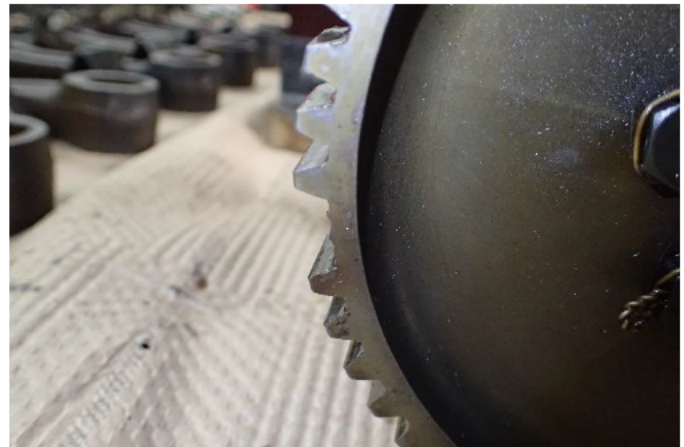
The crankshaft was found to be broken into two pieces; the fracture area occurred at the crankshaft cheek between the #2 main bearing journal and the #2 connecting rod journal. It was noted that the fracture location coincided with the location of the extruded #2 main bearing. The fracture surface displayed several fracture beach marks. The bearing #2 connecting rod bearing journal displayed lubrication distress signatures; the rest of the journals displayed normal operating and lubrication signatures. The crankshaft gear remained secured and one gear tooth had broken free.

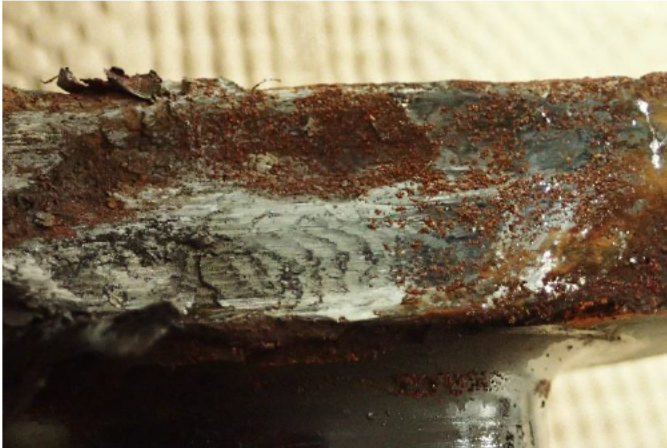
Fracture Surface on Forward Portion of the Crankshaft

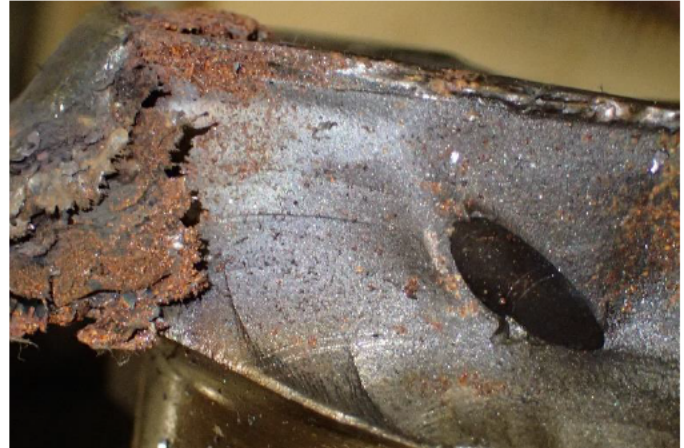
Fracture Surface on Aft Portion of the Crankshaft

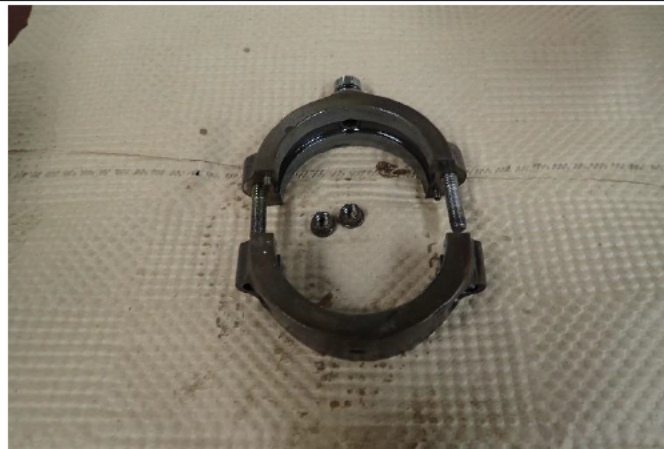
The transfer collar remained intact and was undamaged. The transfer collar displayed normal operating signatures.

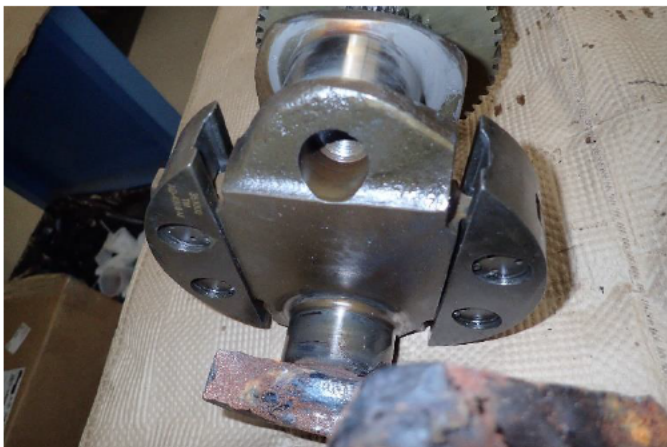
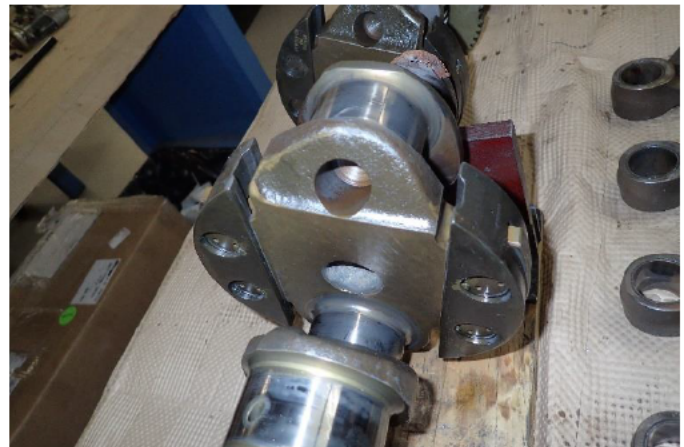
The counterweights remained attached to their hangers, were undamaged, and were capable of normal movement on their hangers.

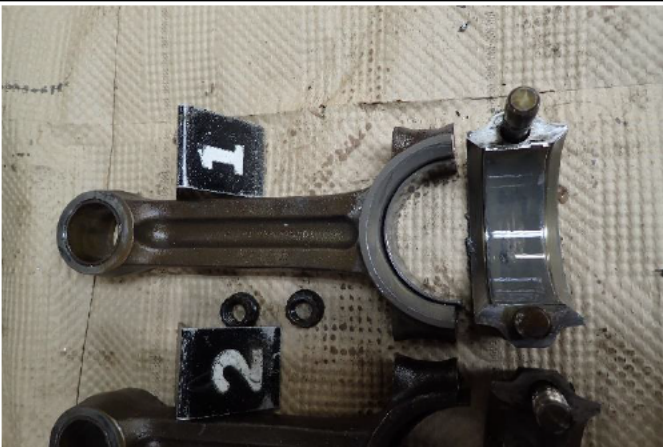
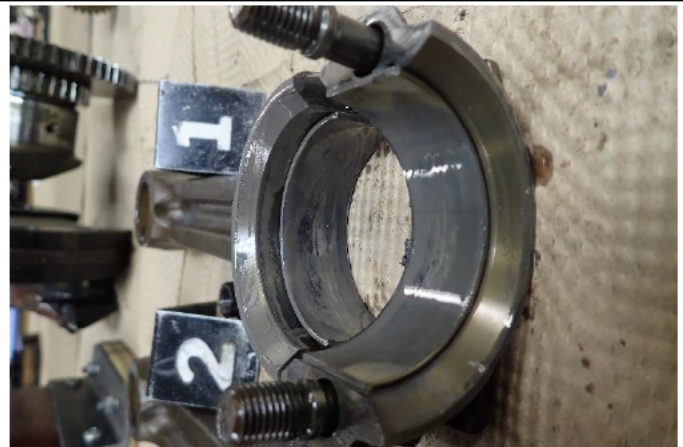
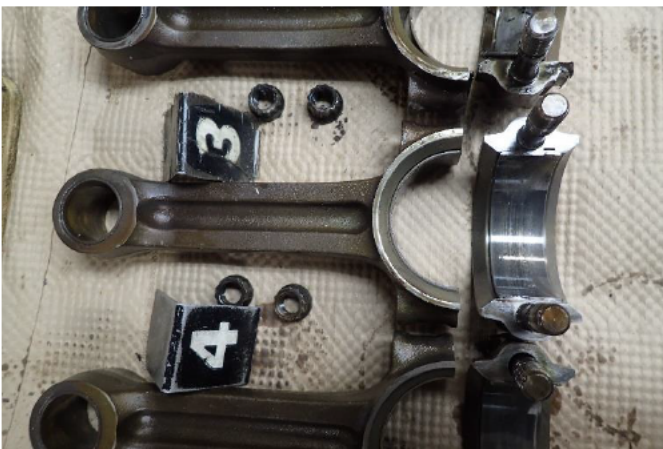
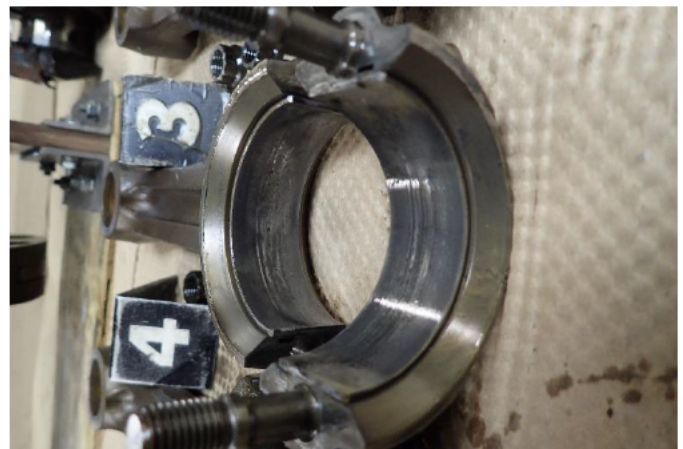
Condition: All of the connecting rods remained attached to their journals and remained intact. The #2 connecting rod journal displayed thermal discoloration consistent with lubrication distress of the bearing. The rest of the connecting rods were undamaged.

Condition: The #2 connecting rod bearing displayed smearing and damage consistent with lubrication distress and the #3 connecting rod bearing displayed minor lubrication distress signatures. The rest of the connecting rod bearing displayed normal operating and lubrication signatures.

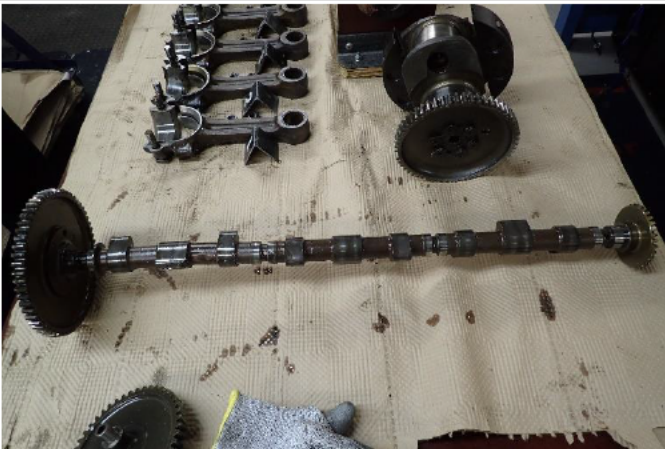
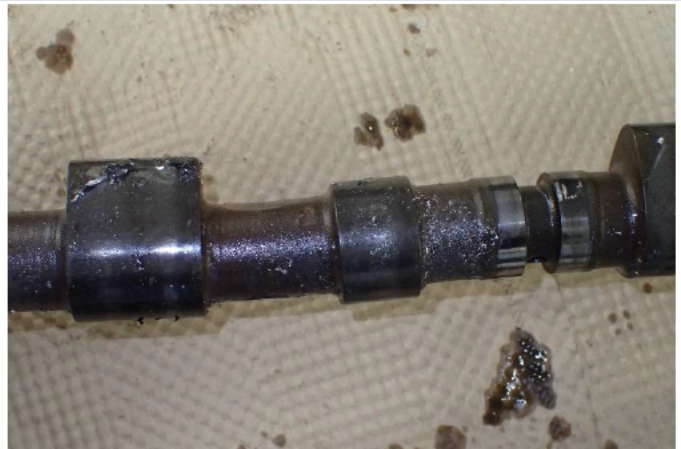
The camshaft remained intact and displayed mechanical damage; the camshaft was bent and there was a crack noted at one of the journals. The camshaft gear remained intact and was undamaged and the camshaft lobes displayed normal operating signatures.

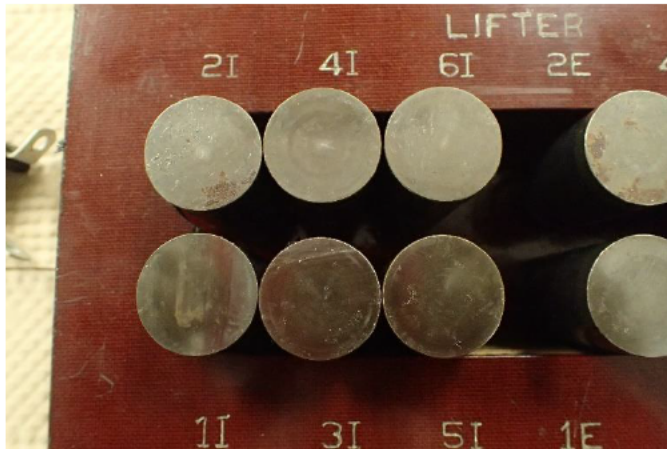
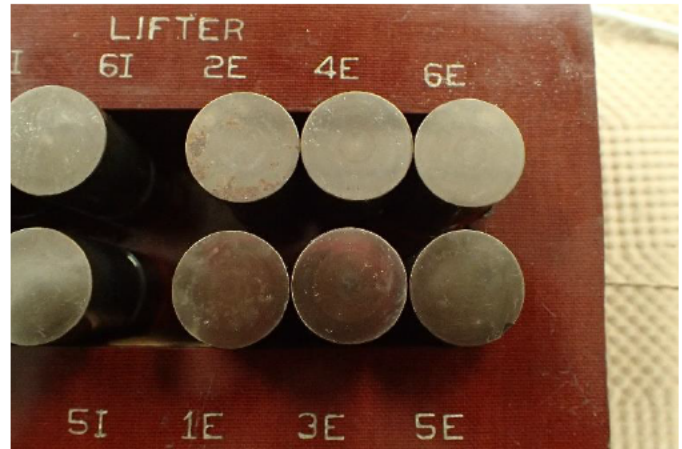
| LIFTERS | #1 | #3 | #5 | #2 | #4 | #6 |
|---|---|---|---|---|---|---|
| Condition: | The lifters remained intact and were undamaged. Some of the lifters displayed minor corrosion and spalling as well as normal operating and lubrication signatures. | | | | | |

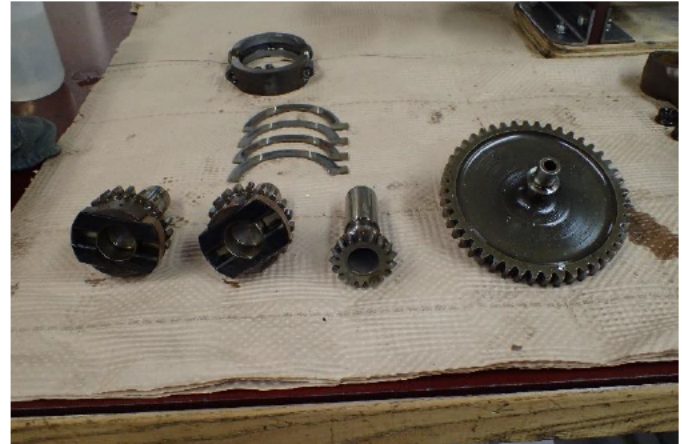
Condition: The magneto drive gears, governor drive gear, and the idler gear displayed normal operating signatures.

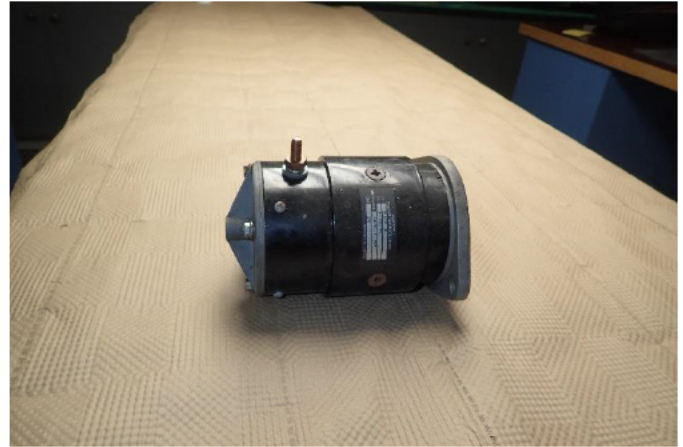
The starter remained intact and was undamaged. The starter was removed, and the driveshaft was noted to be capable of rotation.

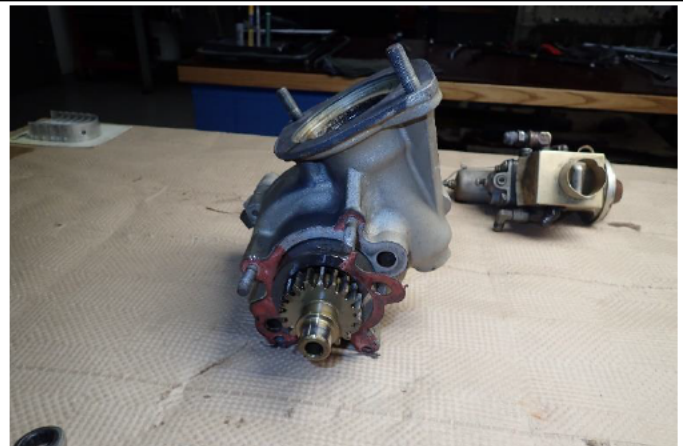
The starter adapter remained attached to its installation point and was undamaged. The adapter was removed and the adapter driveshafts were capable of normal movement.

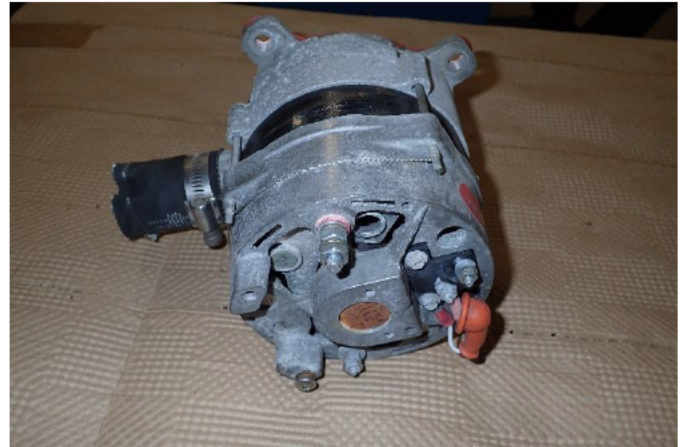
The alternator remained attached to its installation point and was undamaged. The alternator was removed, and the drive coupling was observed to remain intact and was capable of normal movement.
