# ENGINE EXAMINATION REPORT

| ENGINE MODEL | IO-550-B |
| AIRCRAFT REGISTRATION | N80WH |
| FILE NUMBER | 19-072 |

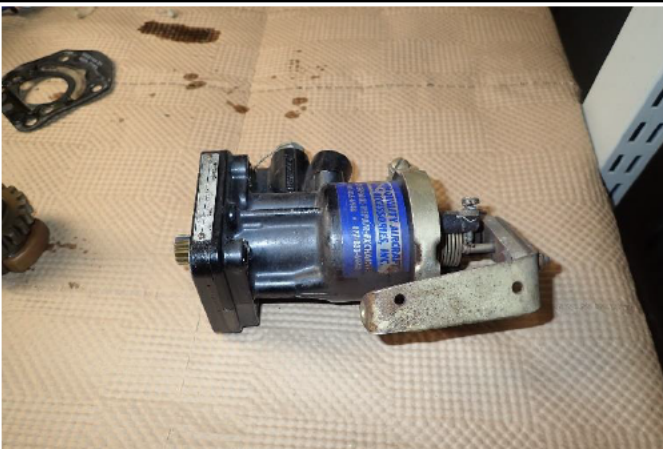
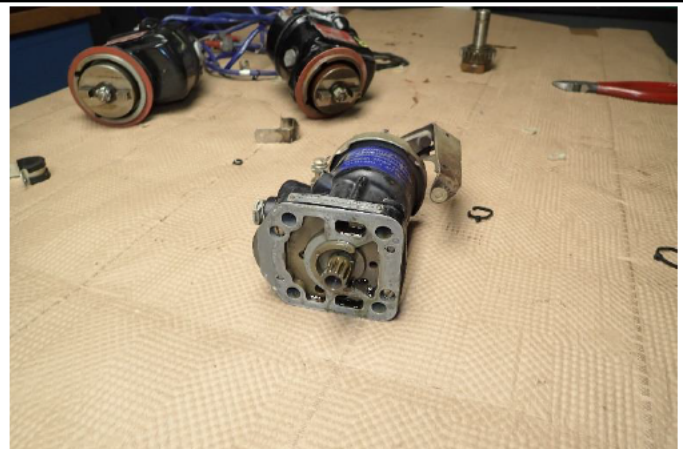
The governor remained attached to its installation point and was undamaged. The governor was removed, and the driveshaft was noted to have remained intact and was capable of normal rotation. During rotation, it was observed that the governor was capable of pumping residual oil. The oil screen gasket was intact and there were no contaminants noted within the screen.
