# NATIONAL TRANSPORTATION SAFETY BOARD

## MATERIALS LABORATORY FACTUAL REPORT

Report No. 20-008

Place : Foley, Alabama  
Date : September 1, 2019  
Vehicle : Cirrus SR22, N878SR  
NTSB No. : ERA19LA264  
Investigator : Lynn Spencer

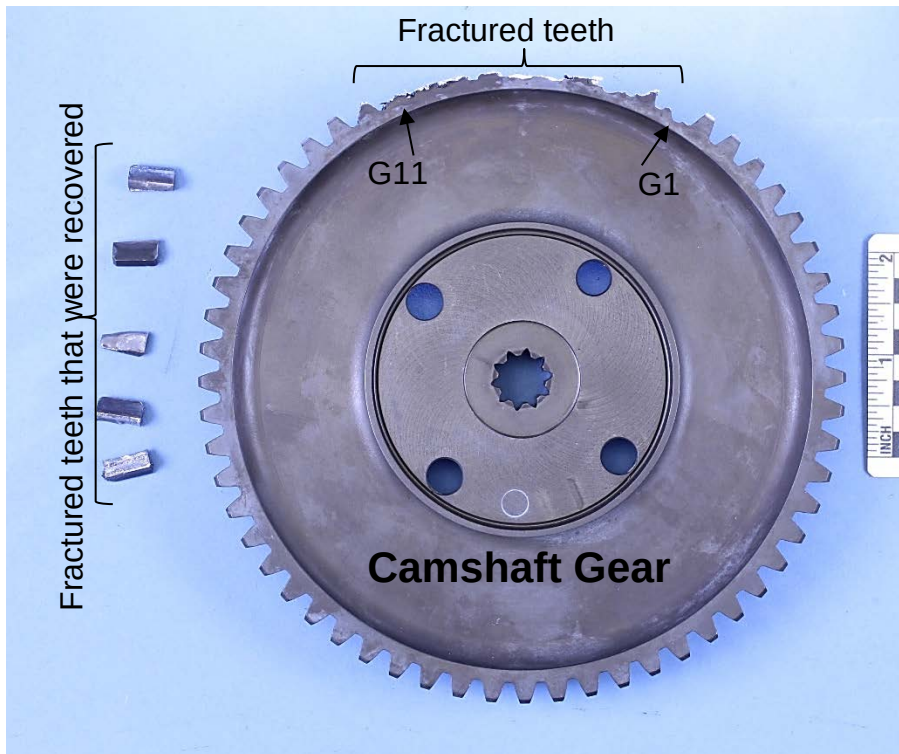
Figure 1 shows a photograph of the as-received camshaft gear. The camshaft gear contains outer teeth and an internal spline at the core. Visual examination of the camshaft gear revealed a total of eleven outer teeth were fractured, in the areas indicated by arrows "G1" through "G11" in figure 1. Five fractured teeth were submitted as shown in figure 1. The forward face of the camshaft gear was marked Teledyne Continental Motors "P/N 631845 J", and "G87". The same face also was marked with a character that appeared similar to a capital "M", where the size of the character "M" was slightly larger than the size of the characters for the part number. The area within the "M" contained the characters "TK" and "5", see figure 2. The opposite face of the gear was marked with the characters "RAM 24".

The fracture faces of gear teeth "G4" through "G11" in figure 1 showed evidence of severe mechanical damage that obliterated the fracture features.

Figure 1. Photograph of the as-received camshaft gear showing the forward face and the location of eleven fractured teeth, indicated by arrows "G1" through "G11", and five fractured teeth that were recovered.

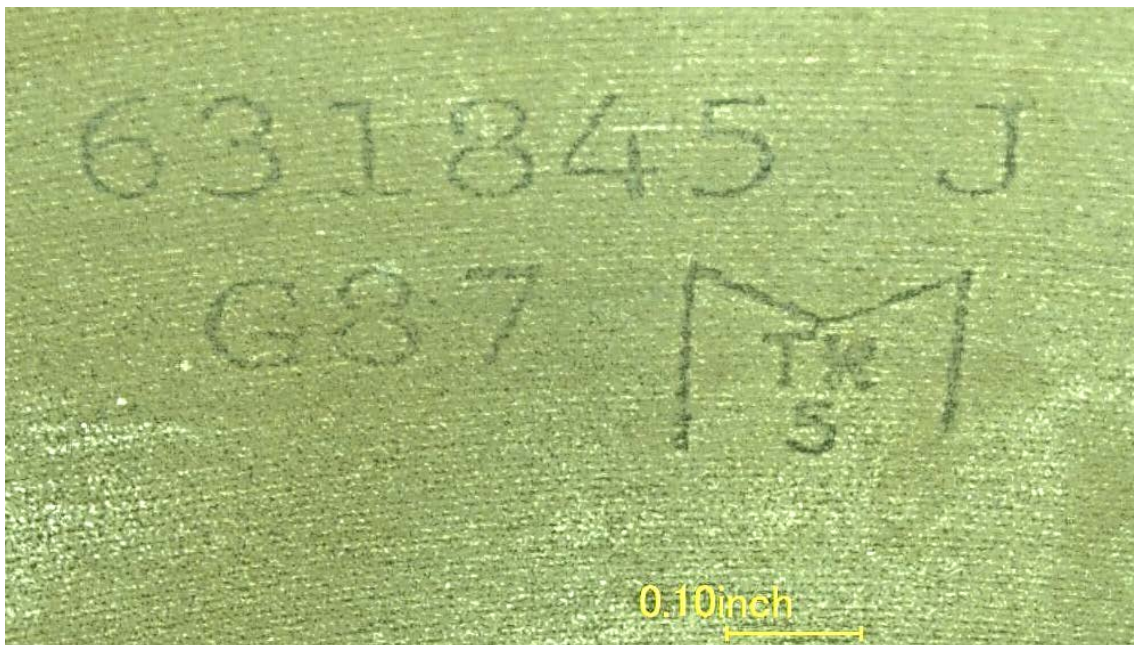
Figure 2. Photograph of the part number "631845" found on the forward face of the camshaft gear.

Continental Motors Aircraft Engines Critical Service Bulletin CSB05-8D was issued to eliminate the possibility of camshaft gear tooth fracture, resulting in power loss or in-flight shutdown, and to inspect and remove from service P/Ns 631845, 655430, 655516, or 656031 and replace with camshaft gear, P/N 656818. According to CSB05-8D, the fractured camshaft gear involved in this accident ERA19LA264 is P/N 631845 and must be (should have been) replaced with P/N 656818.

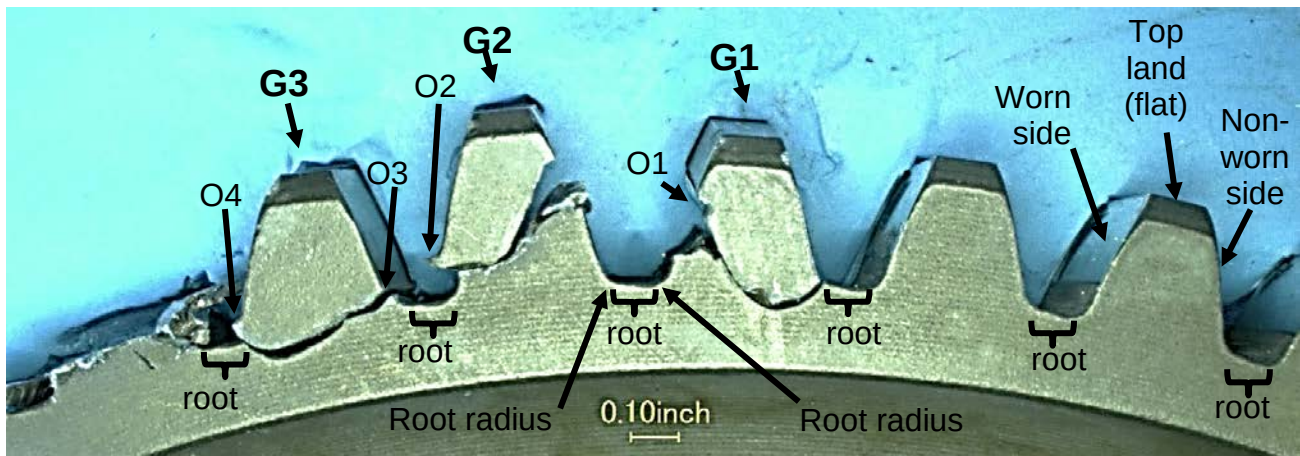
Binocular microscope examination fractured gear tooth "G3" revealed the inner face of the fracture contained a fatigue crack that emanated from the root radius on each side of the tooth in the areas indicated by arrows "03" and "04" in figure 3. Figure 4 shows a photograph of the inner face of the tooth fracture. The fatigue crack origin areas indicated

Figure 3. Photograph of a portion of the camshaft showing the forward face and fractured teeth indicated by arrows "G1" through "G3" positioned next to their respective mating fracture faces. Fatigue crack origin areas are indicated by arrows "O1" through "O4".

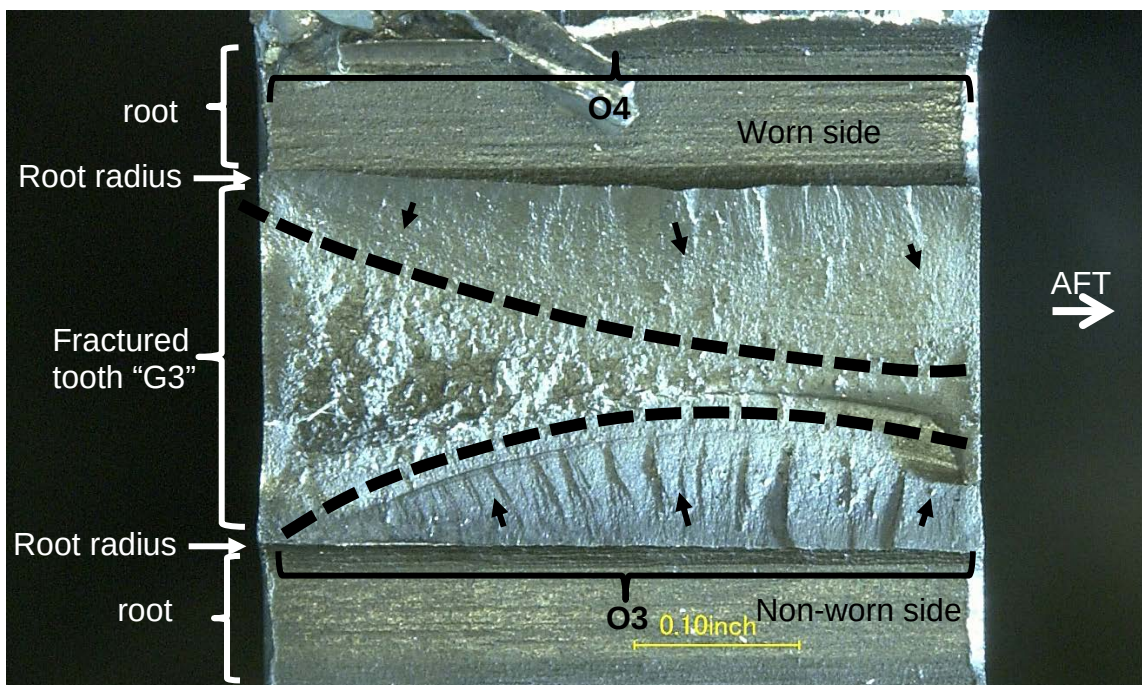
by arrows "03" and "04" in figure 3 corresponded to those indicated by brackets with the same respective numbers in figure 4. Fatigue propagation was toward the core of the tooth in the general direction indicated by arrows in figure 4 and terminated in the areas indicated by dashed lines in figure 4. The areas outside of the fatigue crack region exhibited a rough texture consistent with overstress separation. The mating fracture face (not shown in this report) showed fracture features that were similar to those on the inner face of the fracture.

Figure 4. Close-up photograph the inner fracture face of tooth "G3". A fatigue crack emanated from the root radius on each side of the tooth in the areas indicated by brackets "O3" and "O4".

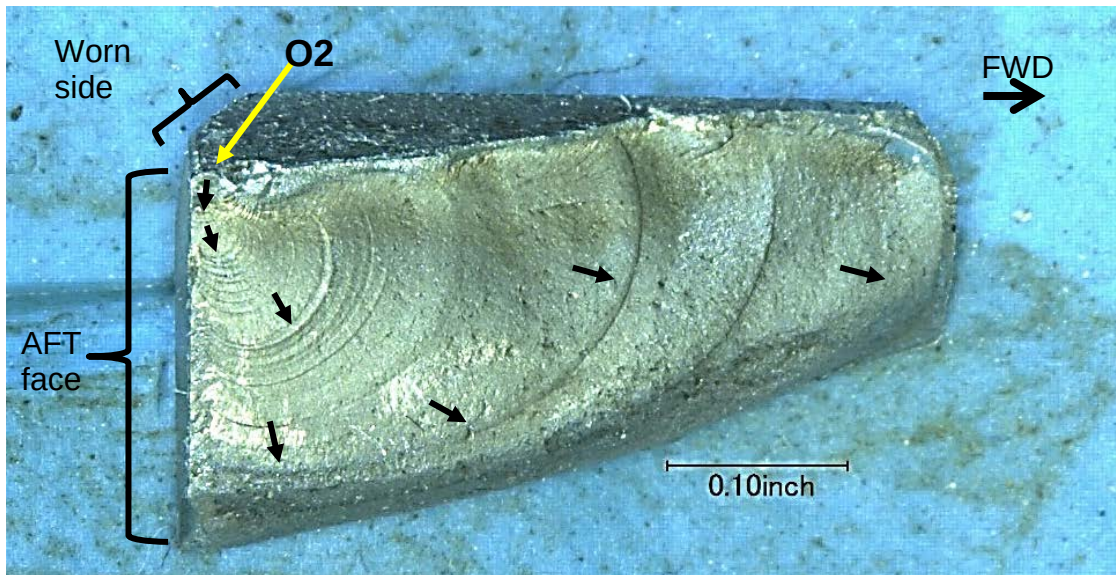
The outer face of fractured gear tooth "G2" contained evidence of fatigue cracking that emanated from the root radius on the worn side of the tooth in the area indicated by arrow "O2" in figures 3 and 5. Fatigue crack propagation was through a major portion of the tooth. The mating fracture face (inner fracture face) was not a mirror image of the outer fracture face, indicating a fragment of the tooth separated from the camshaft gear. The fragment was not submitted.

Figure 5. Close-up photograph of the outer fracture face of tooth "G2". A fatigue crack emanated from the worn side near the forward face in the area indicated by arrow "O2". Fatigue origin arrowed "O2" in this figure corresponded to fatigue origin arrowed "O2" in figure 3.

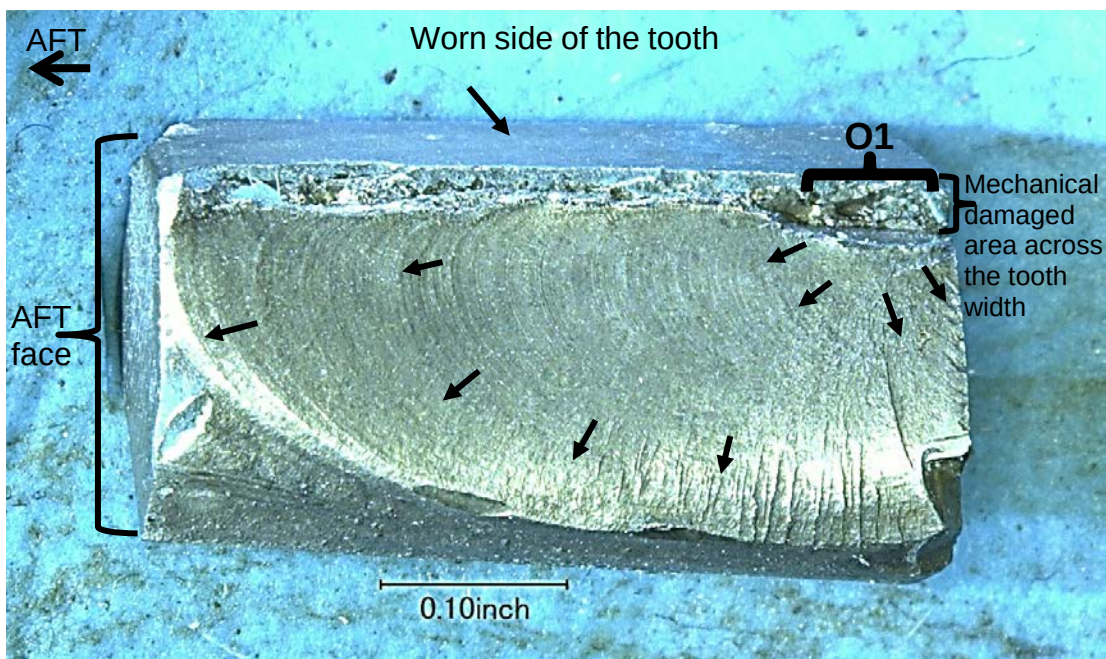
The outer face of fractured gear tooth "G1" in figure 6 showed evidence of fatigue cracking that emanated from the worn side of the tooth. The origin of the fatigue crack showed evidence of severe mechanical damage that obliterated the fracture features in the general area of the fatigue origin. Fatigue crack propagation was through a major portion of the tooth. The mating fracture face (inner face of the fracture) in figure 7 was not a mirror image of the outer face of the fracture, indicating a fragment of the tooth from the inner face of the fracture had separated. The fragment was not submitted.

Figure 6. Close-up photograph of the outer fracture face of tooth "G1". A fatigue crack emanated from the worn side of the tooth in the area indicated by bracket "O1". Fatigue origin indicated by bracket "O1" in this figure corresponded to fatigue origin arrowed "O1" in figure 3.

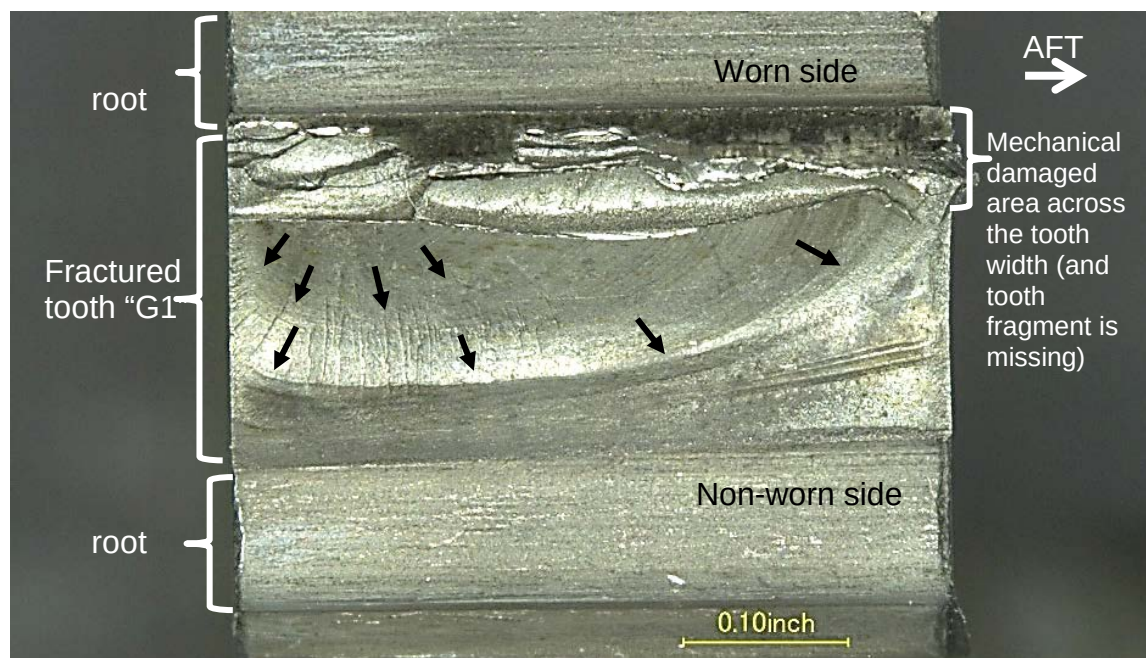
Figure 7. Close-up photograph of the inner fracture face of gear tooth "G1" (it mates with the fracture face in figure 6). A tooth fragment is missing from the origin of the fatigue crack. Fatigue crack propagation was in the general direction indicated by arrows.
