**NATIONAL TRANSPORTATION SAFETY BOARD**

**AIRFRAME AND ENGINE EXAMINATION**

**ERA19LA264**

**ENGINE TEAR-DOWN EXAMINATION**

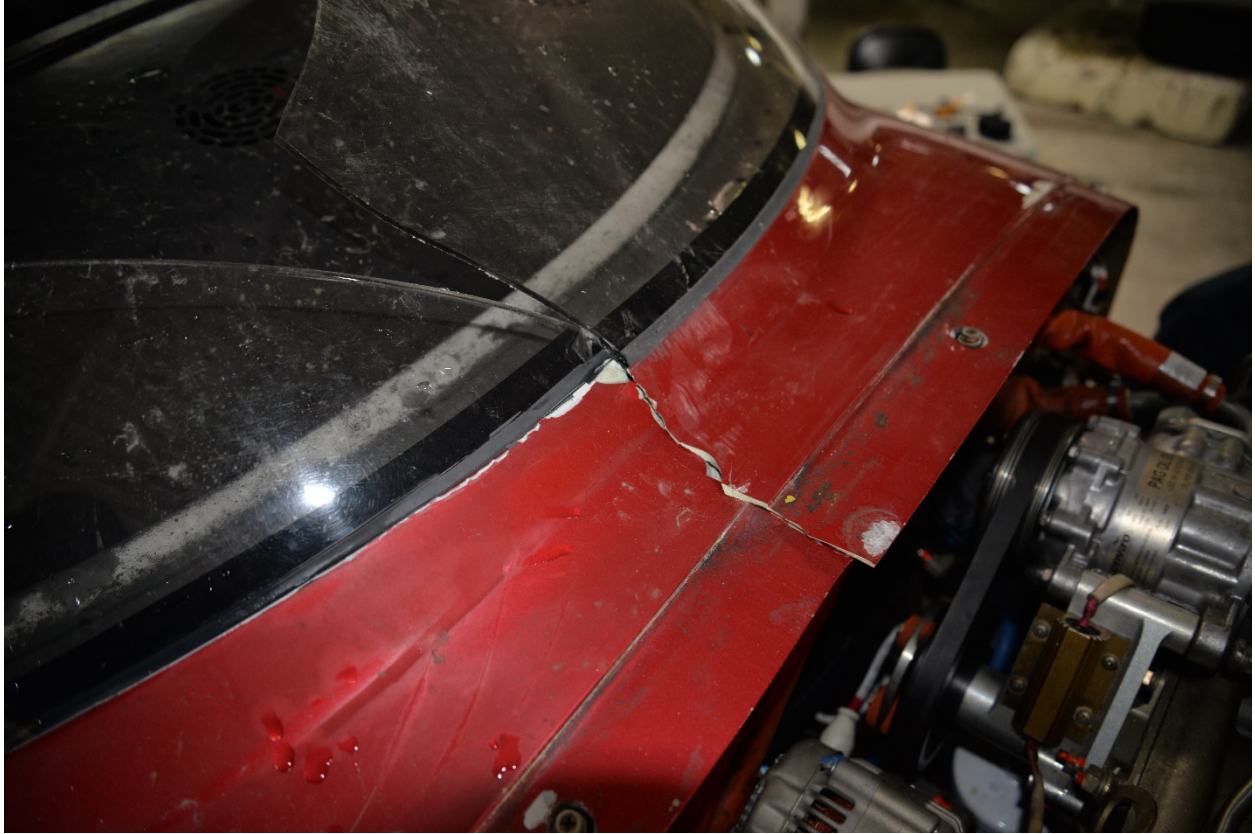
Examination of the airframe revealed damage confined to the nose area. The windshield was fractured with several pieces missing. The fuselage center bond line was fractured behind the firewall. There was a crack above the left and right CAPS harness attach fittings. The aft CAPS harness remained snubbed. Examination of the wing revealed the fracture of the left main landing gear.

*Figure 1: Fuselage fracture at center bond line (Photo Courtesy of Cirrus)*

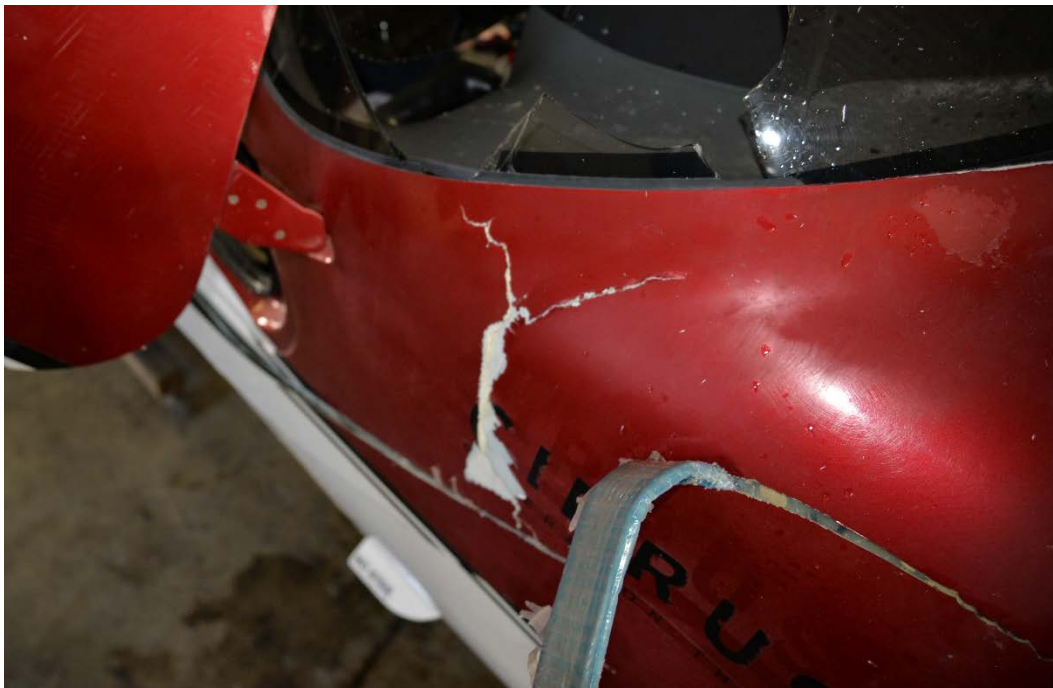
*Figure 2: Fuselage crack above right CAPS harness attach fitting (Photo Courtesy of Cirrus)*

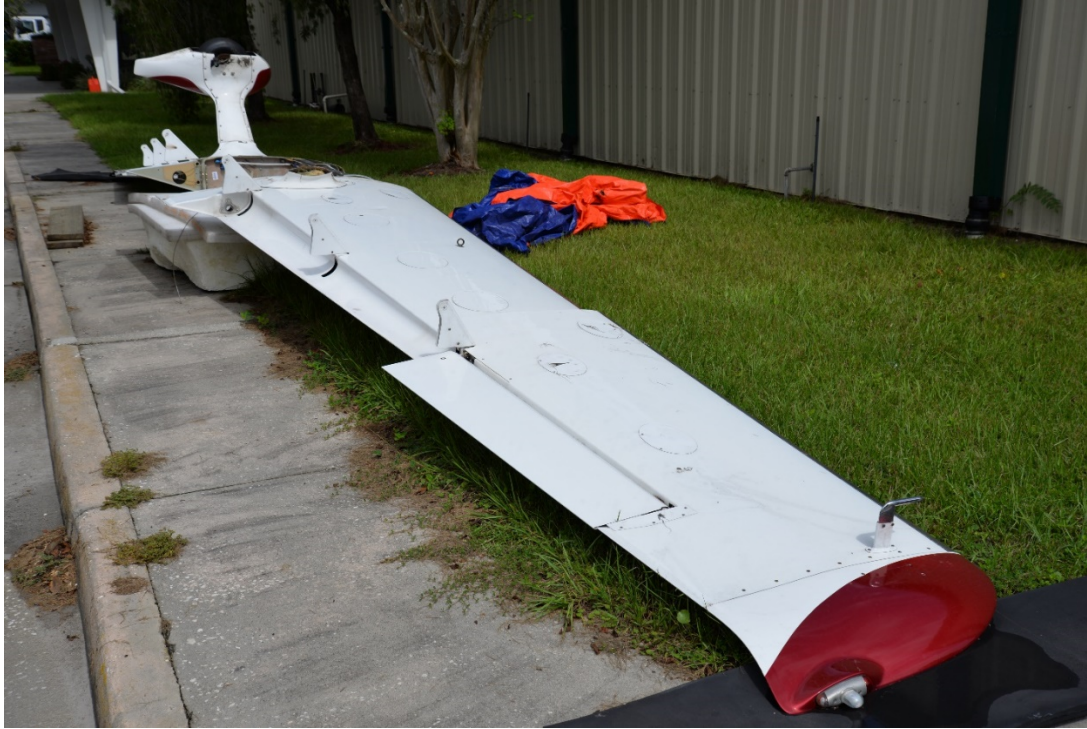
*Figure 5: Left Portion of Wing (Photo Courtesy of Cirrus)*

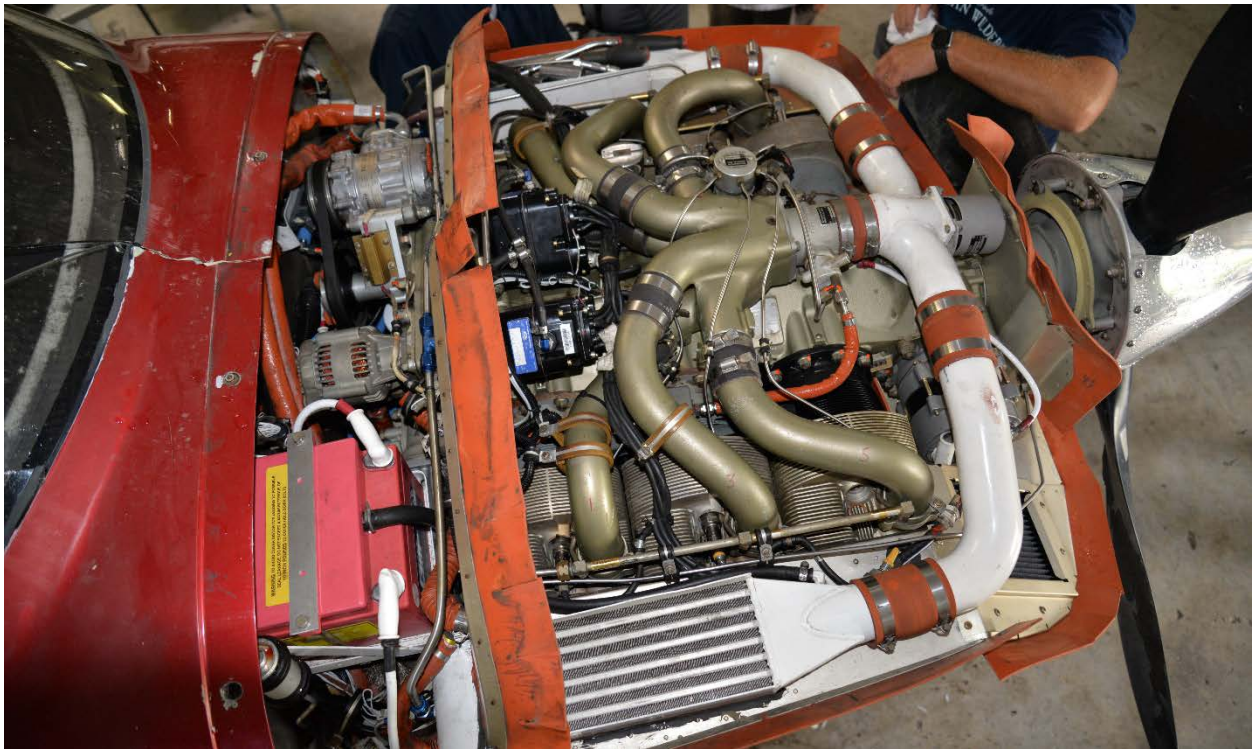
The engine was equipped with a 3-bladed constant speed propeller, which remained attached to its mount. The exterior of the engine showed no evidence of preaccident anomalies. The spinner was crushed from the bottom. One propeller blade was loose in the propeller hub, and the propeller could be rotated with significant resistance. Examination of the engine revealed fractured engine mounts, and the engine was displaced in a positive direction. The crankshaft could not be rotated beyond a few inches.

Figure 7: Uncowled Engine (Photo Courtesy of Cirrus)

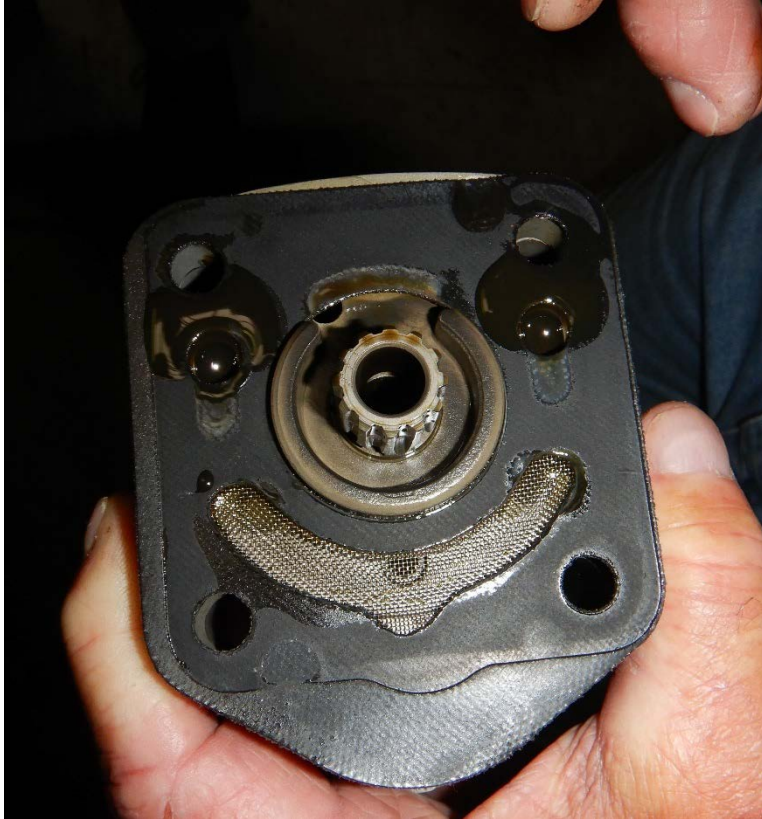
Borescope examination of the cylinders revealed valve strikes on all of the piston faces. The propeller governor screen revealed no metal and the engine accessory drive gear for the governor would not rotate during crankshaft rotation. Upon removal of the alternator, there was no evidence of camshaft rotation upon propeller's manual rotation. The oil filter was removed and cut open. The filter pleats were visually examined and there was noticeable metallic material within the filter pleats.

*Figure 9: Propeller Governor Screen*

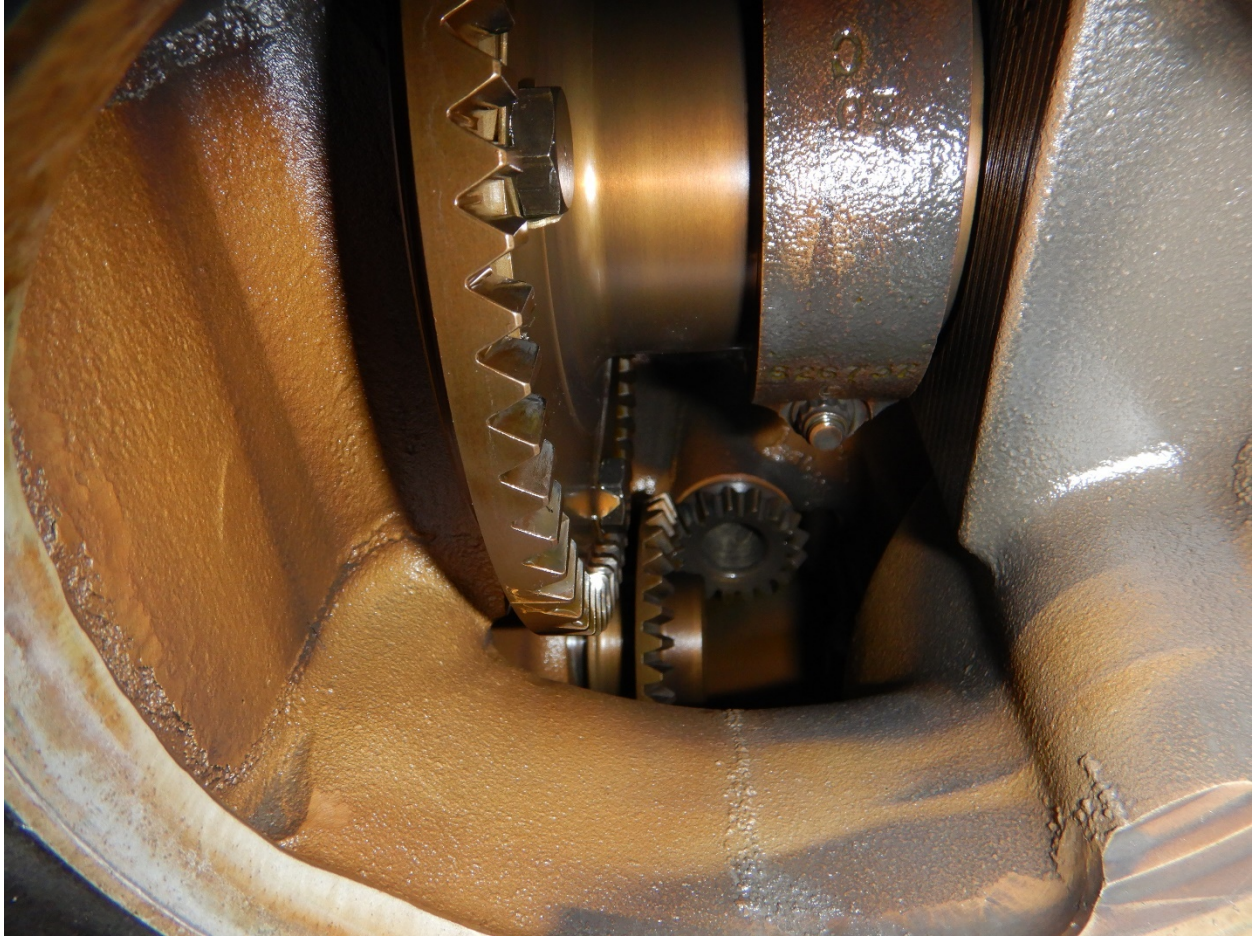
*Figure 10: Camshaft View with Primary Alternator Removed*

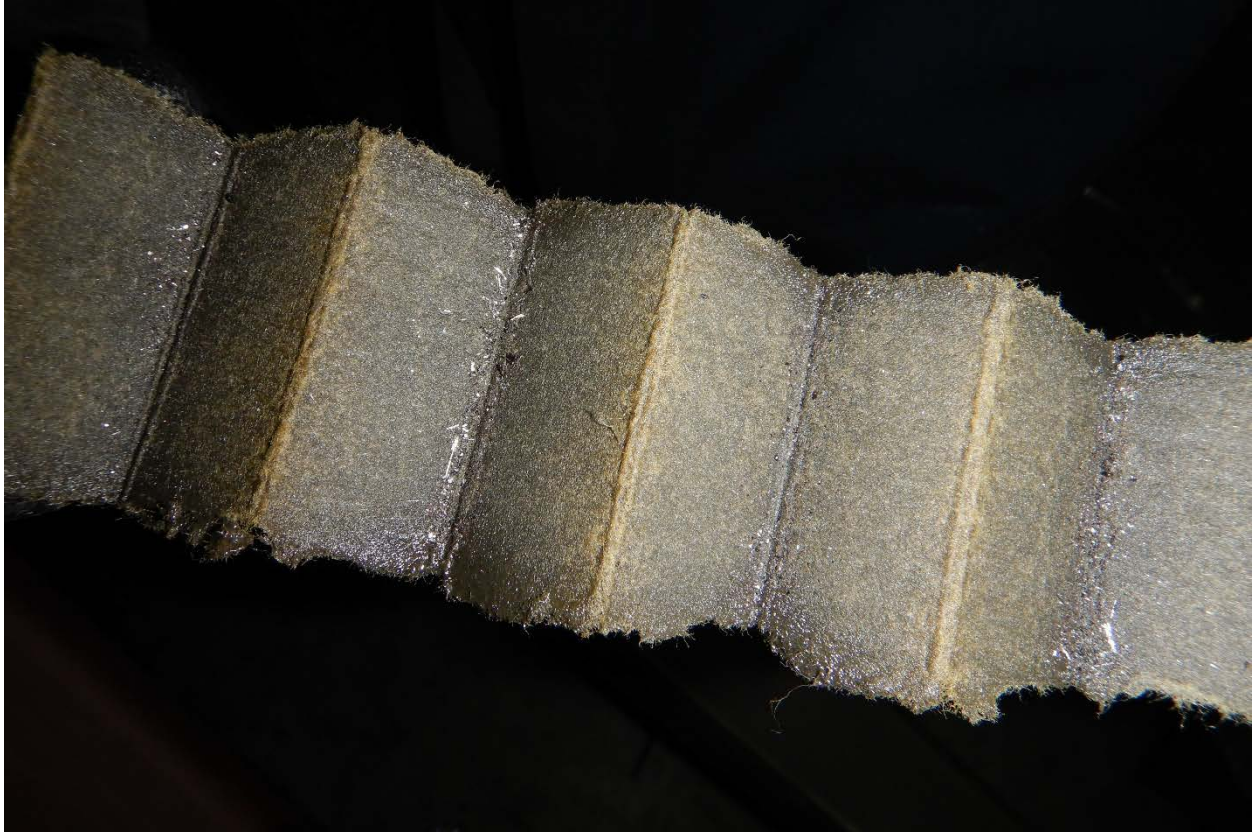
*Figure 11: Metal Shavings on Oil Filter*

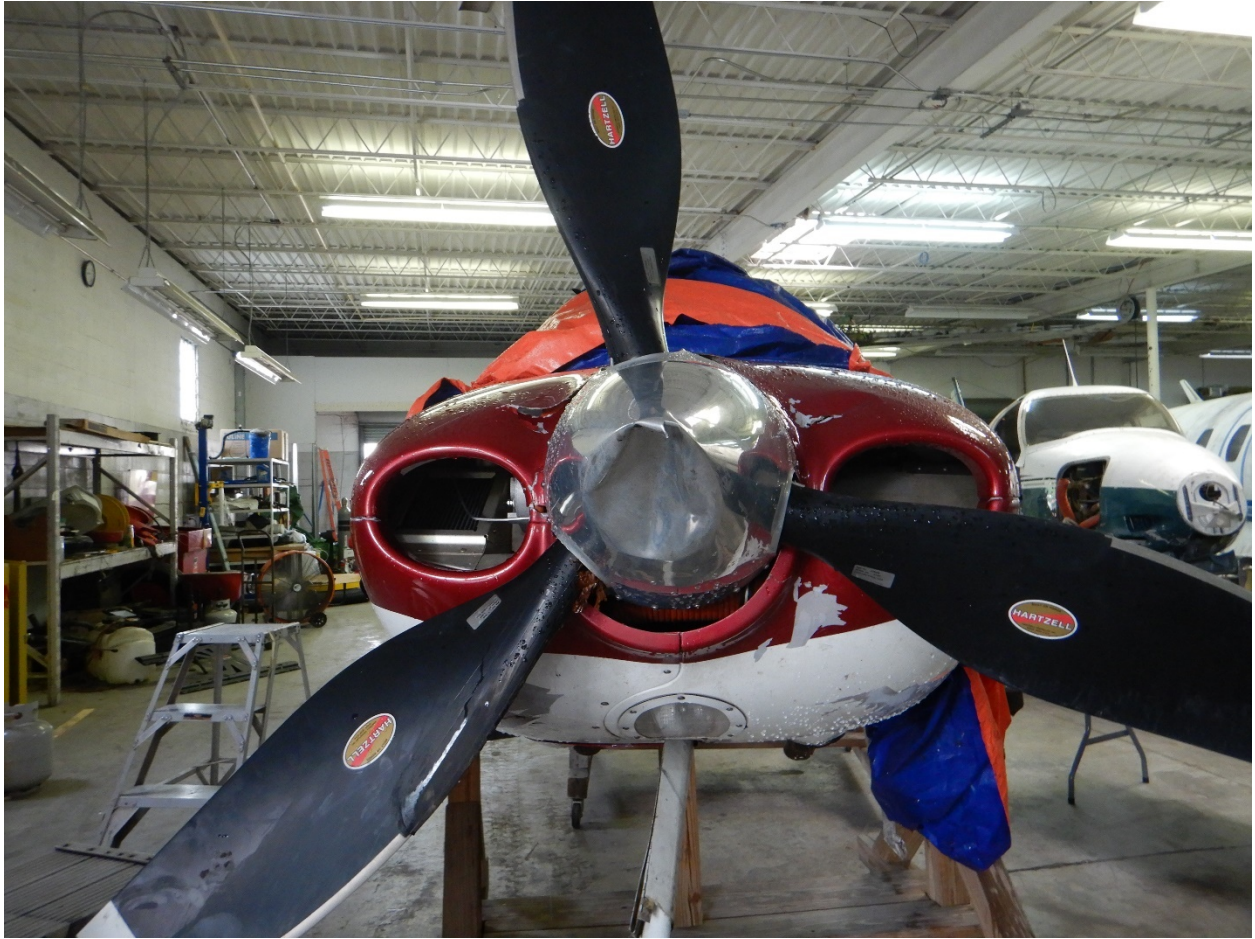
Examination of the propeller revealed that it was attached to the engine. The spinner was crushed from the bottom. There was no indication of rotational deformation. There was no remarkable blade twisting or leading edge damage. One blade was loose.

*Figure 12: Spinner*

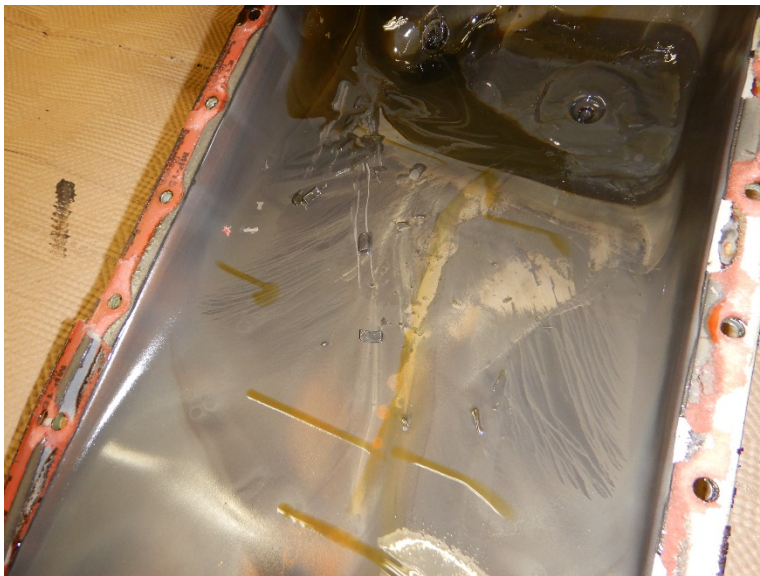
Engine accessories and baffling were removed. Fuel nozzles for all cylinders were found loose in the cylinders. Torque check of through-bolt, deck studs and 7<sup>th</sup> studs torque check revealed no anomalies. The cylinders and pistons were removed. Testing of the left and right magnetos revealed no anomalies. Several gear teeth were observed in the oil pan. Examination of the fuel injectors revealed no anomalies. Examination of the camshaft drive gear revealed the absence of 10 teeth and damage to one tooth.

*Figure 3: Sheered Teeth in Oil Pan*

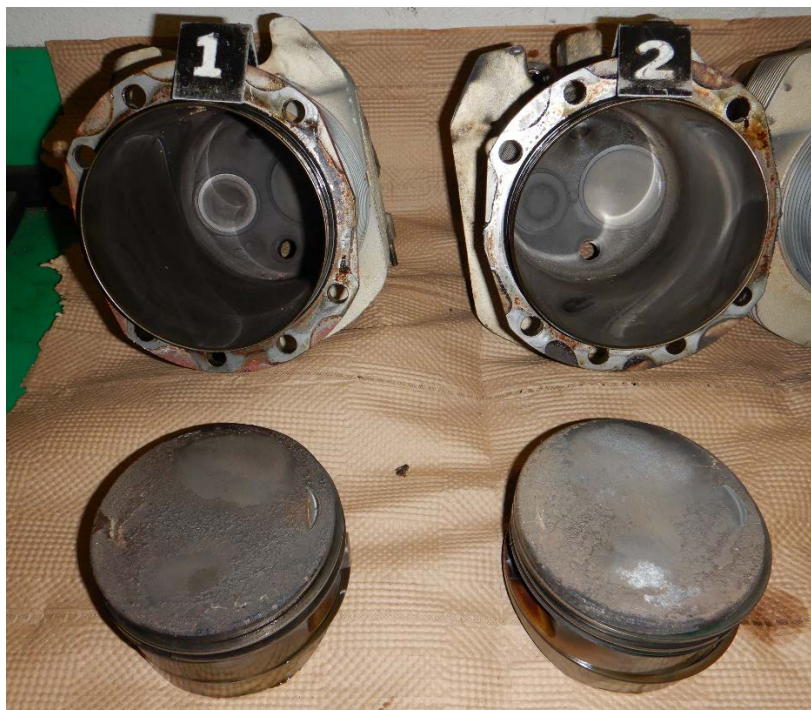
Figure 5: Valve Strikes on Pistons Nos. 1 and 2

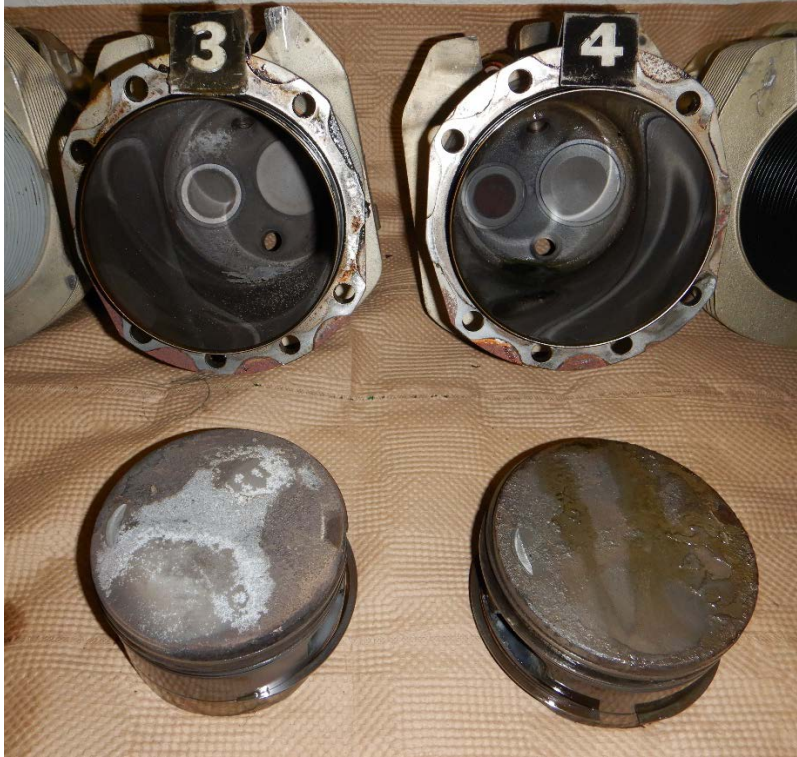
Figure 6: Valve Strikes on Pistons Nos. 3 and 4

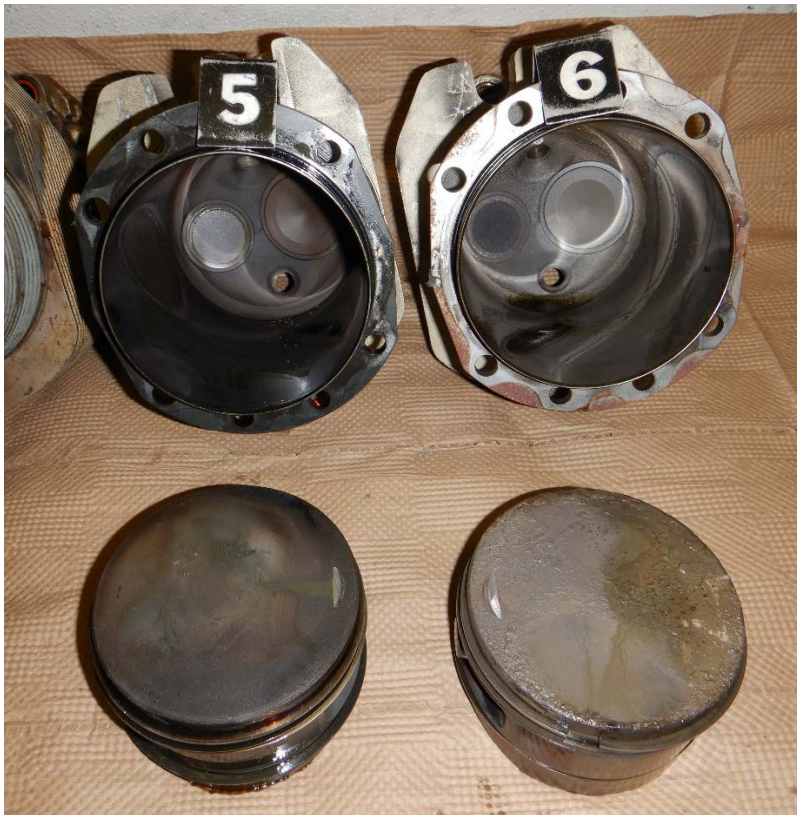
Figure 7: Valve Strikes on Pistons Nos. 5 and 6

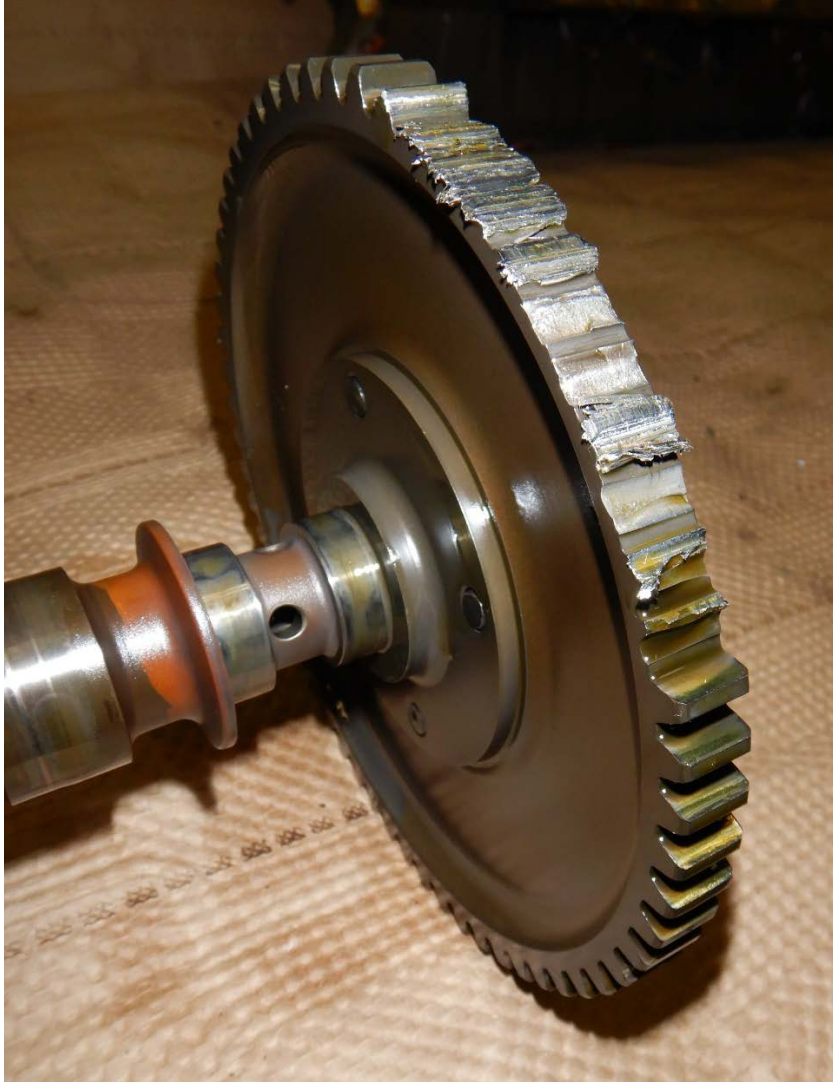
The wreckage of N878SR was recovered from the accident site in Foley, Alabama, several days after the accident. All wreckage was located at and recovered from the accident site. The initial examination of N878SR was conducted on October 8, 2019, at Florida Air Recovery, Jacksonville, FL. Follow-up examination at Continental Aerospace Technologies, Mobile, Alabama, was conducted on December 9, 2019. Examination of the camshaft drive gear revealed the absence of 10 teeth and damage to one tooth.

*Figure 8: Camshaft Drive Gear with Sheered Teeth*
