**SERVICE BULLETIN**

**SB97-6B****FAA APPROVED**Supersedes M87-11 REV. 2,  
SB97-6, 6A**SUBJECT:** MANDATORY REPLACEMENT PARTS**PURPOSE:** TO IDENTIFY ITEMS TO BE REPLACED DURING MAINTENANCE,  
PREVENTATIVE MAINTENANCE AND OVERHAUL**COMPLIANCE:** DURING MAINTENANCE, PREVENTATIVE MAINTENANCE AND  
OVERHAUL**MODELS AFFECTED:** ALL MODELS

**SB05-8****Technical Portions  
FAA Approved****SUBJECT: IMPROVED CAMSHAFT GEAR P/N 656818****PURPOSE:** To announce the production of an improved camshaft gear P/N 656818 which will supersede the current gear P/N 656031**COMPLIANCE:** At next engine overhaul or at camshaft gear replacement.**MODELS****AFFECTED:** IO-470-U,V; IO-520-Series; TSIO-520-Series; IO-550-Series; IOF-550-Series; TSIO-550-Series; TSIOL-550-Series**GENERAL**

**PURPOSE:** To eliminate the possibility of camshaft gear tooth fracture, resulting in power loss or in-flight shutdown, and to inspect and remove from service P/Ns 631845, 655430, 655516, or 656031 and replace with camshaft gear, P/N 656818. This Service Document initially announced the release of improved camshaft gear P/N 656818 in 2005. It now clarifies part number superseding action and amplifies camshaft gear re

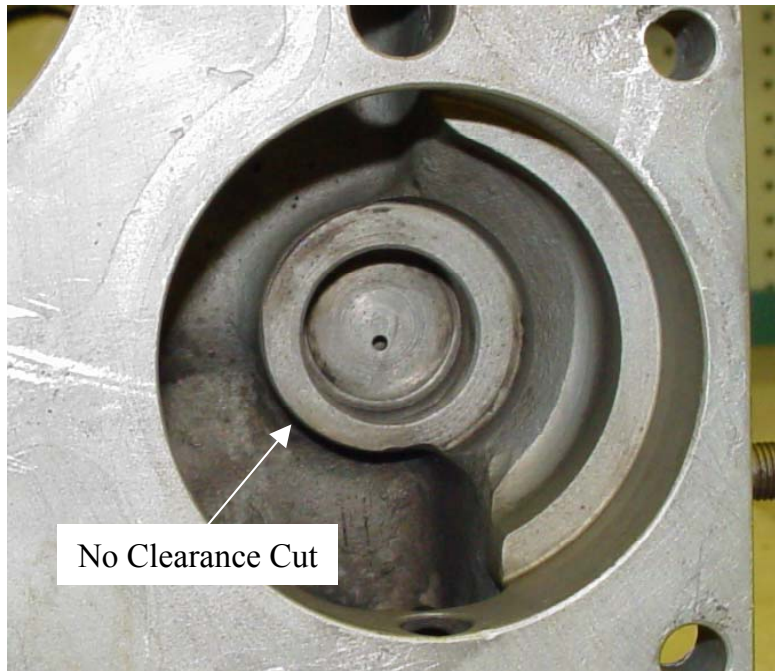
**Figure 1. Un-Modified Permold Crankcase**

**CAUTION...** Installation of the new P/N 656818 gear in an unmodified permold style crankcase will result in damage to the gear and/or the crankcase

The Permold style of crankcase must be modified to allow use of the new, thicker camshaft gear. A clearance cut is made in the starter drive bearing boss in accordance with the dimensions shown in Figure 3. TCM recommends that a properly certified repair station machine the required clearance.

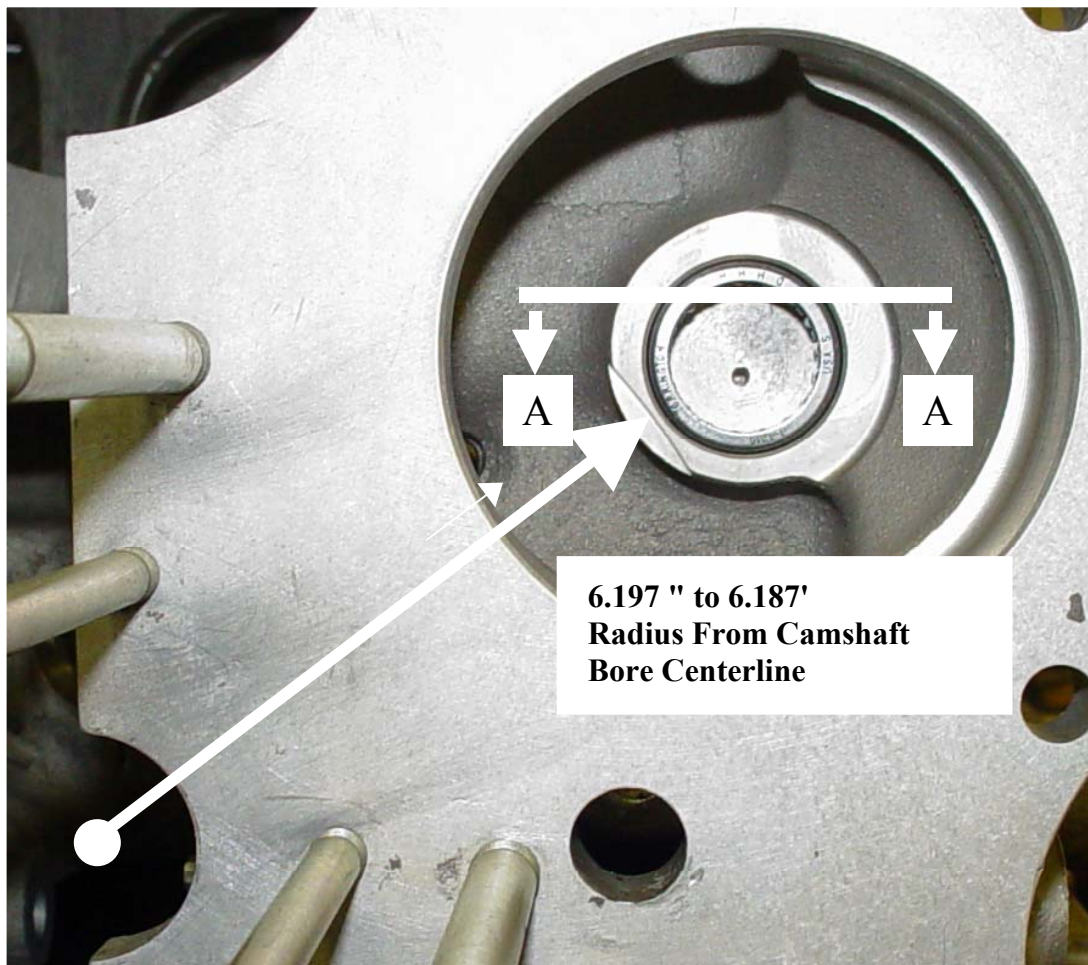
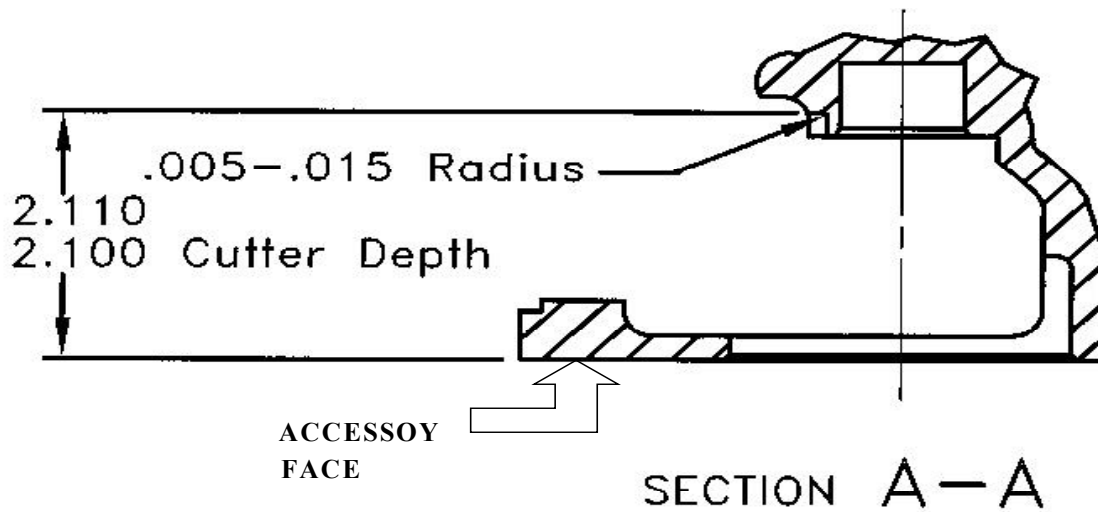
Figure 3. Permold Crankcase Modification

The P/N 656818 camshaft gear is nominally 0.060" wider than the P/N 656031 camshaft gear. On engine models utilizing the Sandcast style of crankcase, the P/N 656818 camshaft gear may be installed as a direct replacement for the P/N 656031 camshaft gear. On engine models utilizing the Permold style of crankcase, modification of the starter adapter bearing boss is required to provide clearance for the wider camshaft gear.

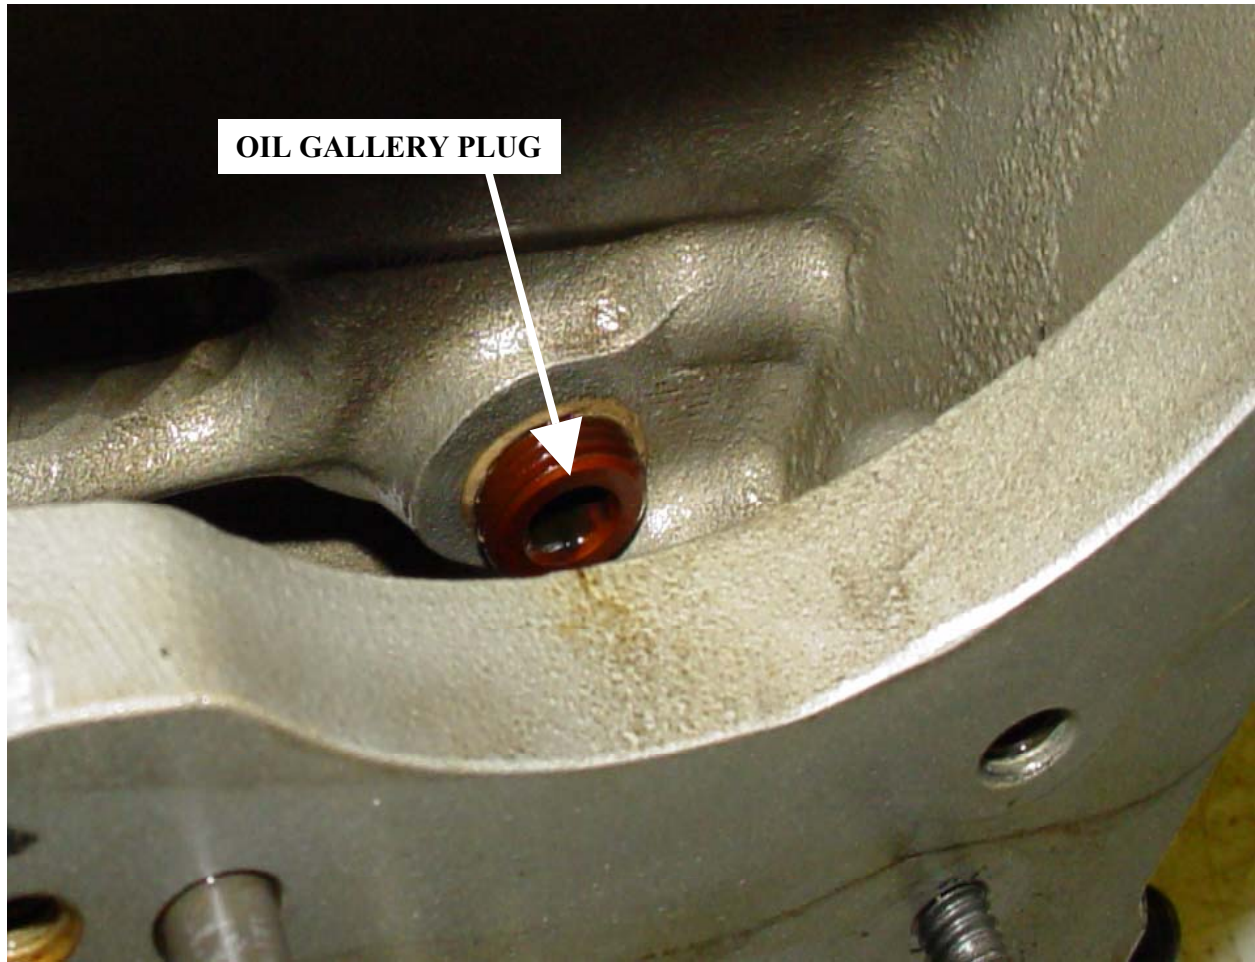
**Figure 4. Inspect For Clearance Between The Camshaft Gear And The End Of The Oil Gallery Plug (Where Indicated).**

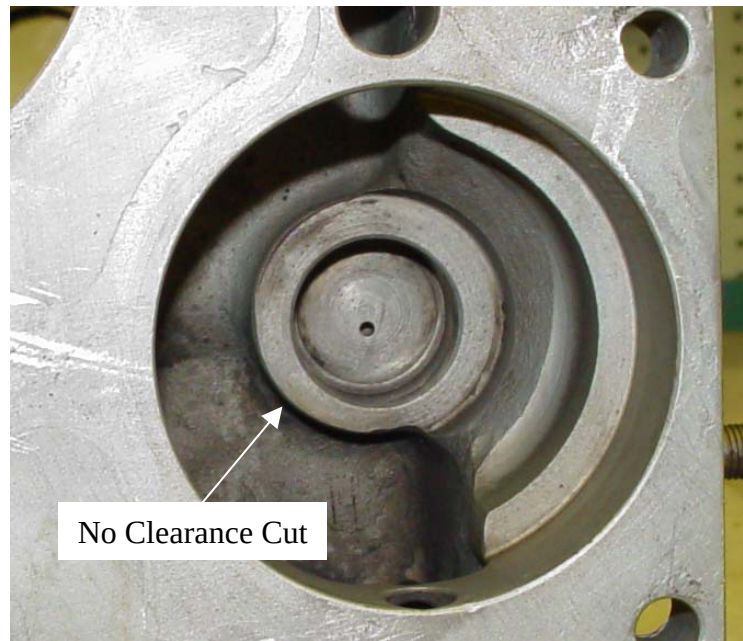
FIGURE 1  
UN-MODIFIED PERMOLD CRANKCASE

**CAUTION...** *Installation of the new P/N 656818 gear in an unmodified permold style crankcase will result in damage to the gear and/or the crankcase*

The Permold style of crankcase must be modified to allow use of the new, thicker camshaft gear. A clearance cut is made in the starter drive bearing boss in accordance with the dimensions shown in Figure 3. TCM recommends that a properly certified repair station machine the required clearance.

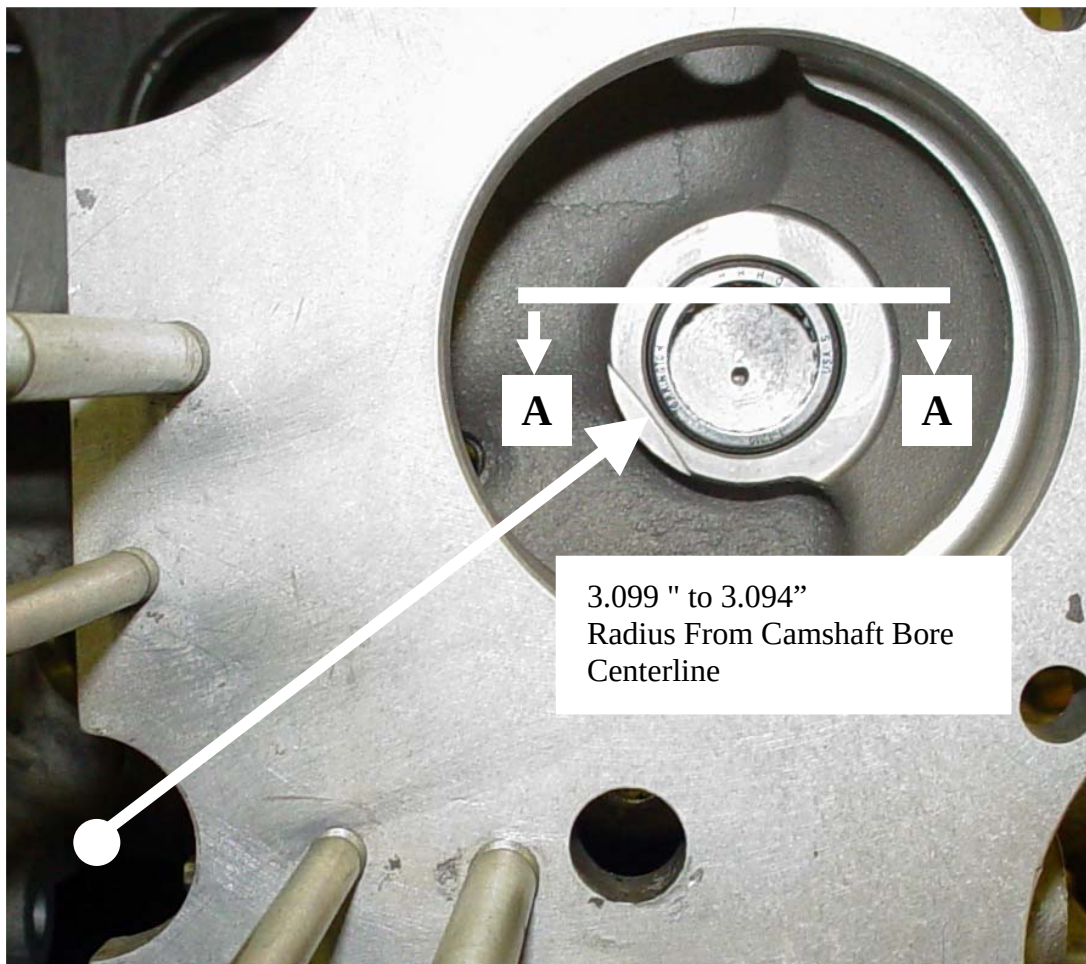
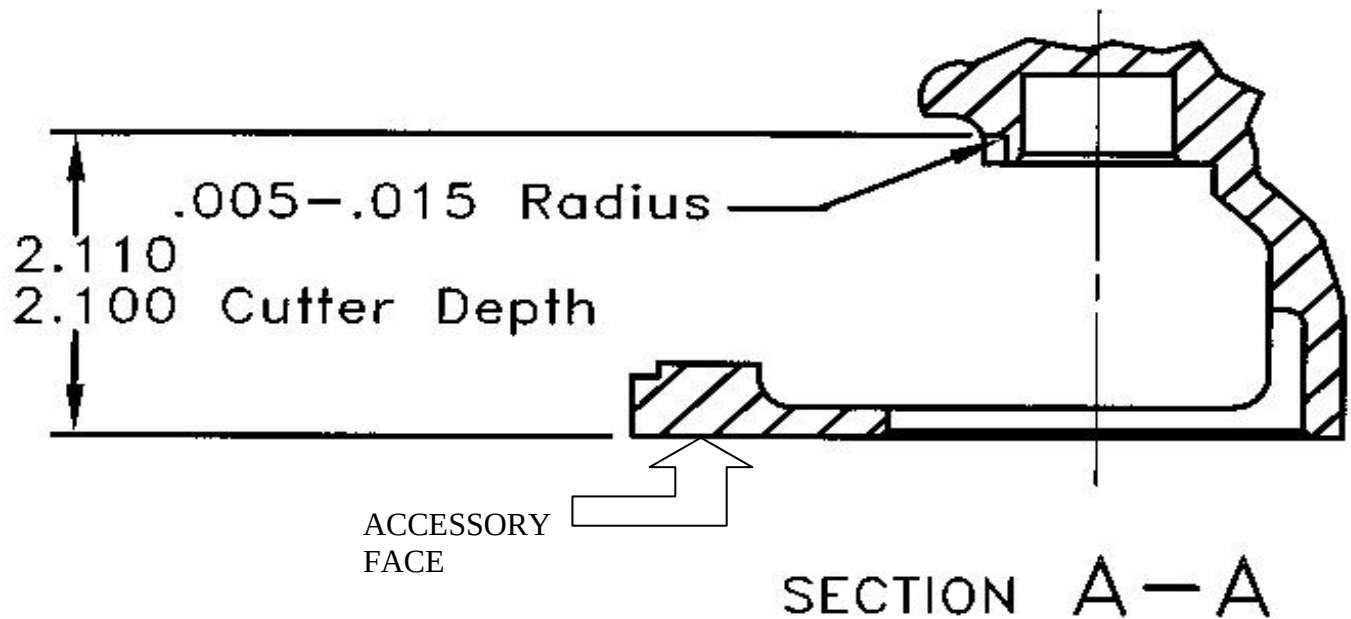
FIGURE 3  
PERMOLD CRANKCASE MODIFICATION

The P/N 656818 camshaft gear is nominally 0.060" wider than the P/N 656031 camshaft gear. On engine models utilizing the Sandcast style crankcase, the P/N 656818 camshaft gear may be installed as a direct replacement for the P/N 656031 camshaft gear. On engine models utilizing the Permold style crankcase, modification of the starter adapter shaftgear bearing boss is required to provide clearance for the wider camshaft gear.

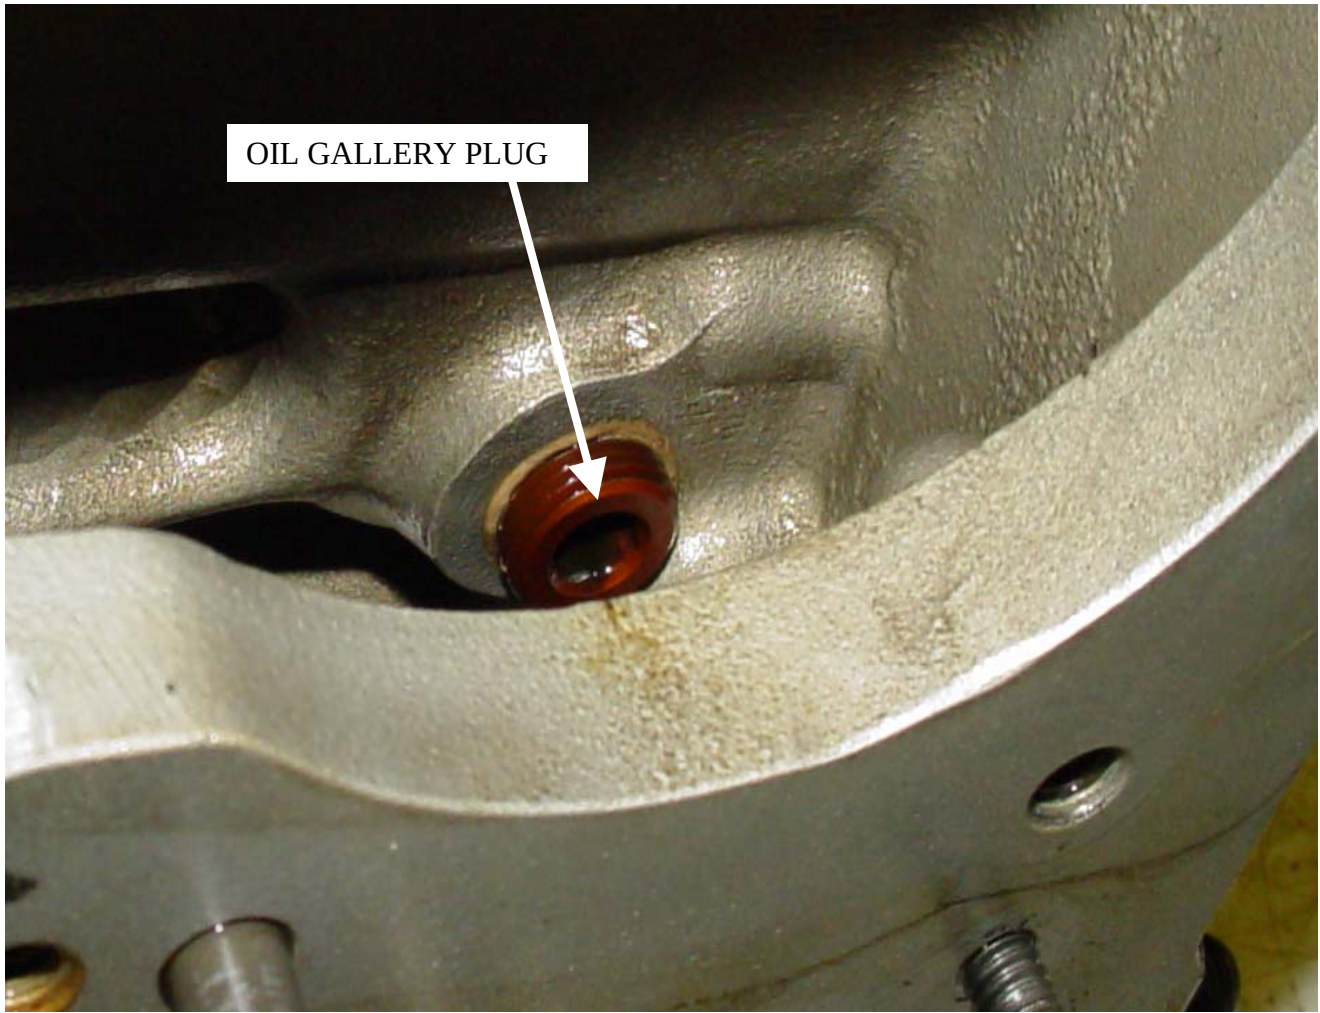
**FIGURE 4**  
**INSTALL CAMSHAFT IN CRANKCASE HALF**  
**INSPECT FOR MINIMUM OF .030 CLEARANCE BETWEEN THE CAMSHAFT**  
**GEAR AND THE END OF THE OIL GALLERY PLUG (WHERE INDICATED).**

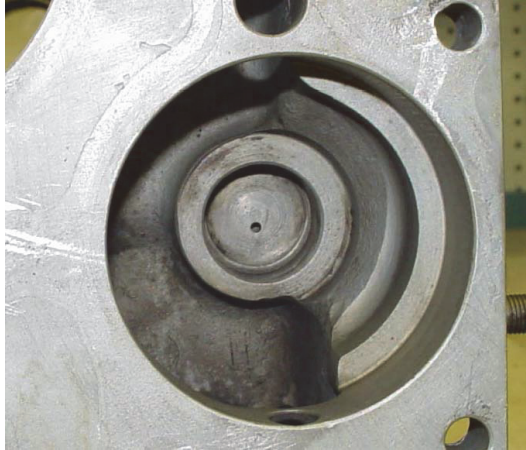
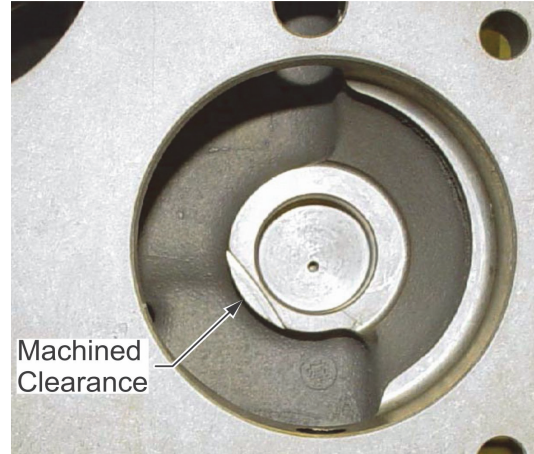
**Figure 1. 1-3-5 Permold Crankcase Half, Clearance Cut Modification**

Camshaft gear, P/N 656818, is 0.060” thicker than the P/Ns 631845, 655430, 655516, or 656031 camshaft gears. The starter adapter bearing boss in Permold crankcases must be machined with a radius cut to provide clearance for the camshaft gear, P/N 656818. For engines with a Sandcast crankcase, the assembler must inspect the clearance between the new camshaft gear and the oil gallery plug installed in the rear of the crankcase below the starter adapter.

*CAUTION: Installing the new camshaft gear, (P/N 656818) in an unmodified Permold crankcase will result in damage to the gear and crankcase.*

*This repair must be performed by an appropriately rated entity holding FAA authorization for Continental engine crankcase repair.*

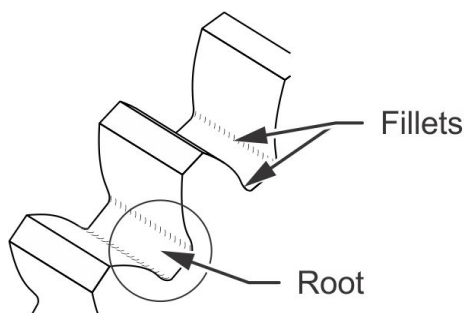
Figure 2. Camshaft Gear Inspection Surfaces, typical

- a. Clean the camshaft gear of all oil and rotate the crankshaft through two complete revolutions while inspecting all visible camshaft gear surfaces for physical damage, fractures, or cracks. Use supplemental lighting and magnification (10X power) as required to perform inspection. Pay particular attention to the gear tooth root and fillets (see Figure 2).

- b. If fractures or cracks are suspect, remove and replace the gear with P/N 656818 according to instructions for either Permold Crankcase (Section VI), Sandcast Crankcase (Section VII), or the standard disassembly and replacement instructions specified in the primary ICA prior to further flight.
6. If camshaft gears 631845, 655430, 655516, or 656031 exhibit no evidence of fractures or cracks, document the 100-hour inspection in the engine log book.
7. Install the starter adapter (and any parts removed to facilitate inspection) according to instructions in the primary ICA.

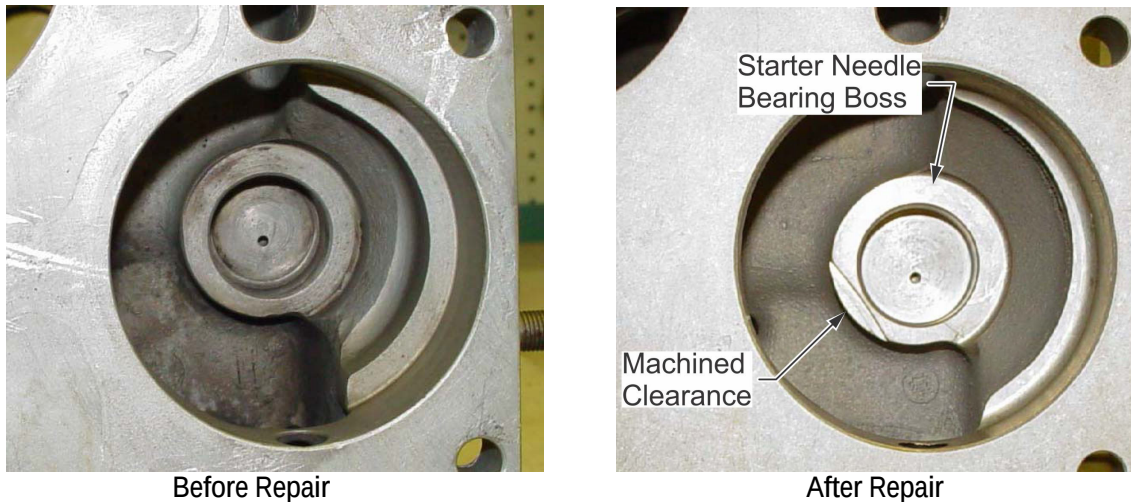
Figure 3. 1-3-5 Permold Crankcase Half, Boss Clearance Cut Repair

1. Inspect the needle bearing boss in the center of the starter adapter mounting pad. If a clearance cut (Figure 3) is present or if a clearance of 0.030" (or greater with the camshaft and gear installed) is provided under all conditions, the crankcase meets the clearance requirement.

2. If no clearance cut is present, or if, (with the camshaft and gear installed) the clearance is less than 0.030" under all conditions, the 1-3-5 crankcase half must be machined according to the following instructions by either:
  - a. sending the 1-3-5 crankcase half to be machined in accordance with instructions in section B. "Option 1, Permold Crankcase Repair, at Overhaul", or by
  - b. replacing the camshaft gear in Permold engines without splitting the crankcase (see C. "Option 2, Permold Crankcase Repair, in Service").

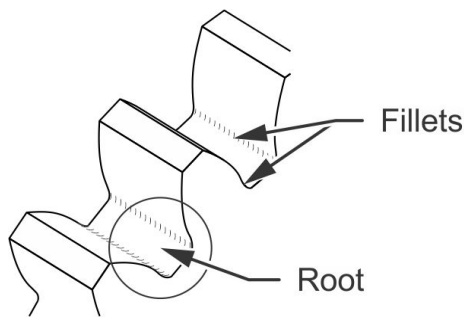
**Figure 2. Camshaft Gear Inspection Surfaces, typical**

required to perform inspection. Pay particular attention to the gear tooth root and fillets (see Figure 2).

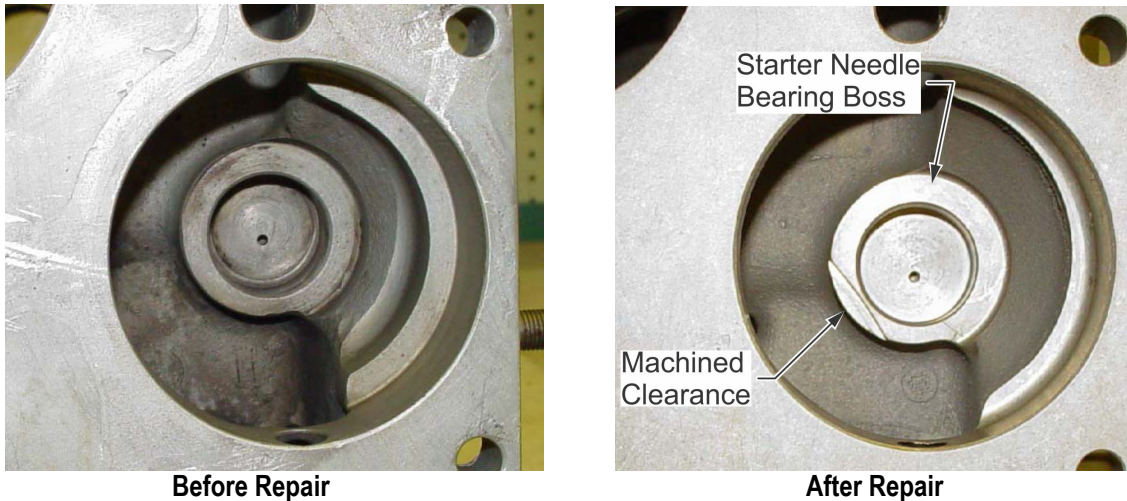
**Figure 3. 1-3-5 Permold Crankcase Half, Boss Clearance Cut Repair**

1. Inspect the needle bearing boss in the center of the starter adapter mounting pad. If a clearance cut (Figure 3) is present or if a clearance of 0.030" (or greater with the camshaft and gear installed) is provided under all conditions, the crankcase meets the clearance requirement.
