## MEMORANDUM FOR RECORD

**Subject:** NTSB investigation ERA19LA268, N5300E, Beech K35, Northeast Florida Regional Airport (SGJ), St. Augustine, Florida, September 11, 2019. Wreckage Examination.

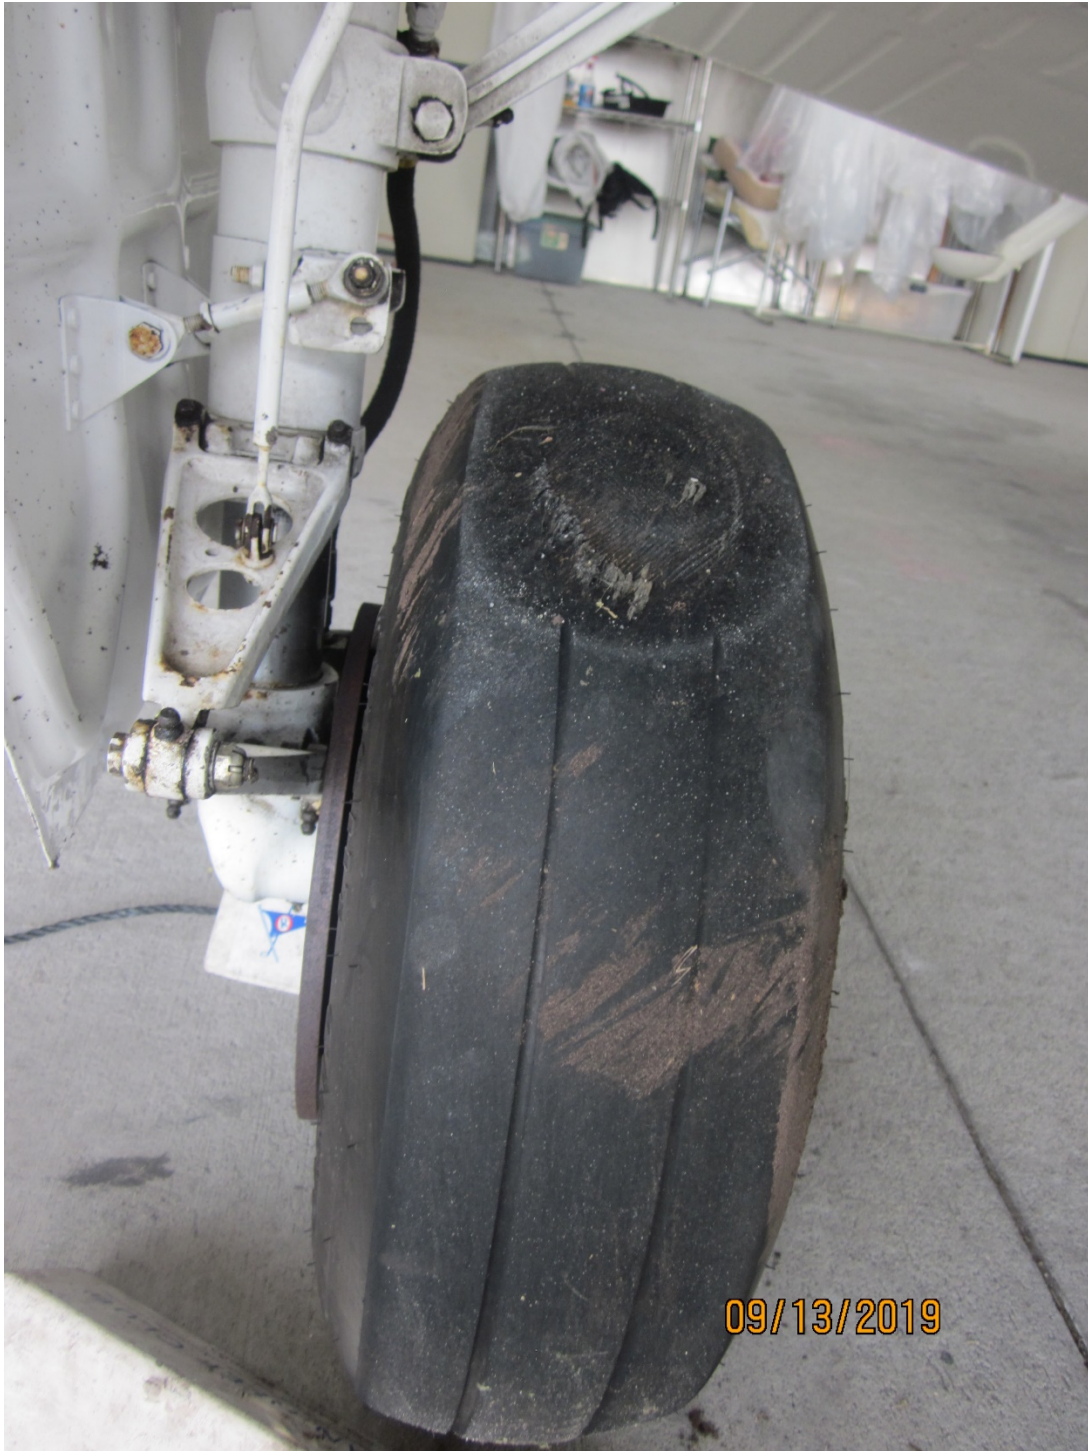
*Figure 1 Right Main Gear Tire (Courtesy FAA)*

The main landing gear wheels rolled smoothly.

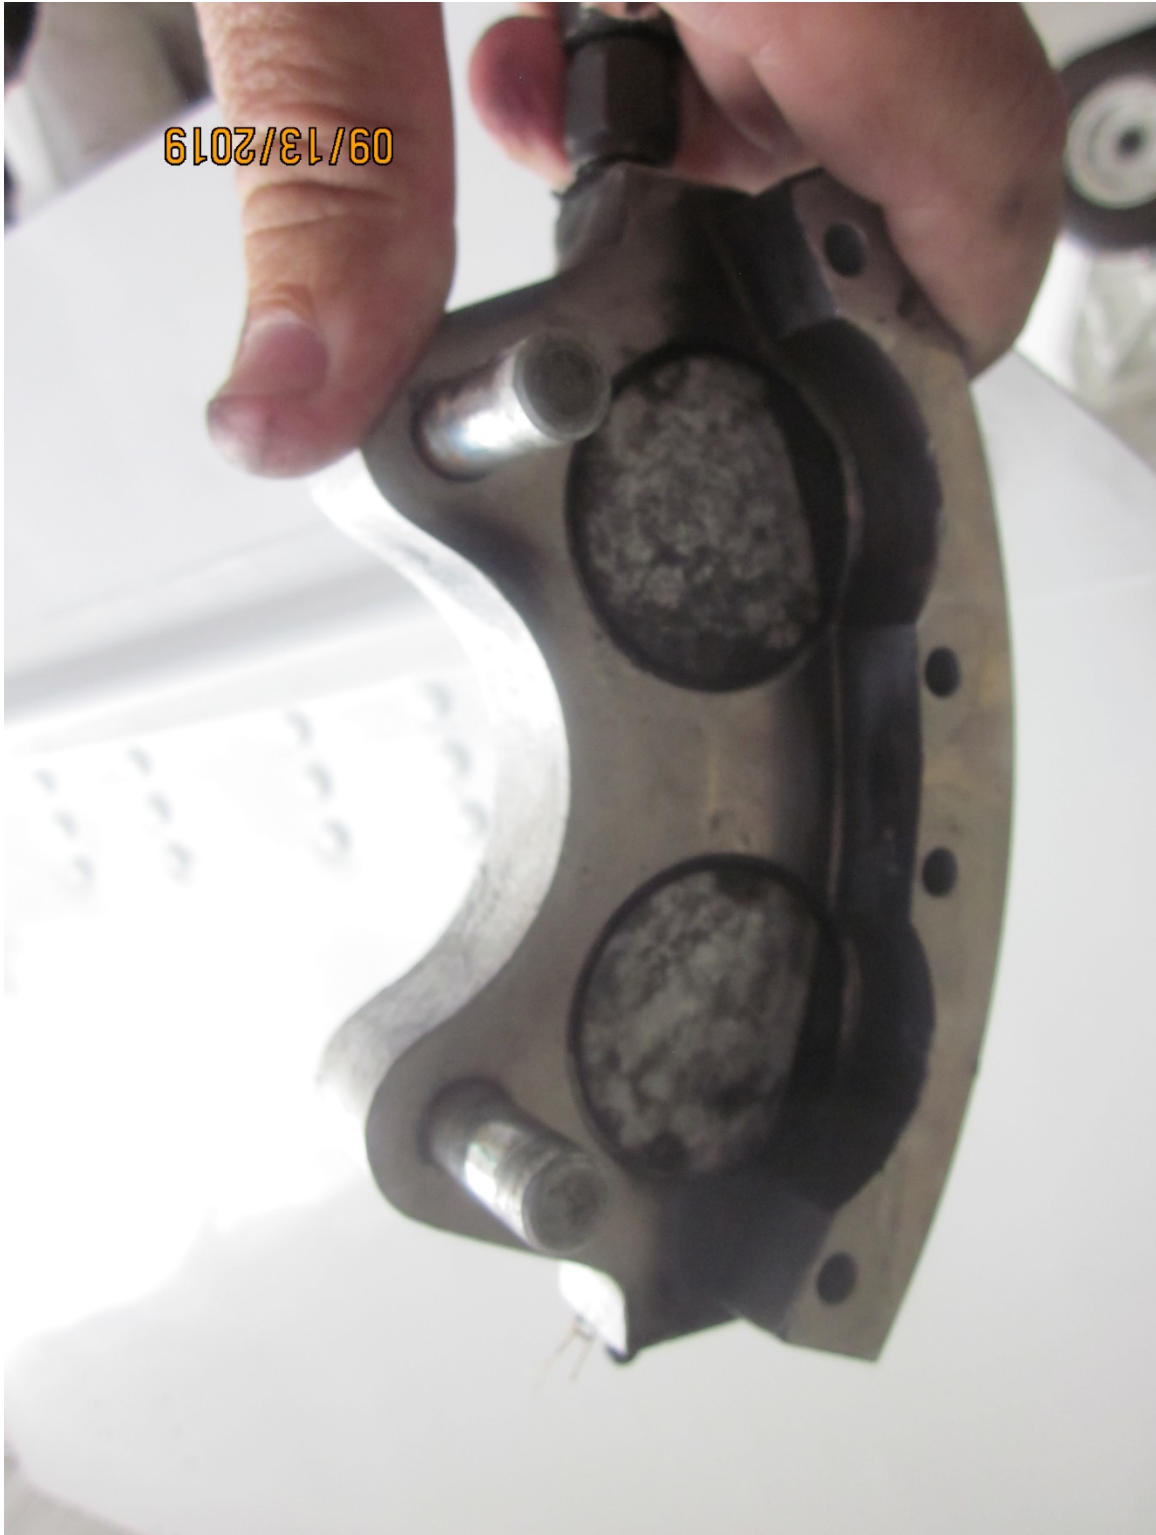
*Figure 2 Right MLG Caliper/Piston Assy (Courtesy FAA)*

There was no mechanical or thermal damage found with the brake disks, calipers, pads or lines. There was no hydraulic fluid leaking from any of the brake components. The brake pads were worn but serviceable.

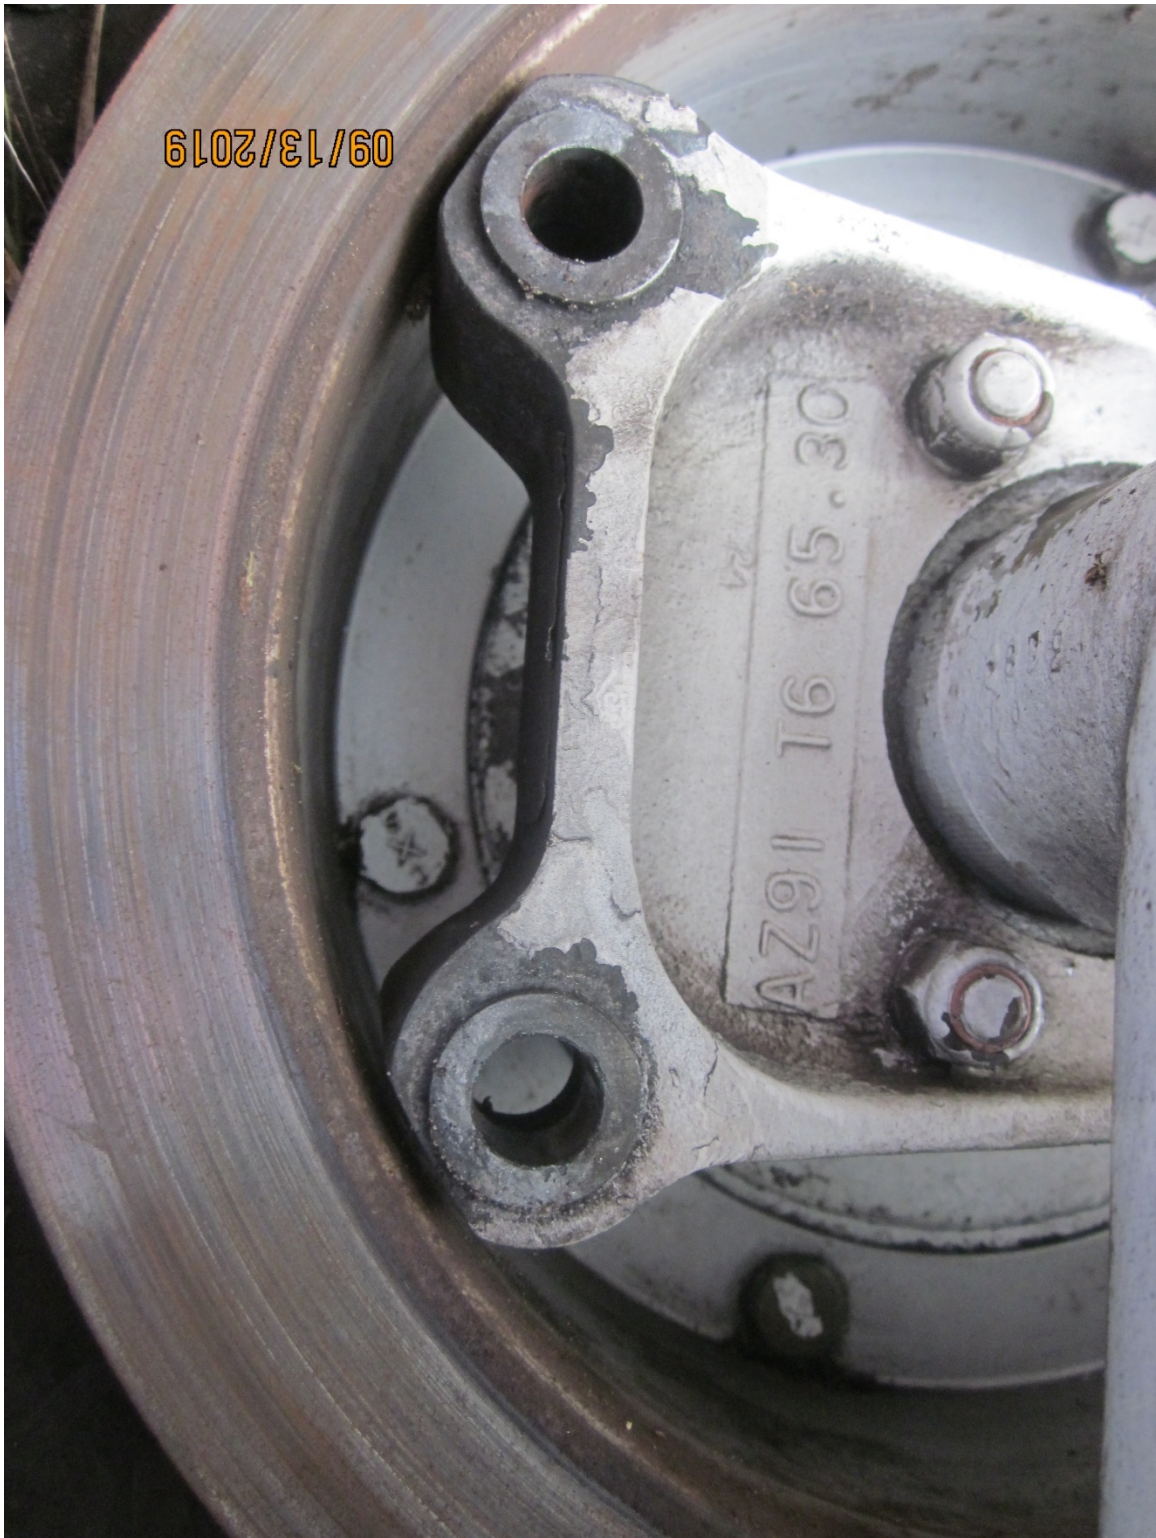
Figure 4 Right MLG Brake Disk and Caliper Mounting Holes (Courtesy FAA)

Neither brake was seized/frozen/applied to the brake disk as found.

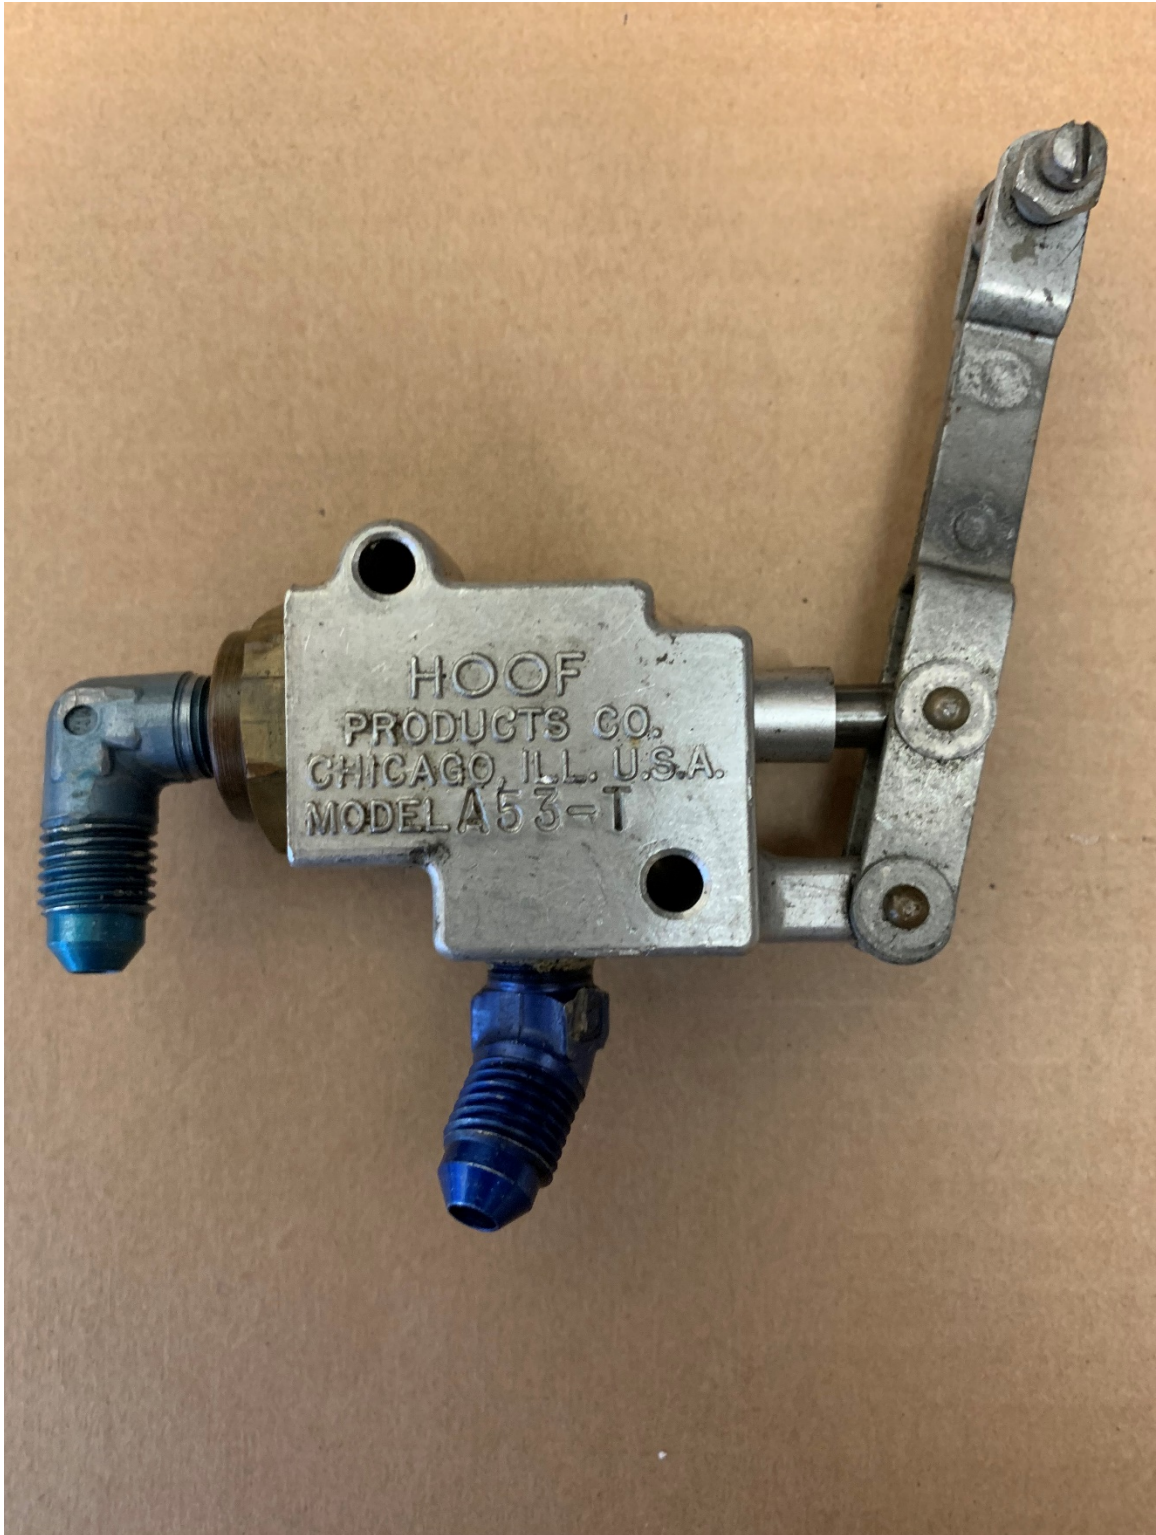
*Figure 5 Parking Brake Valve*

The parking brake actuator valve was sent to the NTSB for examination. The valve operated normally when compressed air was applied to the inlet port. The valve was disassembled, the o-ring was intact, the spring-loaded ball, ball seat and plunger were undamaged. The plunger moved freely when the actuator arm was moved back and forth.
