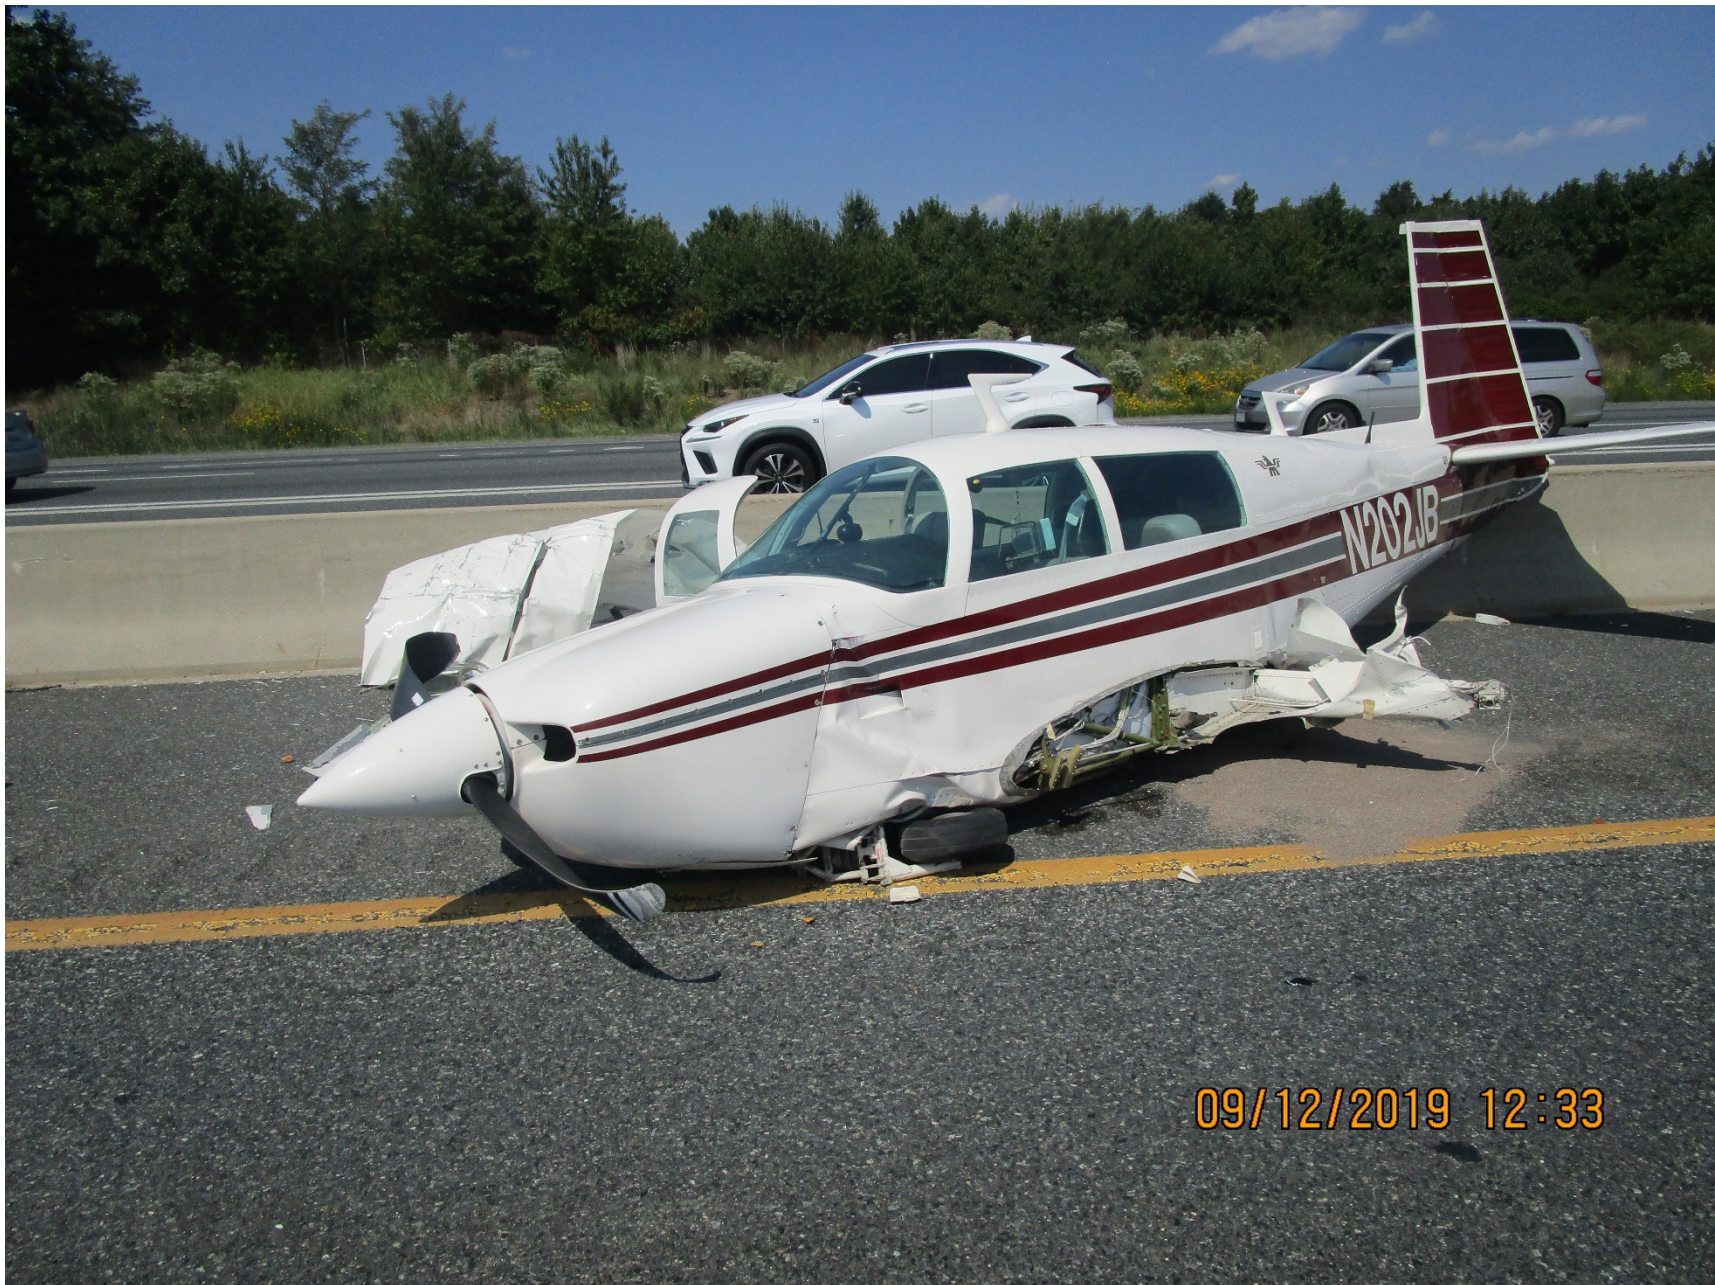
**Photo 1 –View of airplane at rest (Courtesy of FAA)**

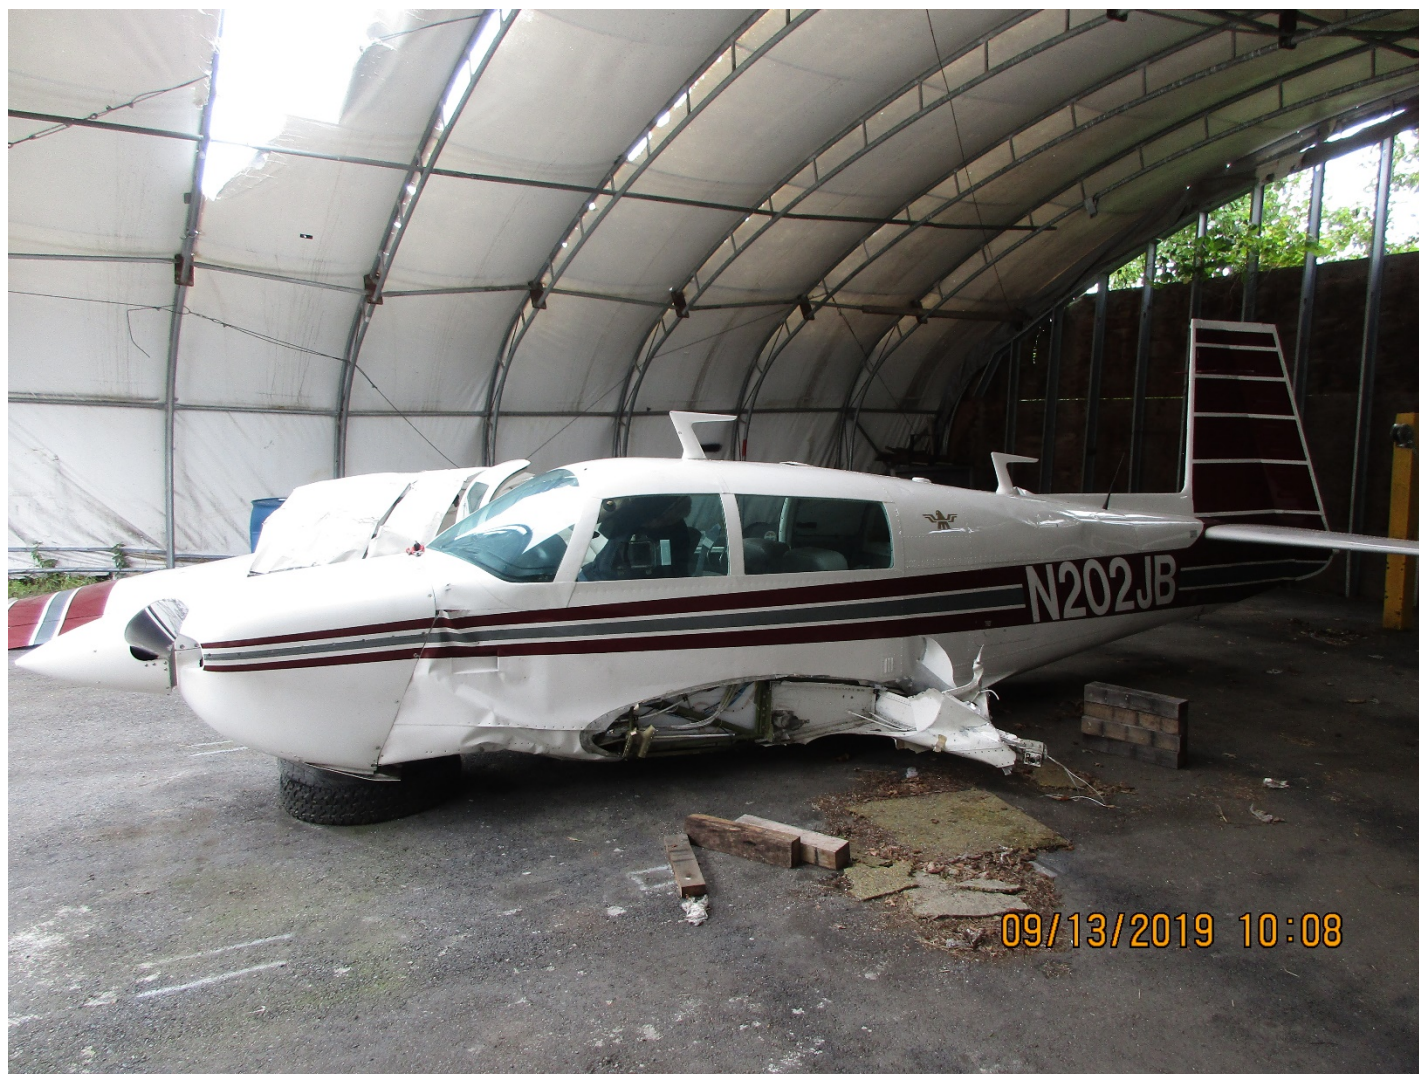
**Photo 2 – View of Airplane After Recovery (Courtesy of FAA)**

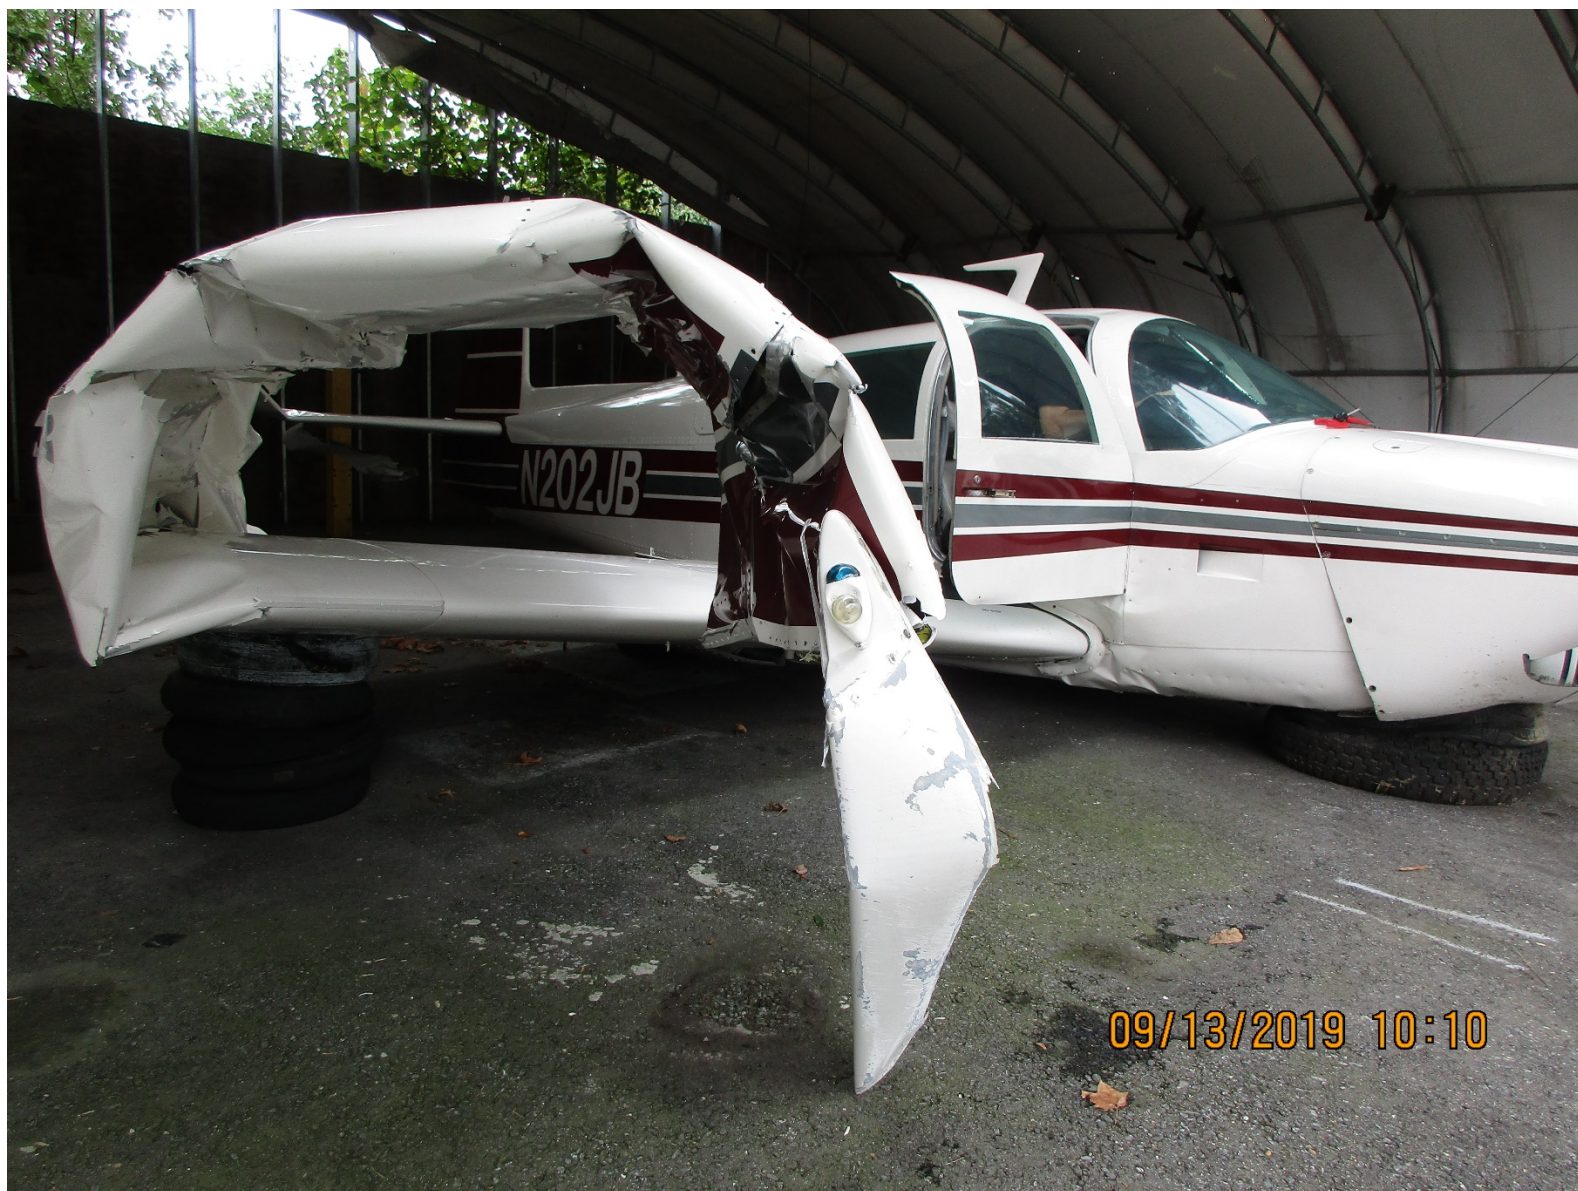
**Photo 3 – View of Right Wing Damage (Courtesy of FAA)**

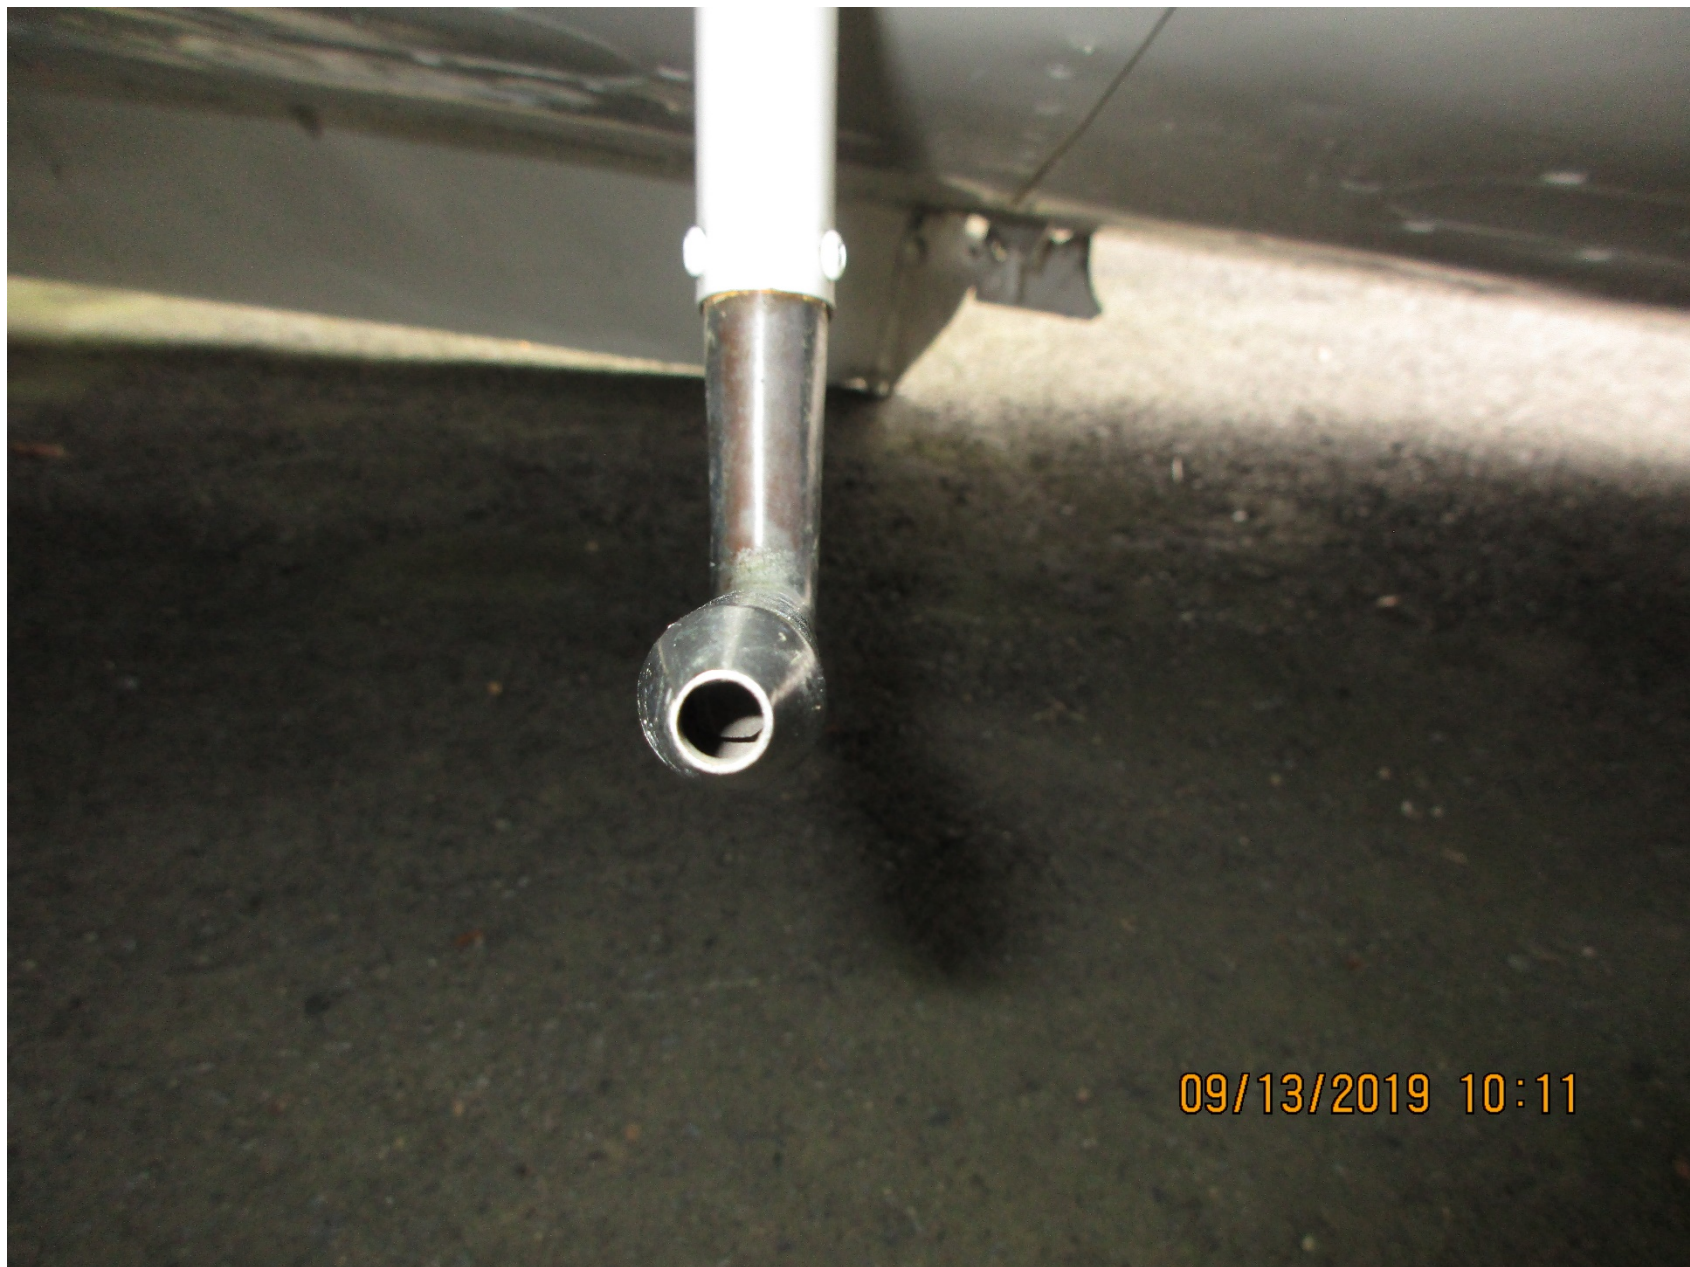
**Photo 4 – Close View of Pitot Tube (Courtesy of FAA)**

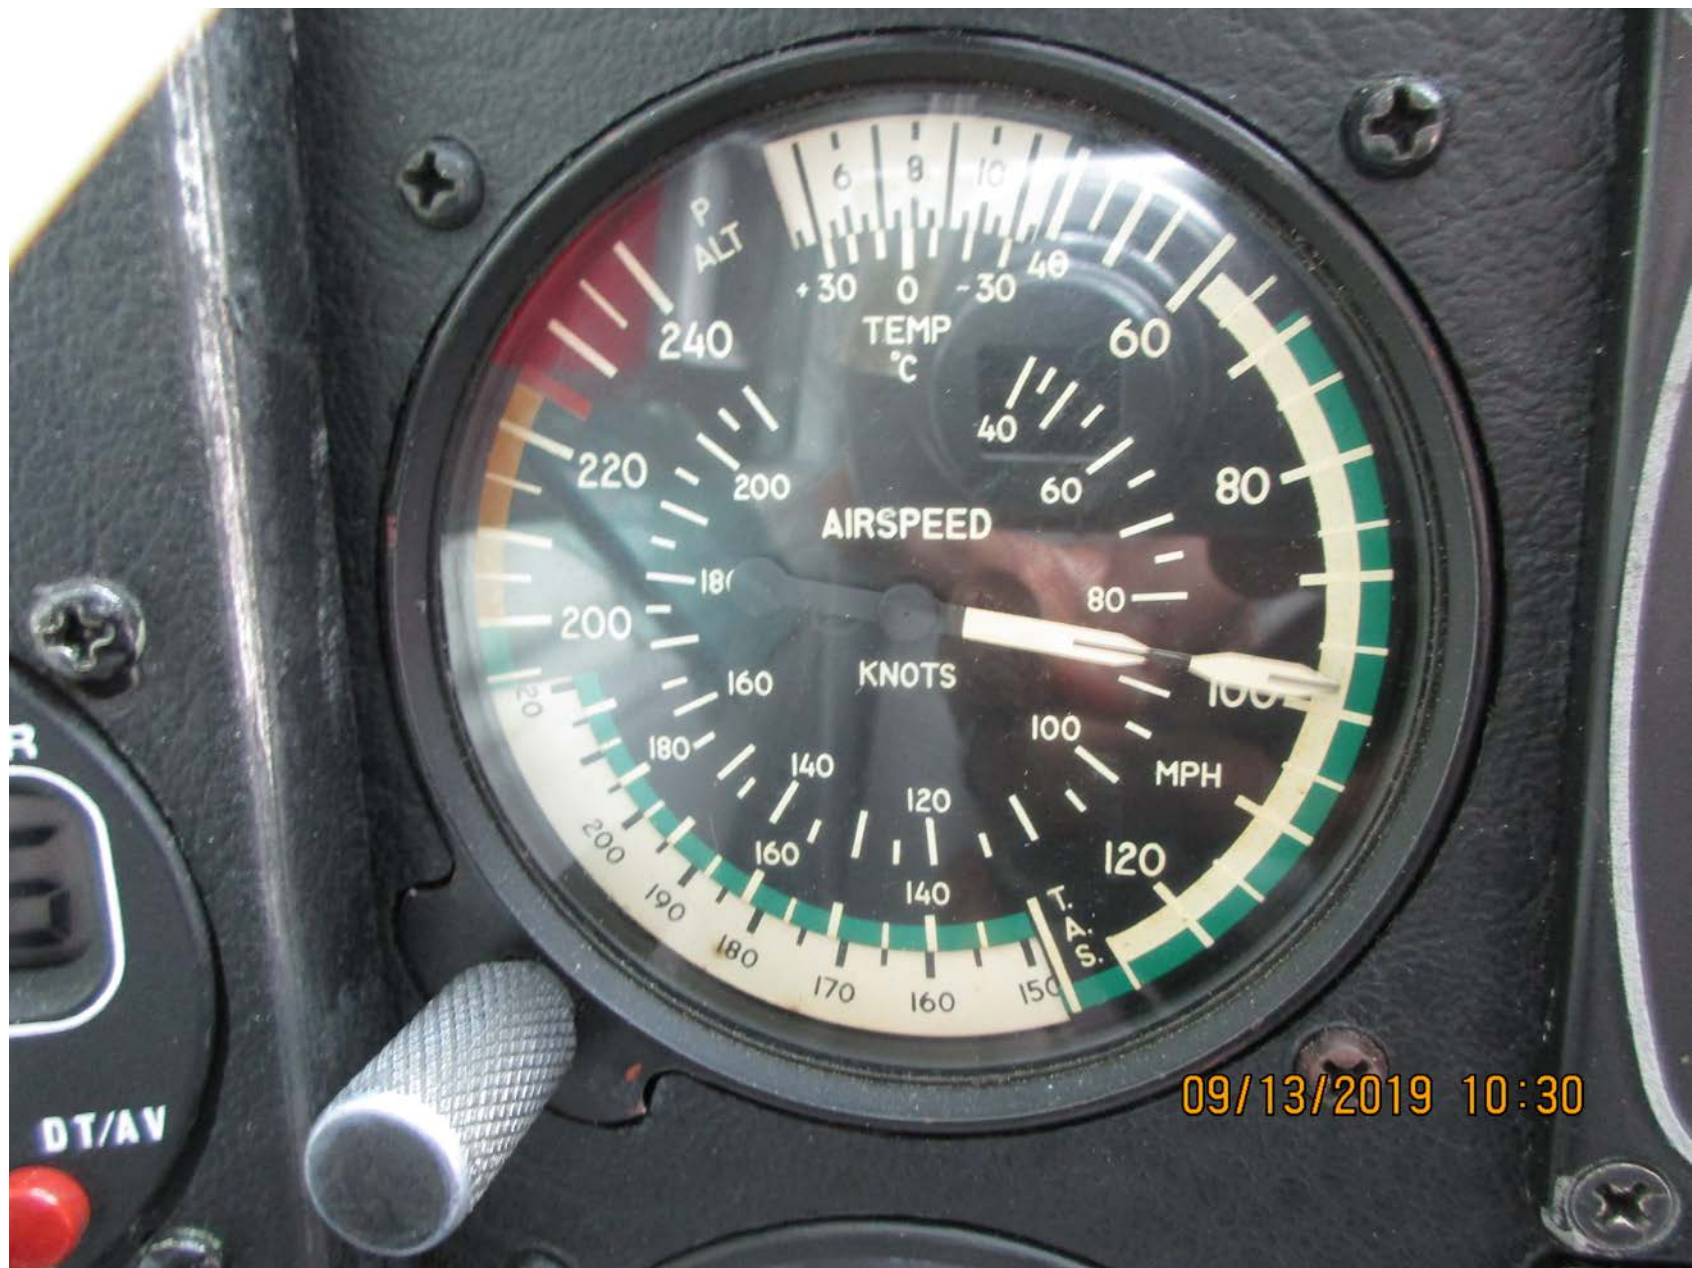
**Photo 5 – View of airspeed indicator in post-accident uncalibrated test.**

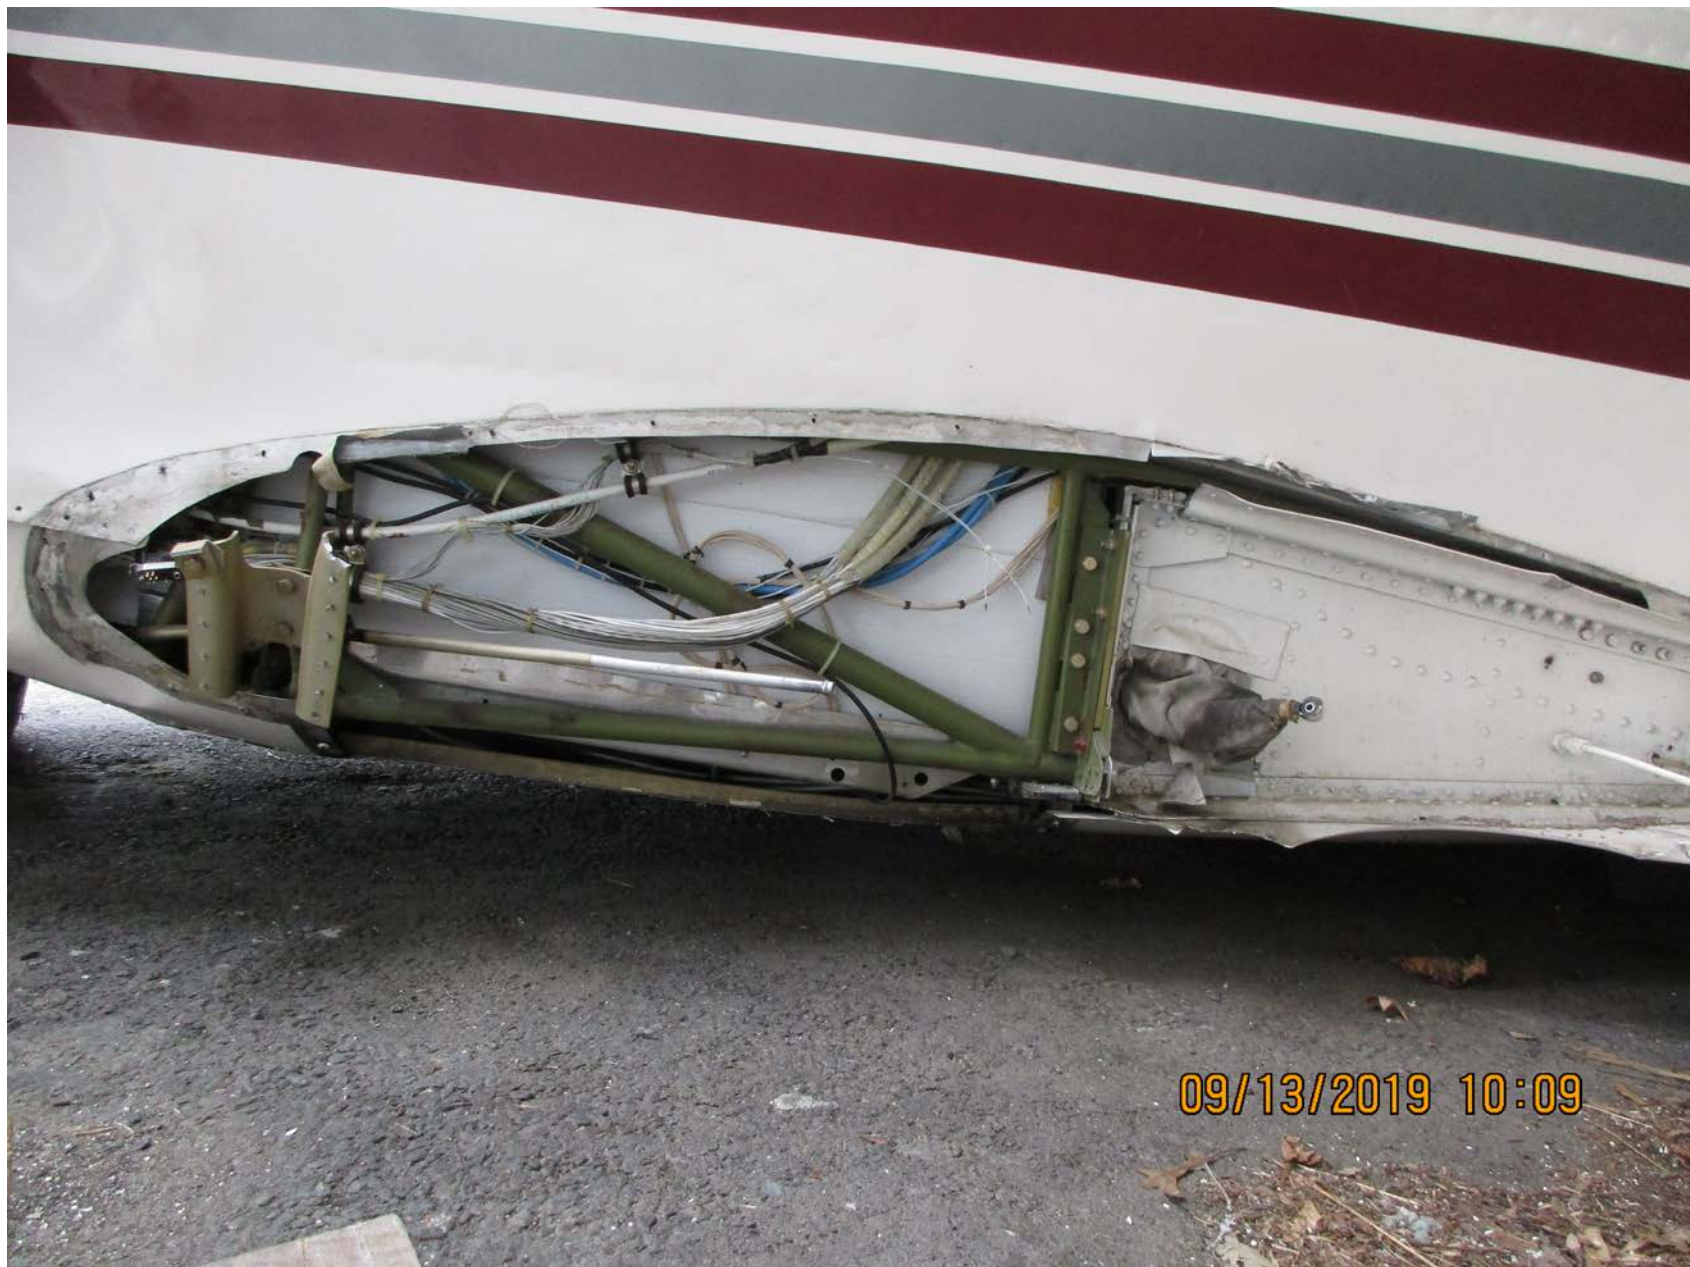
**Photo 6 – View of left wing root (Courtesy of FAA)**

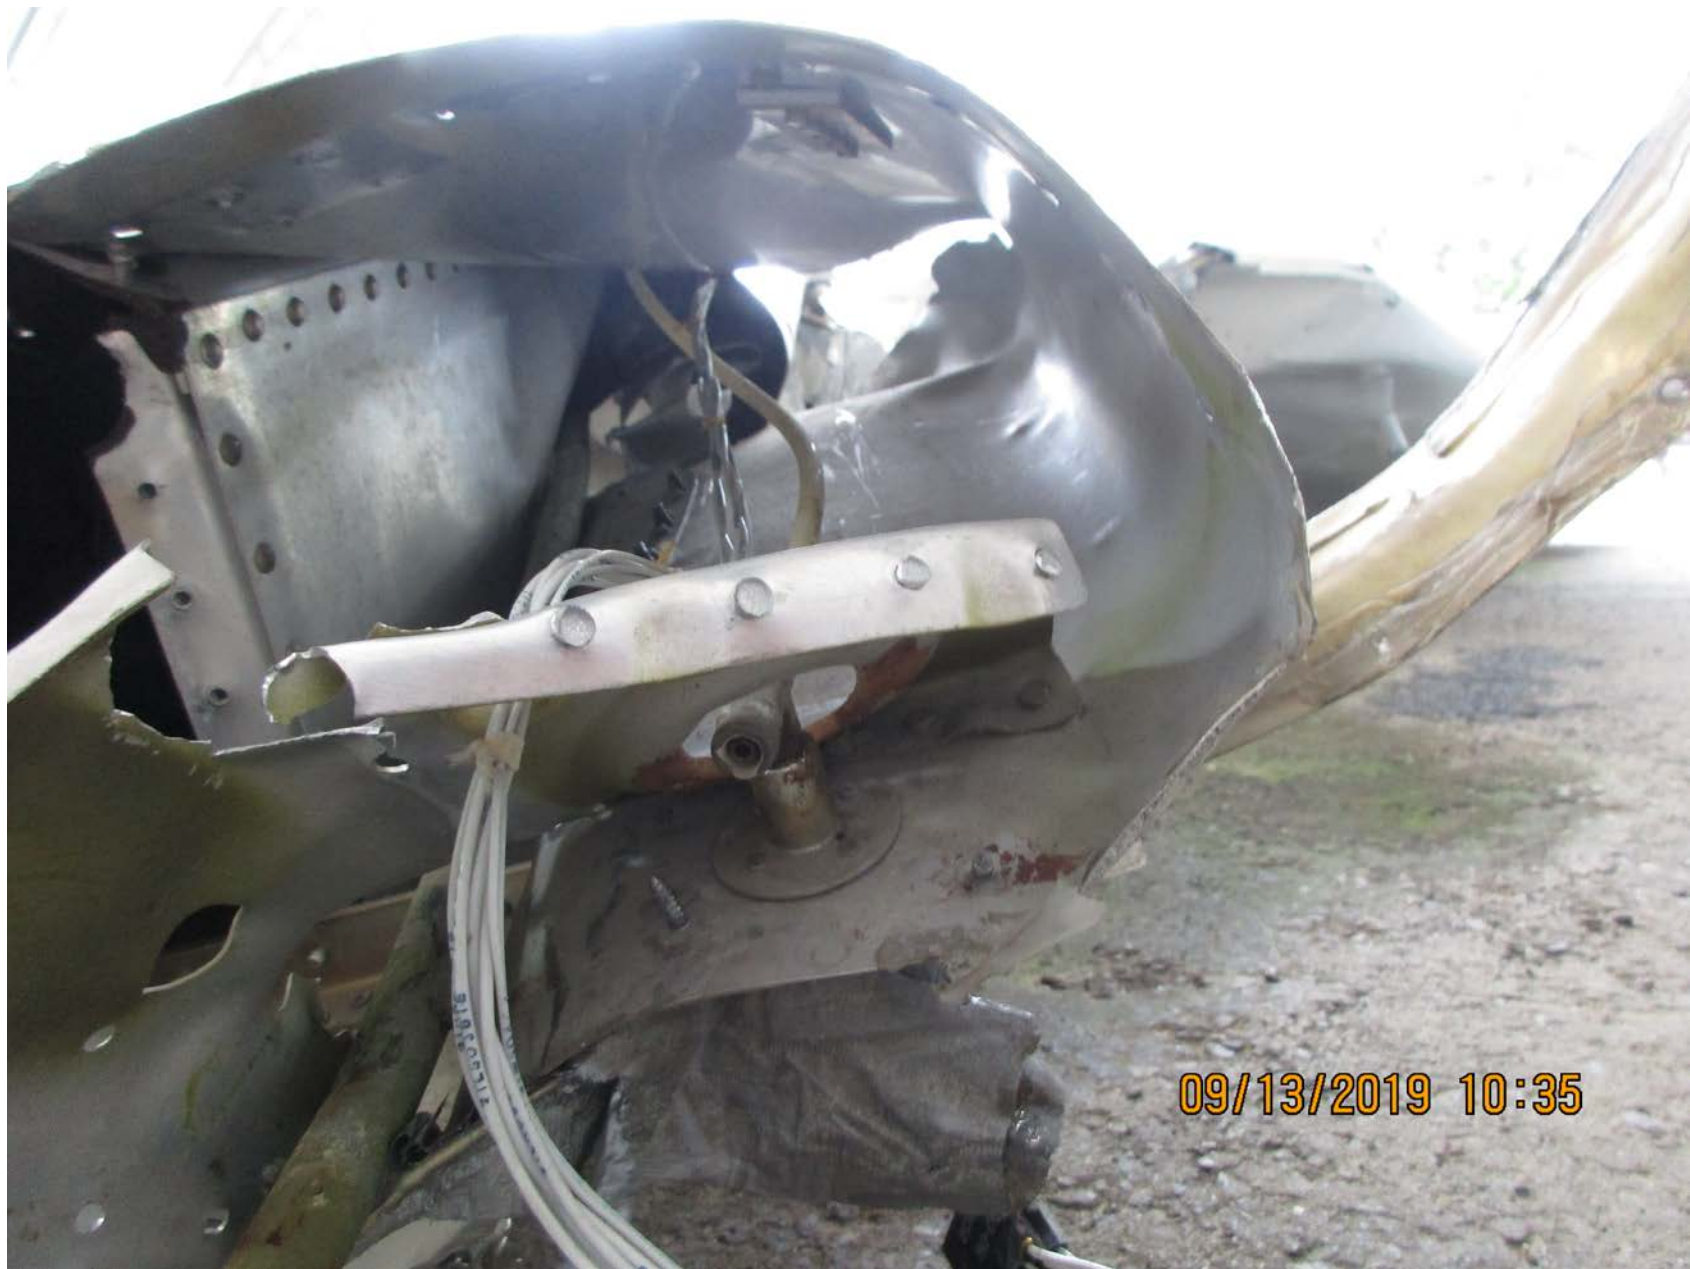
**Photo 7 – View of inboard of left wing (Courtesy of FAA)**

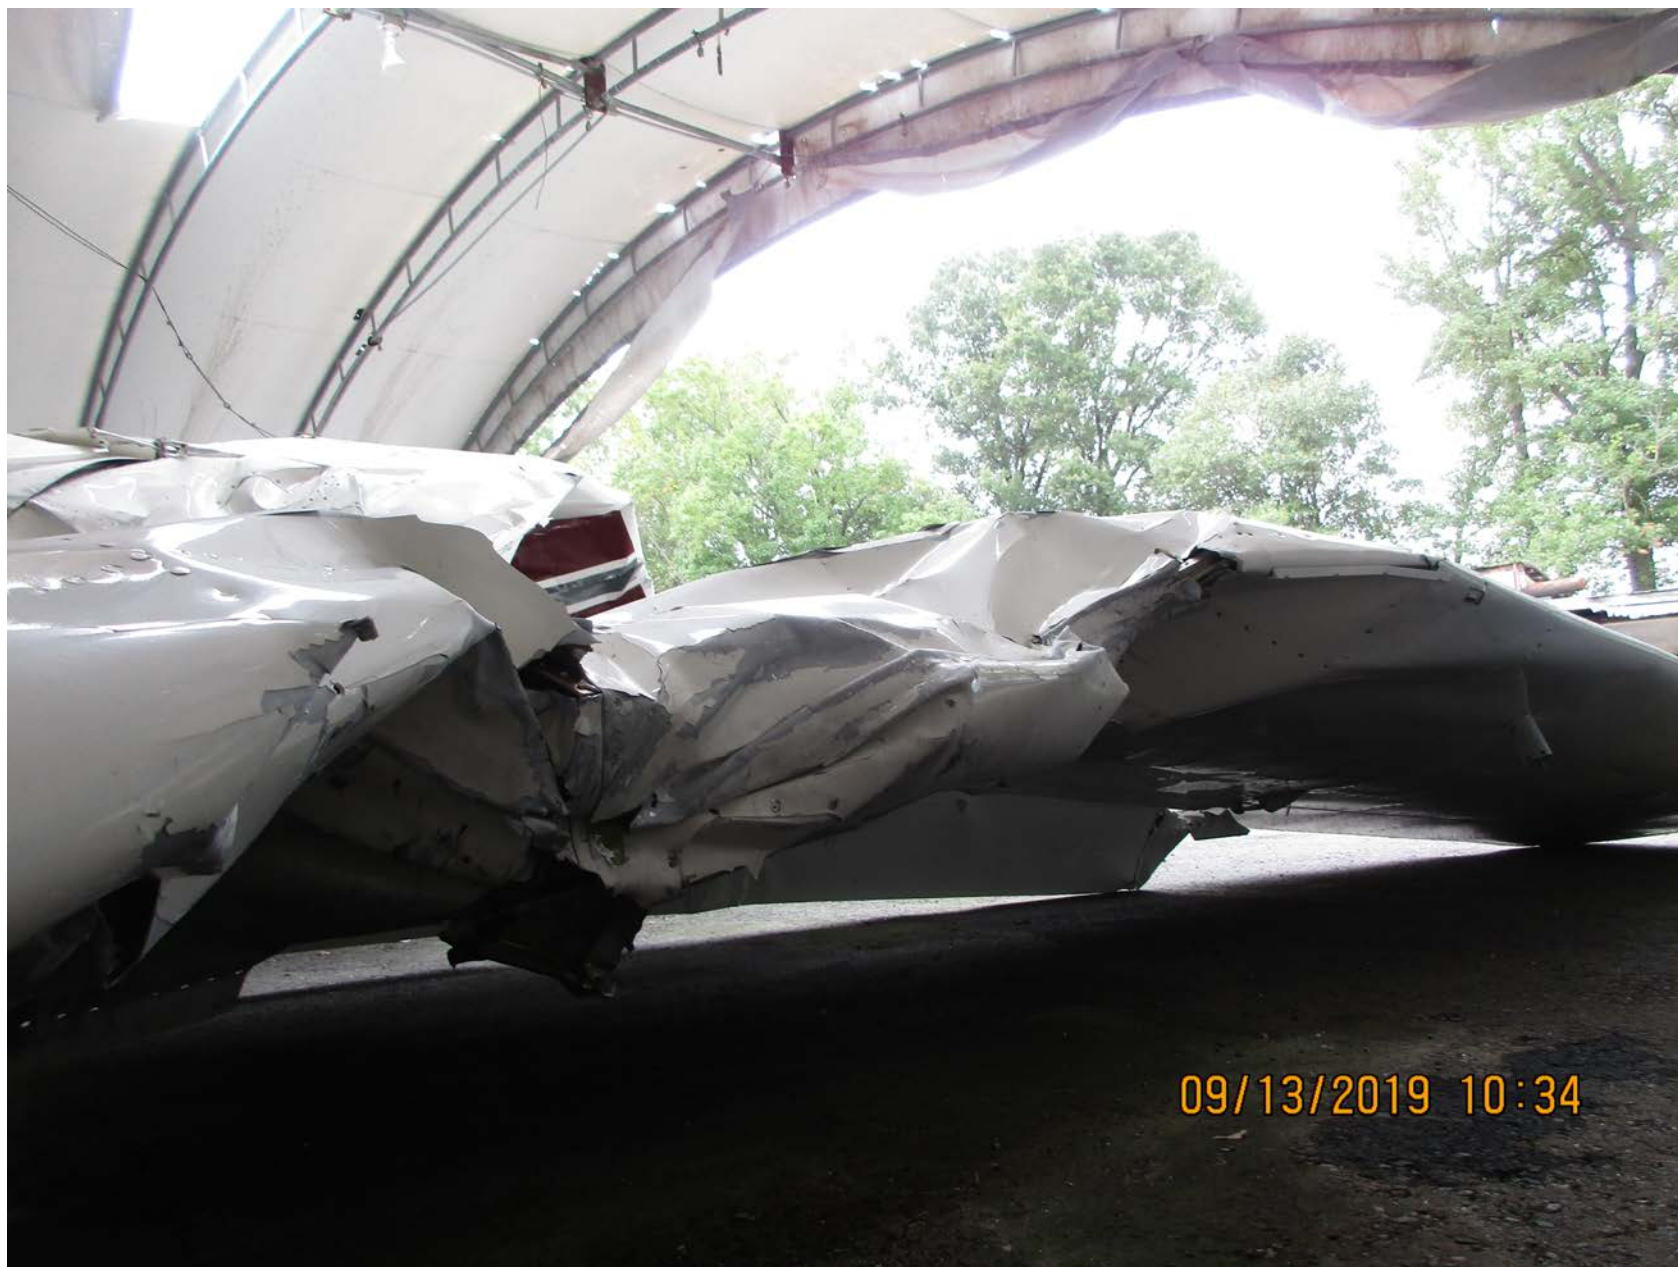
**Photo 8 – Leading edge damage to left wing (Courtesy of FAA)**
