# NATIONAL TRANSPORTATION SAFETY BOARD

## MATERIALS LABORATORY FACTUAL REPORT

Report No. 20-019

Place : Sardis, Georgia  
Date : September 17, 2019  
Vehicle : Robinson R44, N827JE  
NTSB No. : ERA19LA273  
Investigator : Robert Gretz, AS-ERA

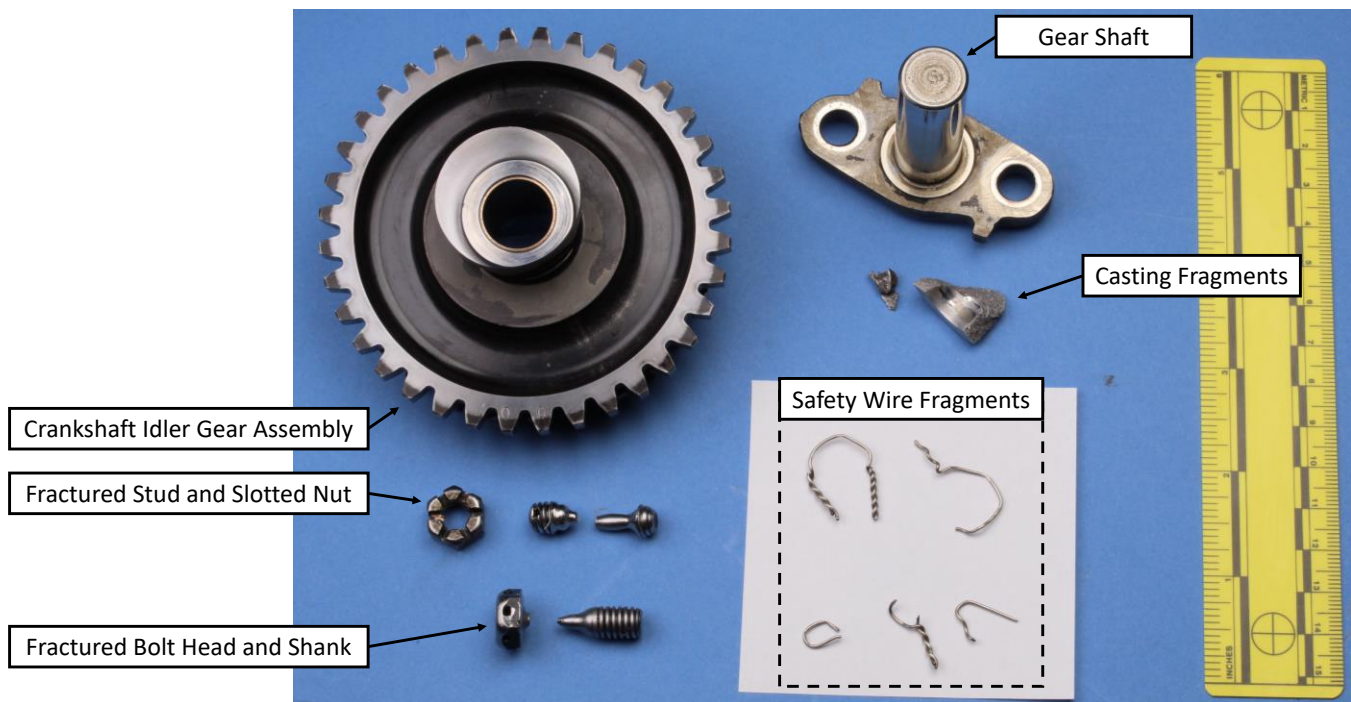
Components retained from a teardown of the accident aircraft engine, a Lycoming model O-540-F1B5, were submitted for examination and are shown in figure 1. The engine teardown was performed by a representative from Lycoming, under the supervision of a Federal Aviation Administration inspector. An exploded view of the engine crankcase and crankshaft idler gear arrangement<sup>1</sup> is shown in figure 2 with the parts received, except for the safety wire fragments, highlighted by red boxes for reference.

Figure 1: Photograph of components as-received. The smaller gear of the crankshaft idler gear assembly is obscured by the larger gear in this photo.

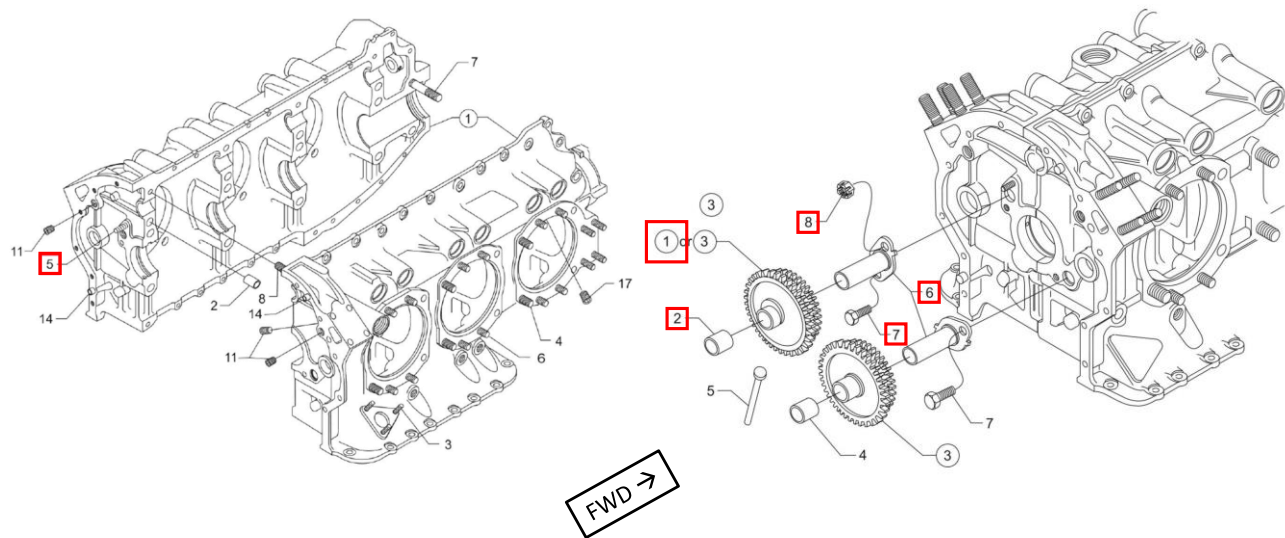
Figure 2: The left image is an exploded view of the aft side of the crankcase showing the location of the stud (item 5) which was received fractured. The right image is the aft side of the assembled crankcase with an exploded view of the crankshaft idler gear arrangement. Item 1 is the crankshaft idler gear assembly received which contained item 2 (a bushing), item 6 is the idler gear shaft, item 7 is a bolt which was received fractured, and item 8 is a slotted nut.

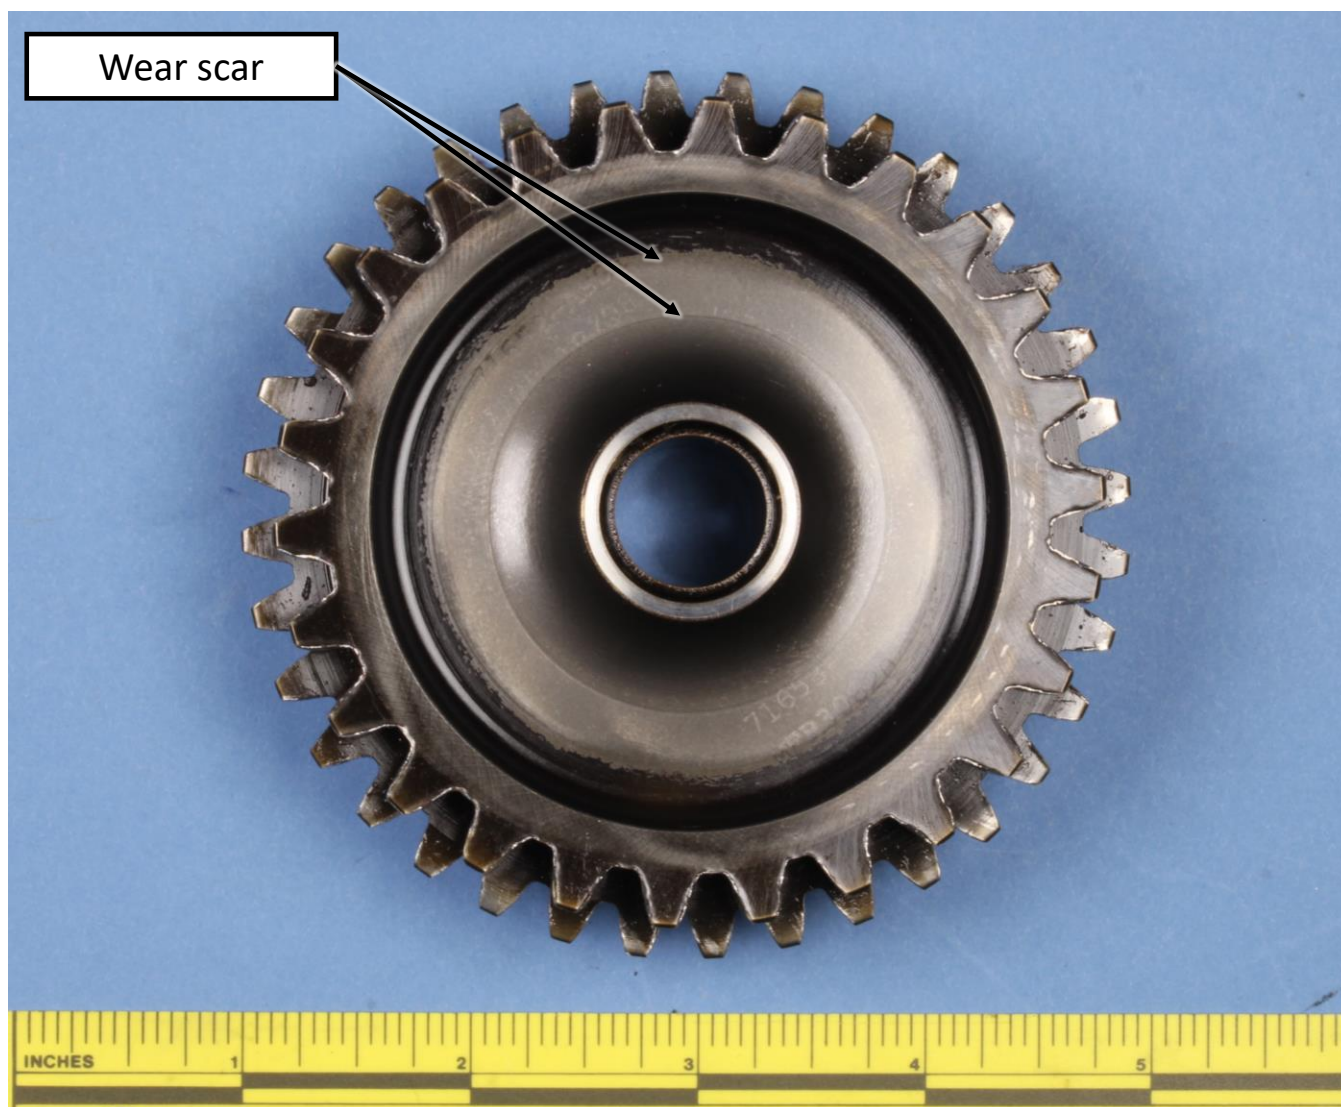
The idler gear, shown in figure 3, was a single component and consisted of two concentric gears, one with greater pitch circle diameter and tooth count than the other (36 teeth versus 26 teeth). A copper colored bushing was retained inside the gear hub. The gear hub had an integrated cam feature on the larger gear side. A dark brown-black coating was present over most of the gear surfaces. The web of the smaller gear contained a circumferential wear scar evidenced by a lightly polished surface free of the dark brown-black

Figure 3: A photograph of the crankshaft idler gear assembly as viewed from the forward side of the engine looking at the smaller gear. The inner and outer boundaries of the circumferential wear scar around the gear web are highlighted. Partially worn part identification information is also observed on the web on each side of the hub at approximately the 10 and 5 o'clock positions. The finned appearance of nearly all the smaller gear teeth edges was evidence of plastic flow of material at these locations.

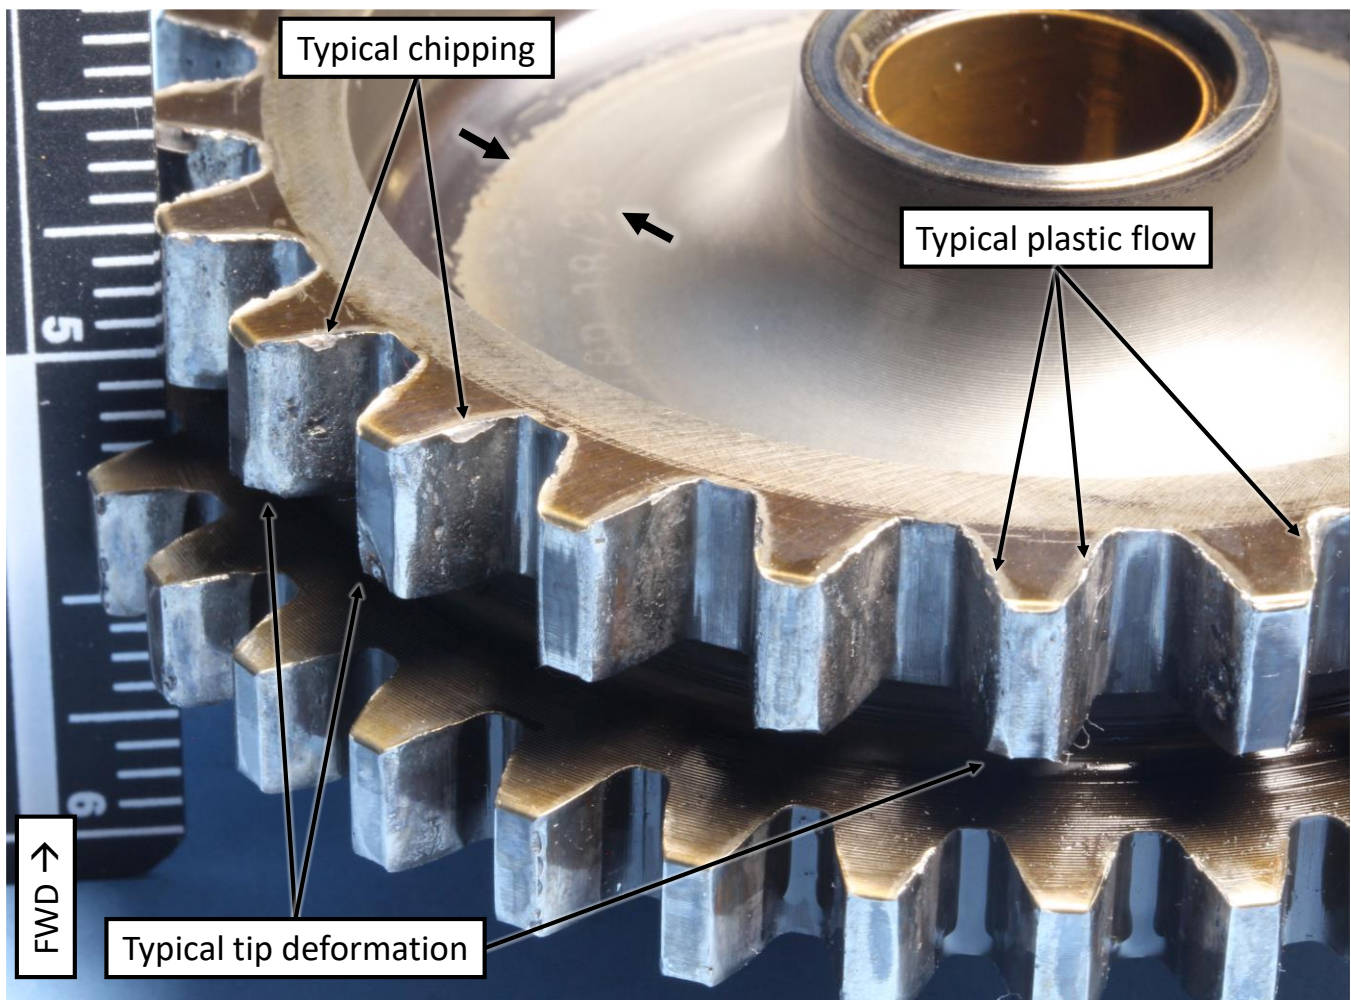
All tooth surfaces of the smaller gear exhibited adhesive wear and pitting over the entire surface as shown in figure 4. The smaller gear also showed evidence of plastic flow of material over the forward ends of the teeth accompanied by local chipping. Approximately 85% of the teeth tips on the smaller gear showed evidence of chipping or deformation. The larger gear tooth surfaces exhibited some adhesive wear, pitting, chipping, and tip deformation but to a much lesser extent relative to the smaller gear. No gear teeth appeared to be completely fractured or missing.

Figure 4: A closer photograph of the gear teeth (smaller gear oriented above the larger gear). Typical observations of plastic flow, chipping, and deformed/impacted teeth are indicated. The teeth surfaces of the smaller gear were polished and pitted. The unlabeled arrows in the gear web indicate the inner and outer boundaries of the circumferential wear scar.

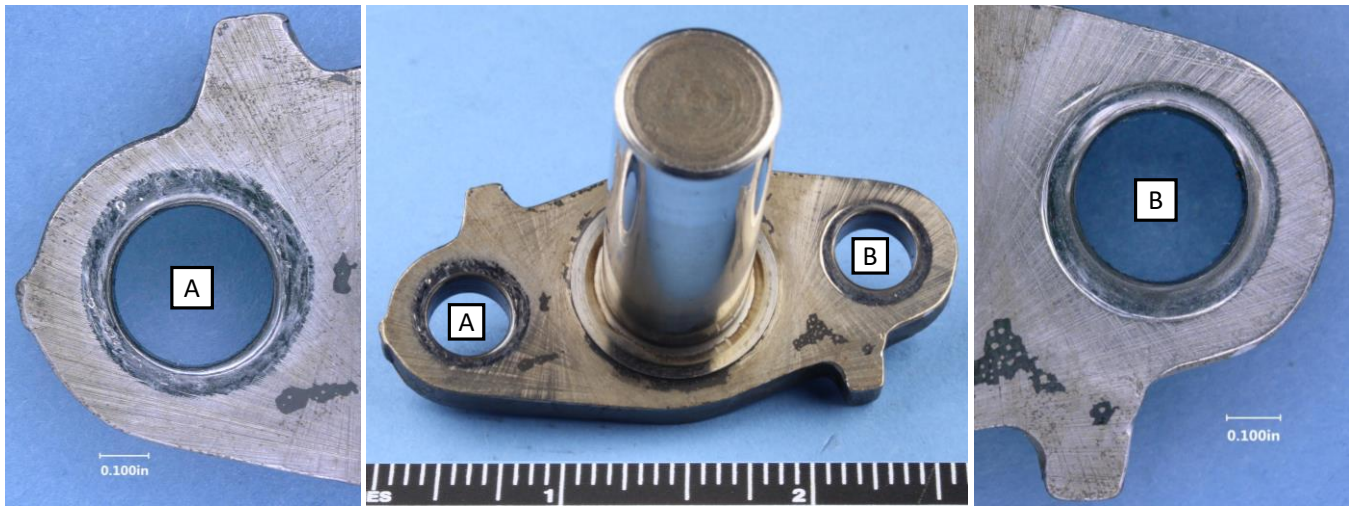
Figure 5a shows an overall view of the crankshaft idler gear shaft flange as viewed from the shaft side. The shaft was smooth and uniform overall with a very fine circumferential scratch directionality except an area at the tip approximately 0.35 inches down the shaft had a slightly brighter and shinier appearance relative to the rest of the shaft. The shaft rotated smoothly and freely when inserted into the gear hub.

The fastener holes have been labeled "A" and "B" for the purposes of this report. Both fastener holes were relatively circular, but the hole "B" edge had an indentation around an approximate 25° segment as viewed from the shaft side. This indentation was at the hole edge only, not all the way through, consistent with impact damage or wear. Both holes contained visible off-center circular haloes of worn and polished metal extending 0.04 – 0.08 inches from the edges of the holes on the shaft side of the flange. The halo around hole "A" was rougher in appearance and had a hazy outer boundary as compared to the halo around hole "B," which was smoother and more uniform in appearance, with a more distinct outer boundary. The inner surface of the holes contained circumferential wear scars which are better observed in figure 5b.

Figure 5a: The central photograph shows an overall view of the of the gear shaft as viewed from the shaft side of the flange. The holes were labeled “A” and “B” arbitrarily for the purposes of this report. To the left and right of this photo are digital microscope images showing closer views of the wear haloes around the holes for holes “A” and “B,” respectively.

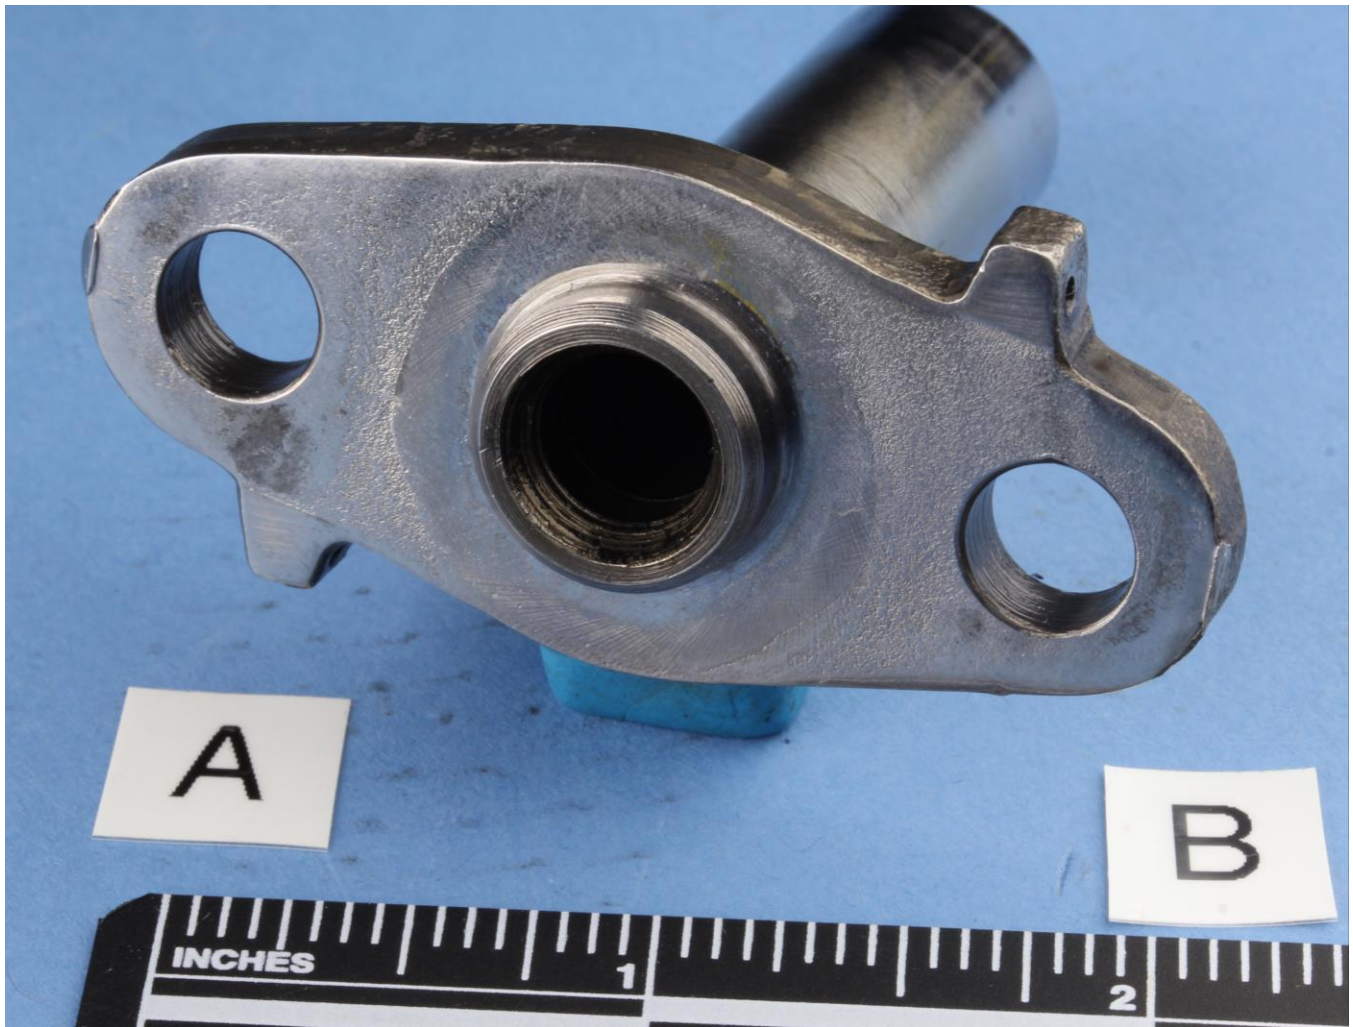
The surface of the flange opposite of the shaft, as shown in figure 5b, was bright, smeared, and battered consistent with mechanical contact against the mating crankcase. There was a visible demarcation line on this surface of the flange at the tab features which exhibited a faint parallel scratch pattern.

Figure 5b: A photograph of the gear shaft viewing the side of the flange opposite of the shaft. The flange surface was bright/shiny, smeared, and battered, consistent with mechanical wear. The hole locations "A" and "B" are indicated for reference. Circumferential scars were visible on the hole surfaces.

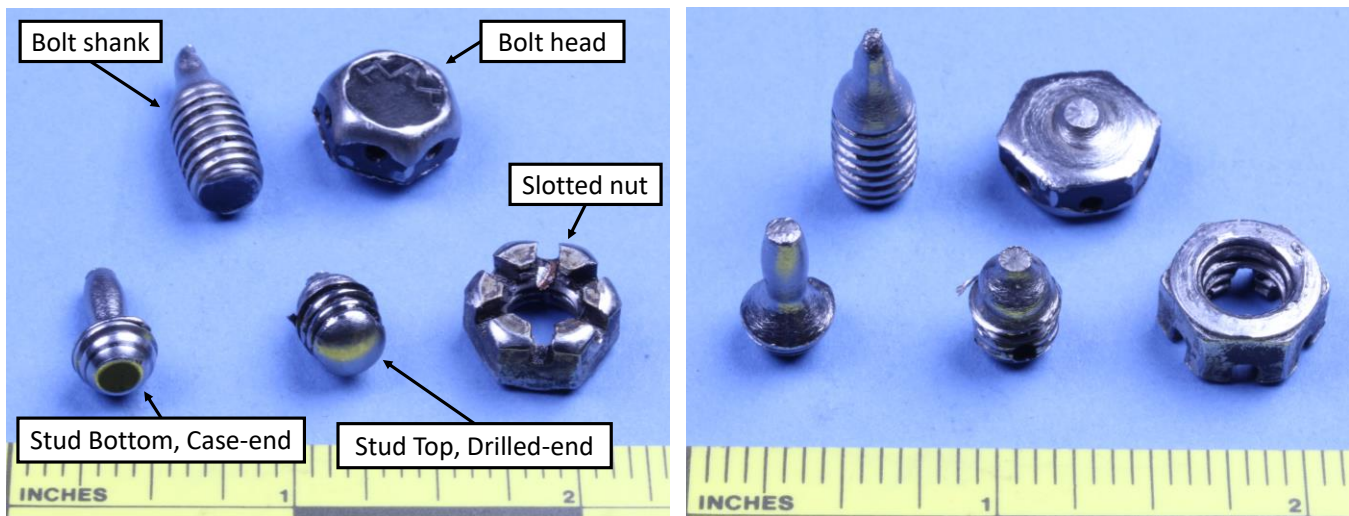
Figure 6 shows a view of the fractured bolt piece, fractured stud piece, and slotted-nut. The top surface of the bolt-head was black in appearance and had the letters "HAP" stamped on the top surface. The top edge of the bolt-head was worn down to the top of the drilled holes and approximately 50% of the height of the bolt head down the hex-flat edges as evidenced by the absence of black color and a shiny, battered, and rounded profile. The bearing surface of the bolt head was also absent of black color and showed rounding and material loss due to wear with visible circumferential scars. A small stud of material approximately 0.06 inches high and 0.12 inches in diameter remained approximately centered on the hex-head where the fastener separated which indicated the nominal bolt grip diameter had been reduced by approximately 85% prior to separation. The fracture features observed are discussed in more detail later in this report.

The bolt fragment containing the grip area was worn and reduced to a half-hourglass shape. From the end of the bolt grip length, partially worn threads were observed for approximately 0.4 inches as thread roots were still visible. Continuing along the grip towards the point of separation, the fastener was worn below the minor diameter, tapering in a half-hourglass shaped profile to approximately 0.08 inches at the point of separation. The fracture surface on this fragment was deformed and smeared, consistent with post fracture impact damage. There were circumferential wear scars on the reduced diameter sections as well as where the thread crests had been worn down.

The outer edges of the tops of the slotted nut and the tip of the drilled end of the stud were shiny, battered, rounded, and worn similarly to the top edge of the hex-head bolt. The bearing surface of the nut was shiny, battered, and had some areas of smeared and flaking metal consistent with adhesive wear.

The fractured stud was worn to an hourglass shaped profile with two to three thread roots still visible at both ends. The threads on the drilled end of the stud fragment were more intact relative to the crankcase fragment, but visibly deformed and somewhat flaky in appearance, consistent with adhesive wear and impact damage. A length of approximately 0.19 inches of the stud fragment (drilled/nut end) had been worn to below the minor diameter and length of approximately 0.42 inches had been reduced below the minor diameter on the mating fragment. At the point of separation, the stud had been worn to a diameter of approximately 0.10 inches which indicated the nominal stud diameter had been reduced by approximately 90% prior to separation. There were circumferential wear scars on the reduced diameter sections as well as polishing where the thread crests had been worn on the crankcase fragment.

Figure 6: The left photograph shows the top of the bolt head, slotted-nut, and stud with evidence of material loss due to adhesive wear. Also in this photo is a bottom view of the worn stud and bolt shank. The right photograph shows (same relative component locations as the left) the bearing surfaces of the bolt head and nut with evidence of adhesive wear. Also shown are the fractured surfaces of the worn bolt and stud.

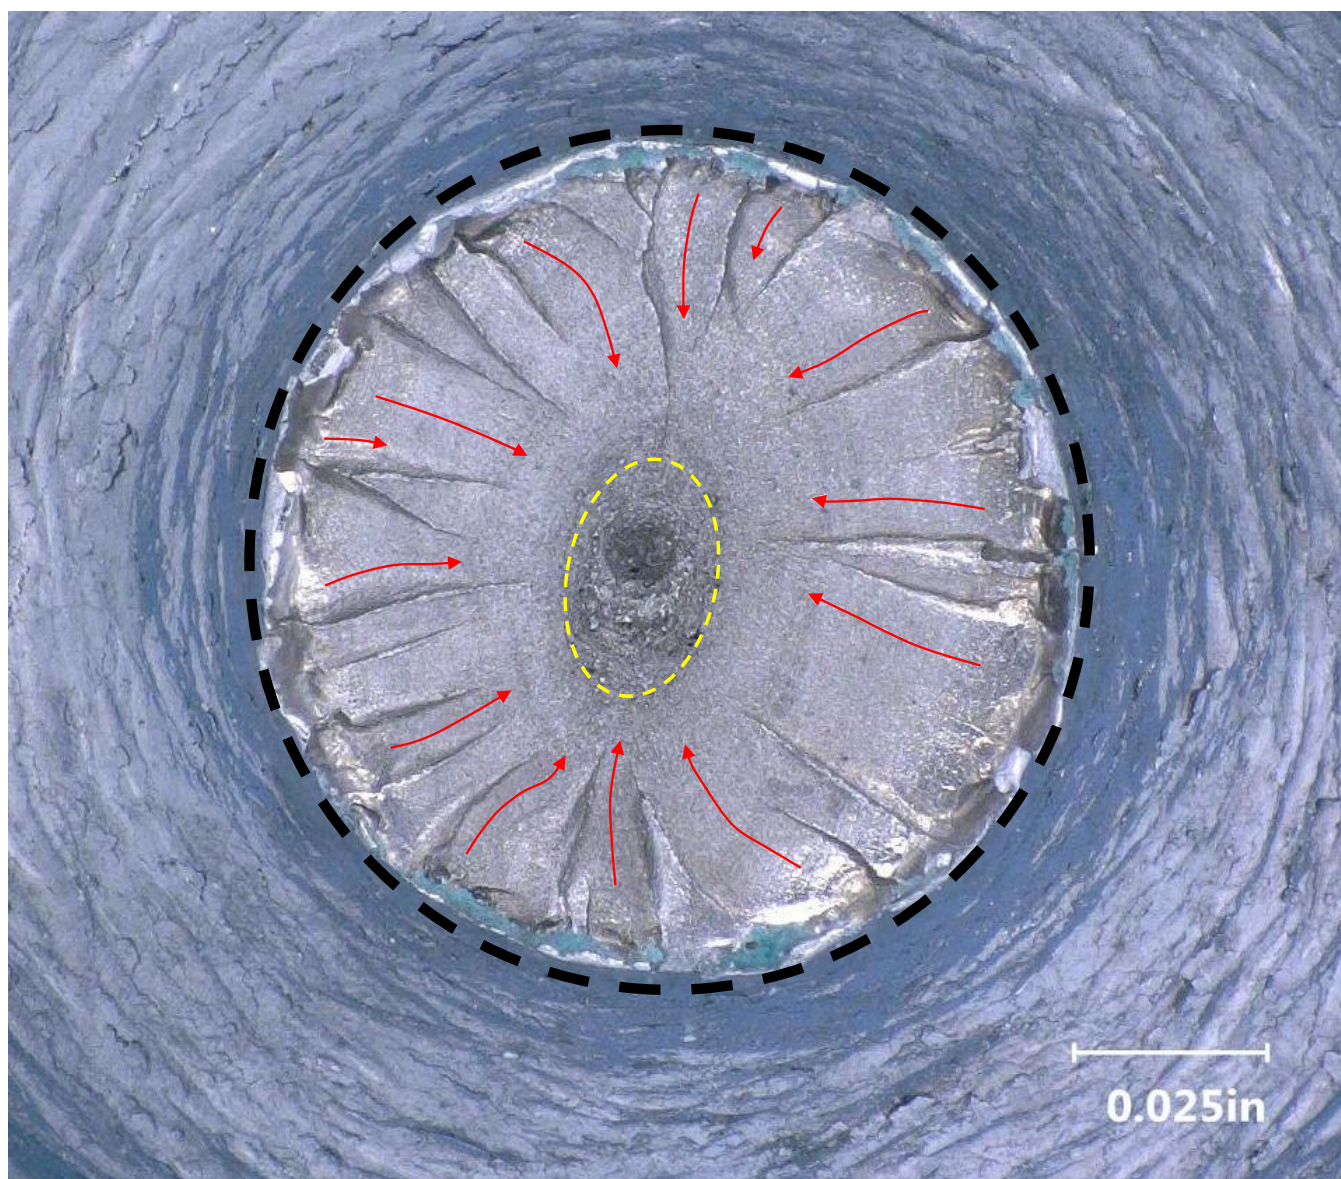
Figure 7 shows a closer view of the stud piece fracture surface using a digital microscope. The fracture surface was flat and multiple fracture origins were present around the entire circumference of the worn stud piece as evidenced by numerous radial ratchet marks.<sup>2</sup> Beach mark<sup>3</sup> features were visible and indicated inward crack propagation. A small

elliptical area of rough morphology was present at the approximate center of the fracture surface consistent with overstress separation. Fatigue cracking traversed approximately 95% of the fracture surface prior to overstress separation. Features present on the fracture surface were consistent with multiple origin rotating bending fatigue at relatively low nominal stress.

Figure 7: A digital microscope image of the circular stud fracture surface contained within the black dashed circle. Multiple fracture origins were observed around the entire circumference of the fracture surface as evidenced by numerous ratchet marks. The red arrows indicate typical fatigue crack propagation direction following ratchet mark and beach mark features. The area within the yellow dashed ellipse was consistent with final overstress separation. Circumferential wear scars on the reduced diameter section of the stud are visible outside of the black dashed circle (below the plane of focus in this image).

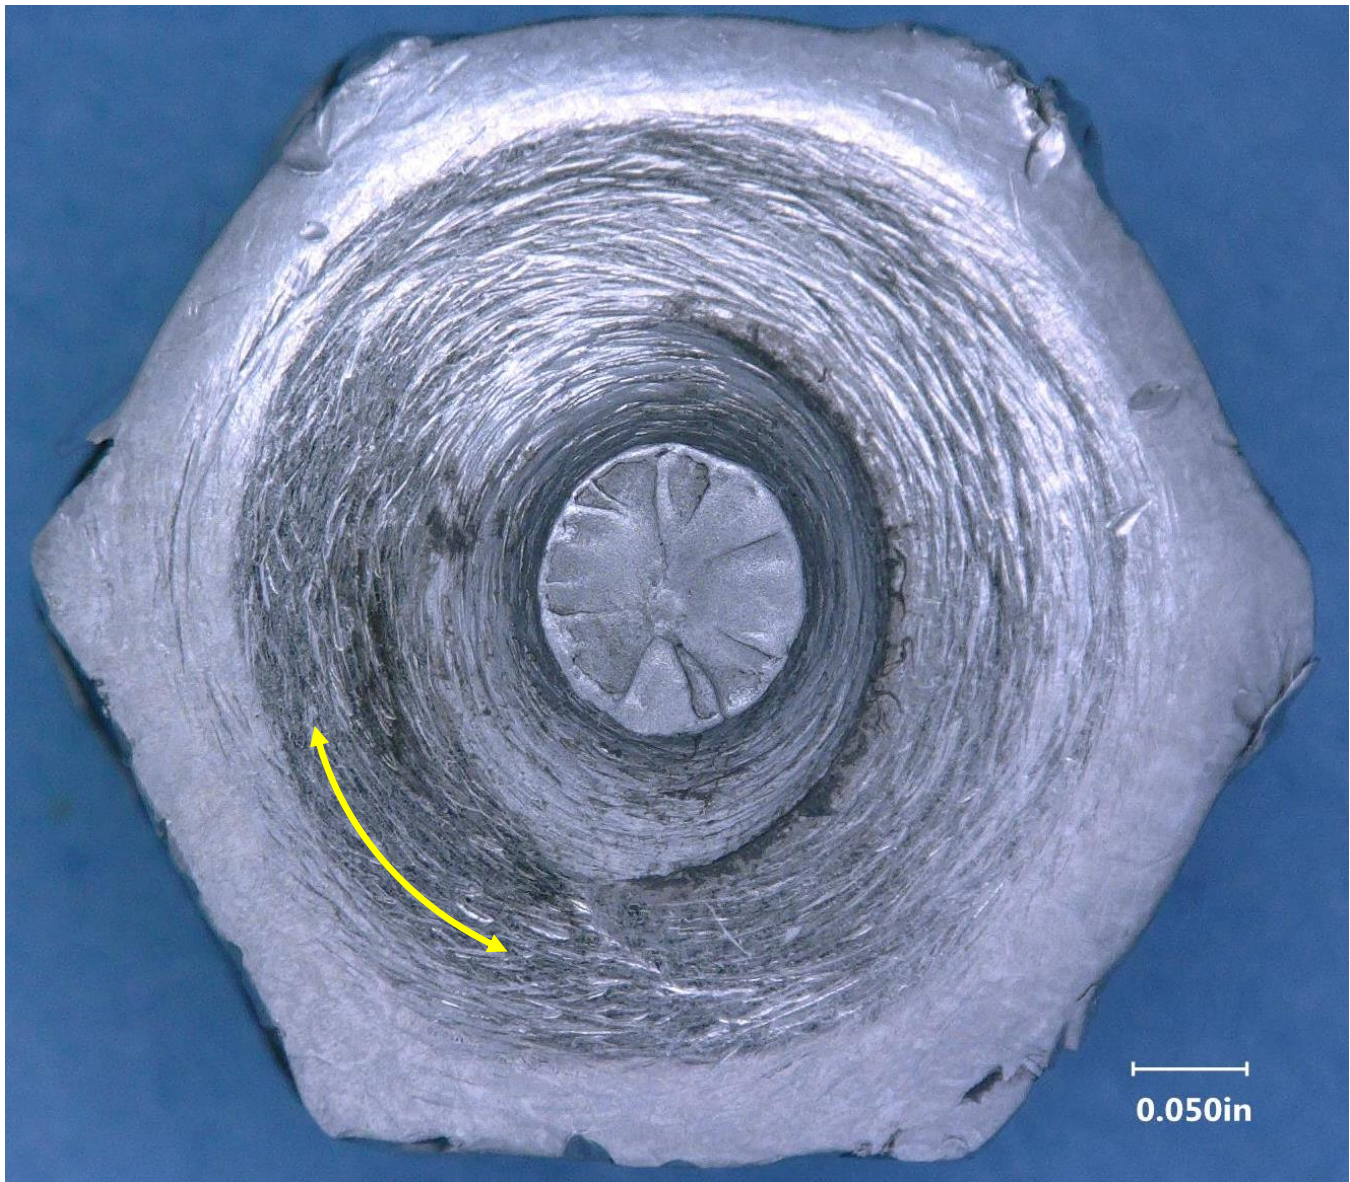
The bolt piece fracture surface, as viewed in figure 8, resembled the stud piece fracture surface; however, features were smoother, somewhat smeared, and less discernible. The circumferential scars were consistent with rotational wear.

Figure 8: Digital microscope image of the polished and worn bearing surface of the bolt head showing the fracture surface. Features were similar to the stud fracture surface but smoother, more smeared, and less discernible. Circumferential wear scars (with orientation highlighted by the yellow arrows) were observed on the bearing surface of the bolt head and reduced diameter section, consistent with rotational wear.

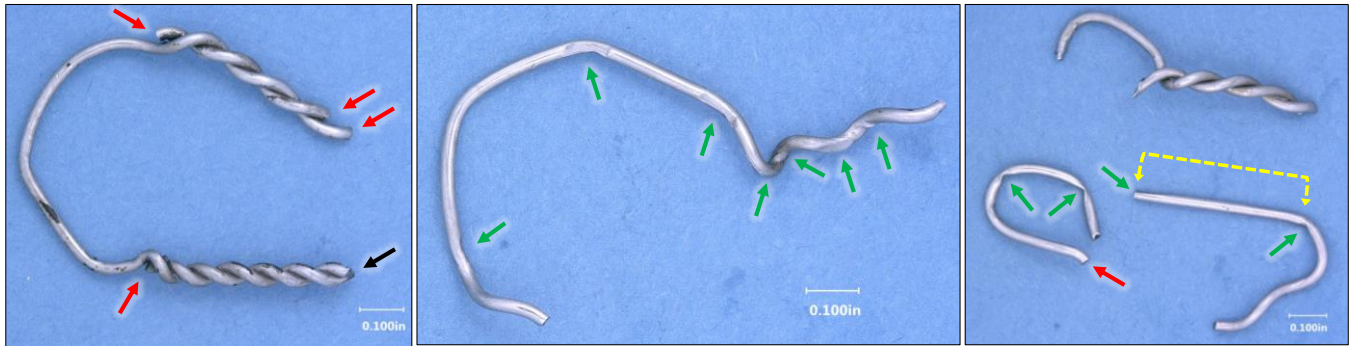
There was a total of 5 fragments of safety wire submitted as shown in figure 9. The fragments shown in the left and center images of this figure contained a single wire that followed a partial hexagonal path consistent with the profile of the slotted-nut and bolt followed by a helical path immediately before and after. The ends of the fragment in the left image each contained an additional fragment of wire twisted together forming a double helix. The fractured ends of wire are highlighted with unlabeled arrows. The red arrows indicate relatively flat fracture surfaces observed using a stereomicroscope. The black arrow indicates an end where both strands of wire terminate in a sharp point at the same location and orientation, consistent with being mechanically cut. The fragment of safety wire in the center image had witness marks consistent with hard contact or rubbing which are highlighted with green arrows. The fractured ends of this fragment appeared more necked down<sup>4</sup>, consistent with tensile stretching and overstress. The smaller fragments are shown grouped together in the right image of figure 9. The fragment indicated with the yellow bracket was of comparable dimension to parallel sides of the slotted-nut and bolt head. Witness marks consistent with hard contact or rubbing are highlighted with green arrows, and the red arrow indicates a relatively flat fracture with no obvious necking observed using a stereomicroscope. The unlabeled fragment ends in the right image were smeared and deformed, consistent with post fracture damage.

Figure 9: Digital microscope images of the safety wire fragments examined. Red arrows indicate relatively flat fracture locations. The black arrow indicates a wire termination consistent with being mechanically cut. Green arrows indicate witness marks and evidence of contact or wear. The yellow bracket indicates a span of wire consistent with dimensions of parallel sides of the slotted nut and hex-head bolt. Unlabeled wire terminations in the center image were consistent with tensile stretching/overstress. Unlabeled wire terminations in the right image were damaged after separation and were not classified.

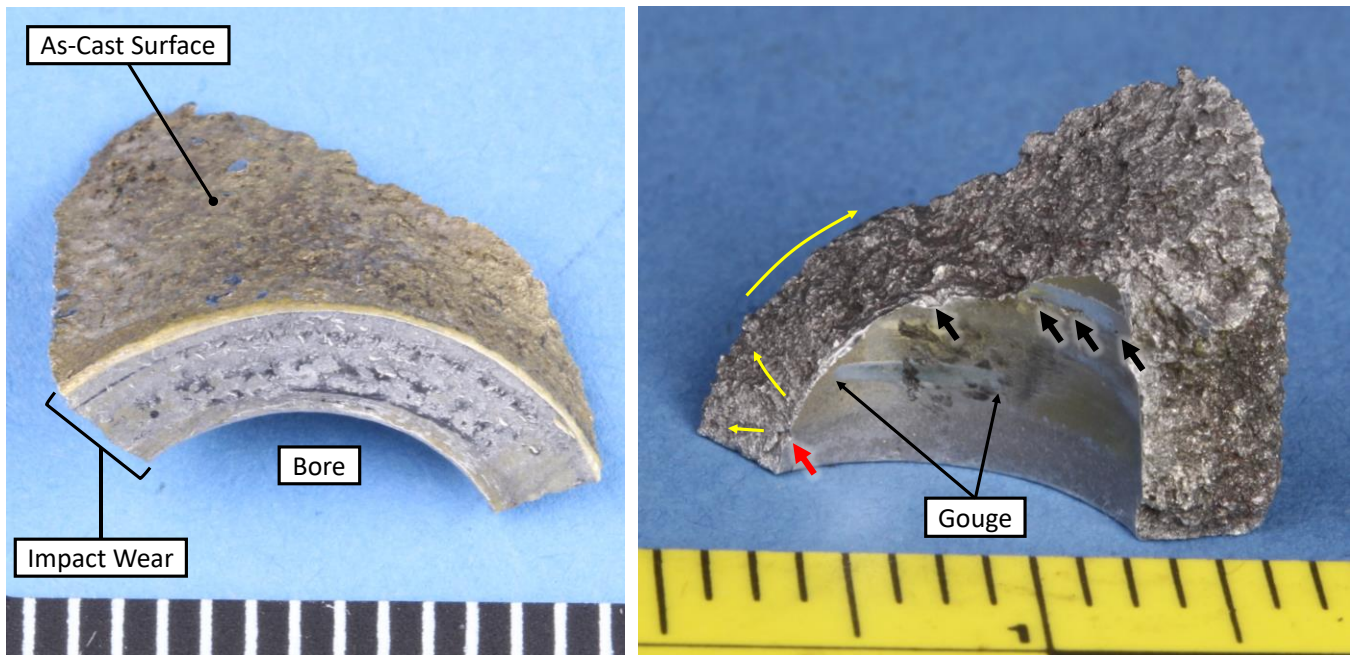
The casting fragment shown in figure 10 was fractured through a circular bore feature that appeared to originate near the unlabeled red arrow. The yellow arrows show the approximate direction of fracture. The as-cast surface exhibited a golden-straw colored appearance. The flat surface oriented normal to the bore surface showed evidence of polished, smeared, and battered metal, consistent with impact wear. On the bore surface, there was a shiny circumferential gouge approximately 0.10 inches from the flat surface and between this gouge and the flat surface was a circumferential band of polished and smeared metal absent of the golden-straw color. An alternating striped pattern was observed on the bore surface that consisted of circumferential bands of smeared/polished metal followed by bands of golden-straw color. There were small pits present on the bore surface as indicated in the photograph.

Figure 10: The left photograph shows a fractured piece of casting where the flat, bright-silver colored surface normal to the bore feature is visible. This surface was shiny and battered, consistent with impact wear. The right photograph shows the fracture surface and inside of the bore feature of the same piece of casting on the left. The red arrow highlights a small pit on the border of a wear band near the fracture initiation. The yellow arrows highlight the approximate direction of fracture. The unlabeled black arrows highlight several other pits observed on this surface. Scale markings are 1/16 inch.
