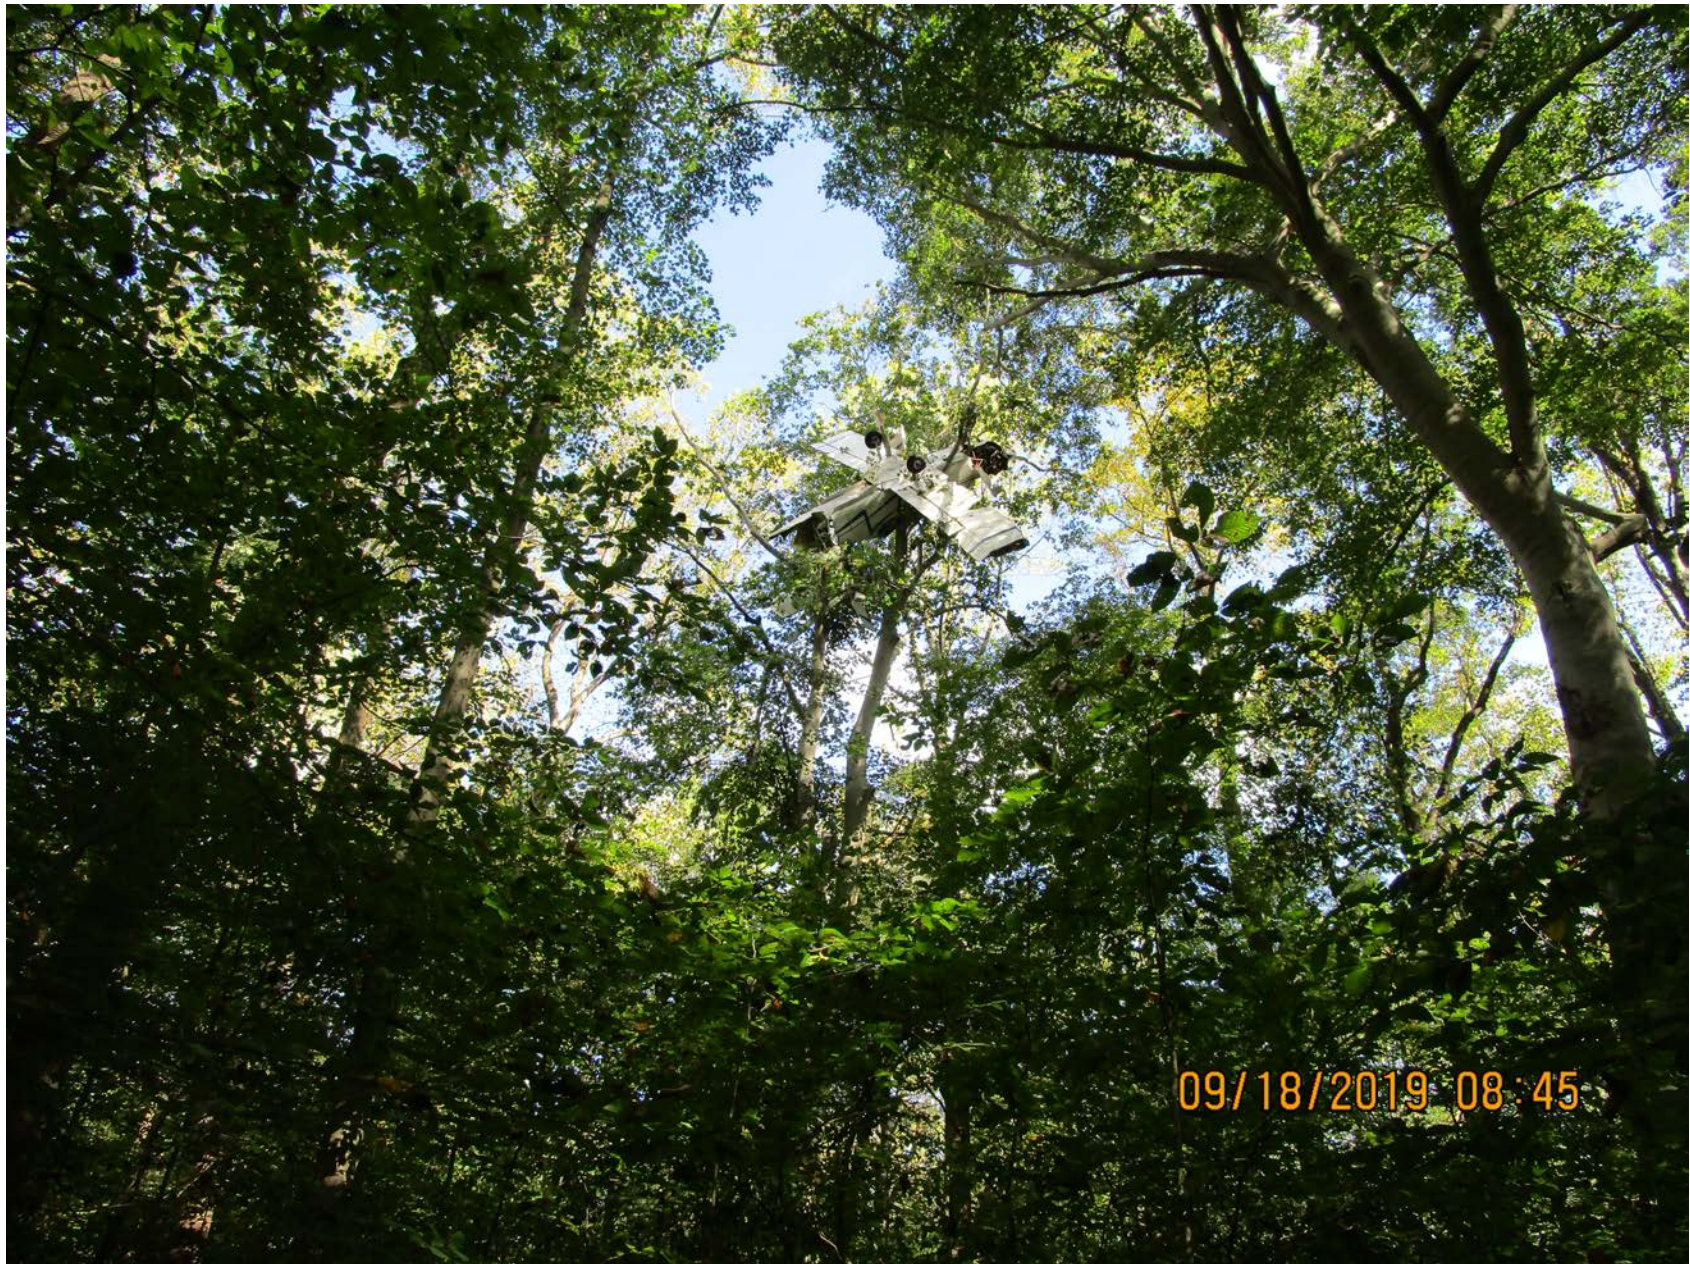
**Photo 1 – View of airplane wreckage in tree showing substantial damage to both wings**

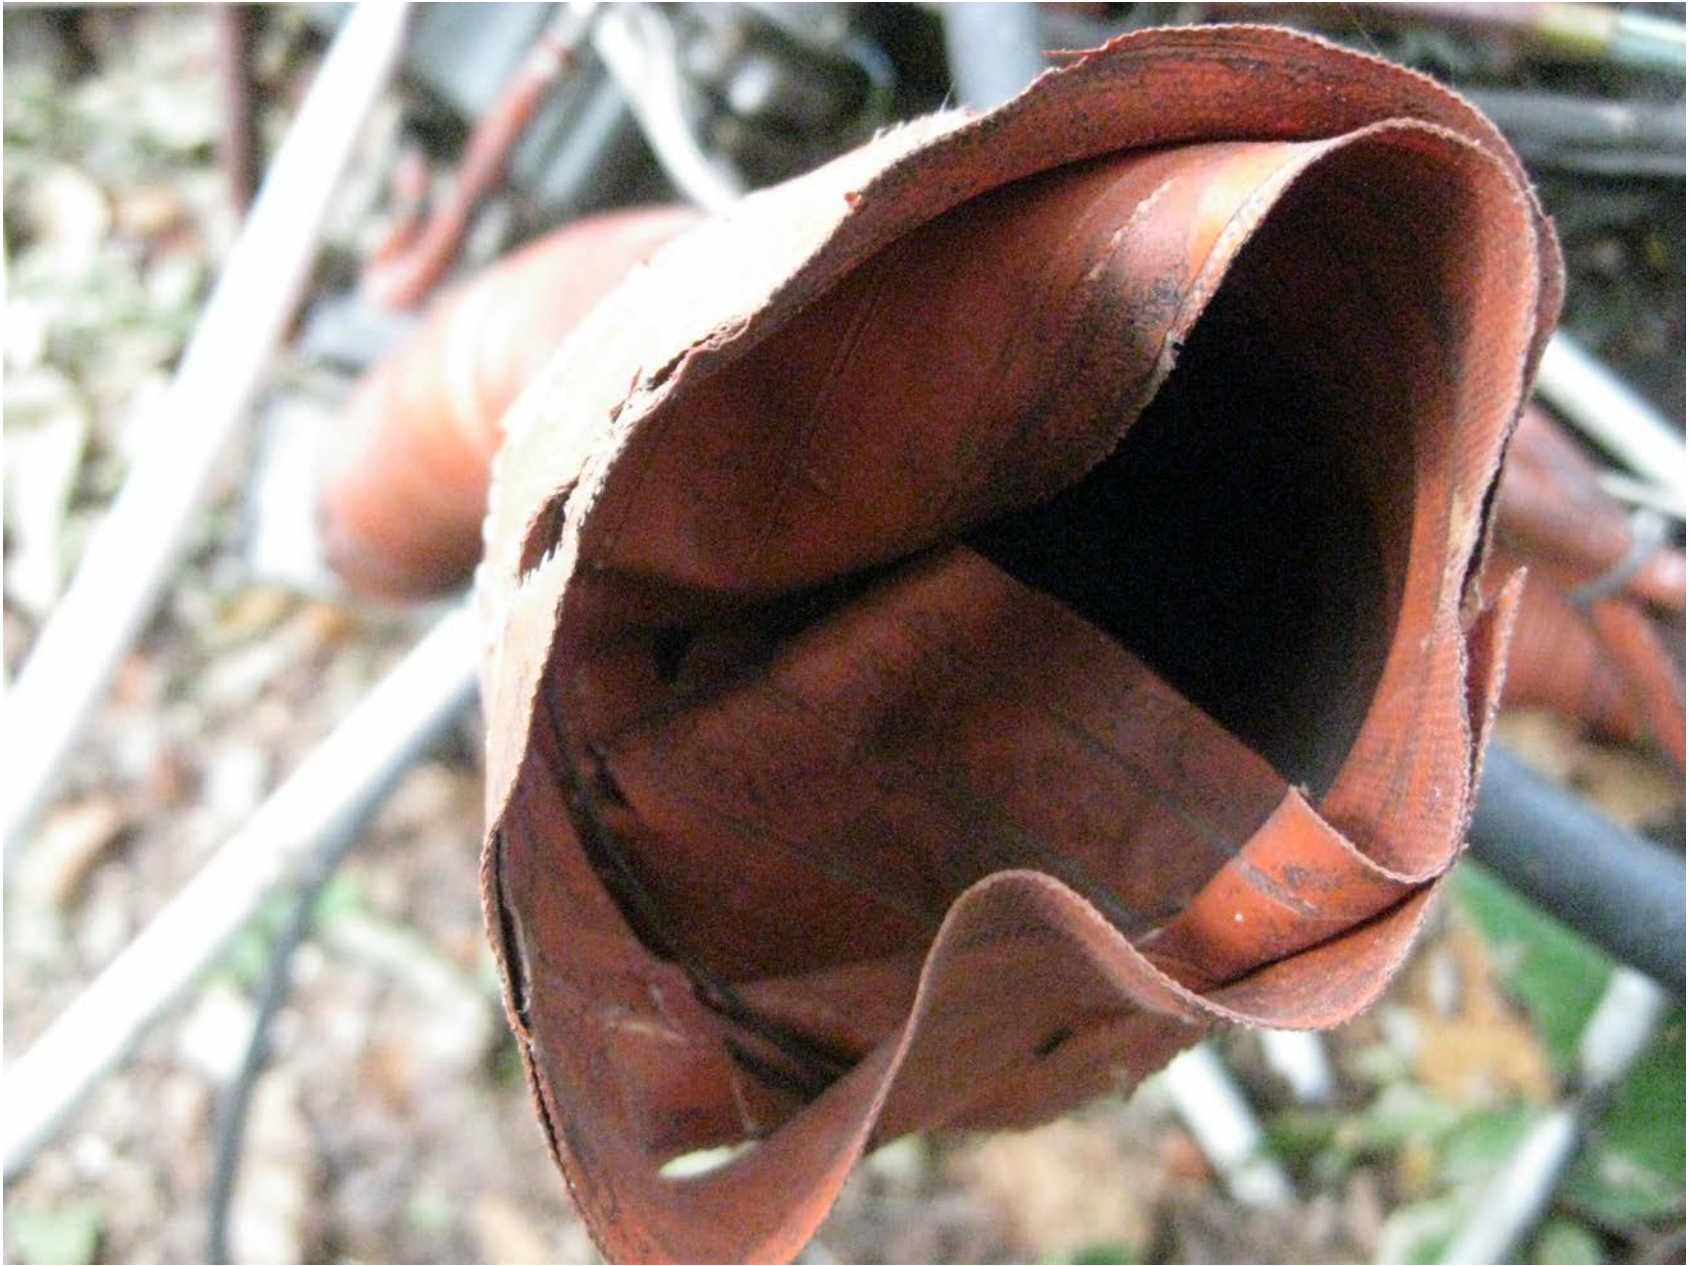
**Photo 2 – View of inside of scat tubing showing the collapsed inner layer**

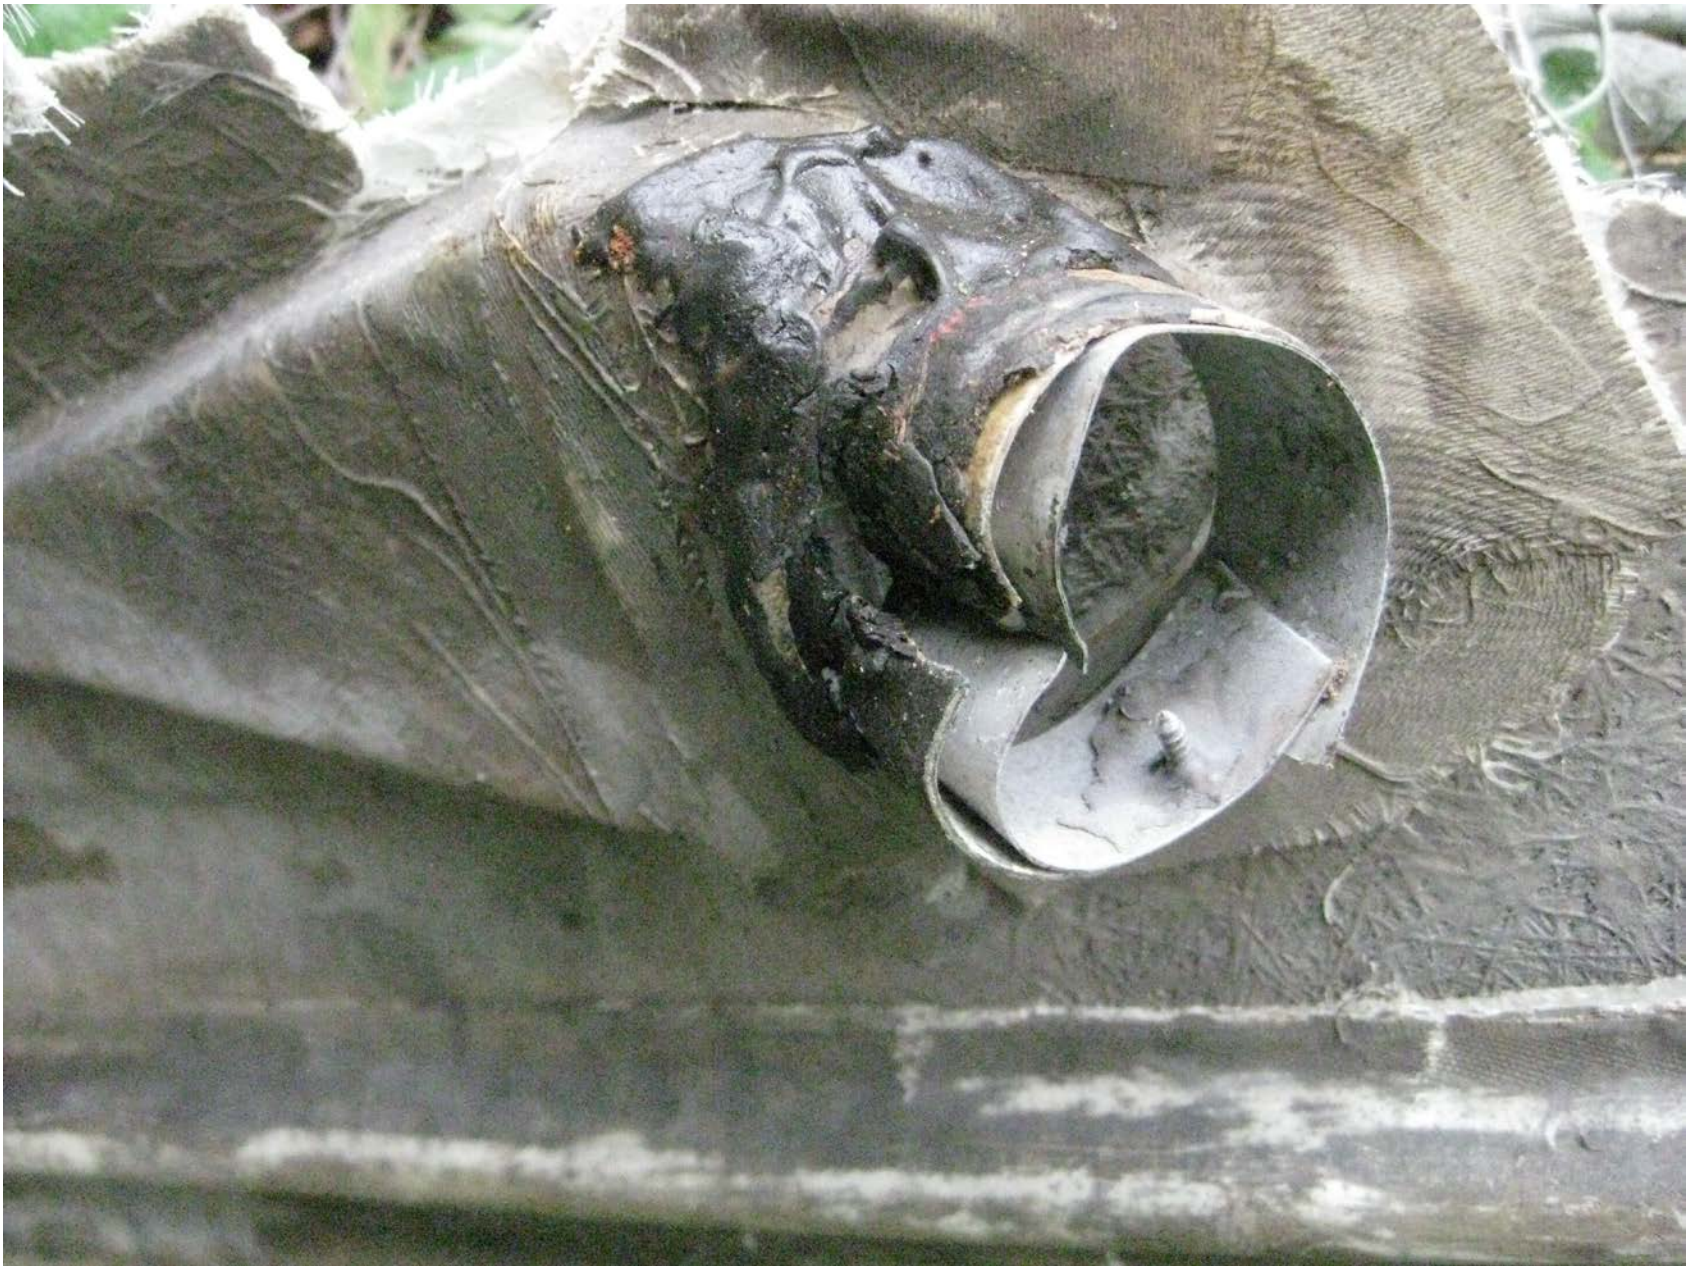
**Photo 3 – View of scat tube connector on airframe intake showing crushed fitting**
