**NATIONAL TRANSPORTATION SAFETY BOARD**

Office of Aviation Safety  
Eastern Region

**Photo Array**

**ERA19LA279**

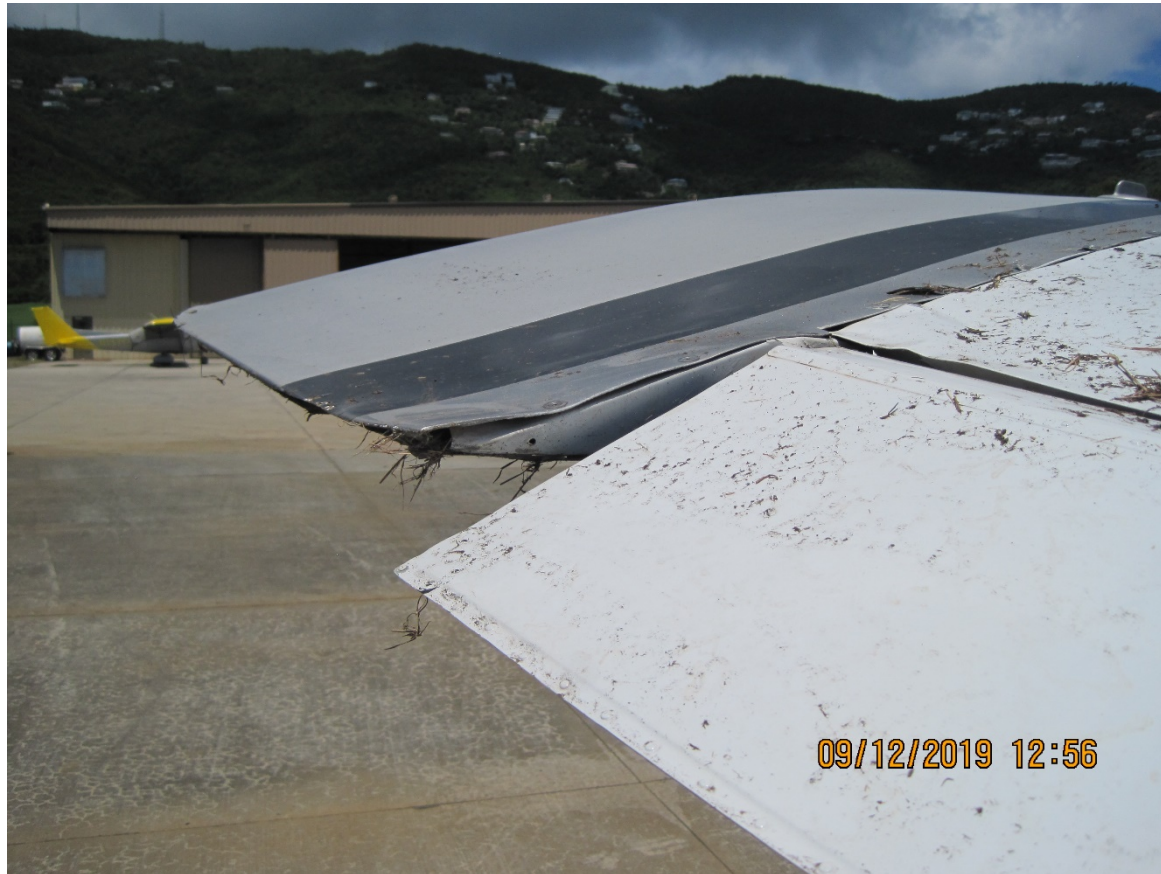
**Photo 1 – View of Left Wing Trailing Edge and Wingtip Damage (Photo Courtesy of FAA)**

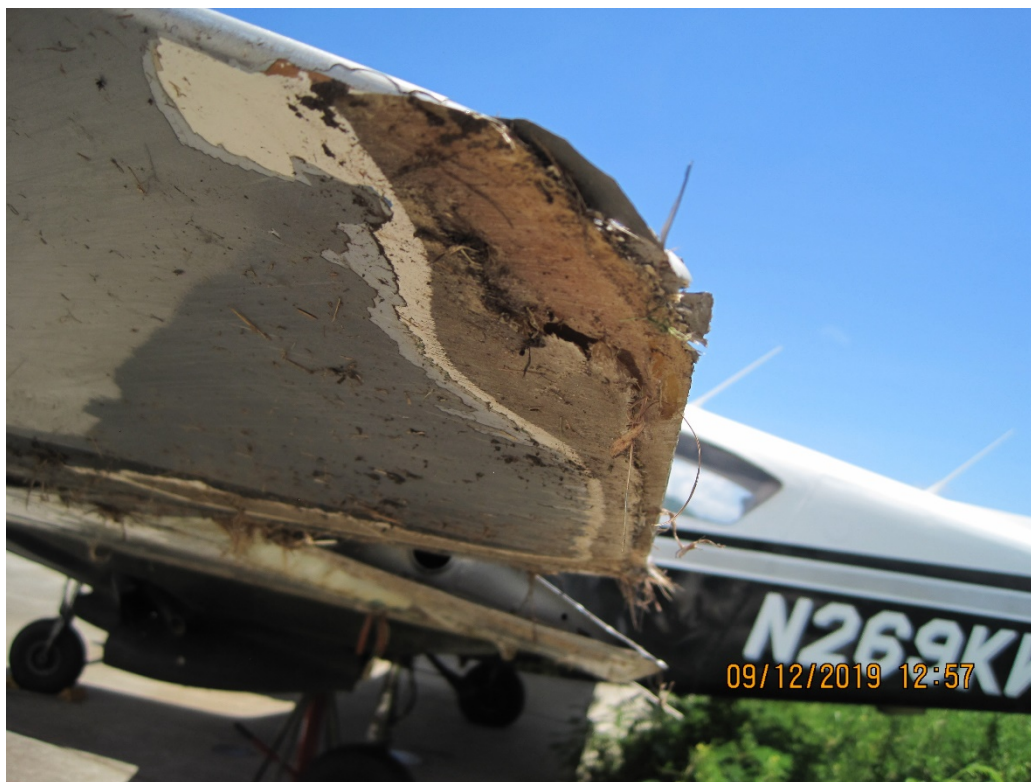
**Photo 2 – Close-Up View of Wingtip Damage (Photo Courtesy of FAA)**

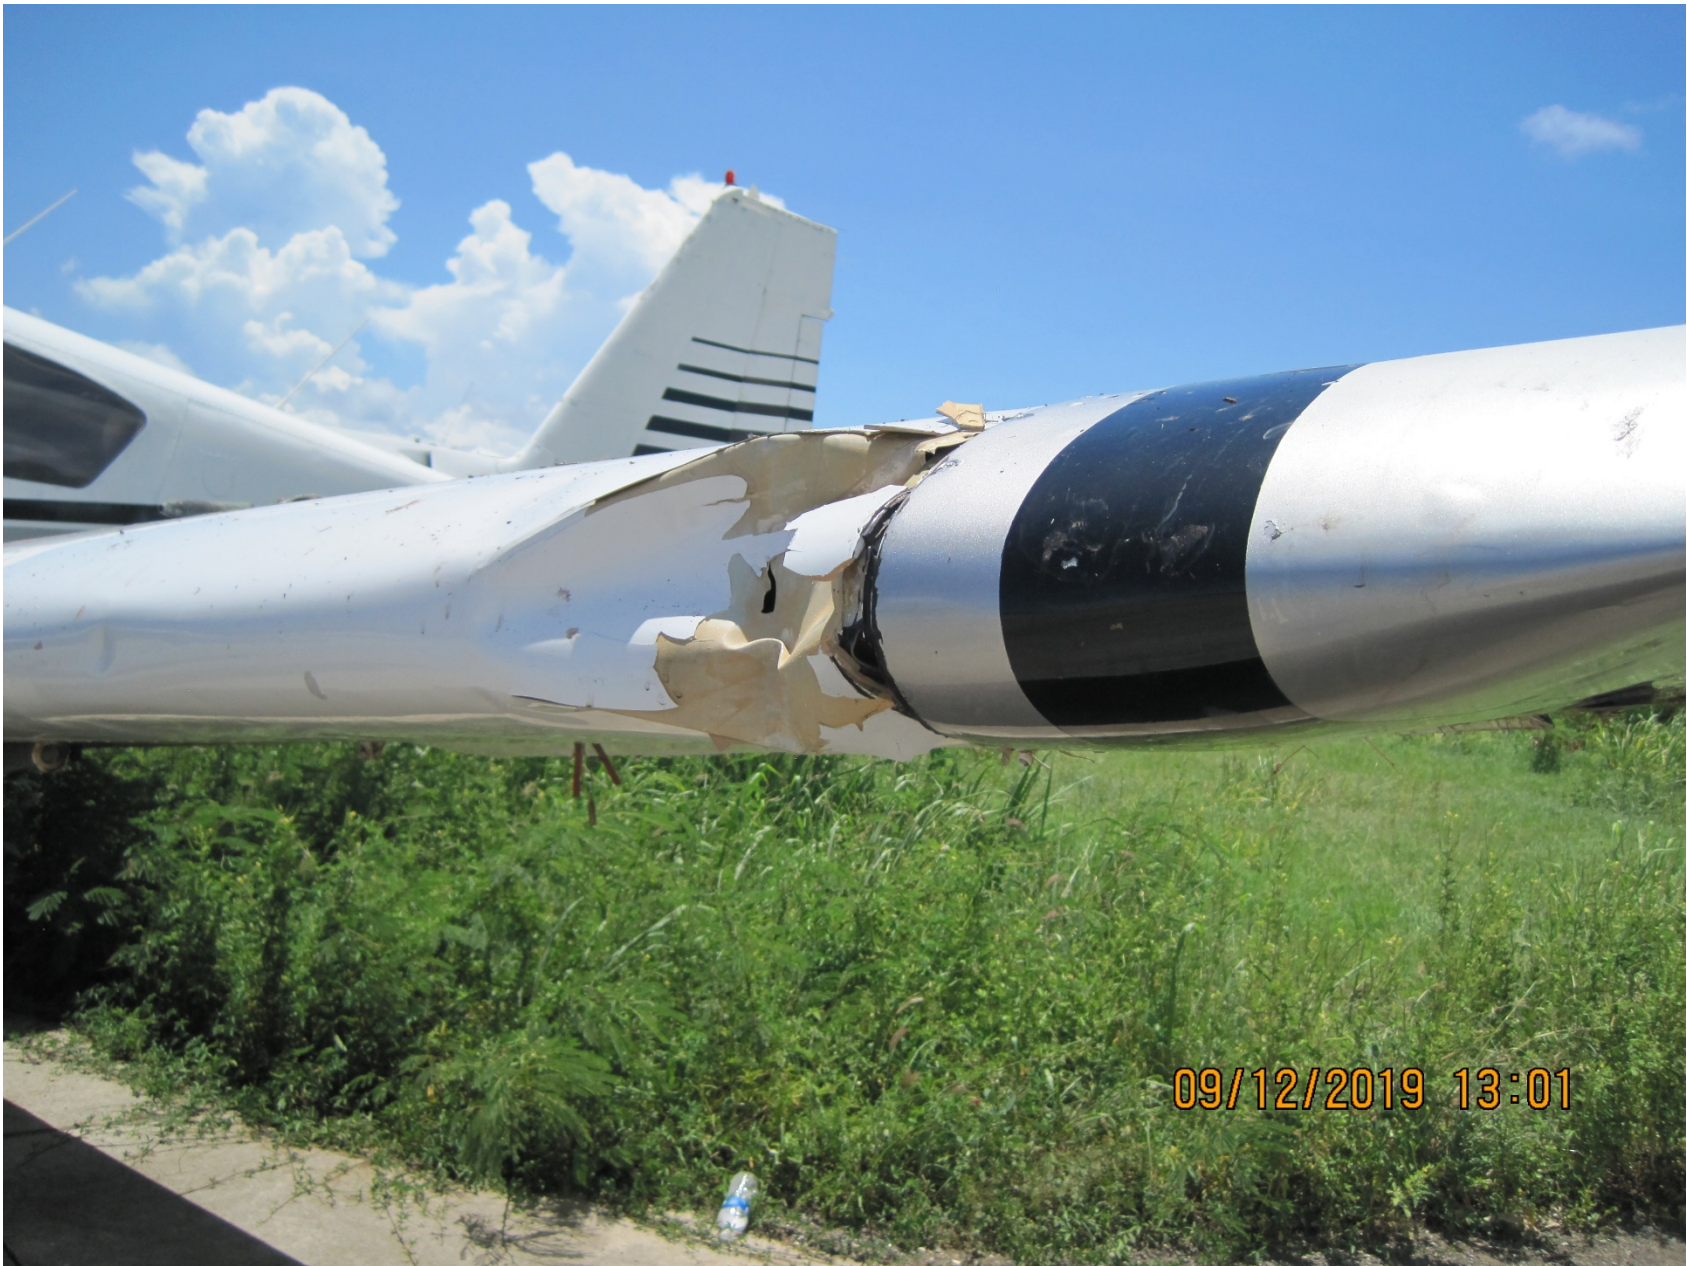
**Photo 3 – View of Left Wing Fracture (Photo Courtesy of FAA)**

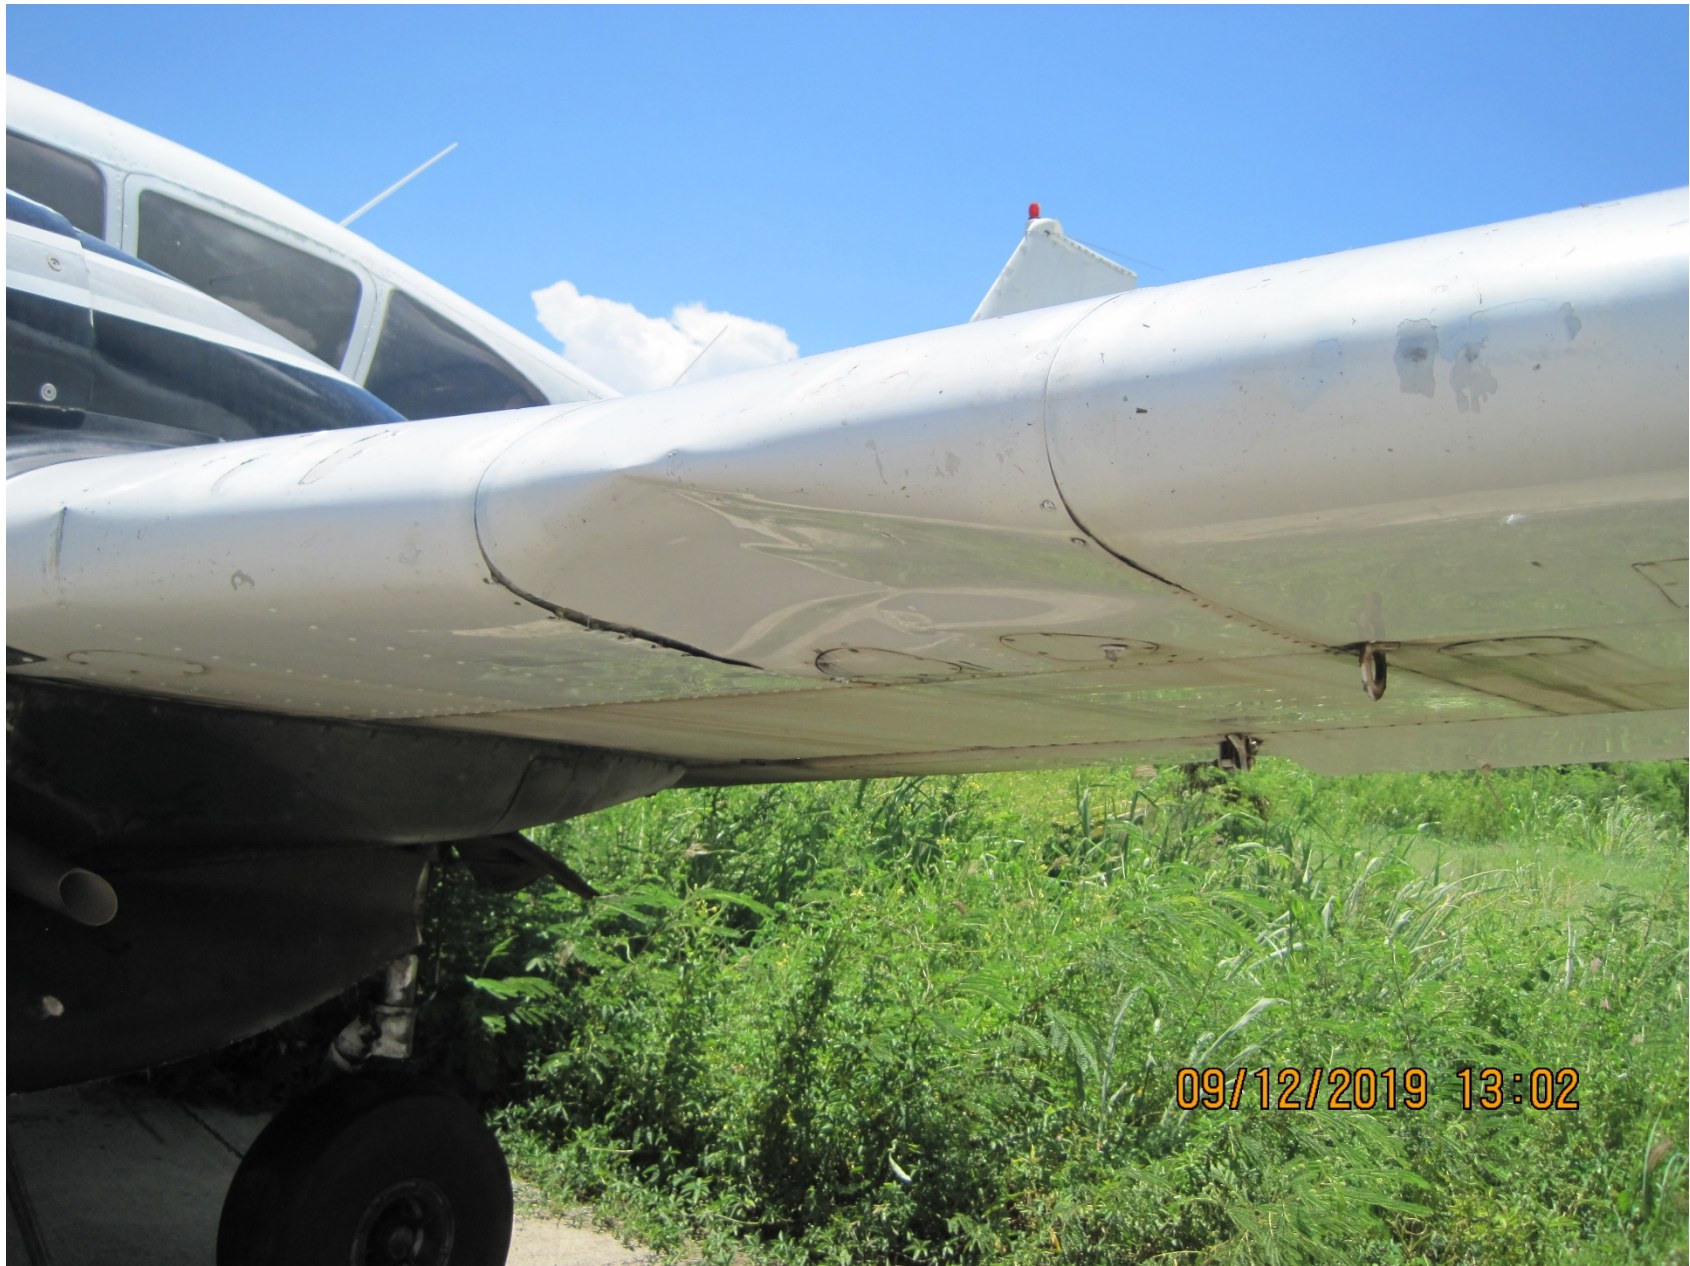
**Photo 4 – Left Wing Damage (Photo Courtesy of FAA)**
