## MEMORANDUM FOR RECORD

**Subject:** N78912, Cessna 172K, 09/24/19, Manville, New Jersey, NTSB Investigation ERA19LA280. Wreckage Examination.

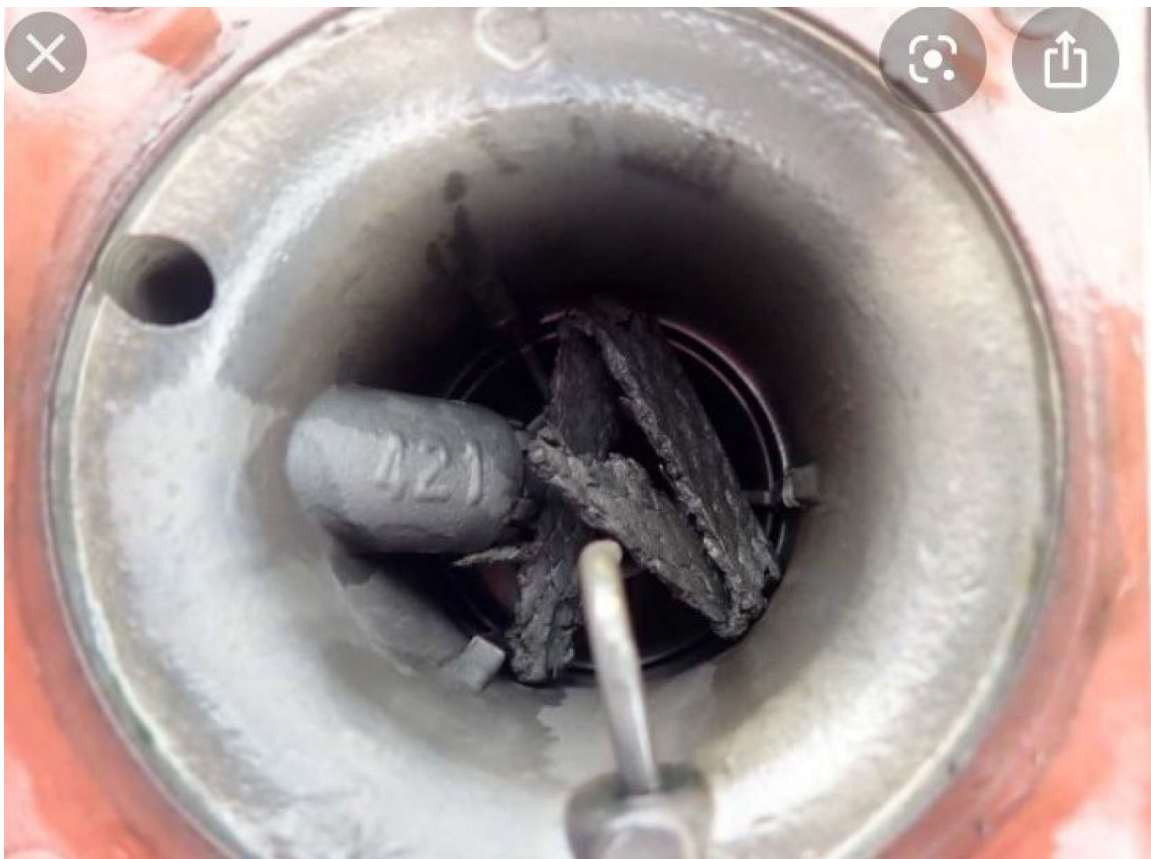
Air filter was singed  
Air filter assembly complies with AD and no loose gasket on air filter housing  
Air box removed.  
Two small pieces of debris fell out of airbox. It appeared to possibly be a clear epoxy used on the air box patches as sealant. Approximate .010" thick 2 inches long. they were grey in color from fretting aluminum chafing. When cleaned it looked clear or opaque. They were not retained.  
The carburetor heat valve had excessive play.  
Sealing material worn, brittle and possible loose particles. No large pieces missing  
Carb Heat shaft was worn and had loose hardware.  
Multiple patches and repairs were made to the airbox; they are fretting and coming loose.  
Sealant coming loose in various areas.  
Plate installed with 2 screws covered opening in airbox. Possible repair or modification.

Example of venturi blockage for reference only (the debris shown in the photo below was found in the airbox upon disassembly. It was not found in the carburetor venturi. In the photo below, the debris was placed in the venturi during the examination to show its size relative to the venturi).
