## **MEMORANDUM for RECORD**

**Date: October 8, 2019**  
**Wreckage Examination**  
**NTSB Accident Number: ERA19LA286 – Dalton, Georgia**

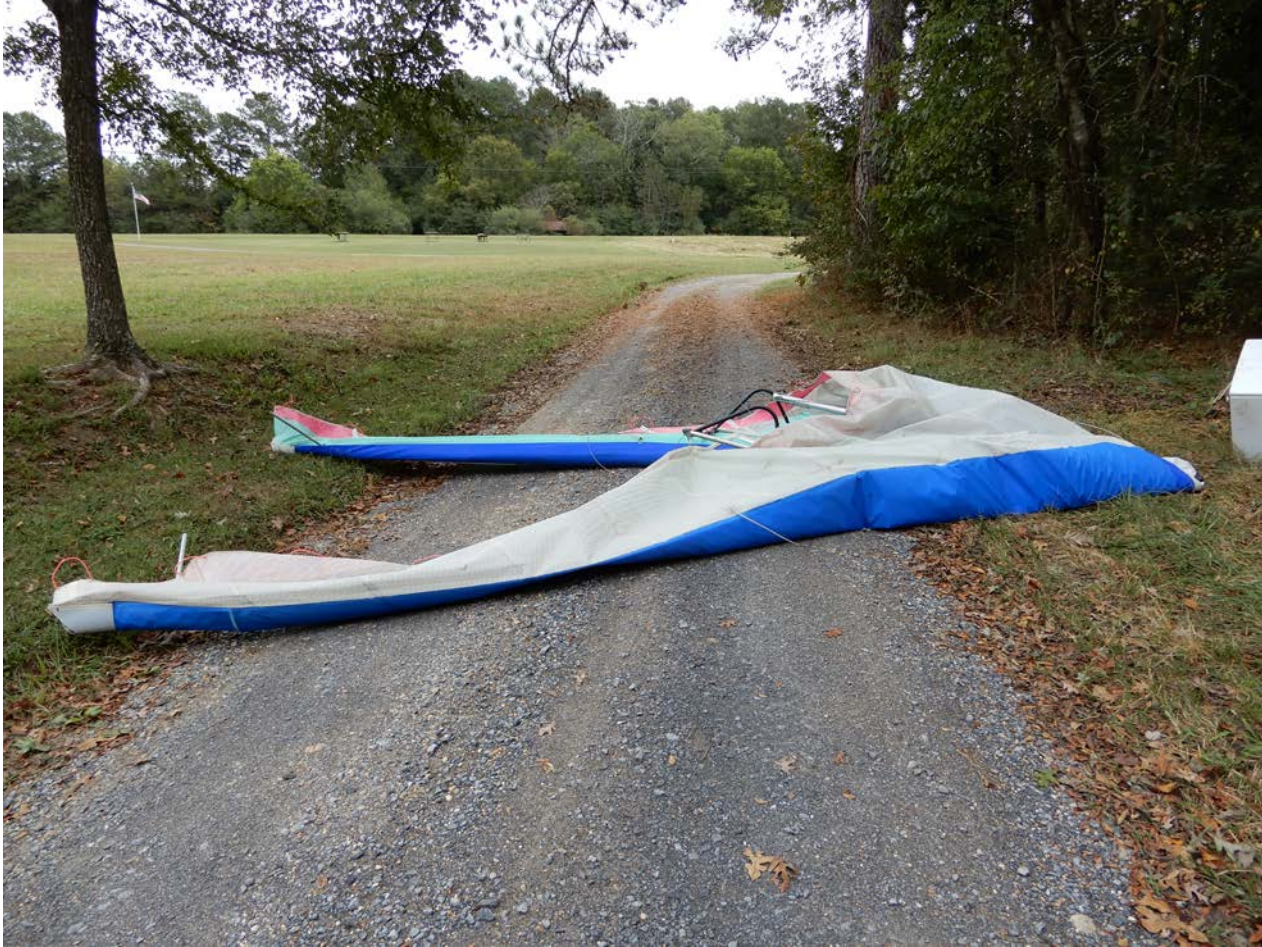
The wing and tubular frame were examined. The wing material was free of cuts or holes and remained attached to the frame. The flight control wires and cables were in place; however, some ends were cut or disconnected during recovery. The pilot's seat was missing. The throttle assembly was still attached and the throttle cable was cut during recovery. The hour meter (Tiny-Tach) was damaged from impact and would not power up. The BRS airplane recovery parachute remained inside its container; the rocket was saftied.

Photo 1 – Weight-Shift Aircraft Wing and Frame

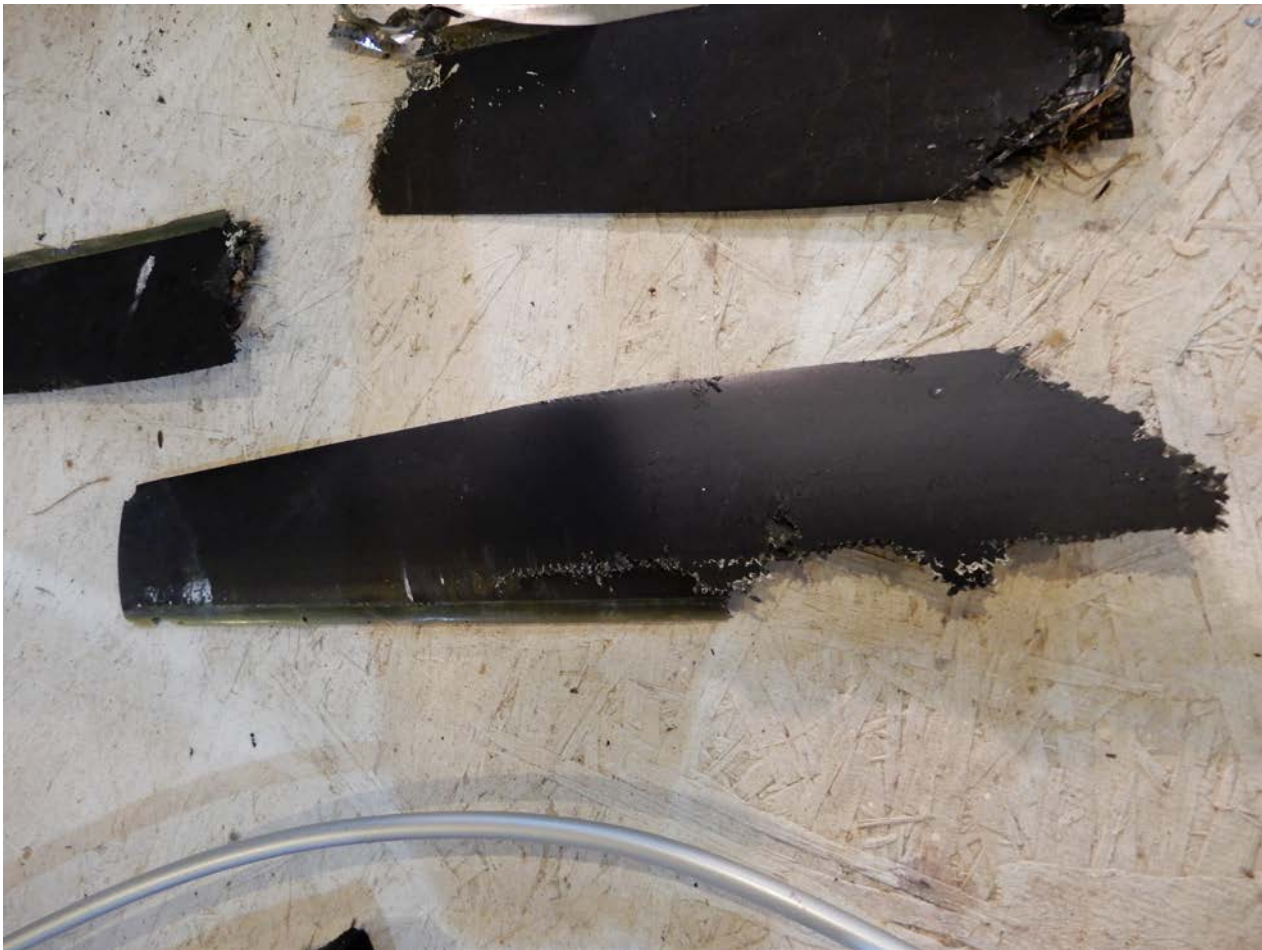
The composite, ground adjustable propeller blades were fractured and fragmented near the blade roots; the propeller hub remained attached to the engine. The leading edge of the blades revealed chordwise scratching and leading edge damage on the surfaces. The leading edge strip on one blade was deformed from impact. The fibers on the fractured areas near the hub were bent in the direction opposite of rotation.

Photo 2 – Fractured Propeller Blades – Notes Chordwise Scratching

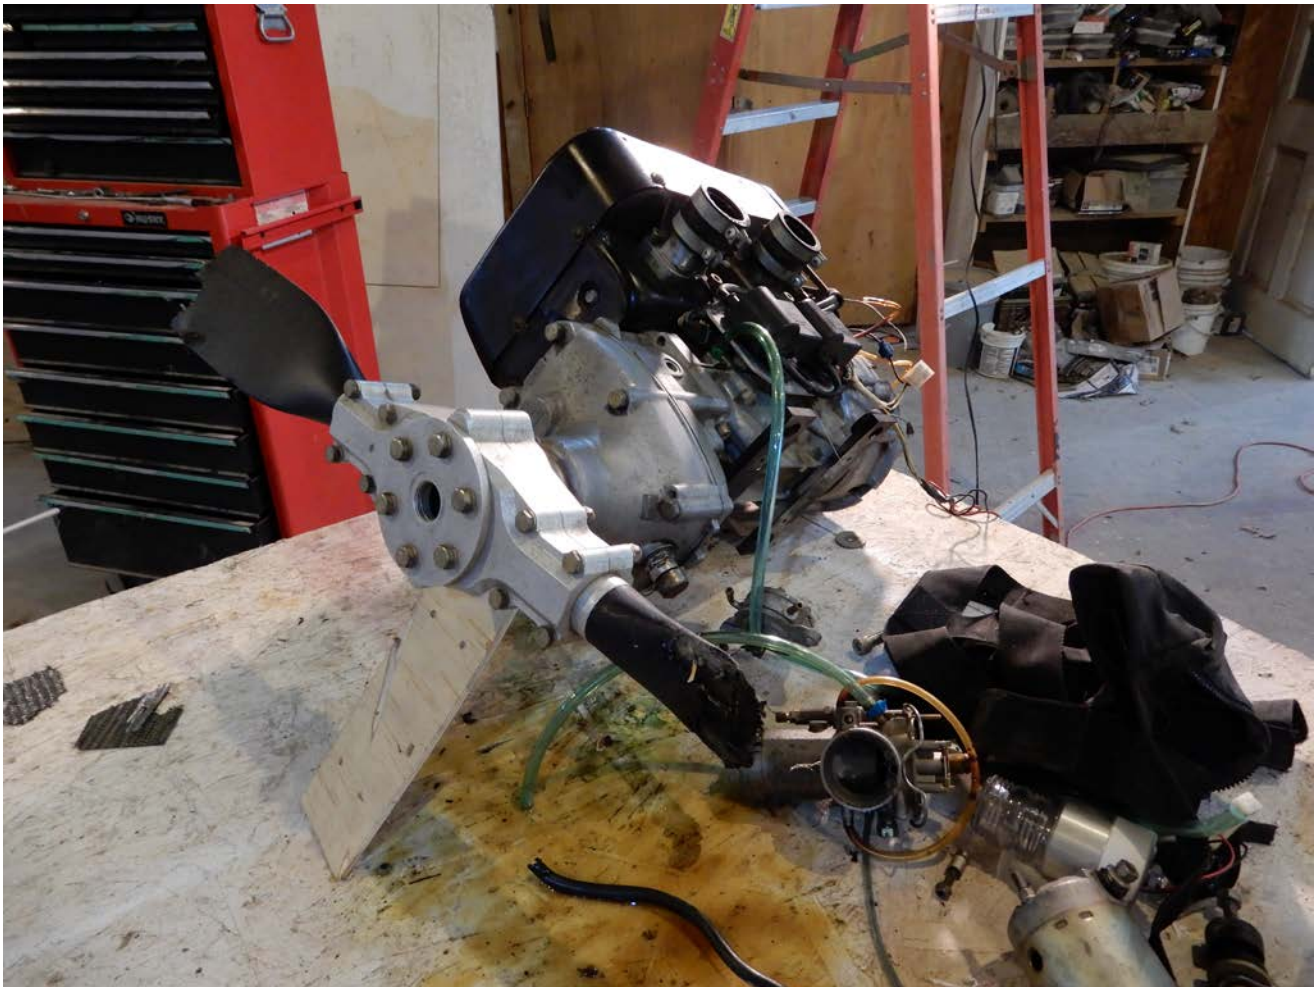
The engine case was free of cracks or holes. One of the two carburetors was missing. The owner reported that it was not found during the wreckage recovery. The recovered carburetor was separated from the engine during impact. It was normal in appearance. The fuel pump was normal in appearance. The in-line fuel filter was clean and unobstructed.

Photo 3 – Engine and Propeller Assembly

One spark plug was removed from each cylinder. The electrodes were normal in color and wear when compared to a Champion Check-A-Plug chart. The propeller was turned manually to check for internal engine continuity. The engine turned through smoothly with no binding or unusual noise. Suction and compression were observed on both cylinders.
