**NATIONAL TRANSPORTATION SAFETY BOARD**

**Wreckage Photo Array**

**ERA19TA204**

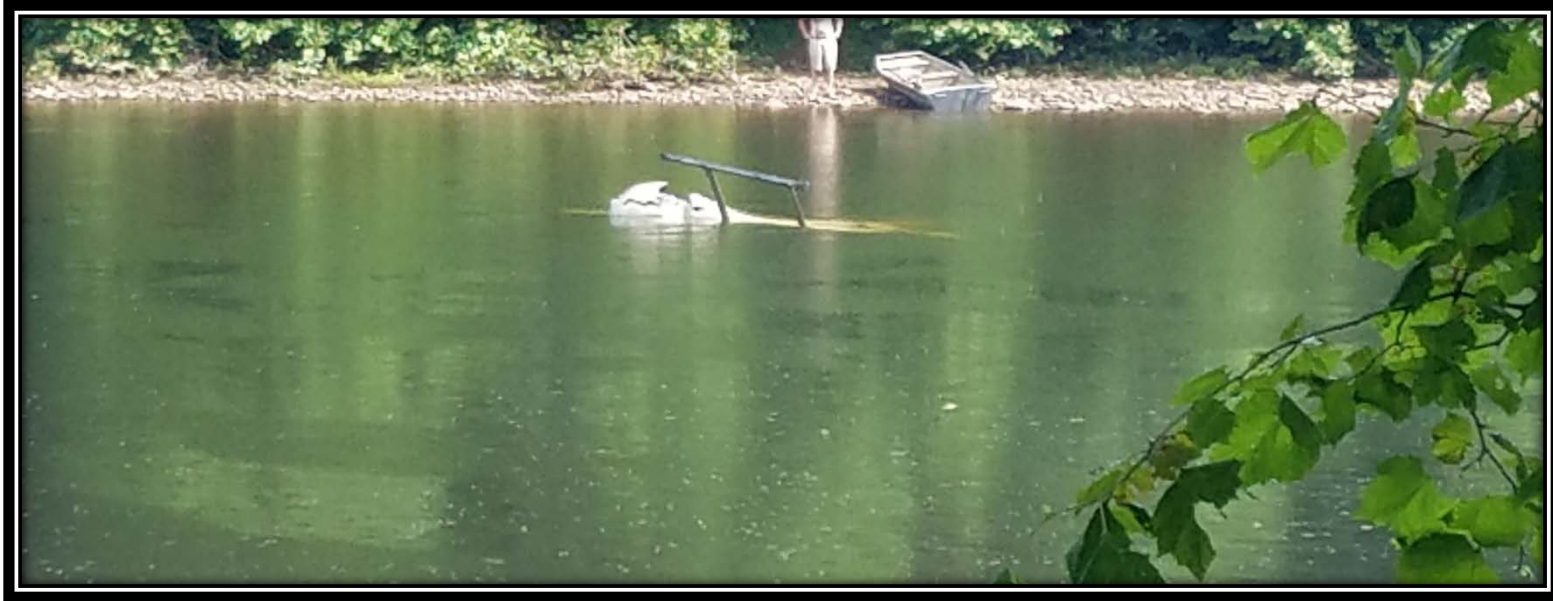
**Photo 1 – Submerged Wreckage (Photo Courtesy of FAA)**

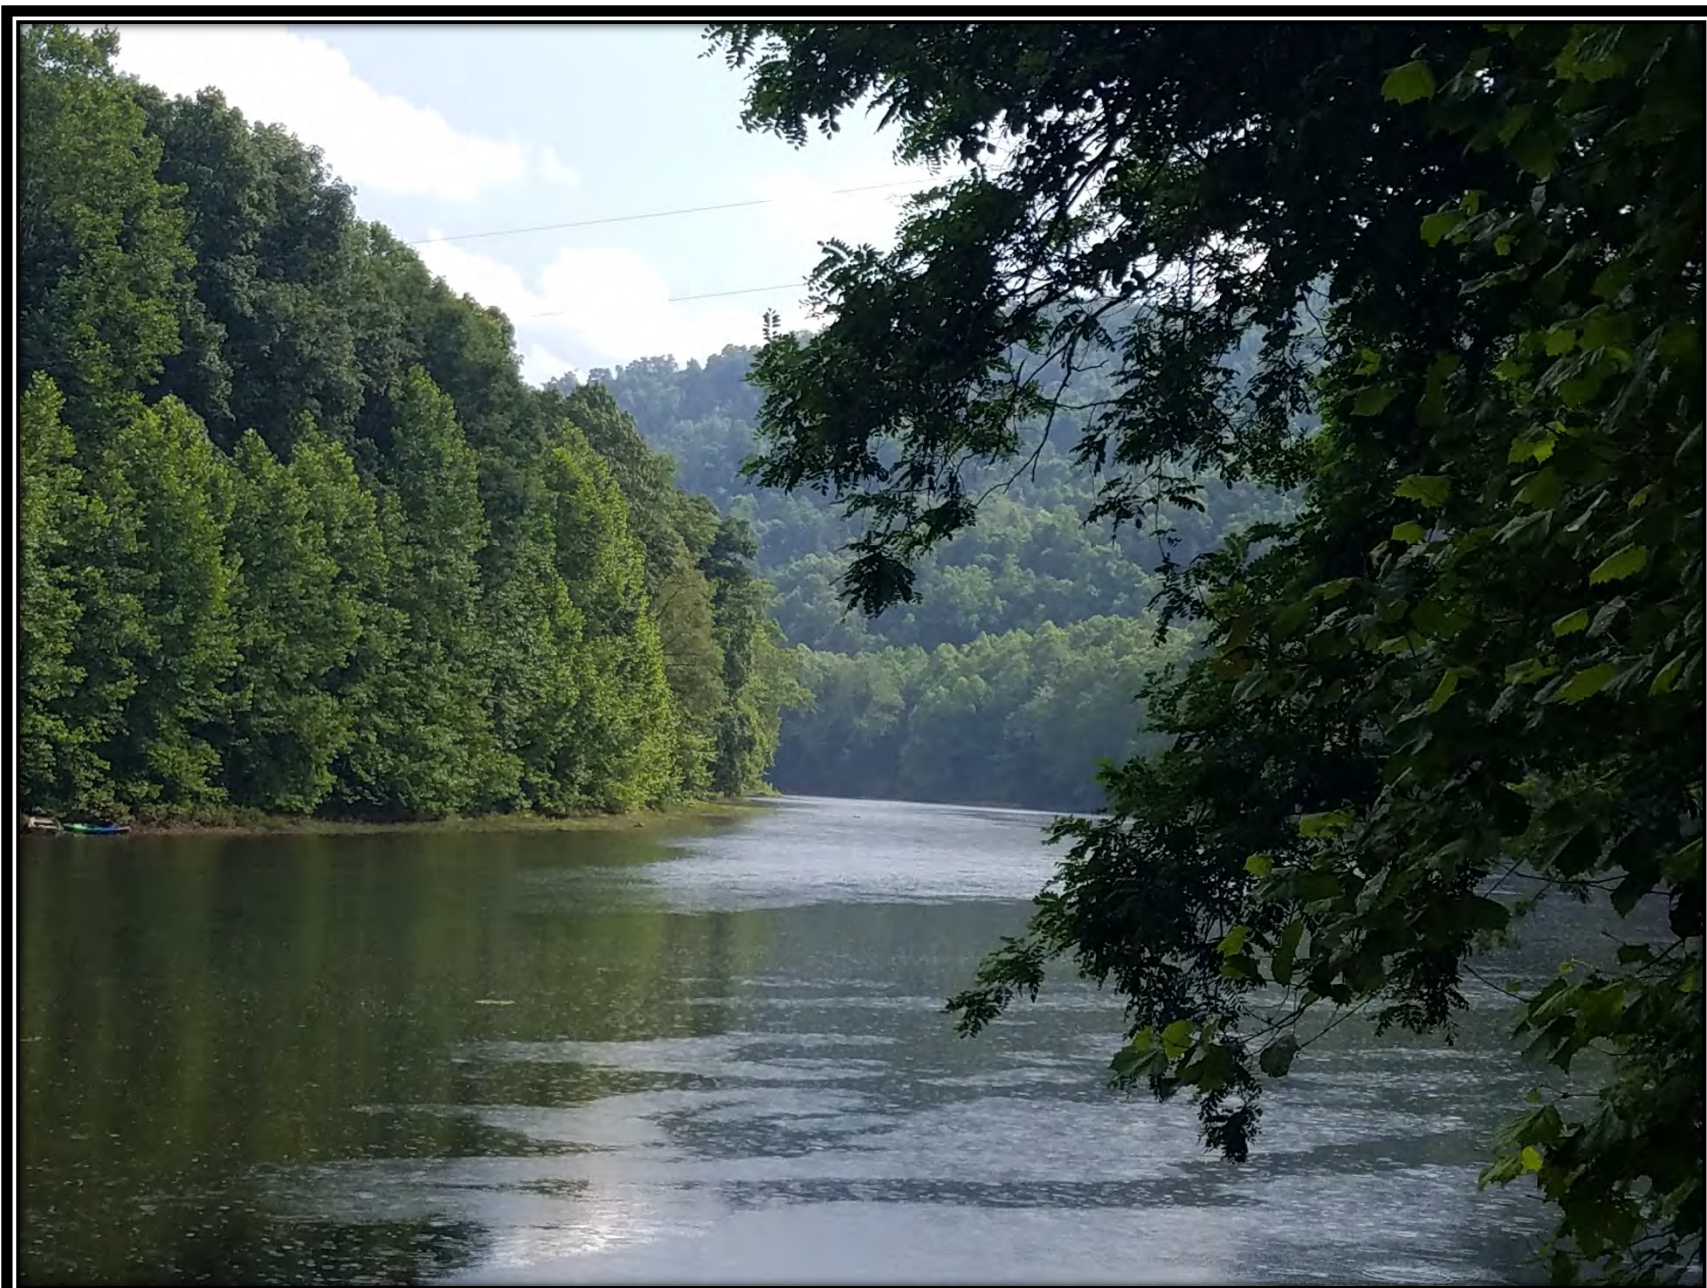
**Photo 2 – Bend in River and Remaining Unmarked Wires (Photo Courtesy of FAA)**

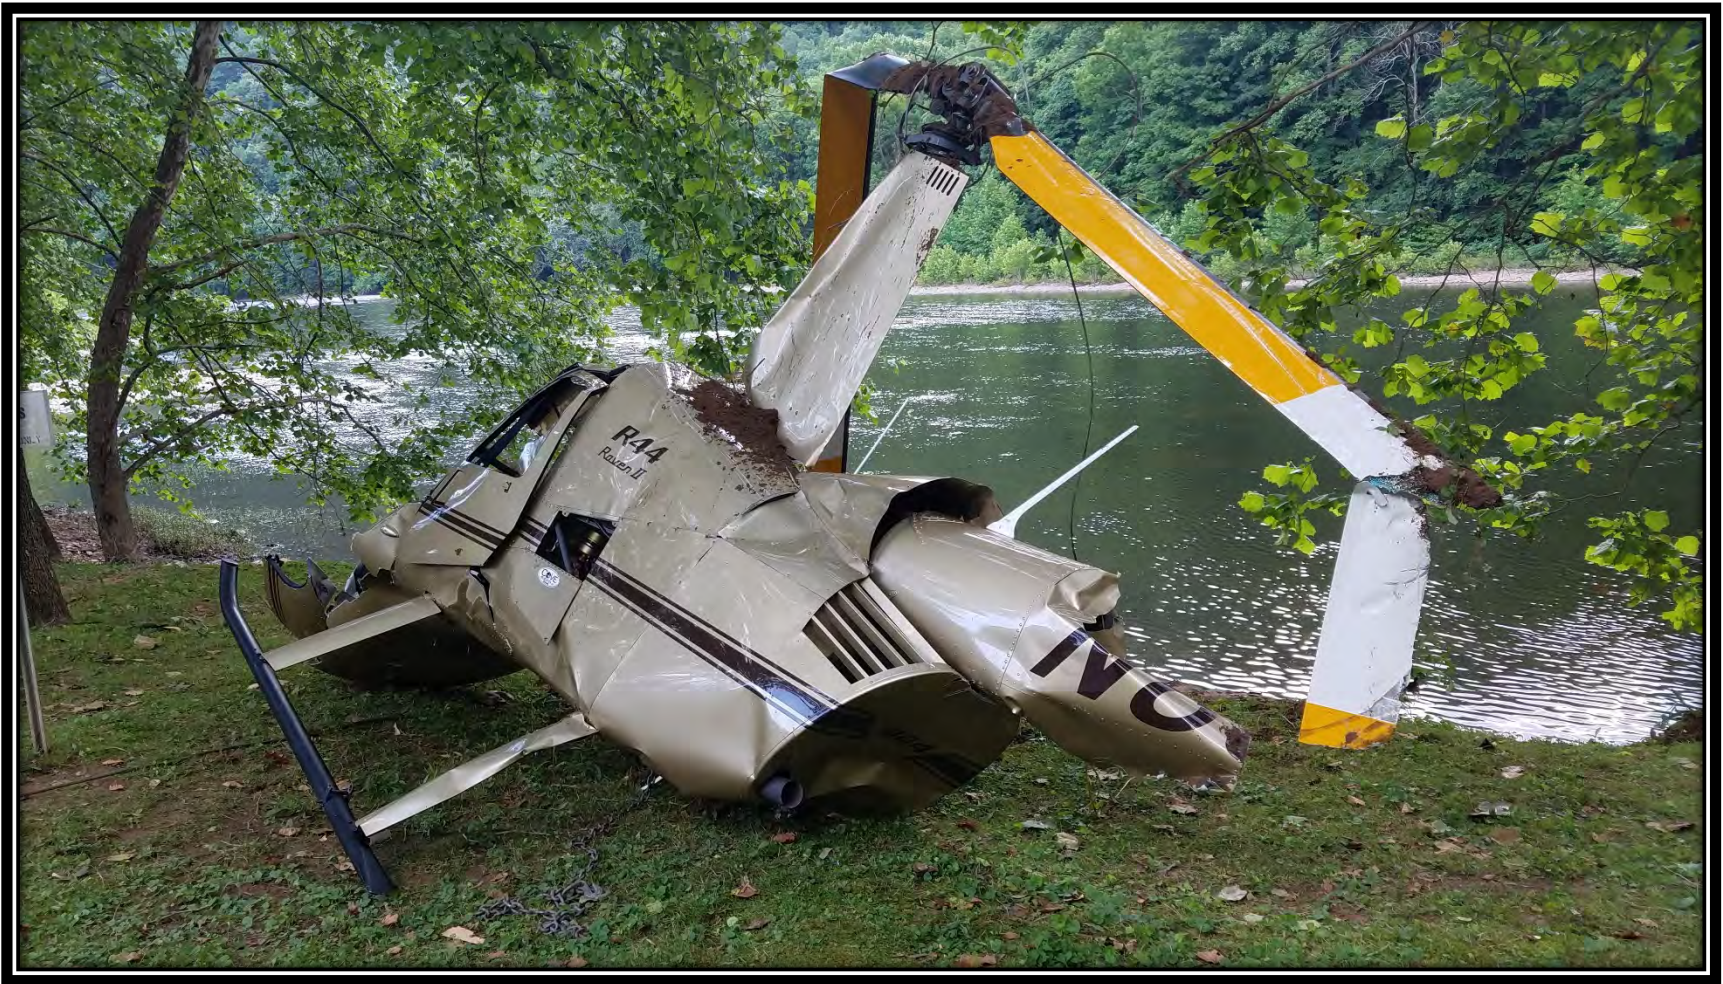
**Photo 3 – Rear View of Helicopter (Photo Courtesy of FAA)**

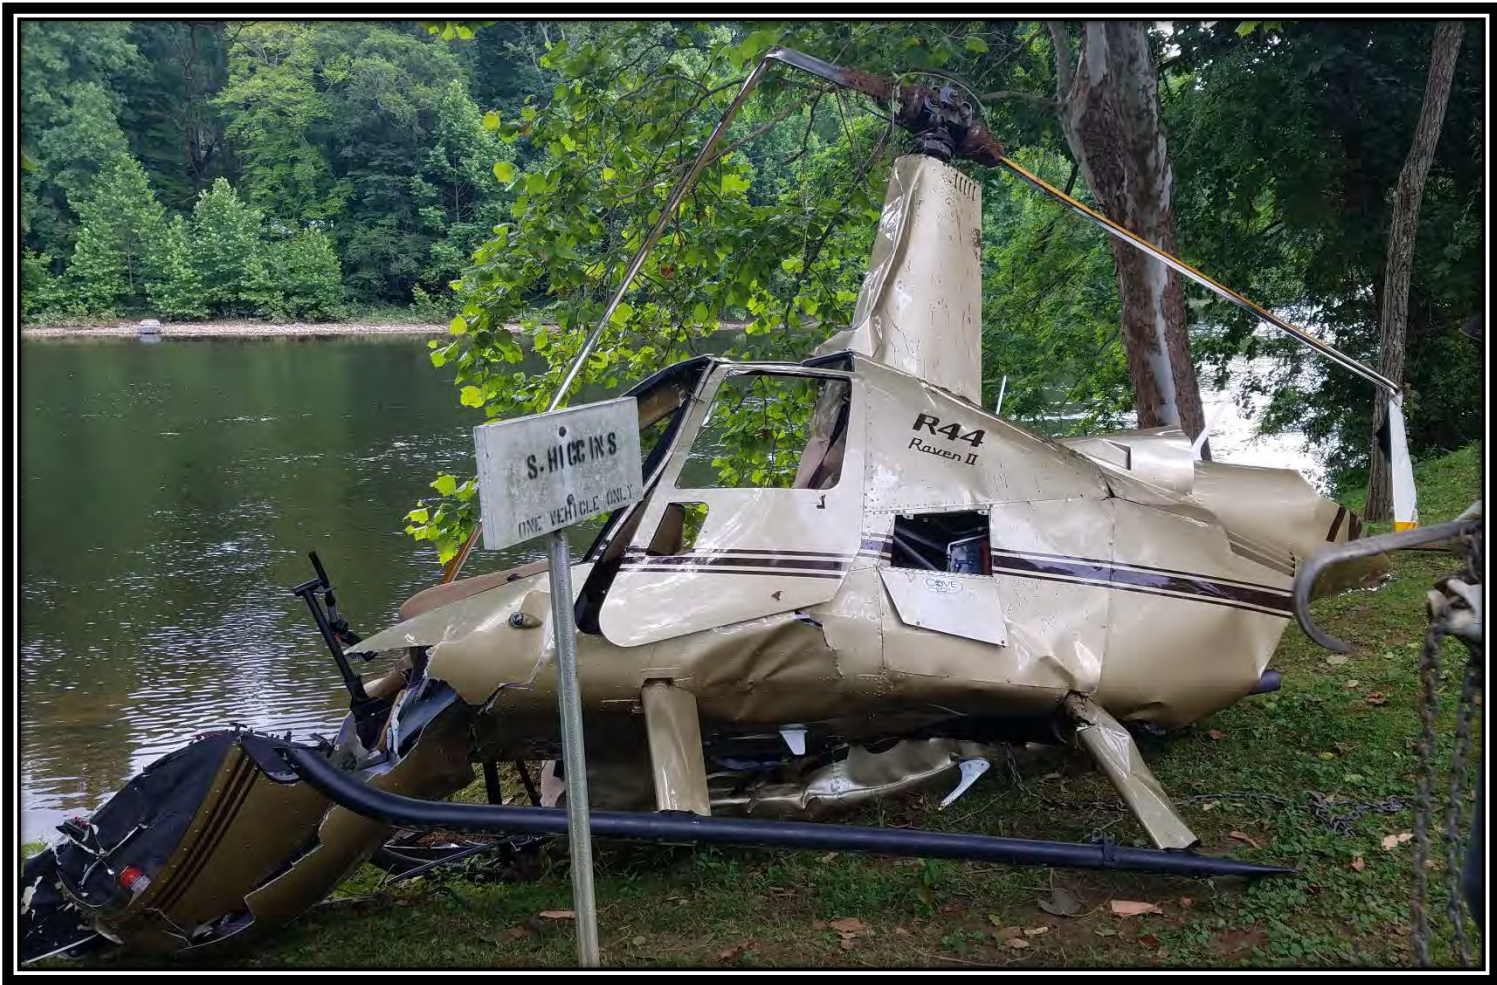
**Photo 4 – Left Side View of Helicopter (Photo Courtesy of FAA)**

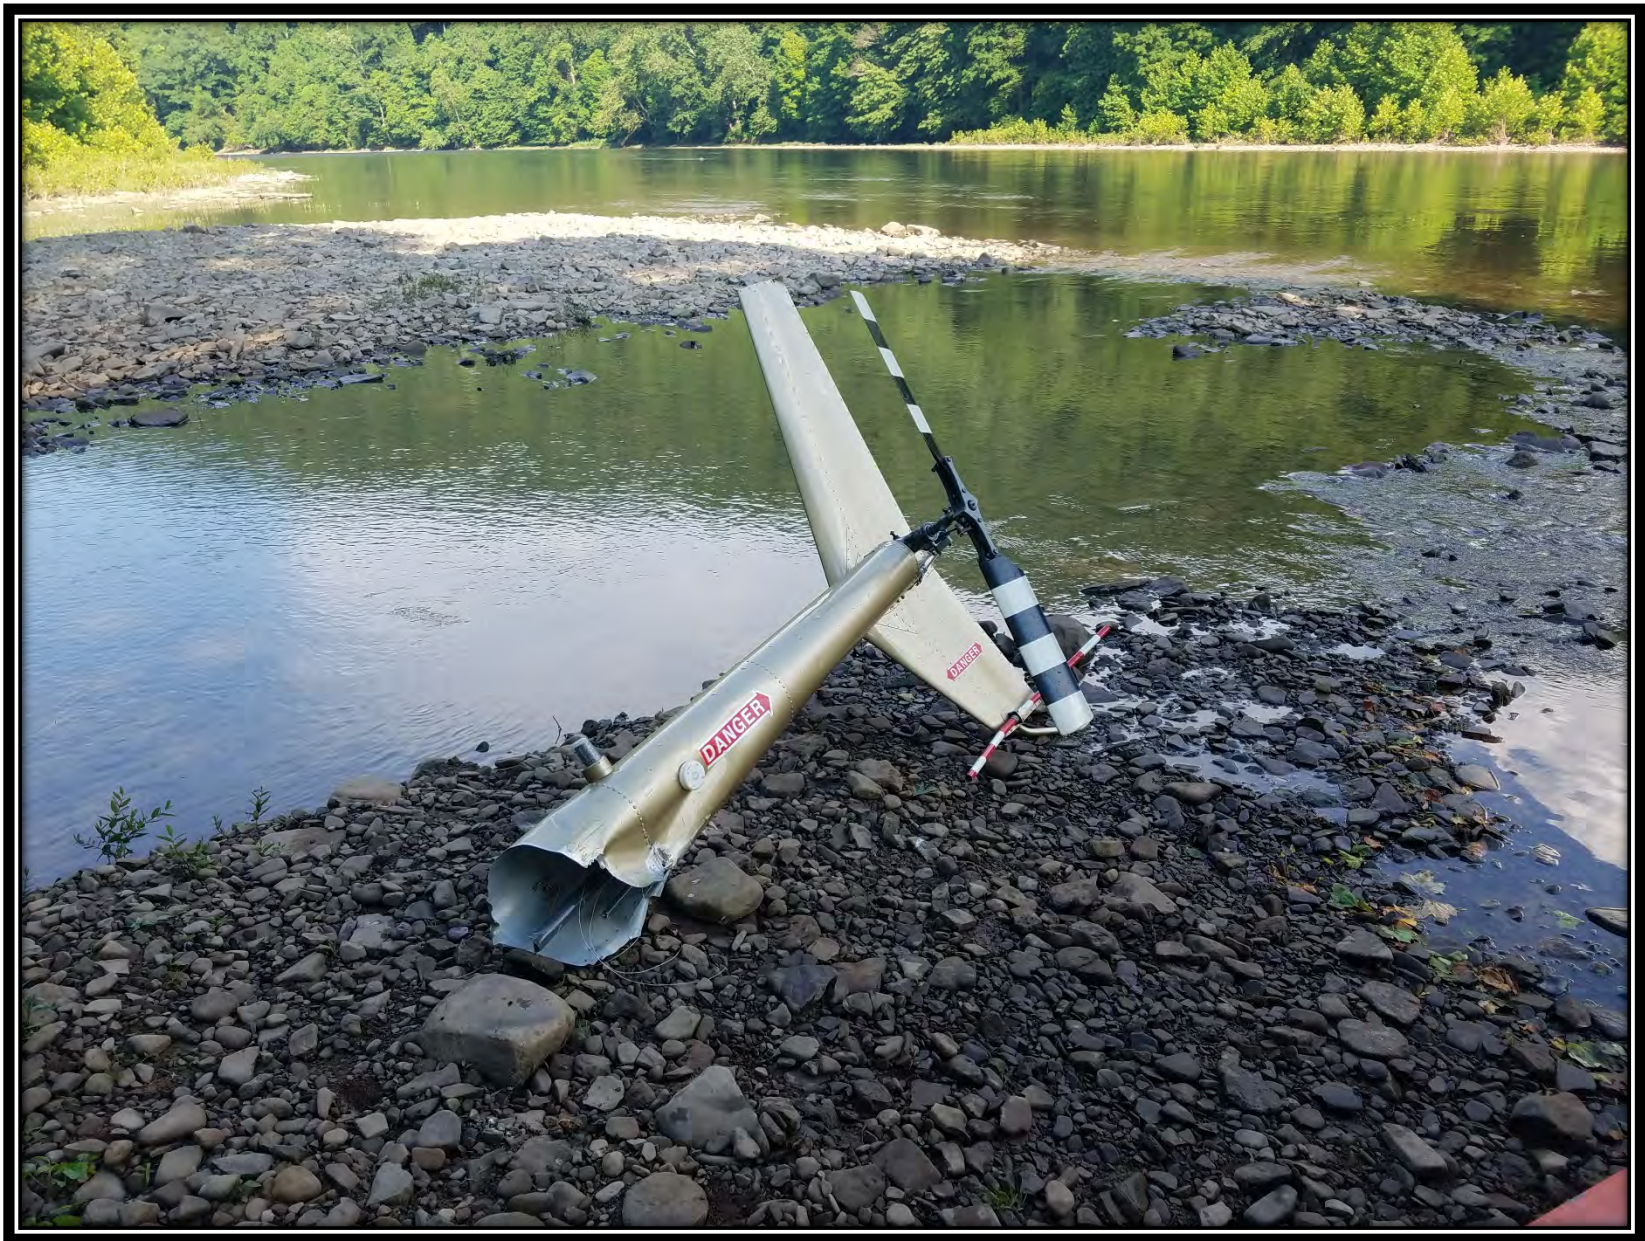
**Photo 5 – Separated Tail Boom (Photo Courtesy of FAA)**

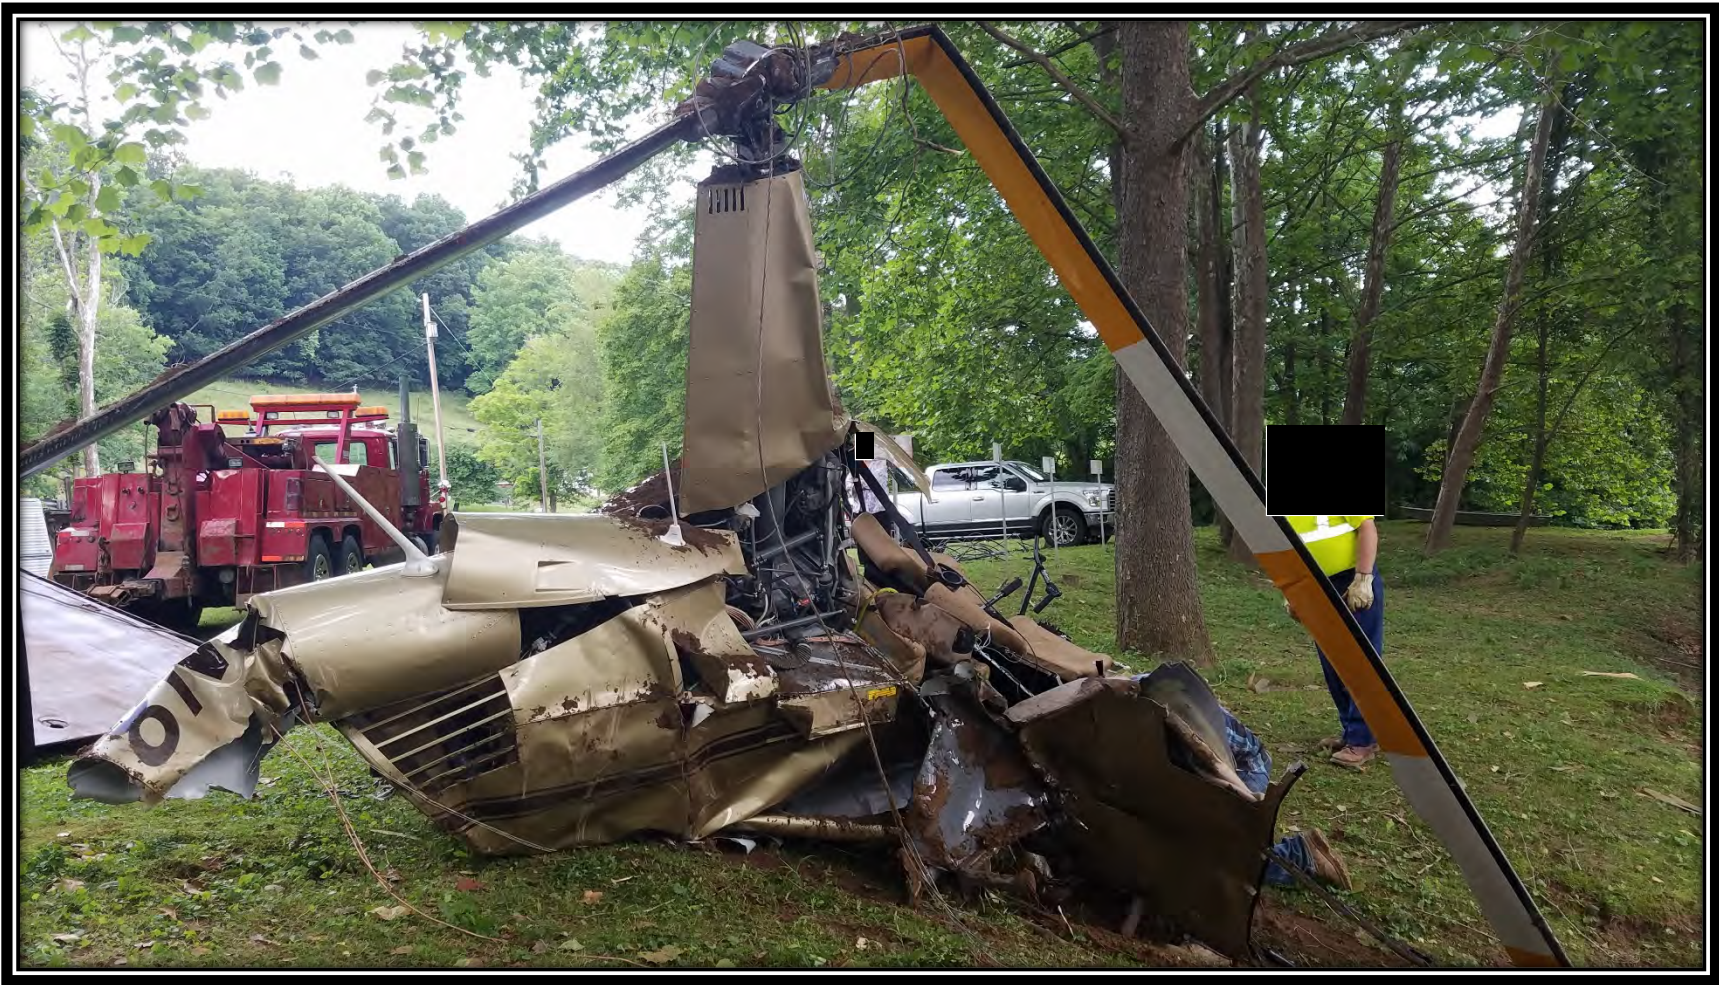
**Photo 6 – Right Side View of Helicopter (Photo Courtesy of FAA)**

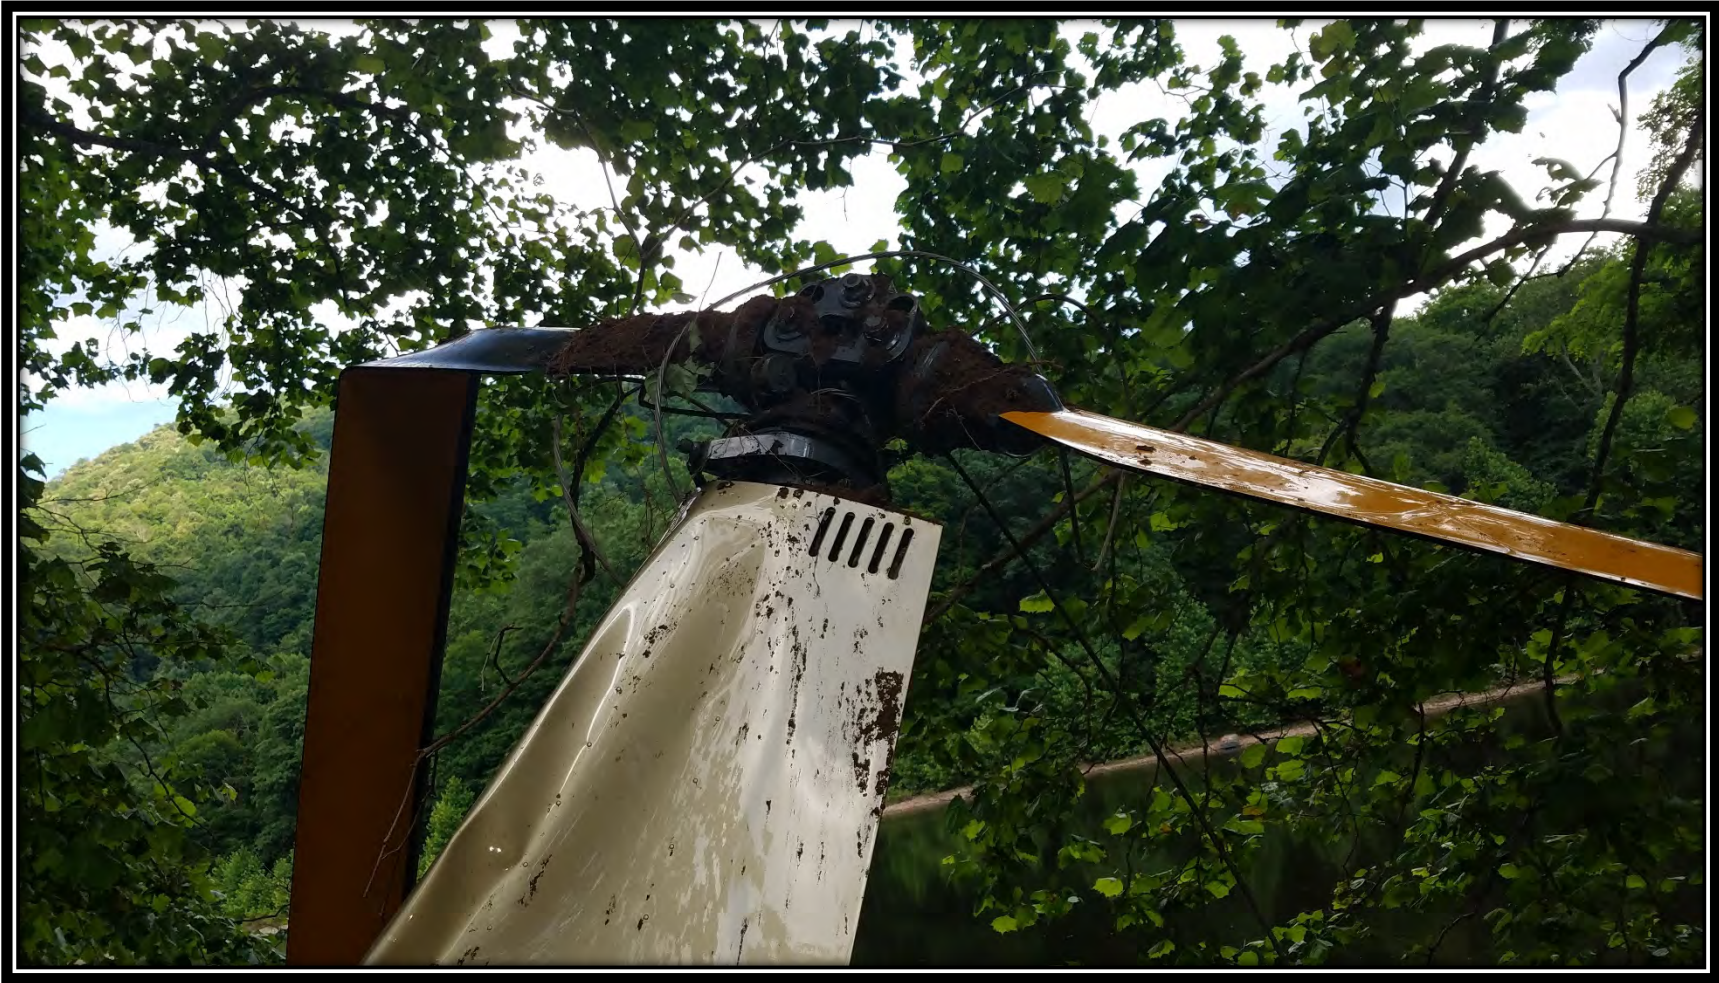
**Photo 7 – Telephone Wire Wrapped Around Main Rotor (Photo Courtesy of FAA)**

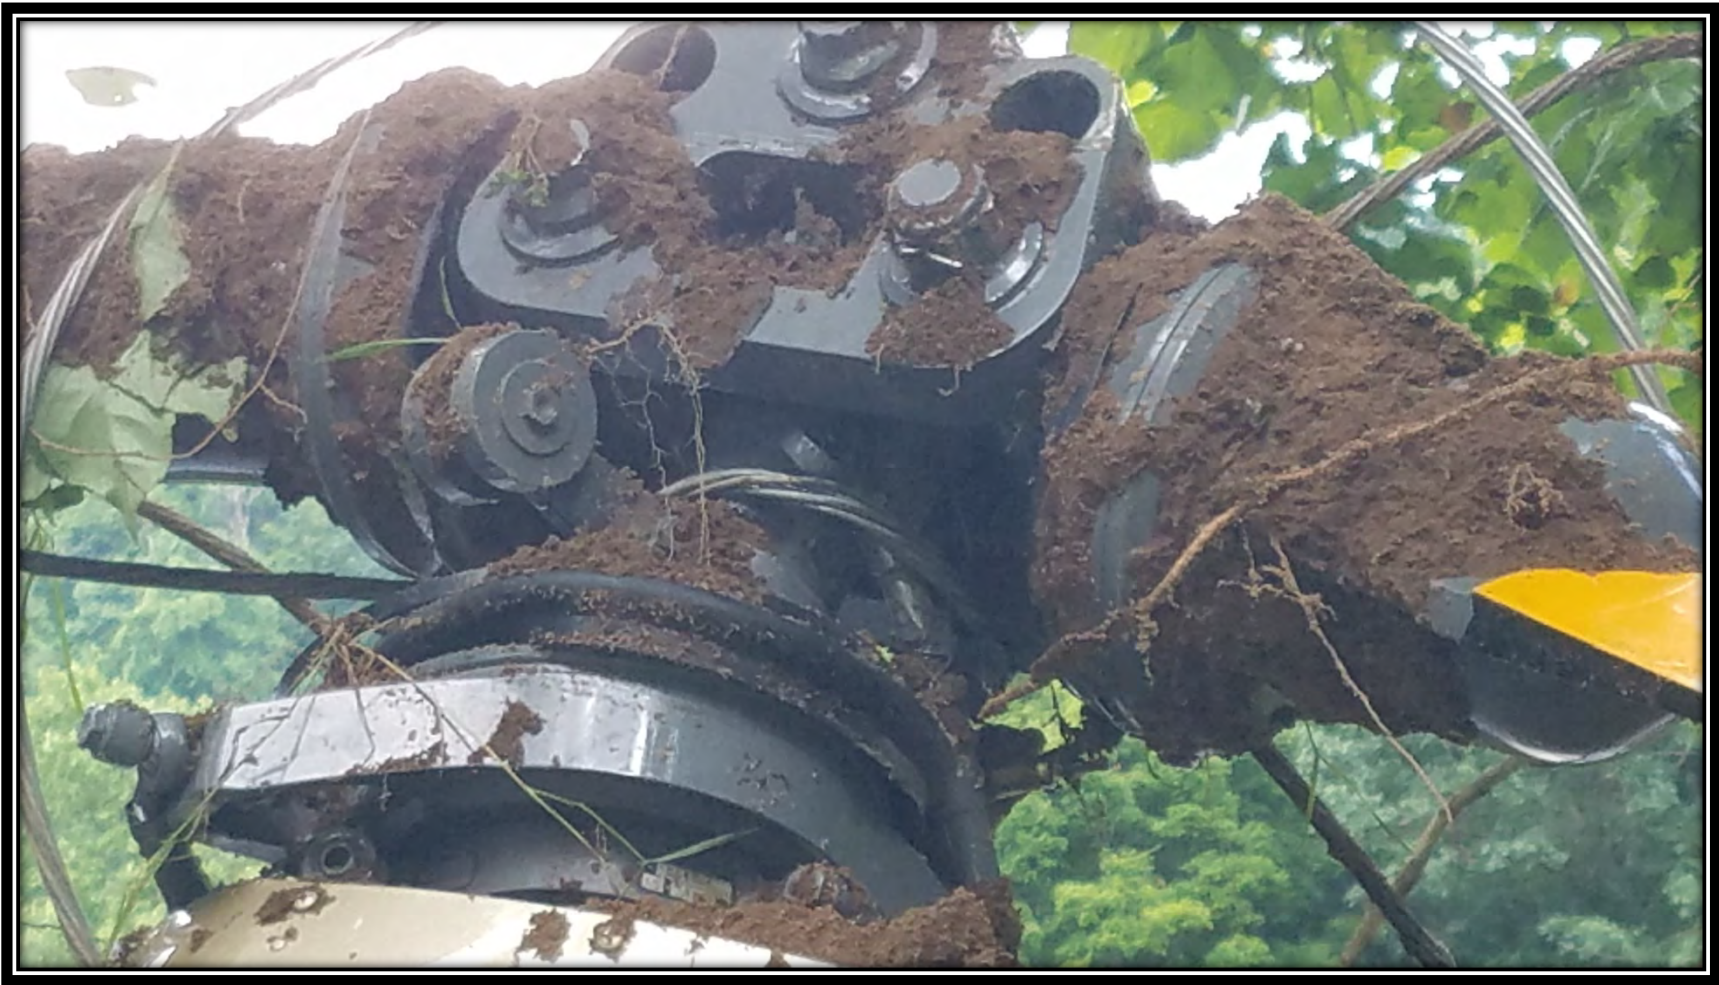
**Photo 8 – Close-up of Telephone Wire Around Main Rotor (Photo Courtesy of FAA)**
