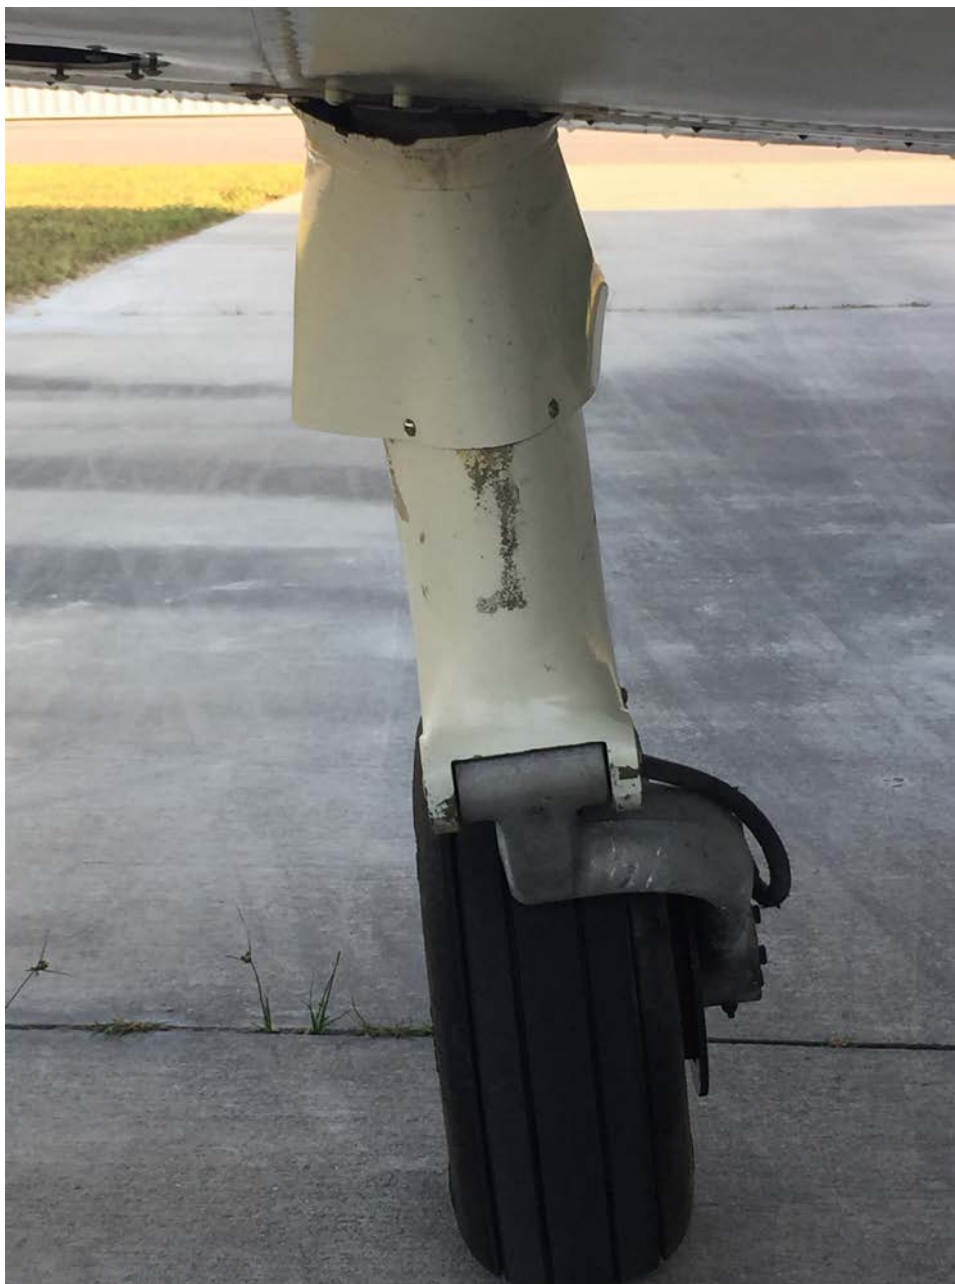
**Photo 1 – Forward view of damaged right landing gear. (Courtesy of FAA)**

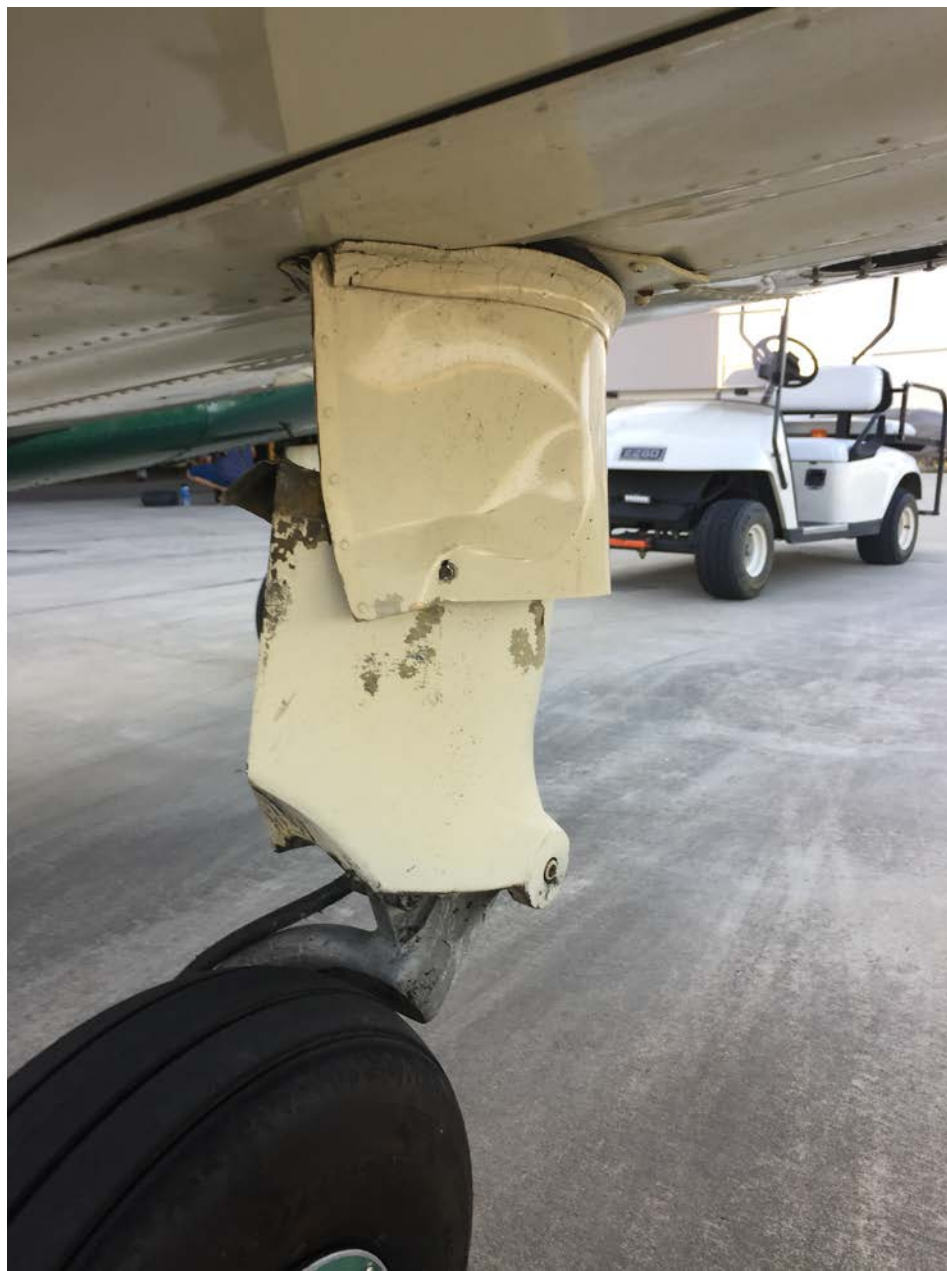
**Photo 2 – Damaged right landing gear. (Courtesy of FAA)**

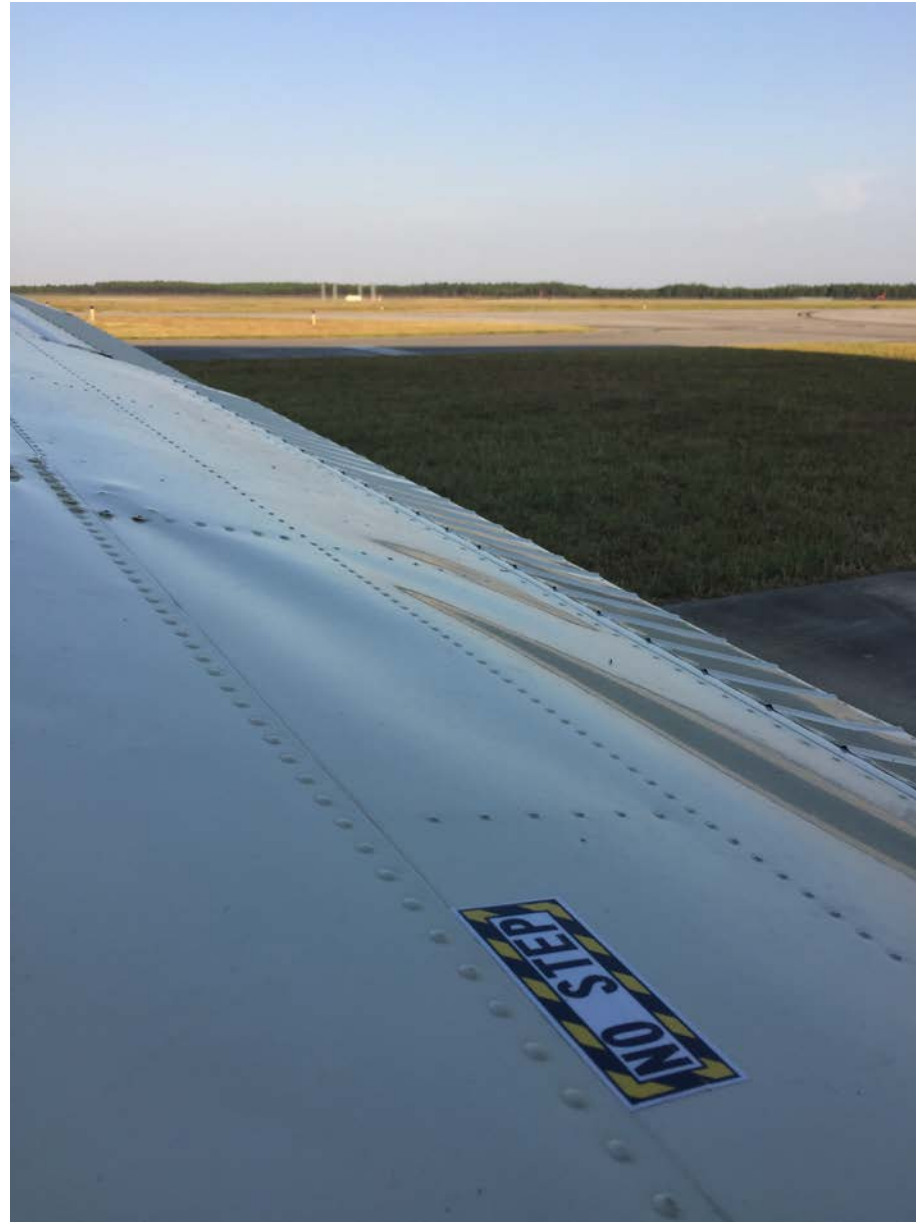
**Photo 3 – Top of right wing buckling. (Courtesy of DCAVIATION)**

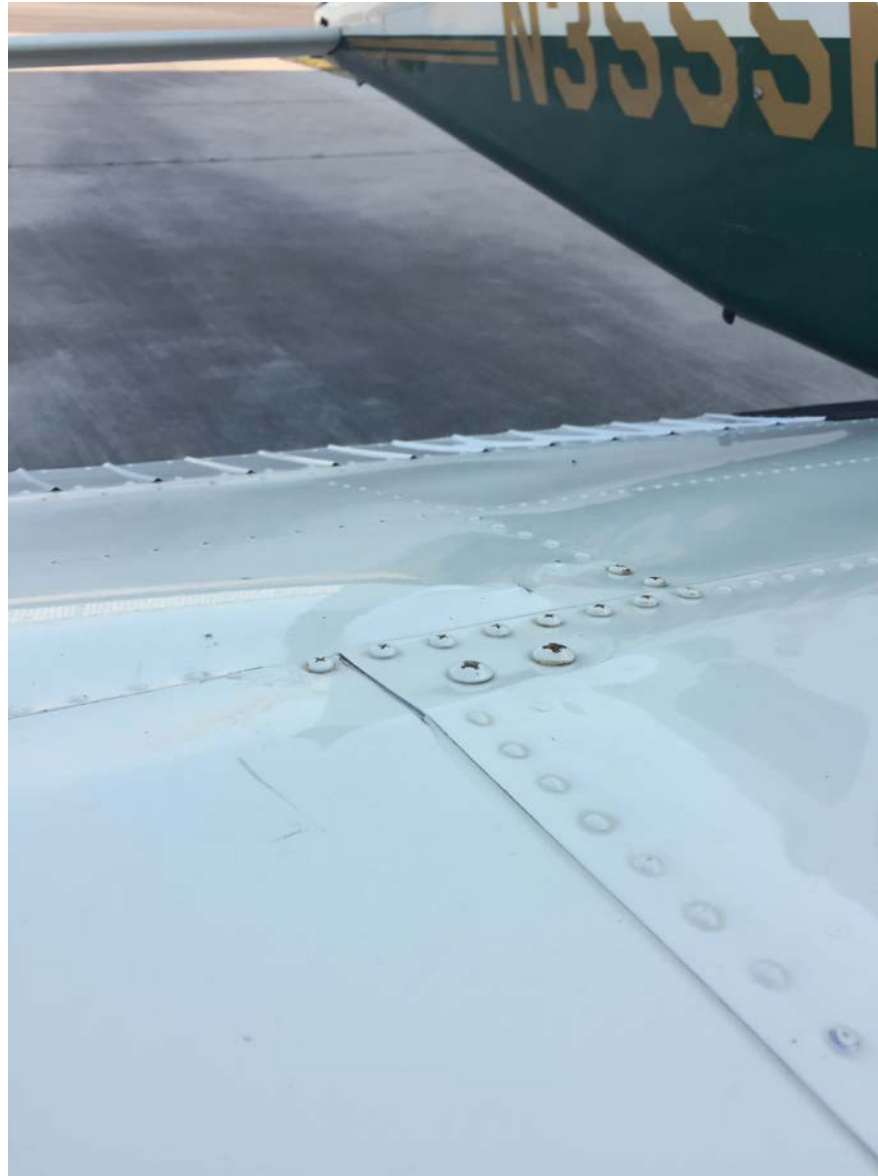
**Photo 4 – Right wing looking aft. Note buckling on rivet line. (Courtesy of DCAVIATION)**

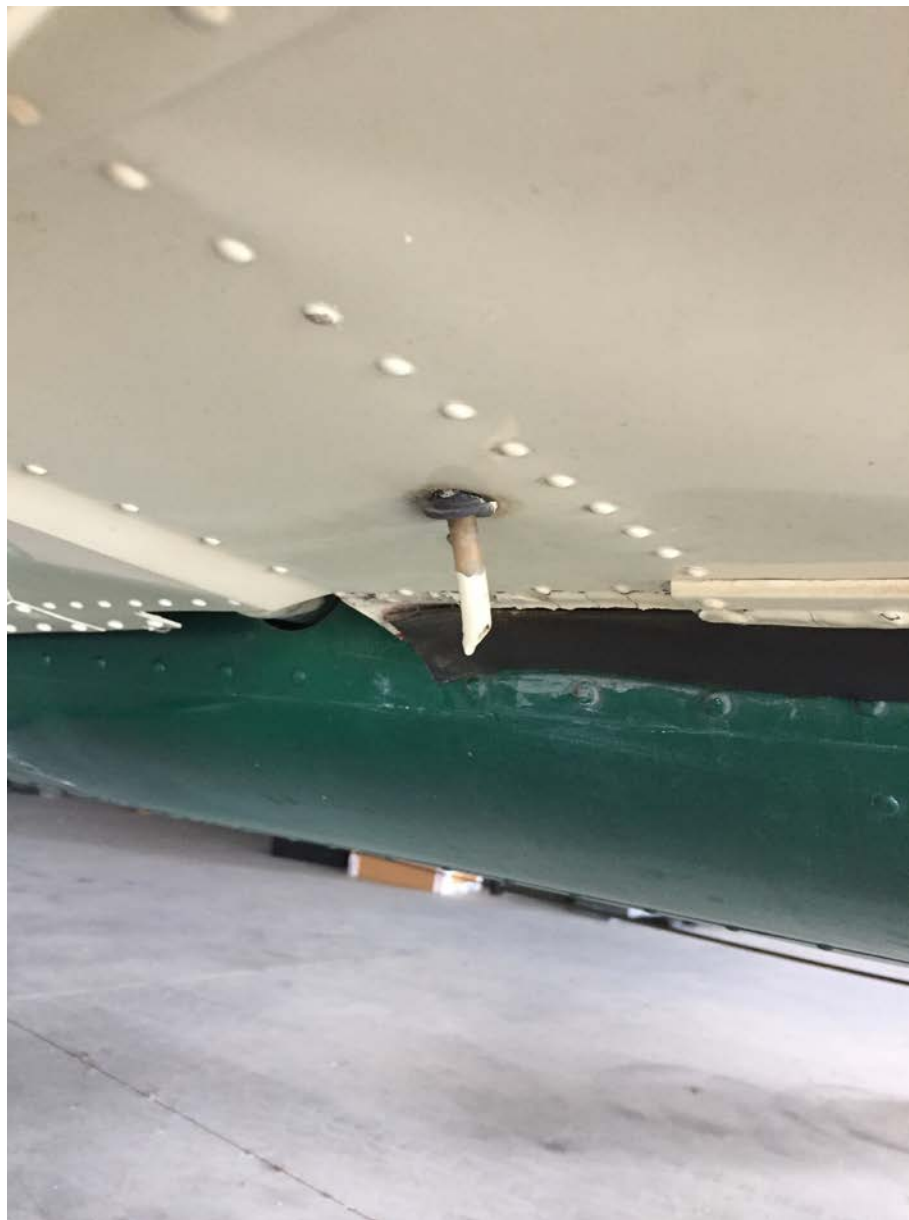
**Photo 5 – View of fuel vent that was blocked with debris. (Courtesy of DCAVIATION)**
