**NATIONAL TRANSPORTATION SAFETY BOARD**

**Photo Array**

**ERA20CA048**

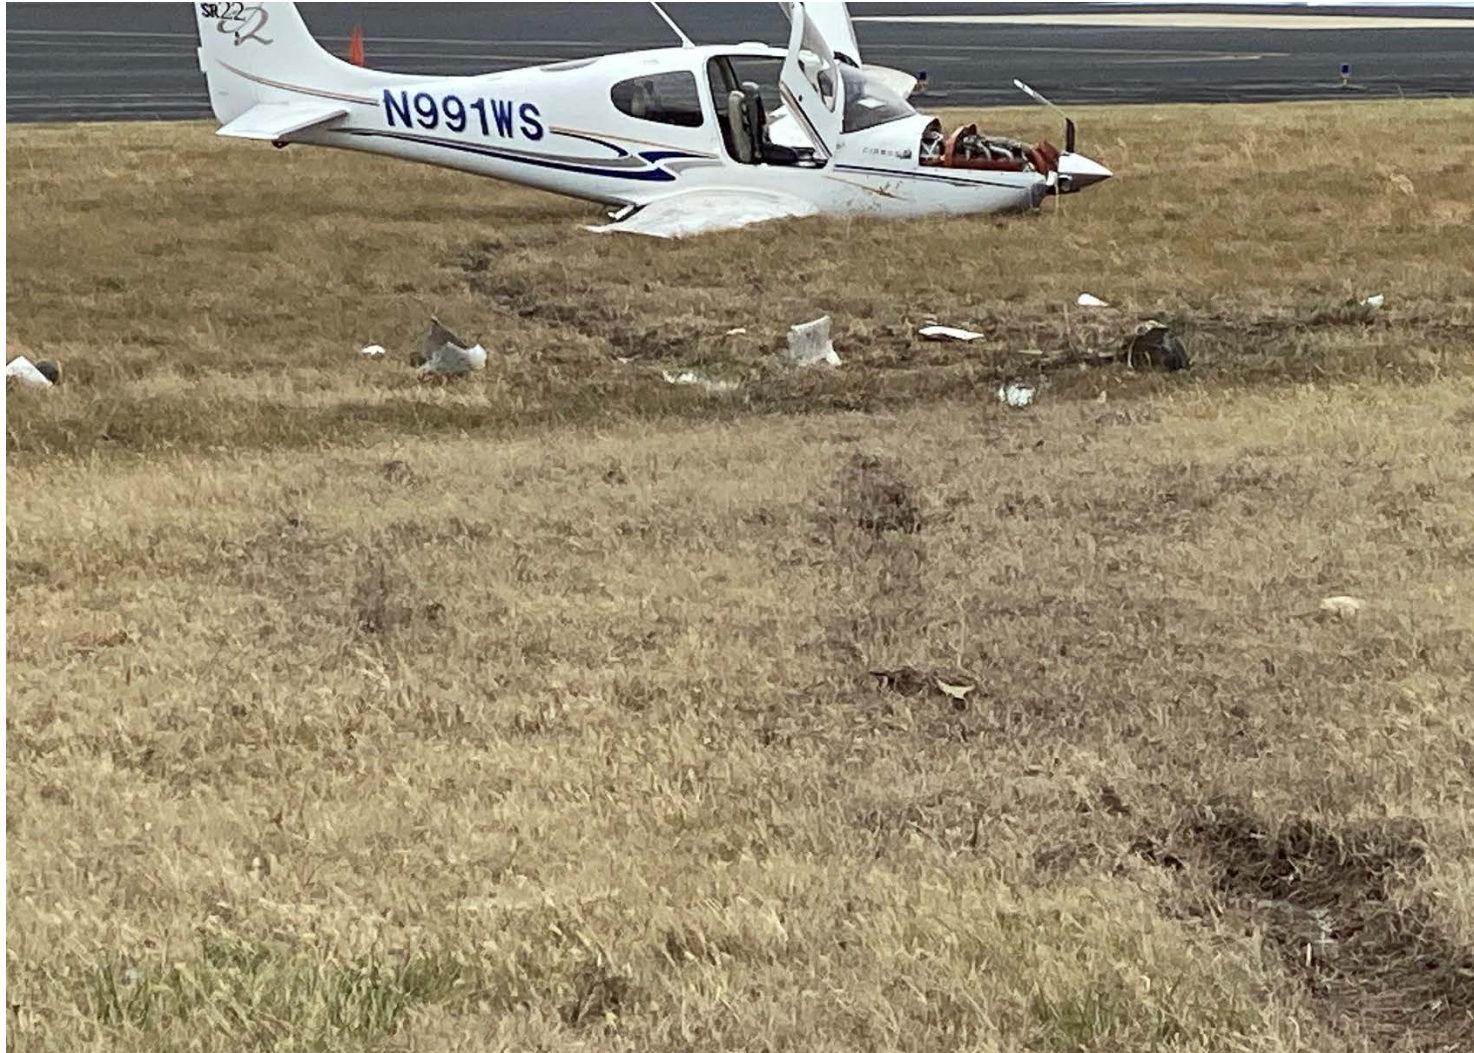
**Photo 1 – View of Airplane from Right Side (Photo Courtesy of FAA)**

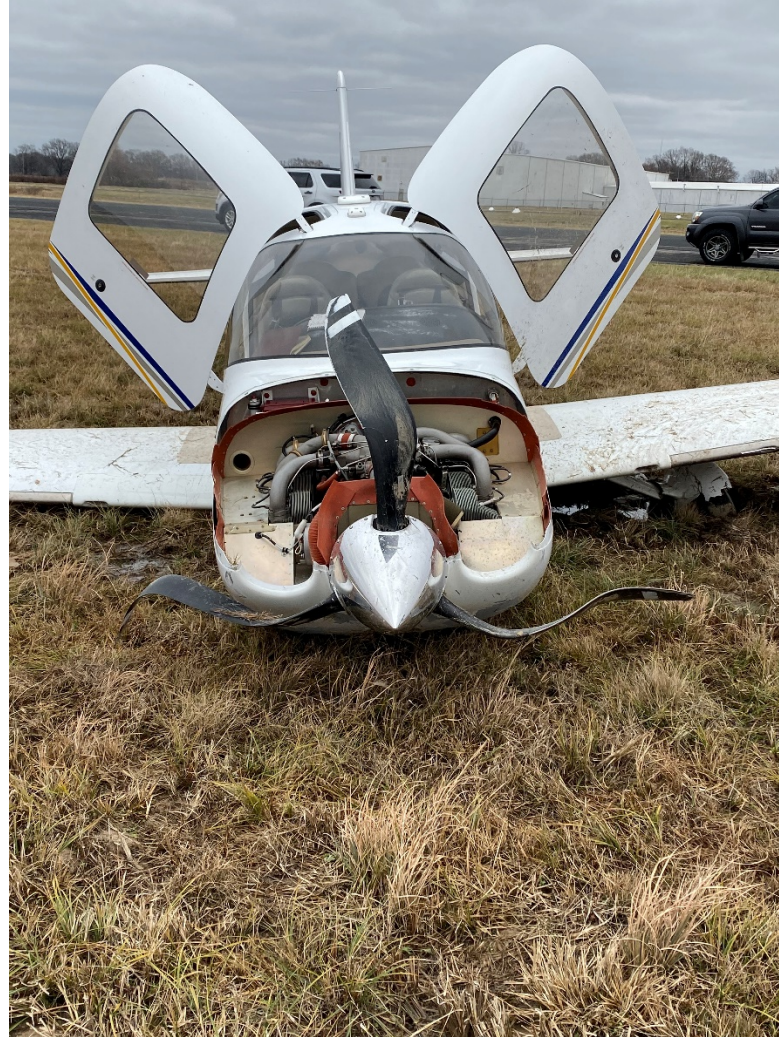
**Photo 2 – View of Airplane from Front (Photo Courtesy of FAA)**

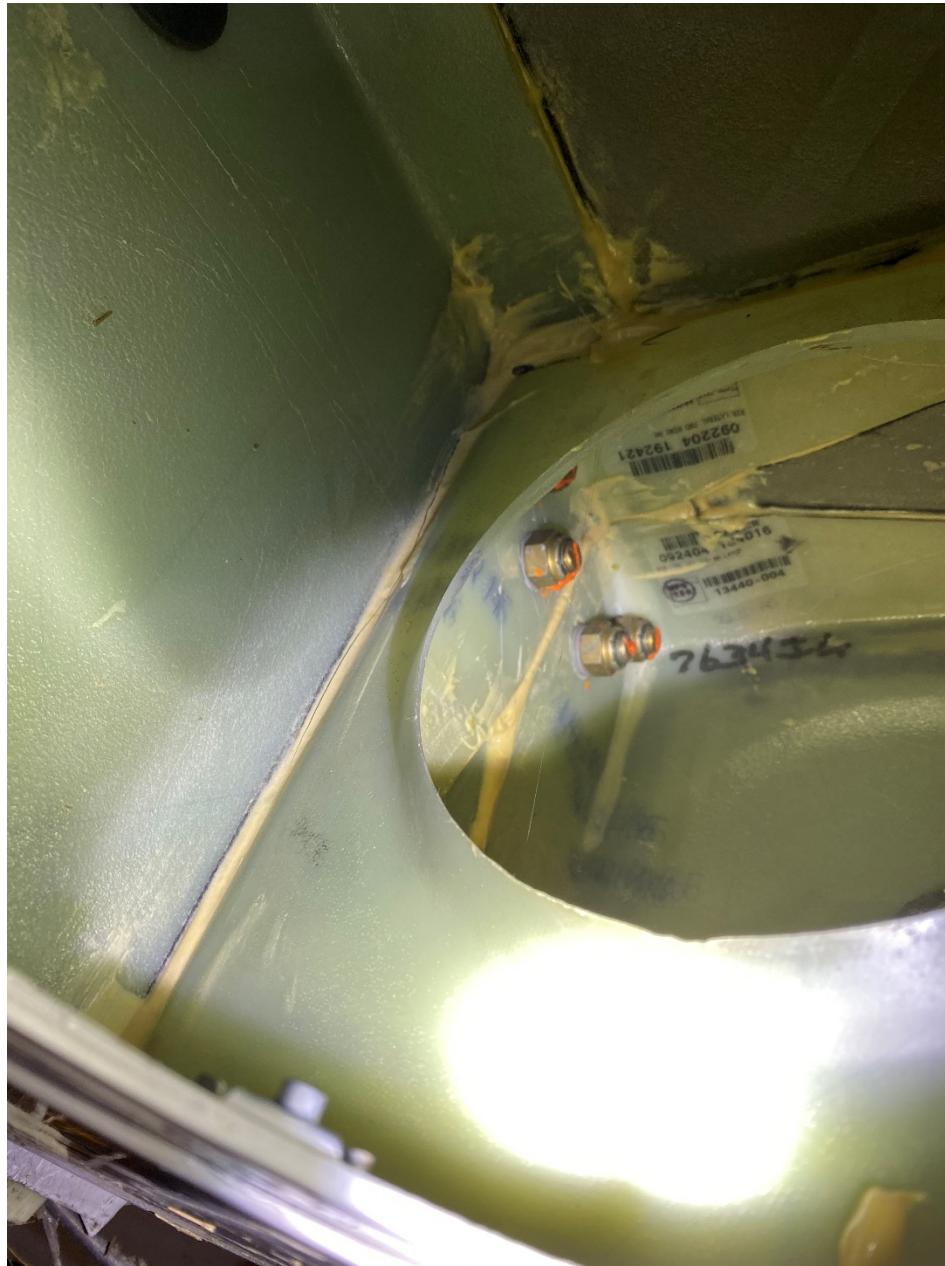
**Photo 3 – Delamination of Wing Spar (Photo Courtesy of FAA)**

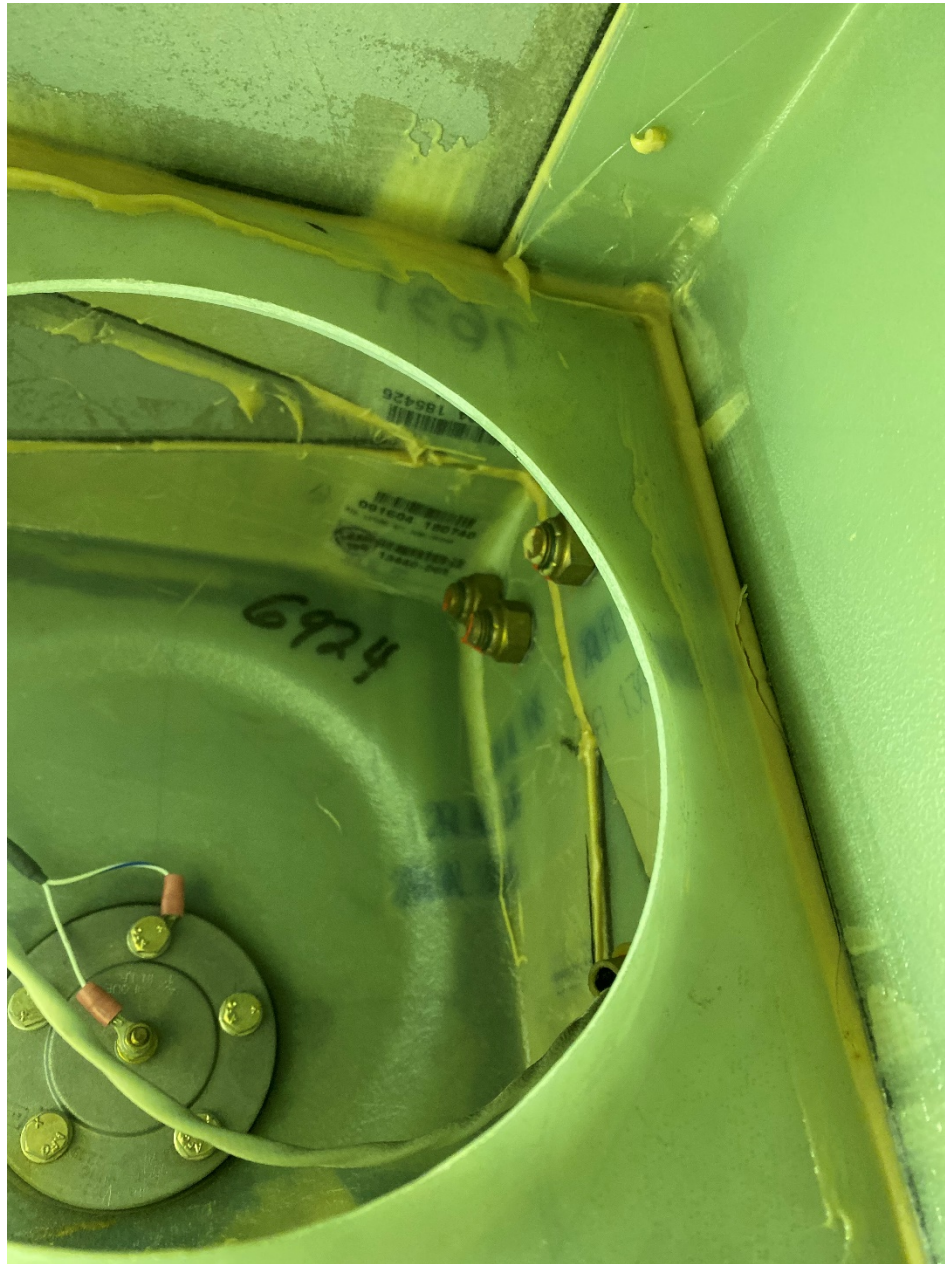
**Photo 4 – Delamination of Wing Spar (Photo Courtesy of FAA)**
