# Photo Array for ERA20LA103

Photographs provided by the Federal Aviation Administration

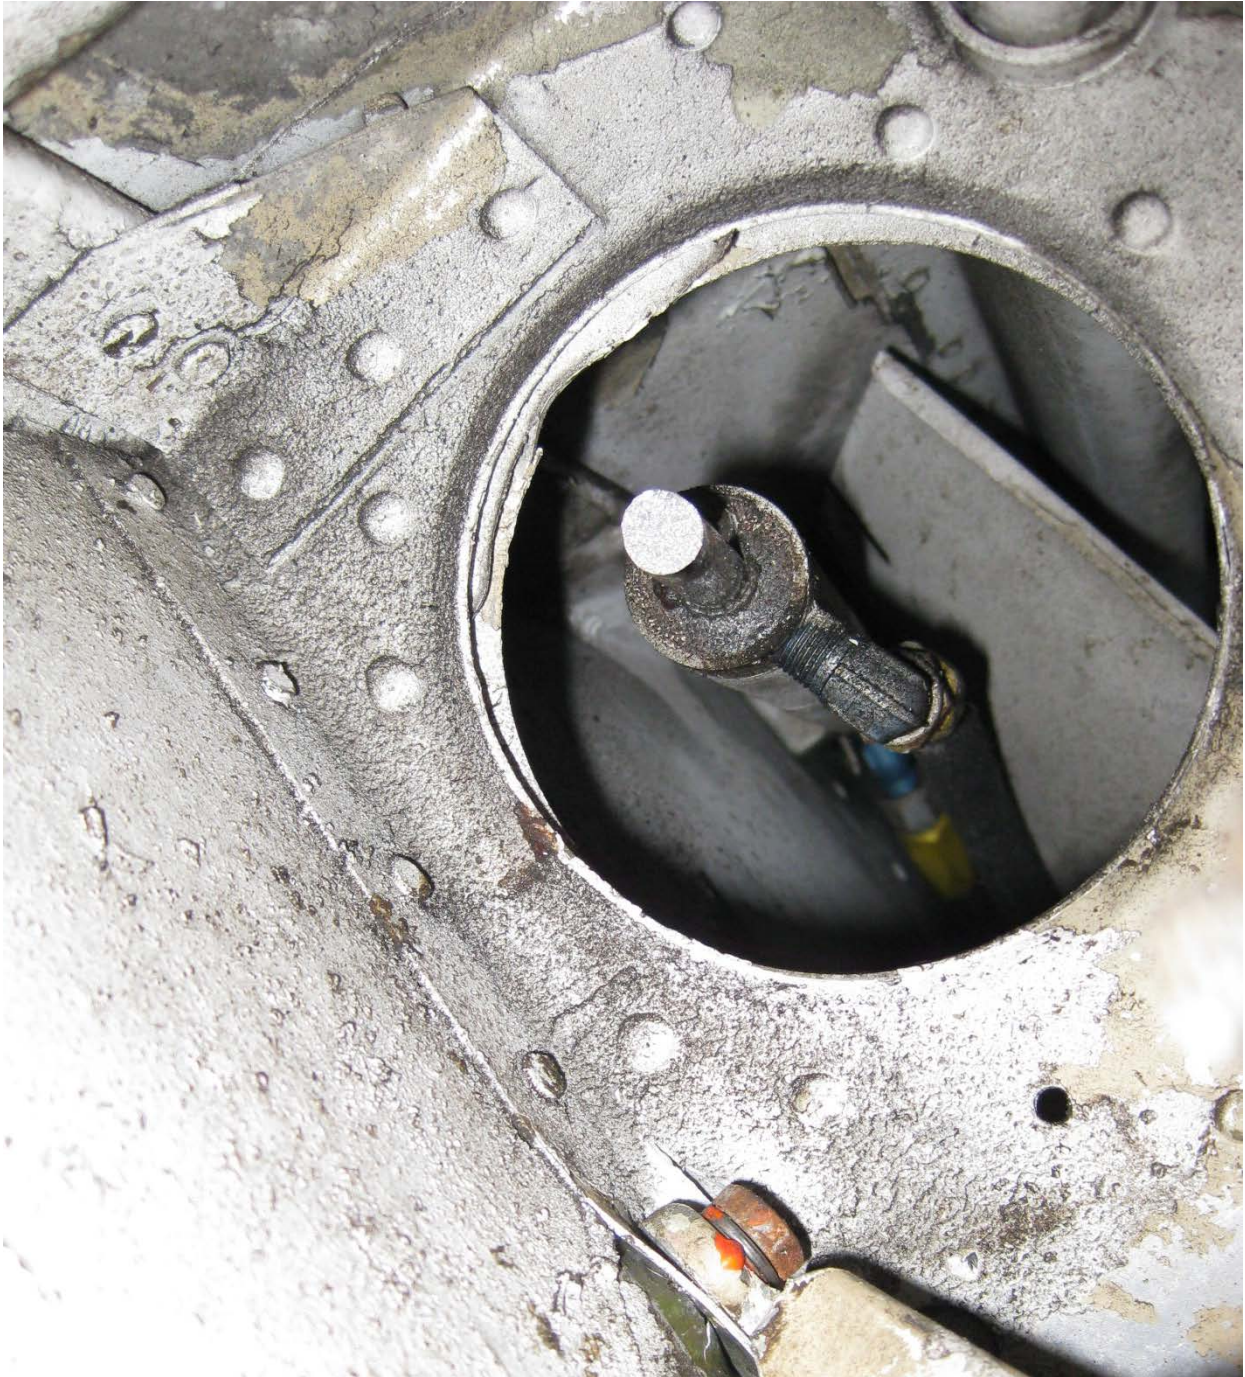
**Photograph 1 - Accident airplane right main gear sheared torque link bolt.**

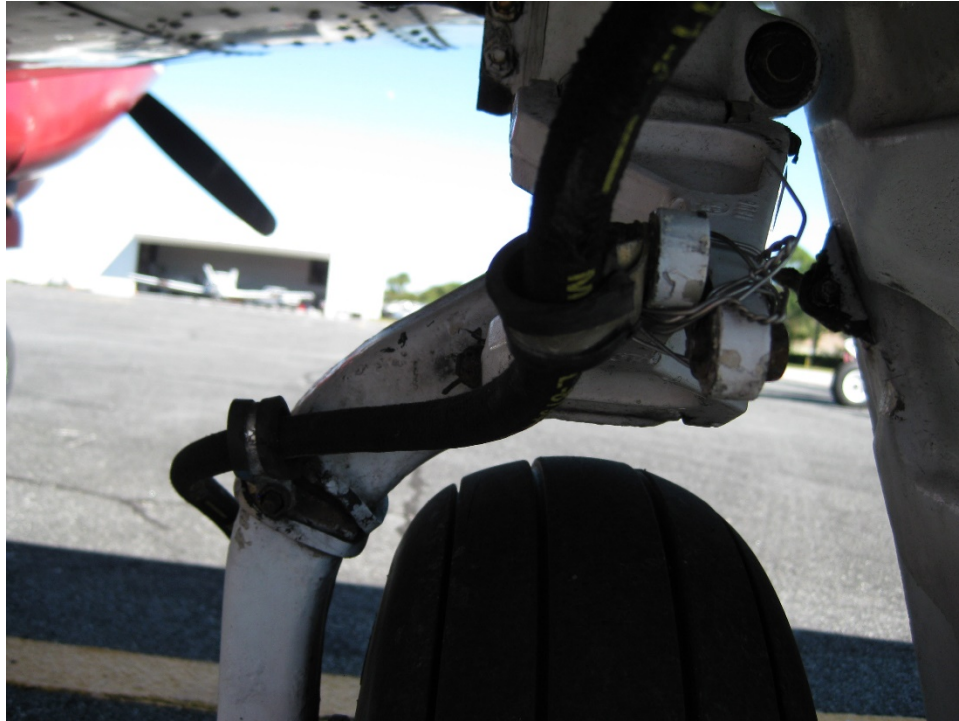
**Photograph 2 - Accident airplane left main gear.**

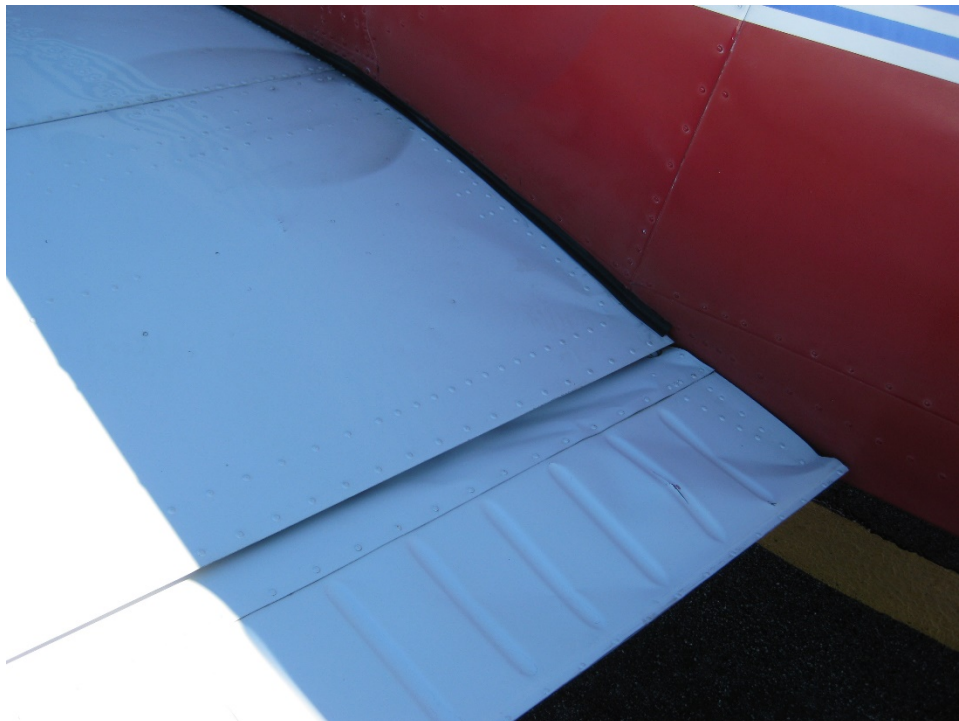
**Photograph 3 - Accident airplane left wing damage.**
