## AIRFRAME AND ENGINE EXAMINATION REPORT

NTSB ACCIDENT NUMBER: ERA20FA009

AIRCRAFT REGISTRATION: N4332J

ACCIDENT LOCATION: Cameron, NC

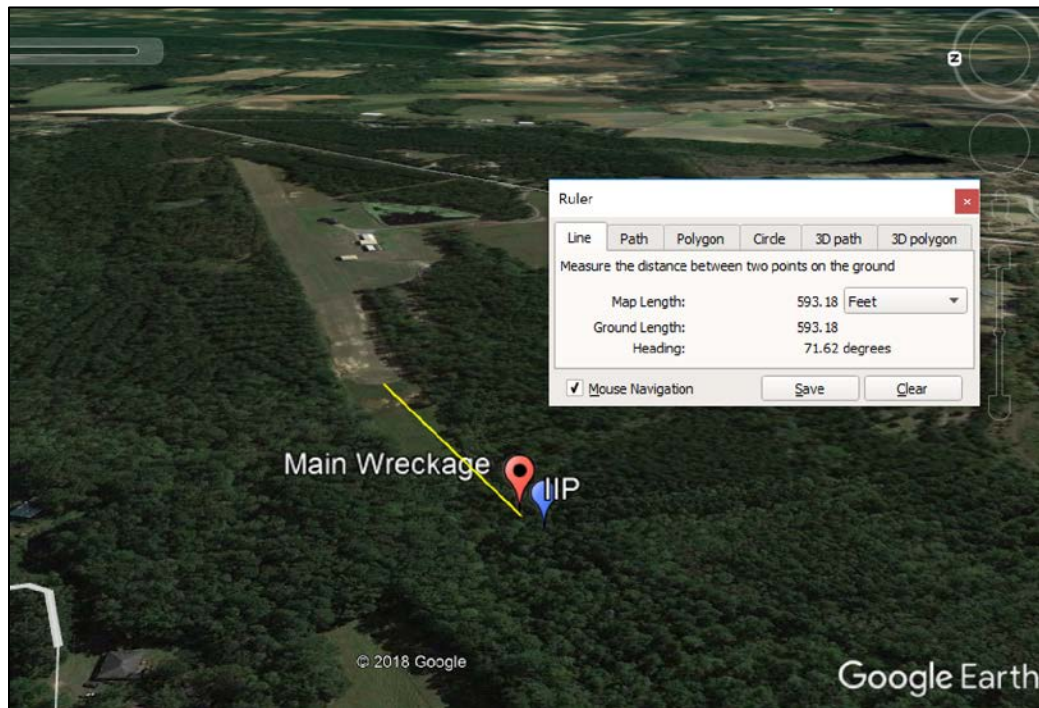
*Figure 1: Accident site location and initial impact point in relation to runway 9-27 at 84NC*

The initial impact point and main wreckage were co-located in heavily wooded terrain about 590 feet from the runway 9 threshold at 84NC. The airplane was found inverted oriented on a 050° heading. All major components of the airplane were found with the main wreckage; flight control continuity was established from all flight control surfaces to the cockpit. The left aileron had separated from its attach point and was found about 10 ft forward of the main wreckage. All other control surfaces remained attached to their attach points.

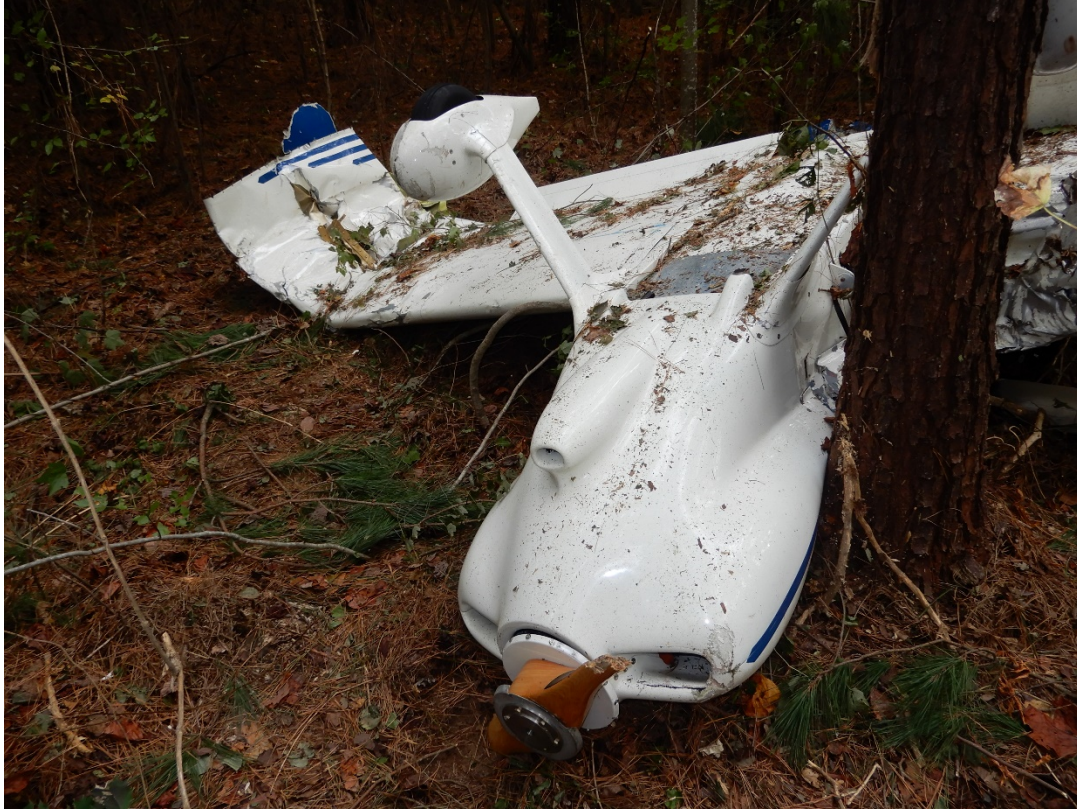
*Photo 2: View of airplane at the accident site, inverted (NTSB Photo)*

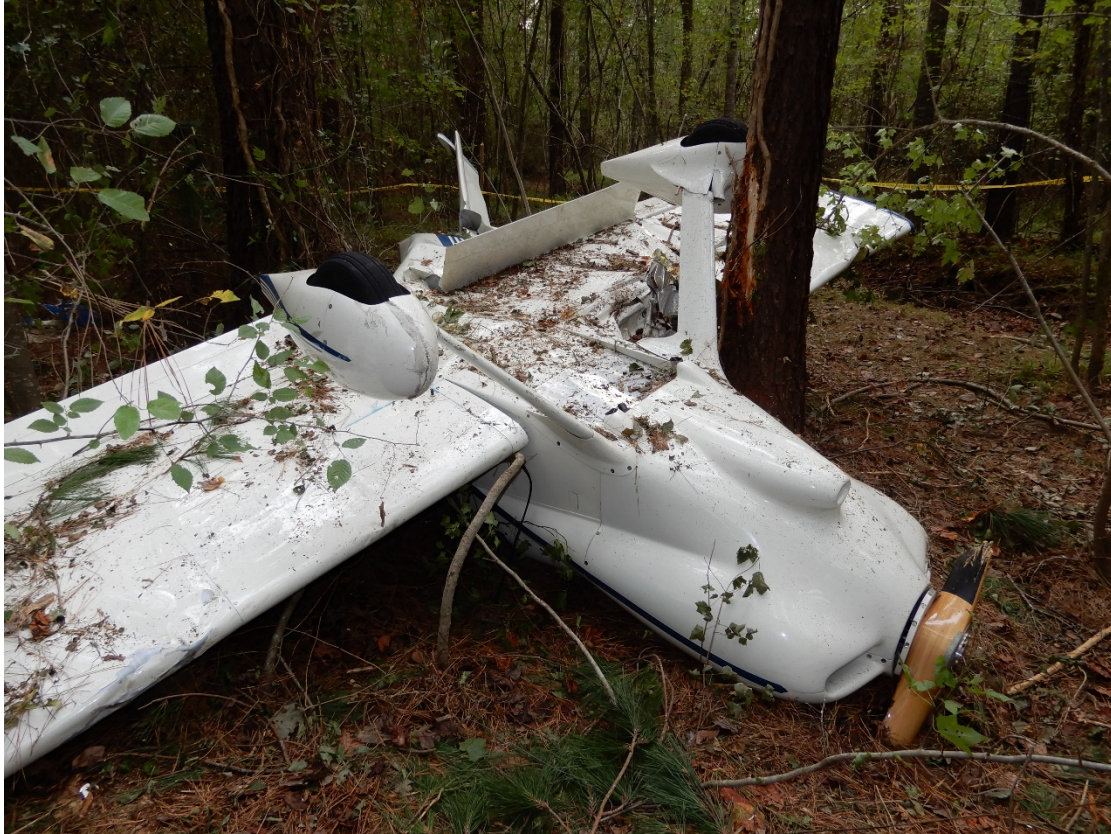
*Photo 3: Additional view of the accident airplane inverted (NTSB Photo)*

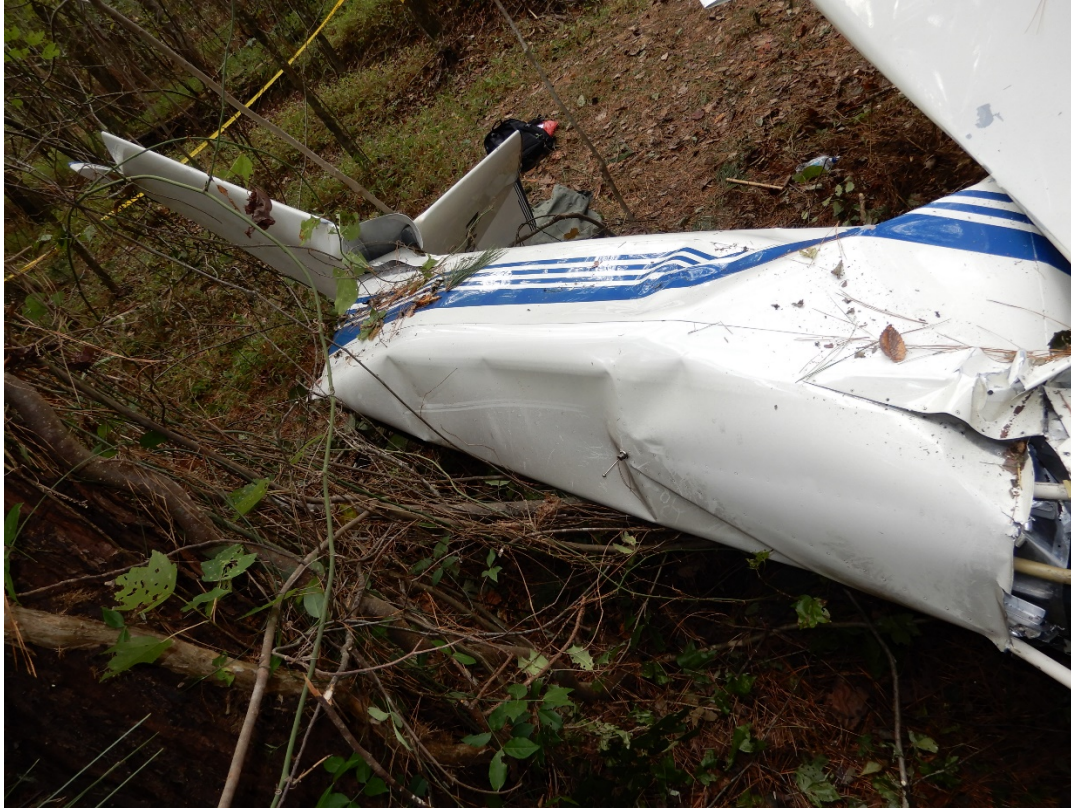
Fuel remained in the left wing and was observed to be leaking; no debris was noted in a fuel sample and it tested negative for water when exposed to water finding paste. The inboard portion of the right wing displayed significant aft crushing and no fuel was present in the wing as the fuel tank had been breached. The left and right flaps were found partially extended. Elevator trim continuity was established from the cockpit to the control surface.

*Photo 4: View of the aft portion of the fuselage and empennage (NTSB Photo)*

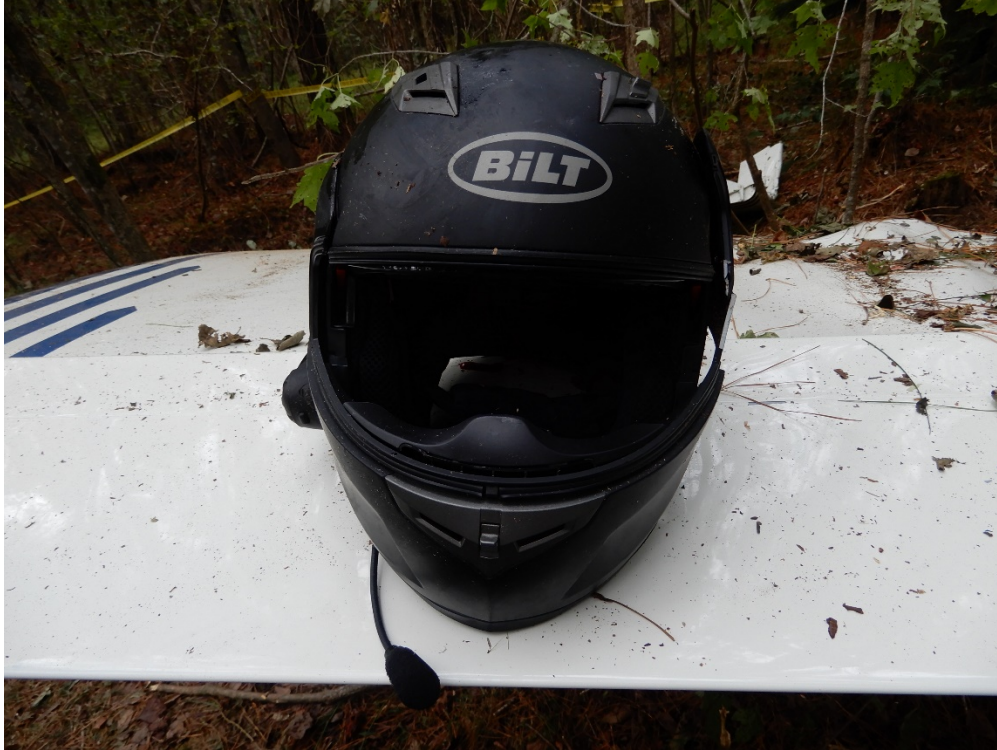
According to first responders, the pilot was wearing the motorcycle helmet that had a full-face mask, the 5-point harness remained buckled and was cut during the recovery. The roll bar in the cockpit area also remained intact and was cut during the recovery. The cockpit, instrument panel and seat remained largely intact. It was equipped with a panel mounted Garmin 296 GPS unit. Refer to the GPS Factual Report for information on the data extracted.

*Photo 5: Motorcycle helmet found at the accident site (NTSB Photo)*

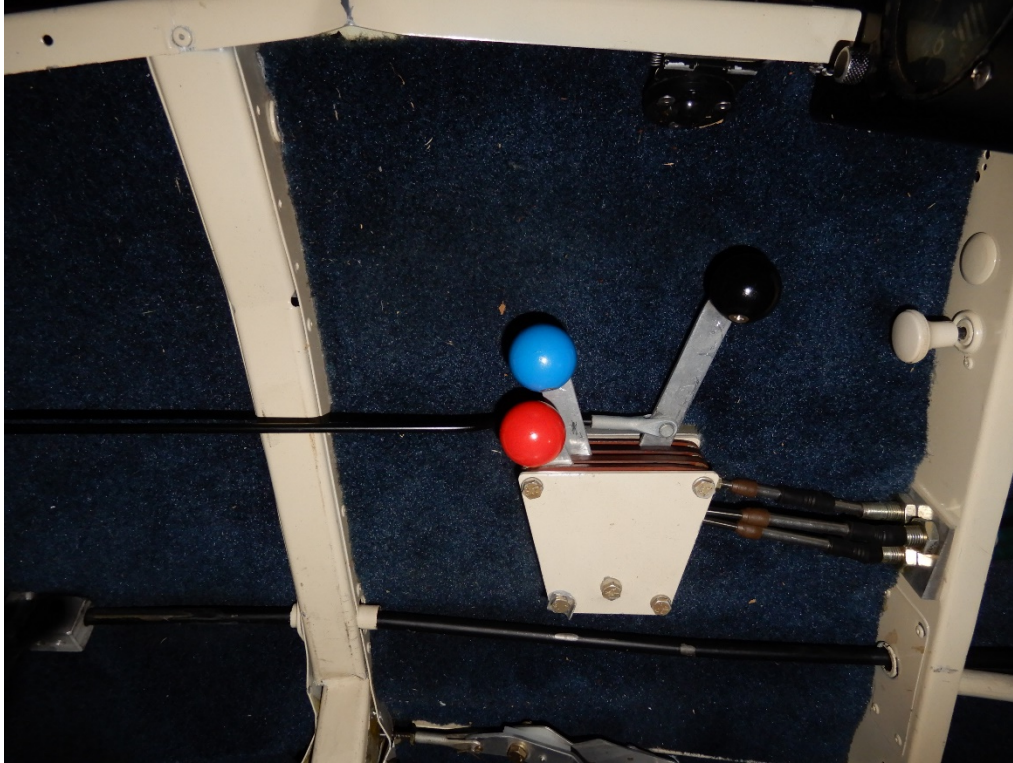
The ignition was found on both, the fuel selector was selected to the right tank, and the primer lever was stowed. The throttle lever (black lever) was found full forward; the mixture (red lever) and propeller levers (blue lever) were found full aft (idle-cut-off). The canopy, nor were any canopy fragments located.

*Photo 6: Throttle, propeller and mixture levers as found at the accident site (NTSB Photo)*

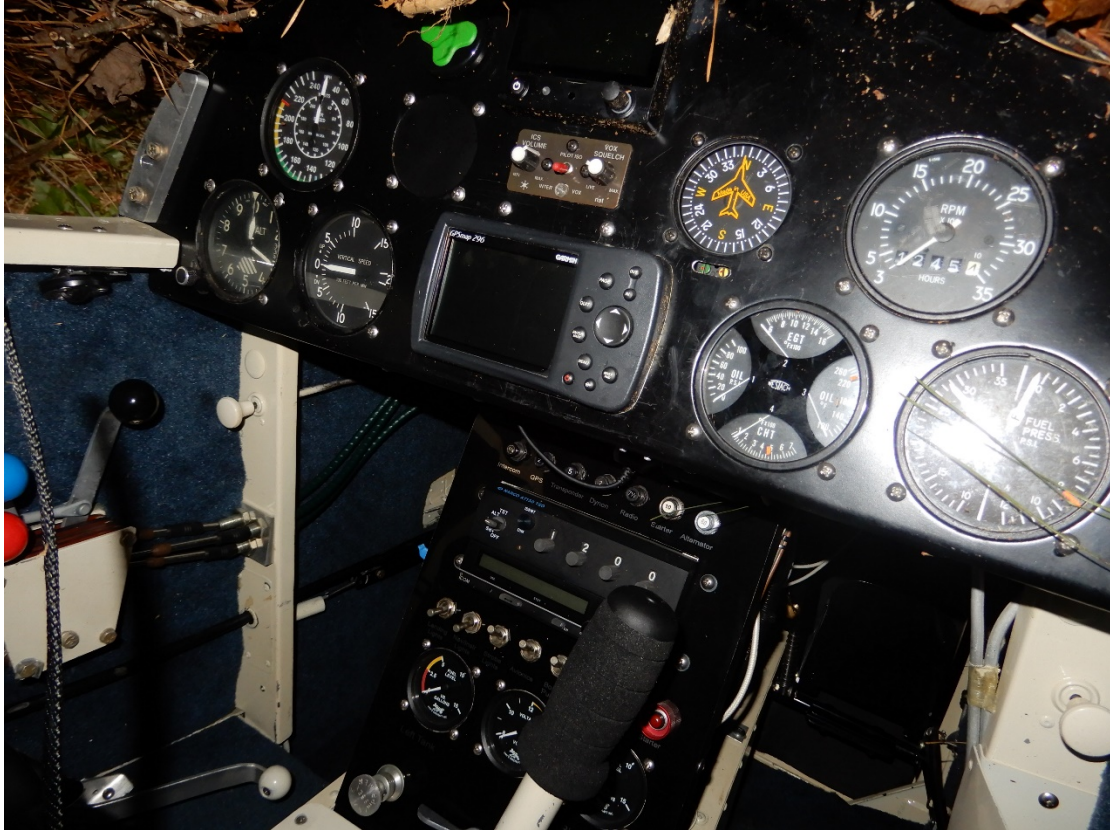
*Photo 7: View of the cockpit (NTSB Photo)*

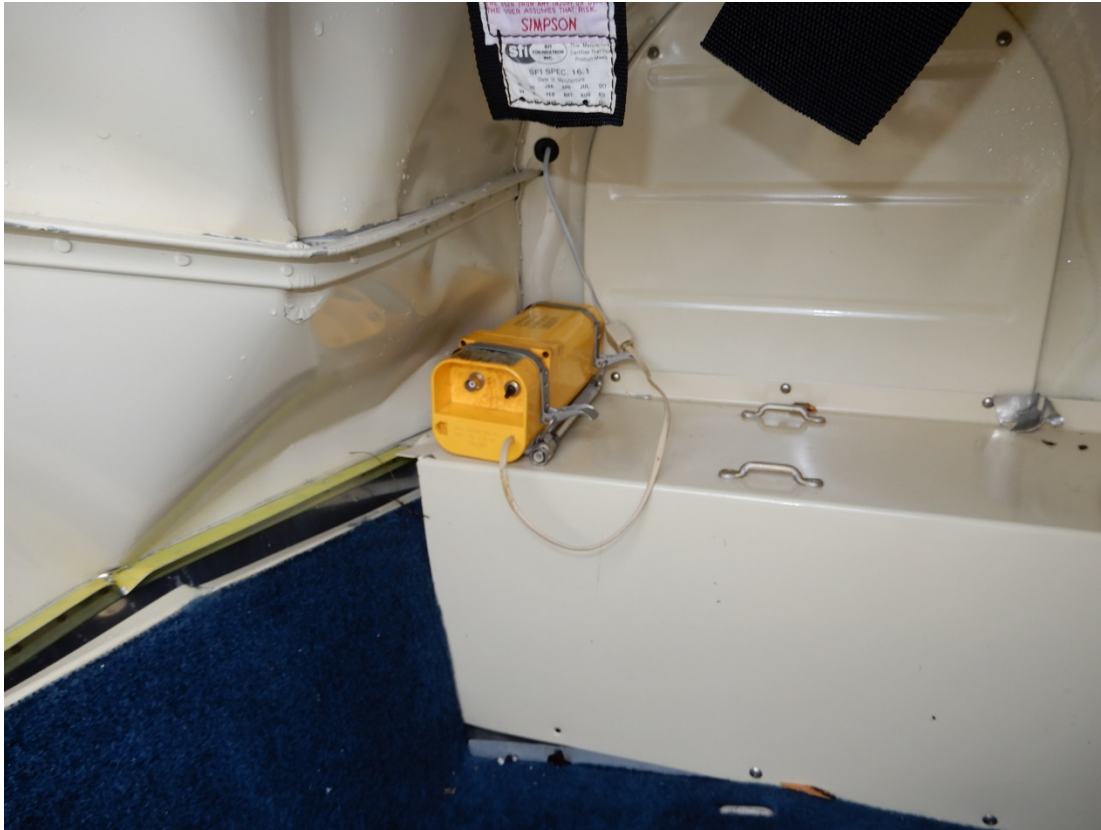
An emergency locator transmitter (ELT) was installed near the baggage compartment along the airframe and was set to the arm position. A telephone cable wire was found plugged into the ELT and was connected to the ELT on/ test switch in the cockpit. The ELT was not found connected to an external antenna. During a postaccident test, the ELT was dropped from a height of about 10 ft; an emergency beacon sound was heard immediately after it contacted the ground on the frequency 121.5 via a handheld aviation radio.

*Photo 8: Emergency locator transmitter as found (NTSB Photo)*

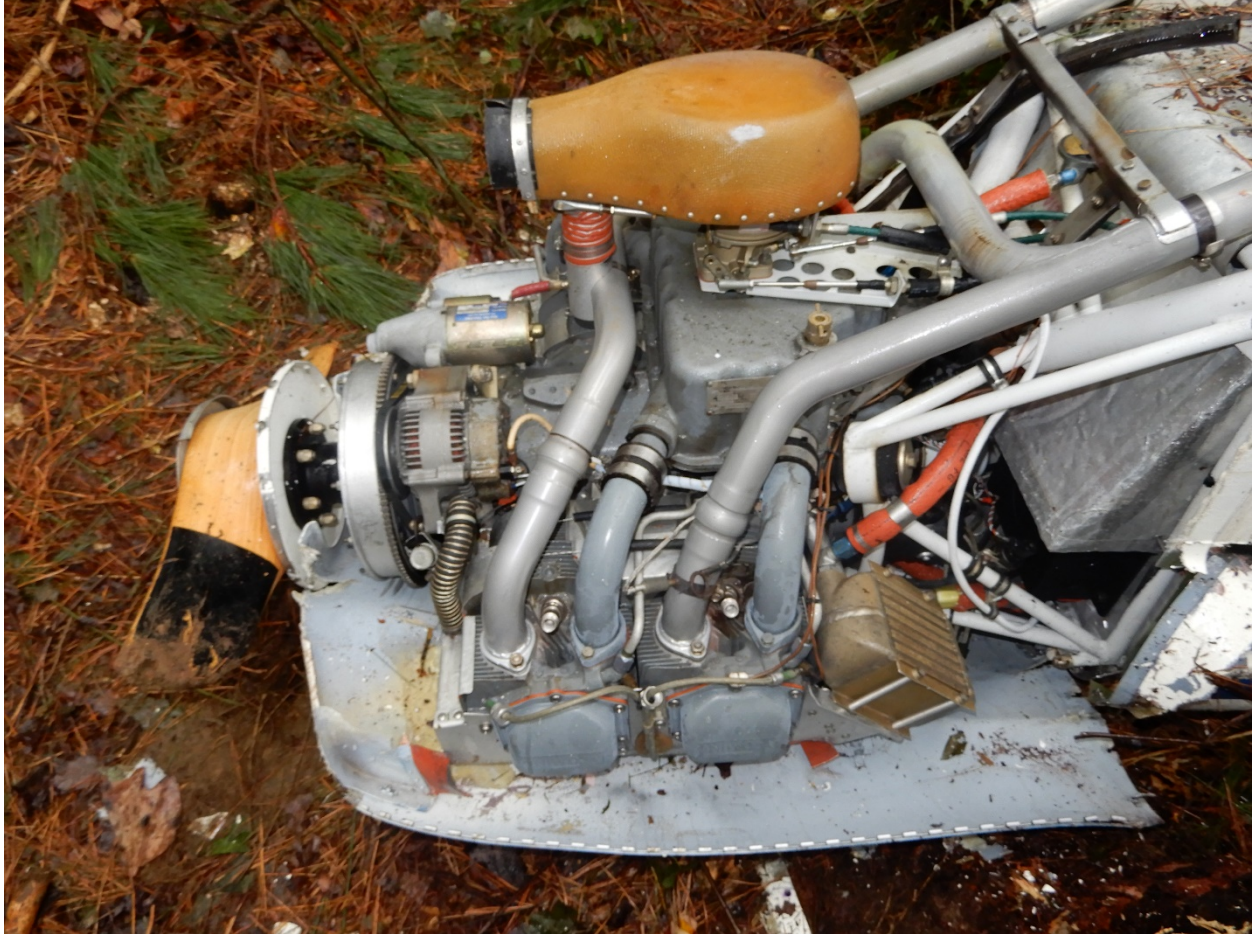
The engine remained attached to the engine mounts. The majority of the wooden propeller blades separated from the hub and were splintered. During an engine examination, the remnants of the propeller were rotated by hand and valve train continuity was established. All cylinders remained attached to the crankcase and thumb compression and suction was attained on all cylinders. All spark plugs sparked during engine rotation; each were removed and displayed normal operating and combustion signatures.

*Photo 9: View of the engine with the cowling removed (NTSB Photo)*

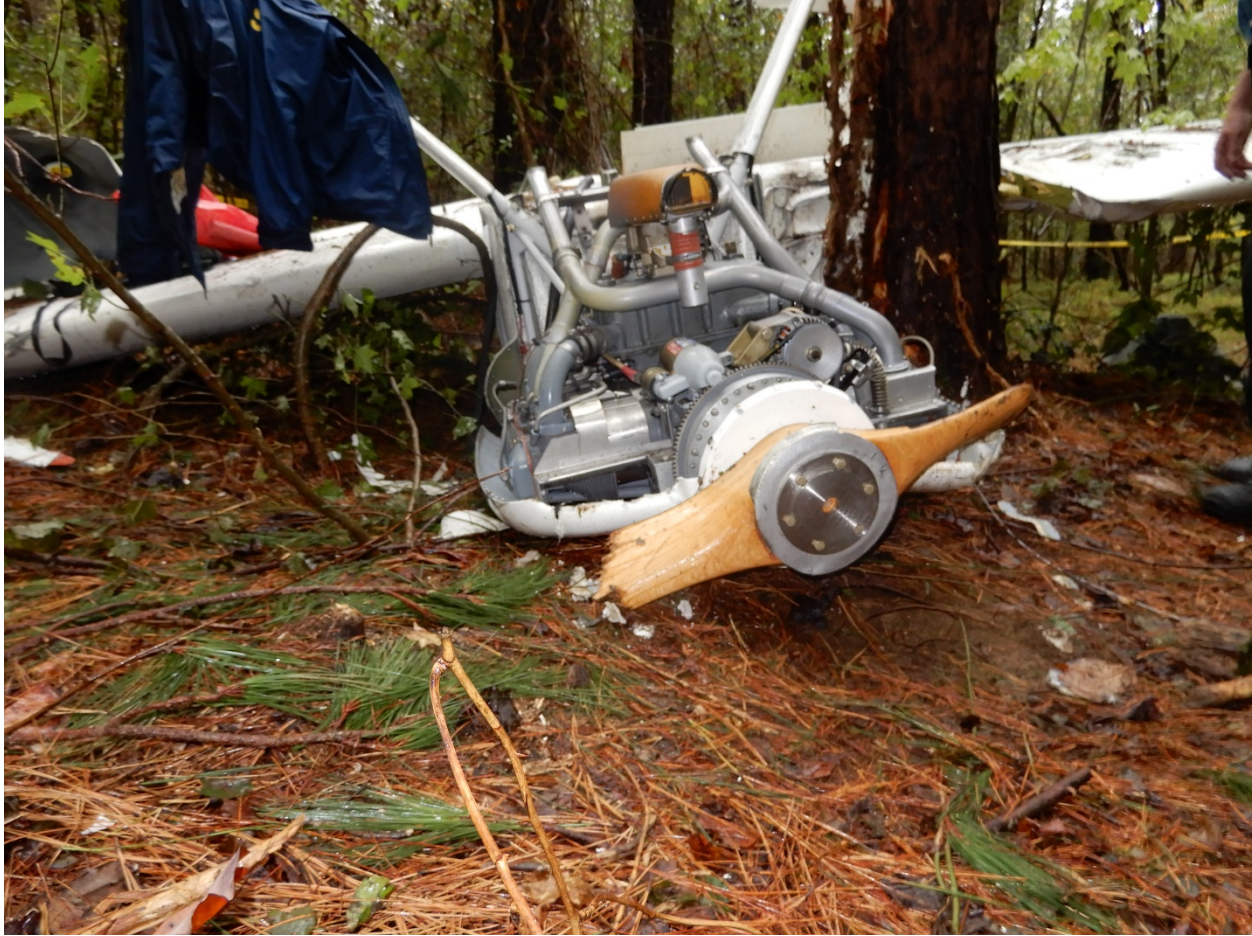
*Photo 10: View of the propeller fragments and hub (NTSB Photo)*

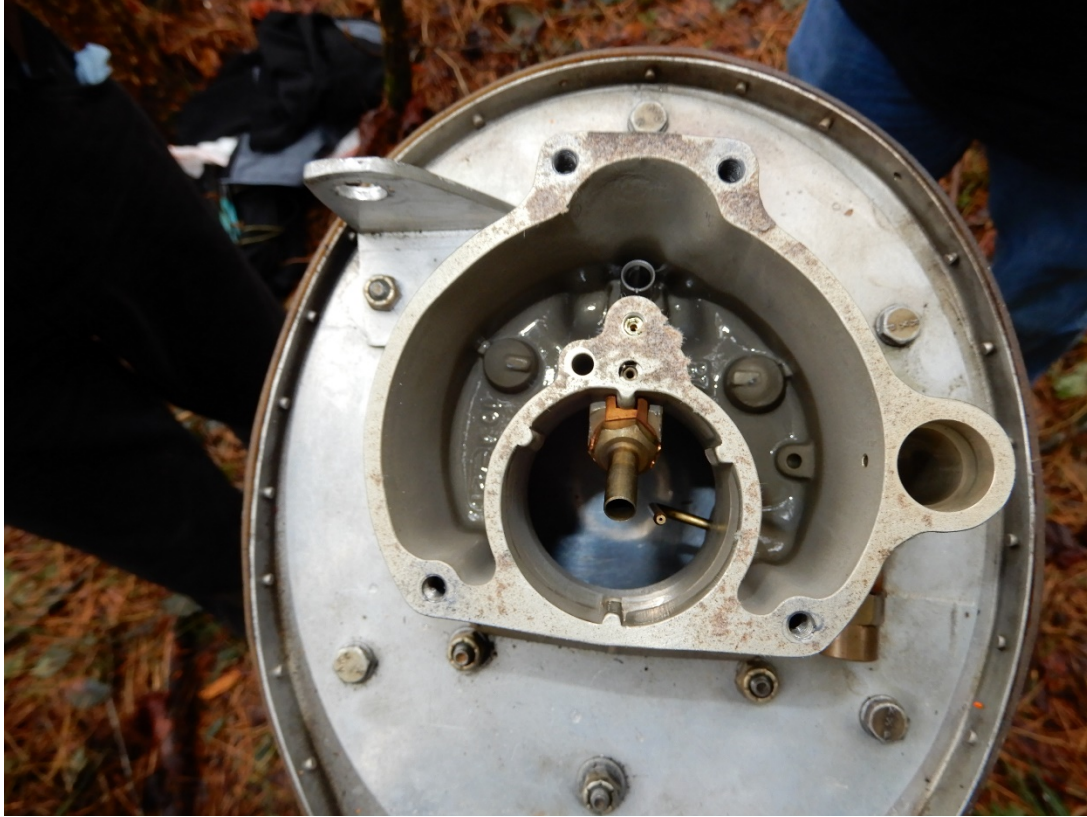
The carburetor remained intact and attached to the engine, the butterfly valve remained attached to the throttle arm and moved freely. The carburetor was disassembled; the carburetor floats were intact, and no debris or fuel was observed in the bowl, and the venturi needle was clear of debris. The smell of fuel was present in the bowl. The engine oil was observed to be black in color and no metal or debris was observed.

*Photo 11: View of the carburetor partially disassembled (NTSB Photo)*
